SPRING 2018

VOLVO TECHTIPS

Information for the Independent Volvo Specialist

5-CYLINDER HEAD GASKET REPLACEMENT

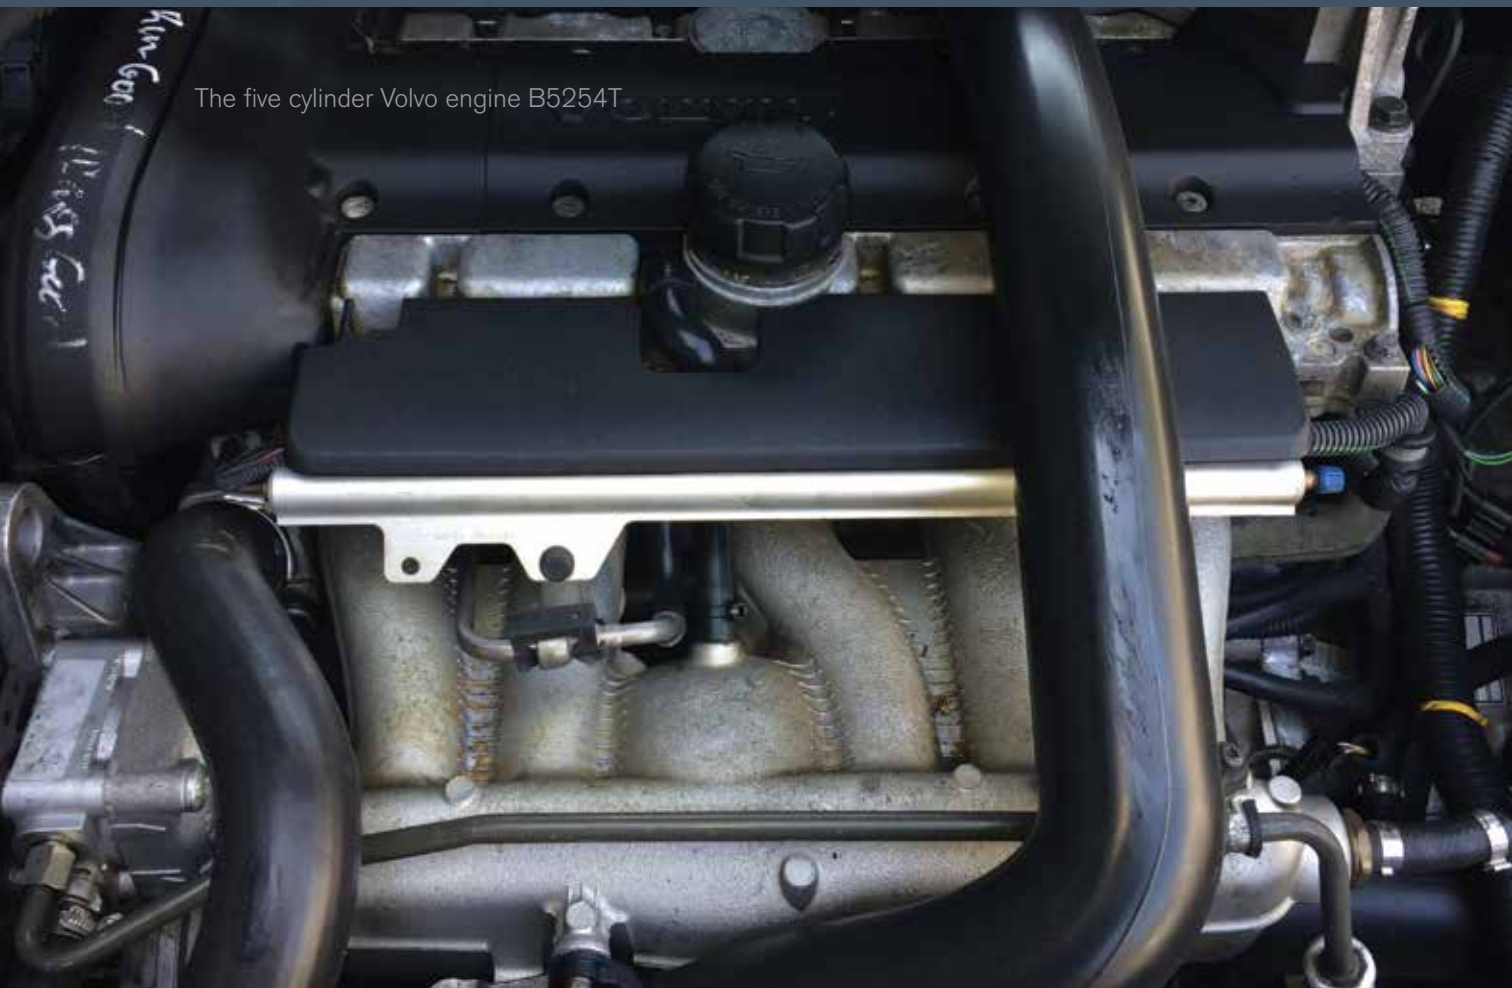
The five cylinder Volvo engine B5254T

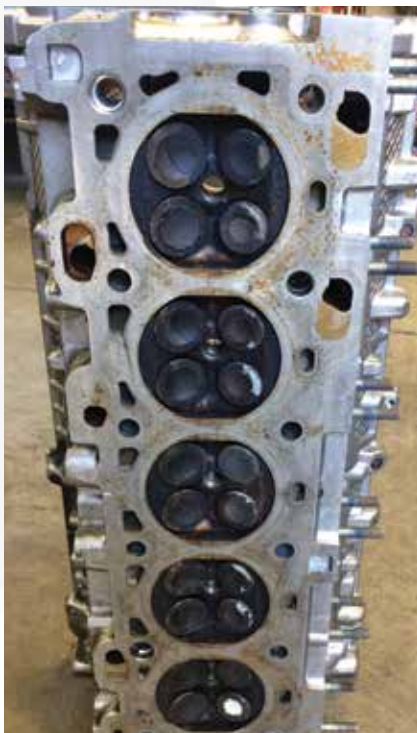
Cylinder head removed

you need to slide the head towards the intake side in order to remove it. When setting the cylinder head down use two small 2x4s to set it on. Remove the head gasket and you should be able to see what part of the gasket failed.

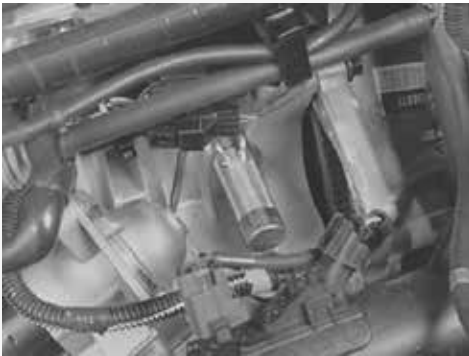
Be sure to use the special tool behind the starter to make sure the crankshaft is aligned during reassembly.

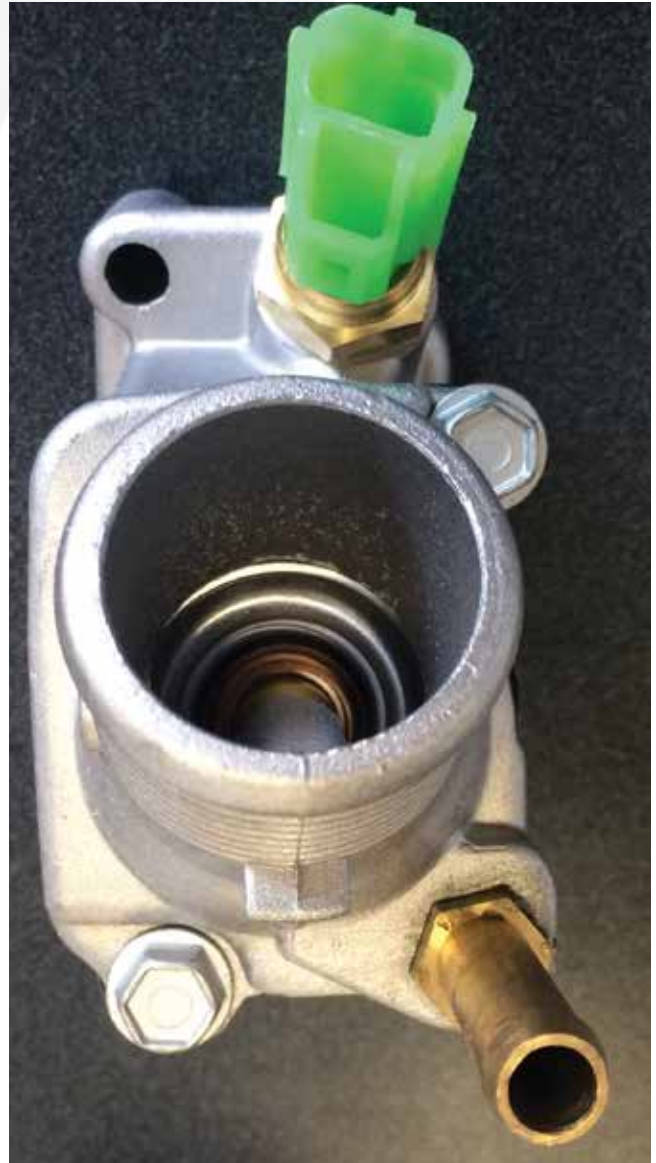
The coolant temperature sensor is right in the thermostat housing as shown.

Install the thermostat housing and replace the thermostat and sensor. It's always a good idea to replace this sensor since it may be compromised due to previous wear and overheating.

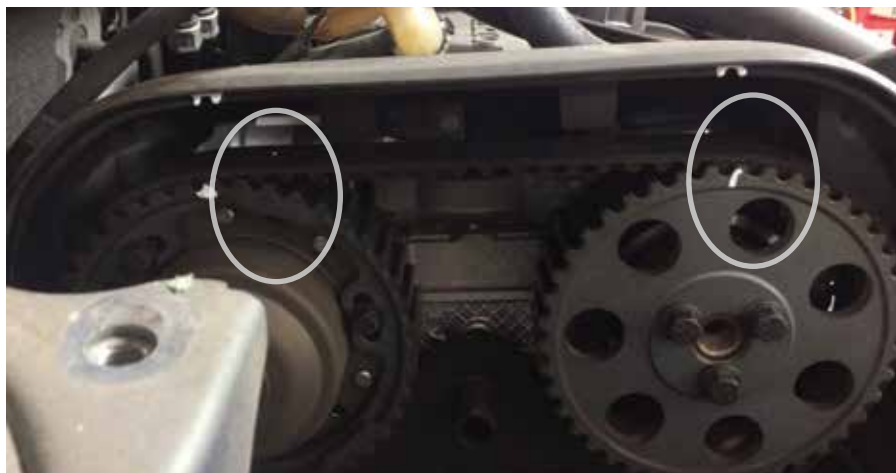
9995719

Here are the marks when lined up correctly.

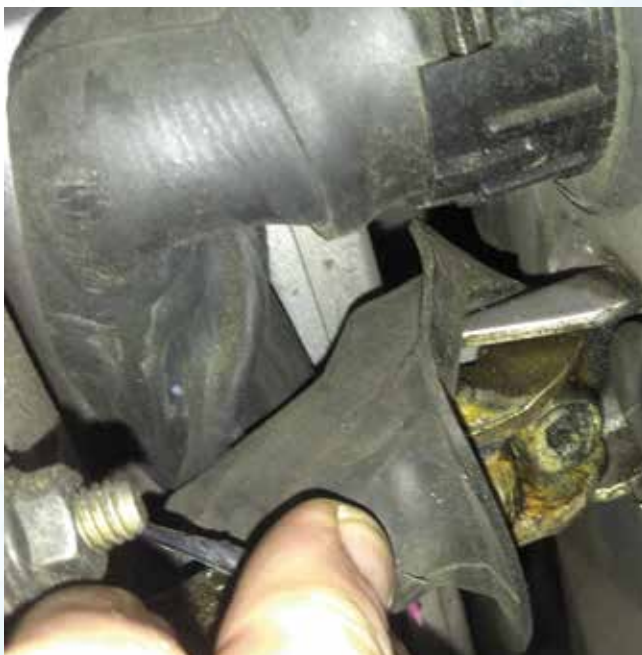
If you work on a lot of older Volvos, you have probably opened a door or two to the sound of a loud 'POP' or 'CRACK' noise, caused by cracks in the body where the door stay is attached. In most cases, this is a repair that can be done in house and, if done properly, can last for years to come.

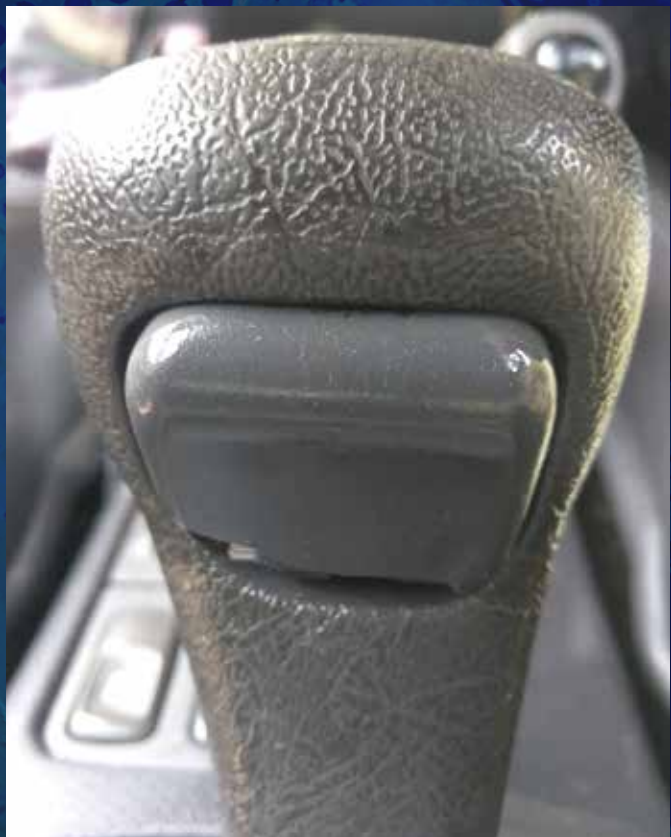
If you are test driving a customer's Volvo and you feel a jagged edge on the lower part of the shift button, you should recommend replacement of the shift knob assembly before a sticking button causes a real problem for the customer.

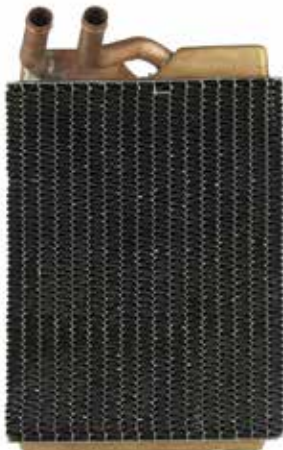
Older 240 style

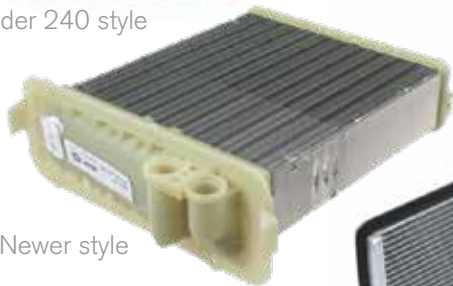
Newer style

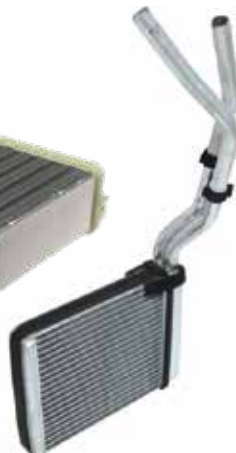
Examples of different heater cores

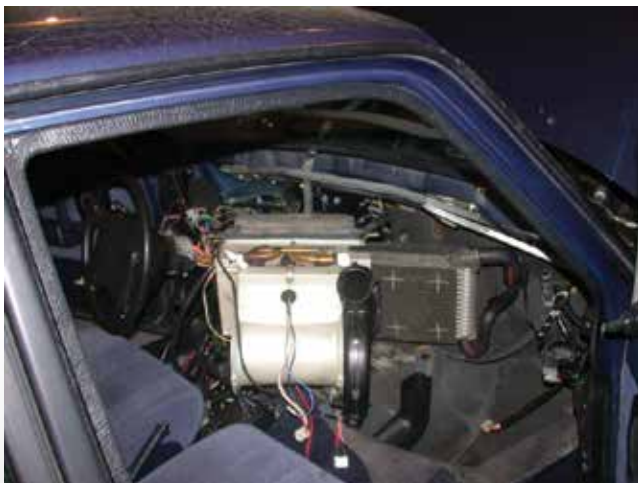
Heater core box from 240 modules

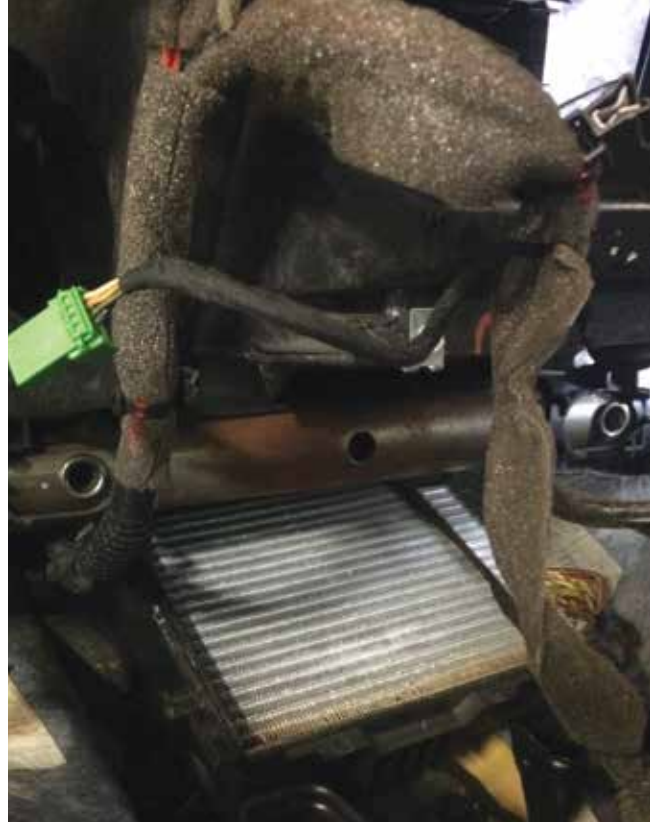
Here is a 2006 Volvo S40 heater core in dash, exposed.

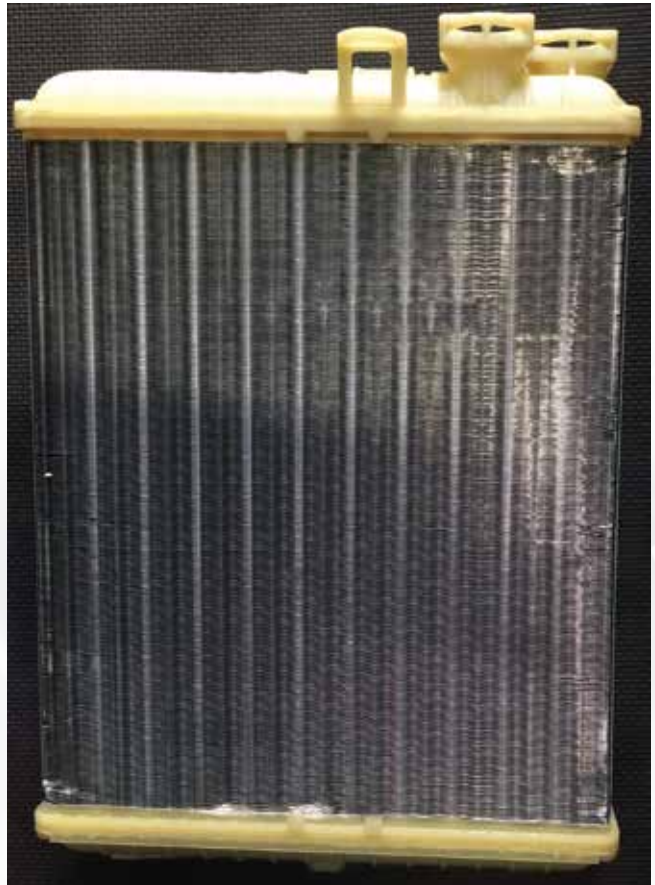
Heater core in 850 Volvo

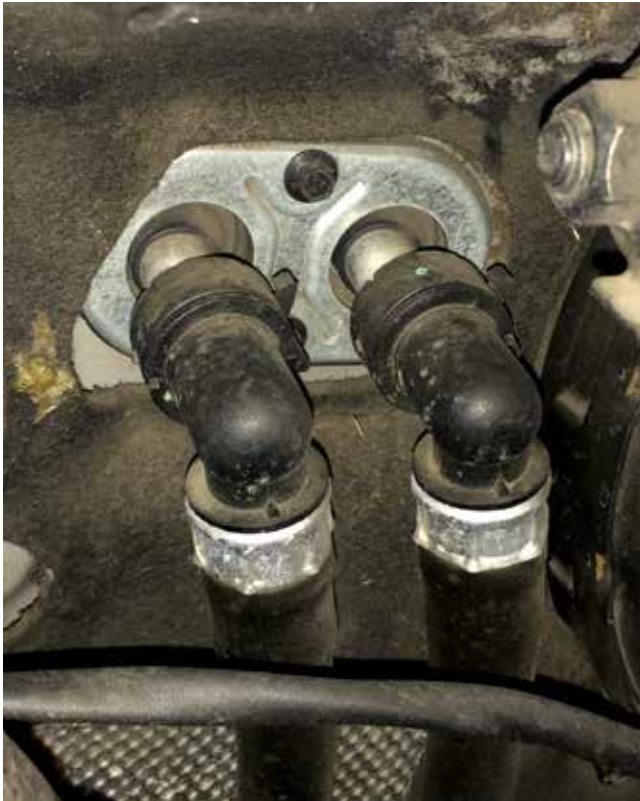
Example of heater hose connector under the hood at the firewall

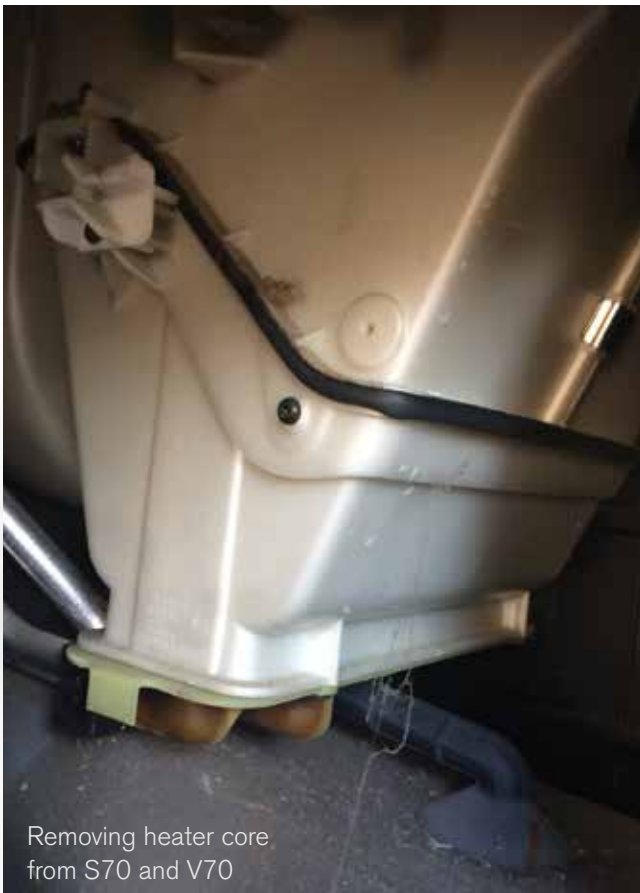
Removing heater core from S70 and V70

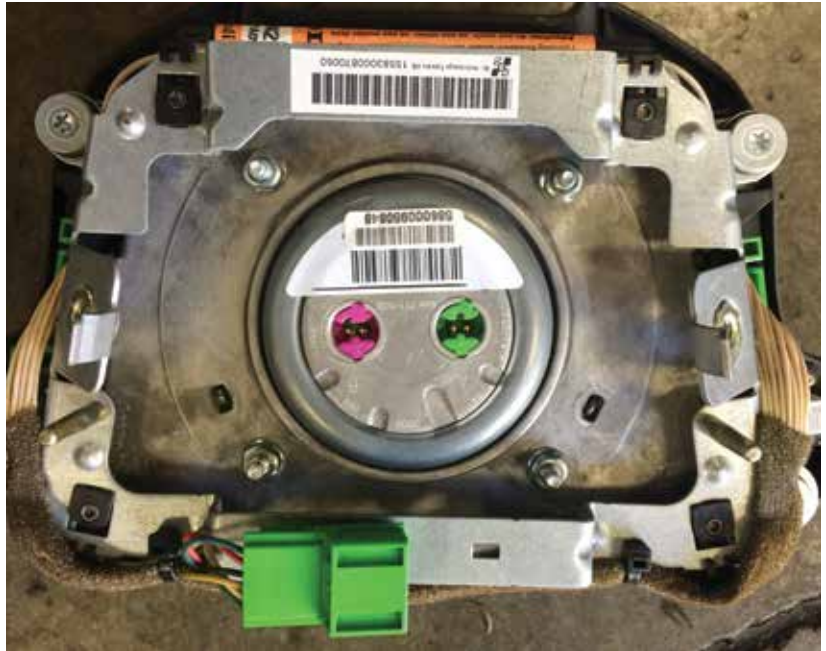
Connectors at air bag, driver's side

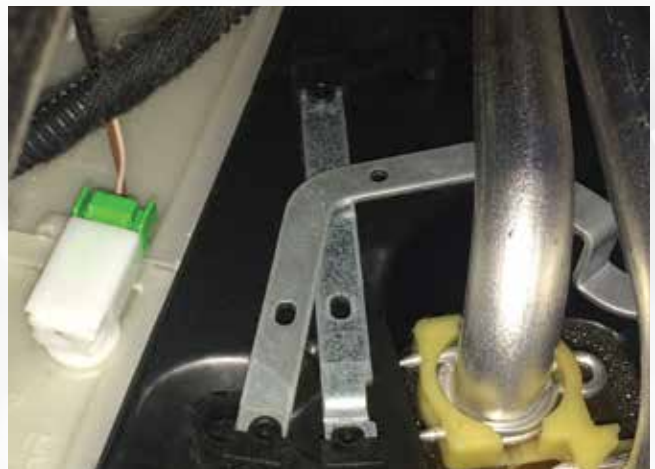
Here are the control levers that need to be moved.

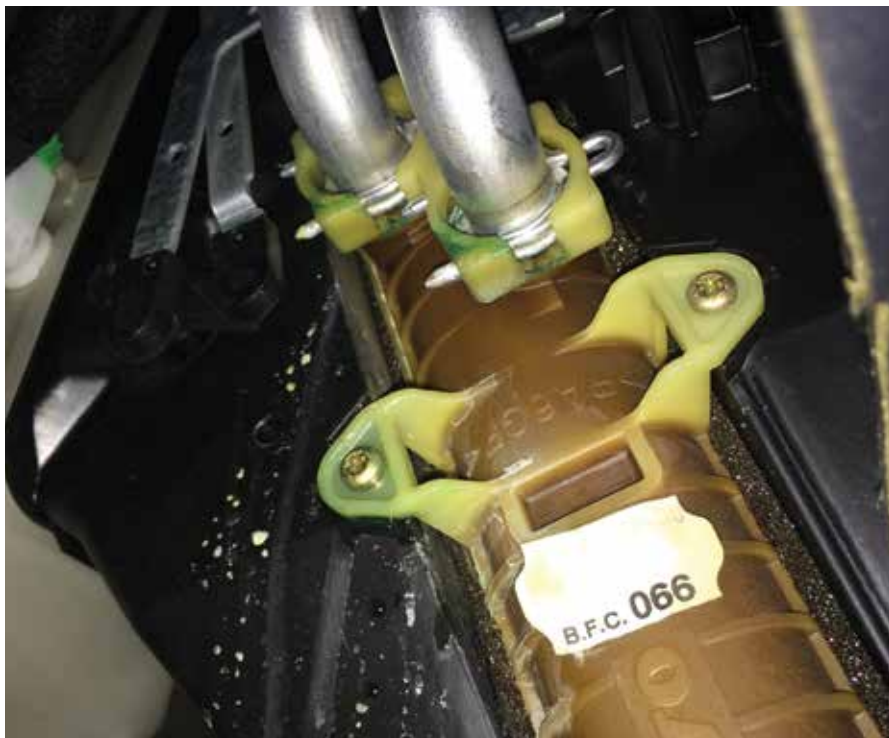
Hard pipes going into the heater core

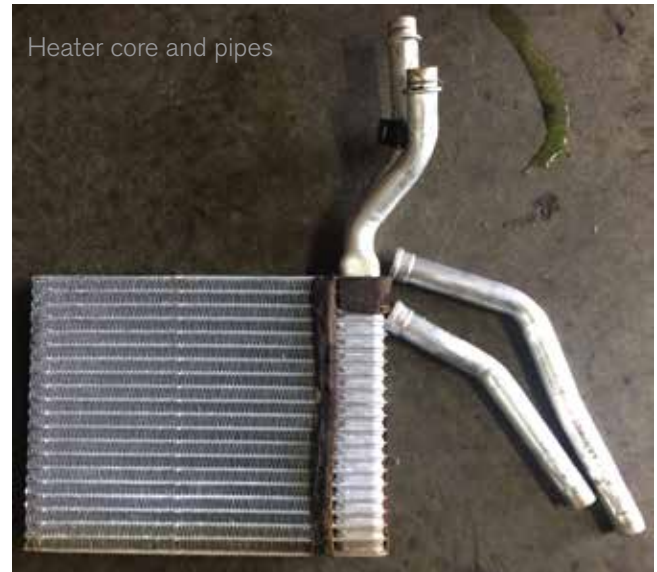
Coolant pipes connected at heater core for removal

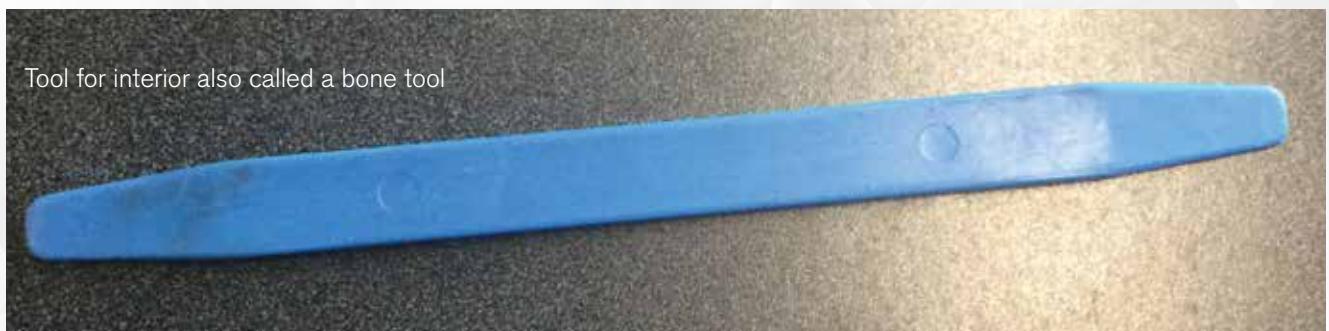
Tool for interior also called a bone tool
