CLIMATRONIC

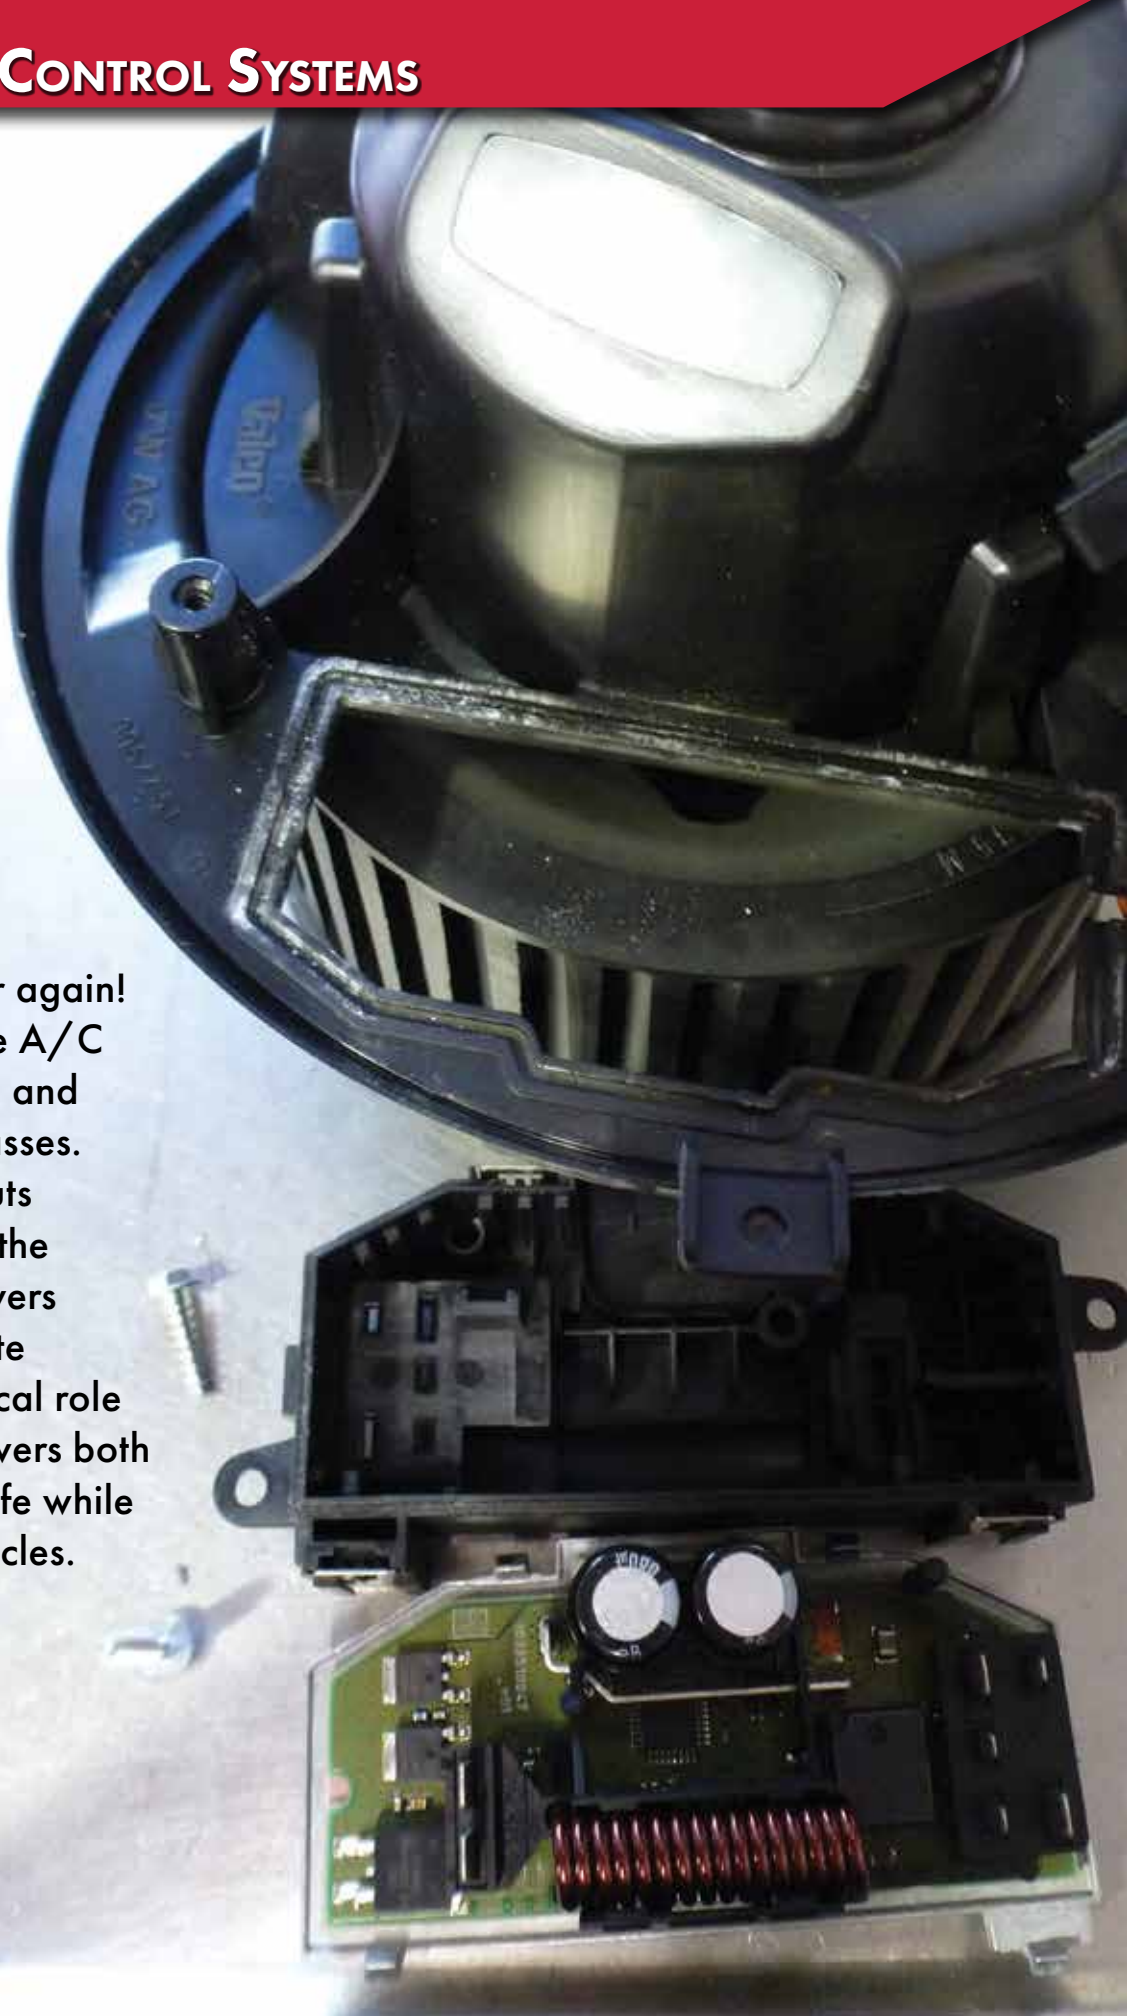
Shown Here: Easily serviced, the blower and resistor can usually be accessed and replaced in minutes on many Audi models.

If the blower only operates at the high-speed setting, it is likely the resistor has failed, requiring replacement. When the resistor has failed, the blower motor receives full 12 volt power. This is generally the high-speed setting on the control head. This allows limited blower function, aiding in safety for the driver. Replacing the resistor is normally a straightforward operation. After removal of the passenger side lower cover, the blower motor and resistor pack are visible and accessible for replacement and testing. Thanks to the work of Audi design engineers, few tools and little time are needed to get to this piece of the HVAC system.

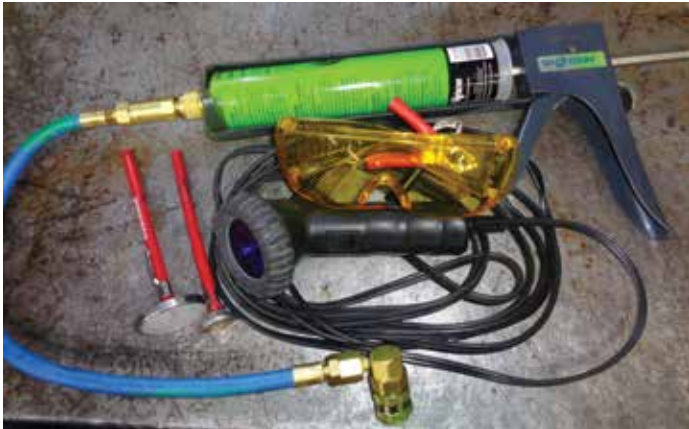
Dont forget the basics! Thermometers for the dash vents, and UV for the leaks!

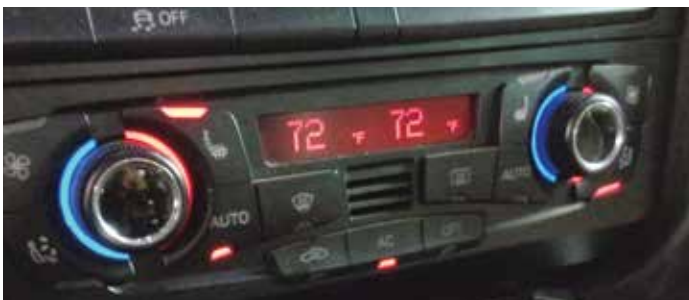
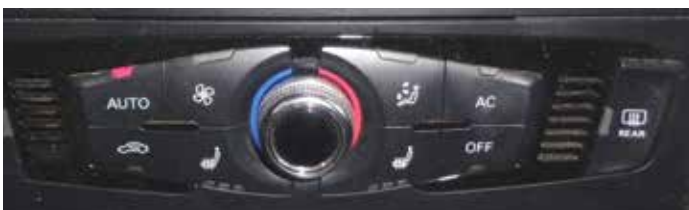
Audi has streamlined and simplified the climate control in this dual zone interface, integrating heated seats as well in the control surface.

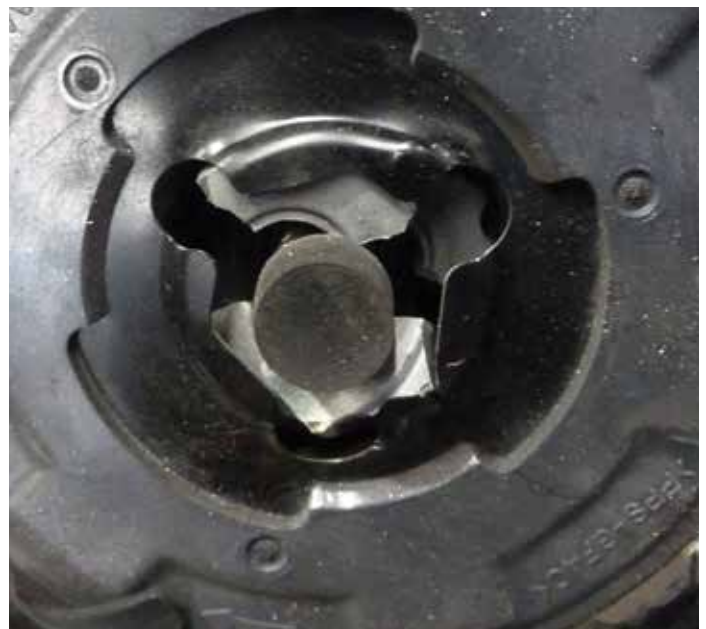
This compressor was exhibiting a clunking noise.

locking up if it becomes damaged. This pulley design also dampens the compressor from engine forces. Often, a low or empty refrigerant level can cause pulley failure. The refrigerant and oil normally act as lubricants, keeping the inside of the compressor spinning smoothly. Without them, overheating of the internals may occur, causing extreme drag and eventual pulley failure.

If the compressor exhibits strange noises or customers complain of drive belt noise, it is wise to inspect the compressor pulley. Using a stethoscope is a good way to localize these strange noises and isolate them from accessories. Visual inspection is also possible but may be difficult without removing the dust cap on the front of the compressor. When the pulley has separated, bits of material may remain on the bearing surface, creating loud noise as it spins.

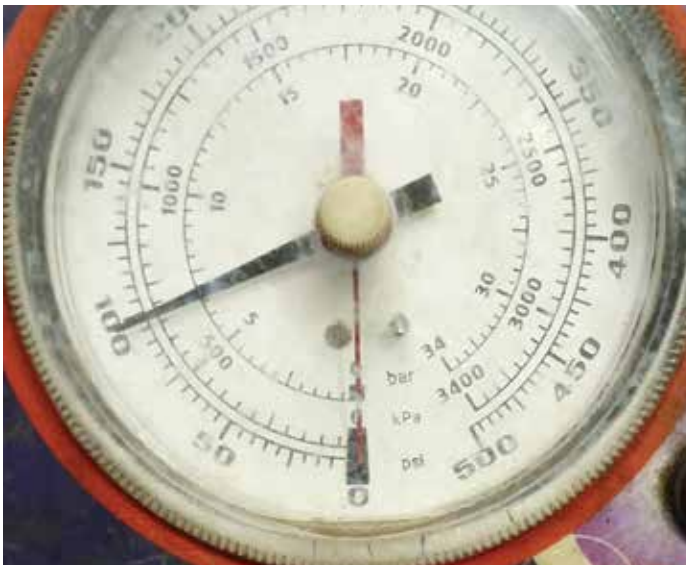
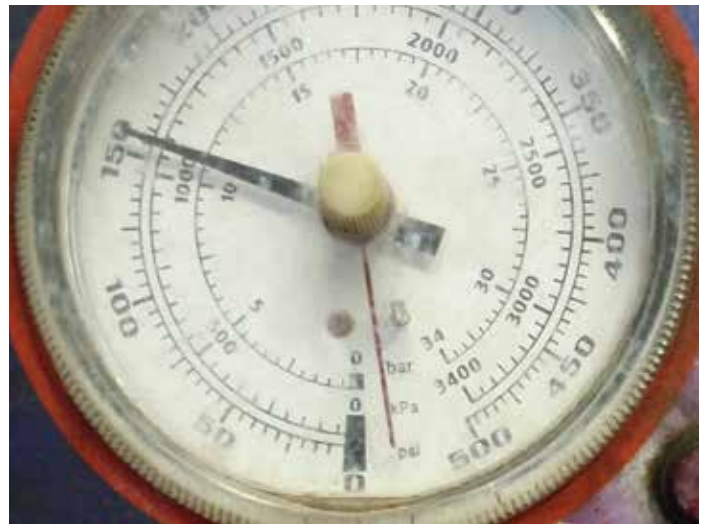
This image shows an inactive system with refrigerant pressure even on both low and high sides.

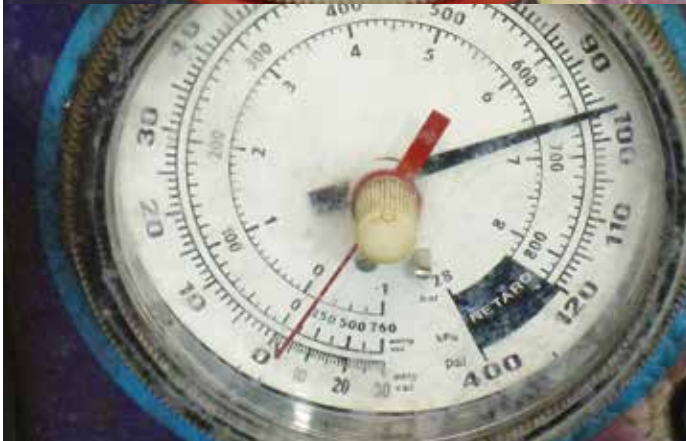
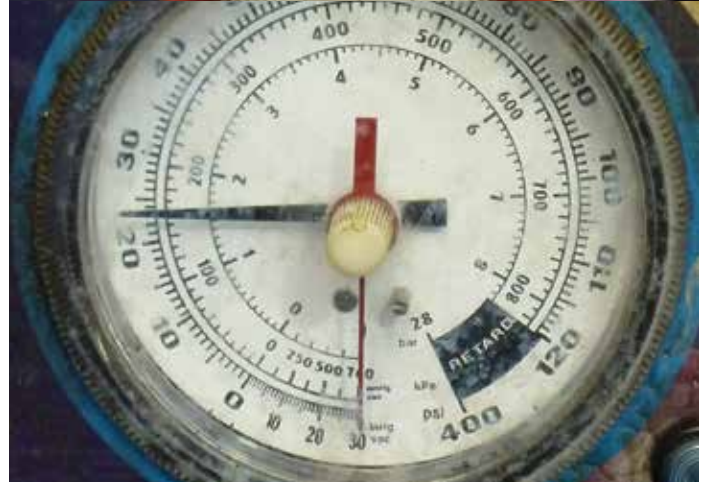
This is a great pressure drop reading from a properly operating A/C system.

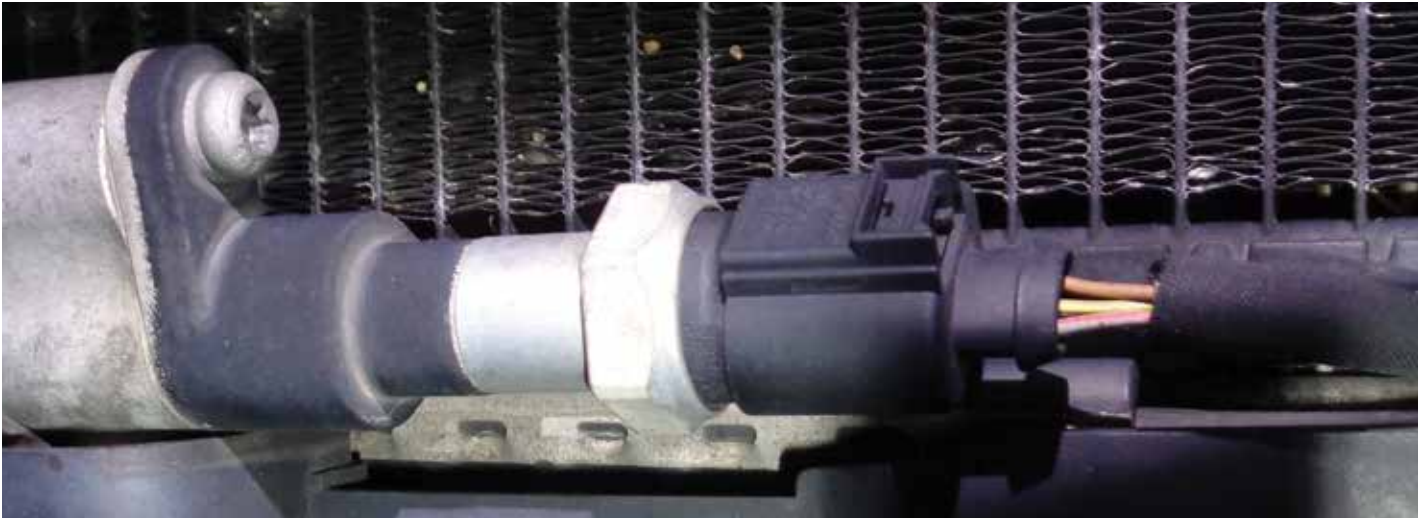
This sensor is readily visible through the front grille of most late model Audi vehicles. Always check this area if leaks are suspected.

The G395 high-pressure sensor has become a common failure item on Audi models. This sensor often leaks refrigerant into the sender body, destroying the internal components. In extreme cases, refrigerant leaks externally through the sensor itself, depleting the refrigerant charge.

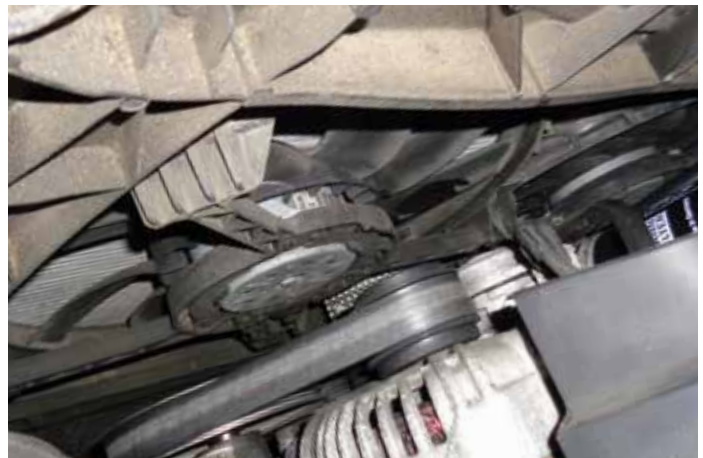
Both fans must work properly for effective A/C operation!

The electric cooling fan is a necessary component of the climate control system. When the refrigerant is forced through the condenser at the front of the vehicle, the vapor is condensed into a liquid. This thermal reaction creates a lot of heat. When the vehicle is moving, air is naturally forced through the condenser where the refrigerant is cooled. In stop and go traffic, the electric fan is especially needed to pull air across the condenser. The electric fan helps dissipate the heat, which can otherwise increase engine coolant temperatures to unsafe levels if left unchecked.

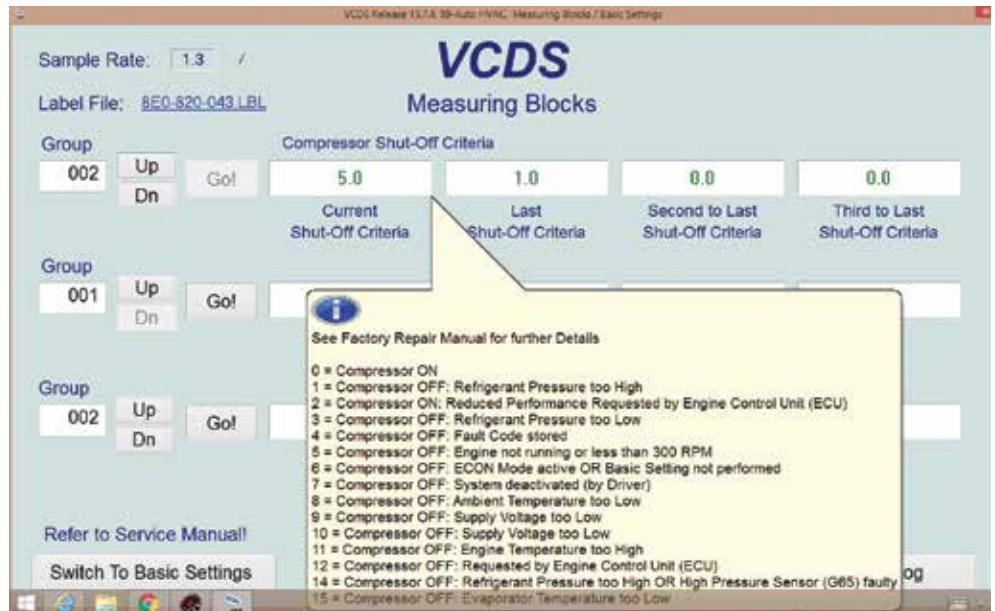
These shutoff criteria can be extremely valuable when tracing climate control issues.

As part of programming, if failure of the electric cooling fan or fan control module occurs or if refrigerant pressure is too high, the A/C system will be disabled. This ensures that the engine coolant level does not reach unsafe levels. It usually triggers a fault code to store in the control unit, aiding diagnosis. The fans report to the engine control unit, not the climate control unit, so faults are stored there. It is also possible to run activations on the electric fan to test for proper function. If the fan is bad, this limits the A/C system's operation. The Climatronic control unit stores shut-off condition information that can directly identify faulty components.

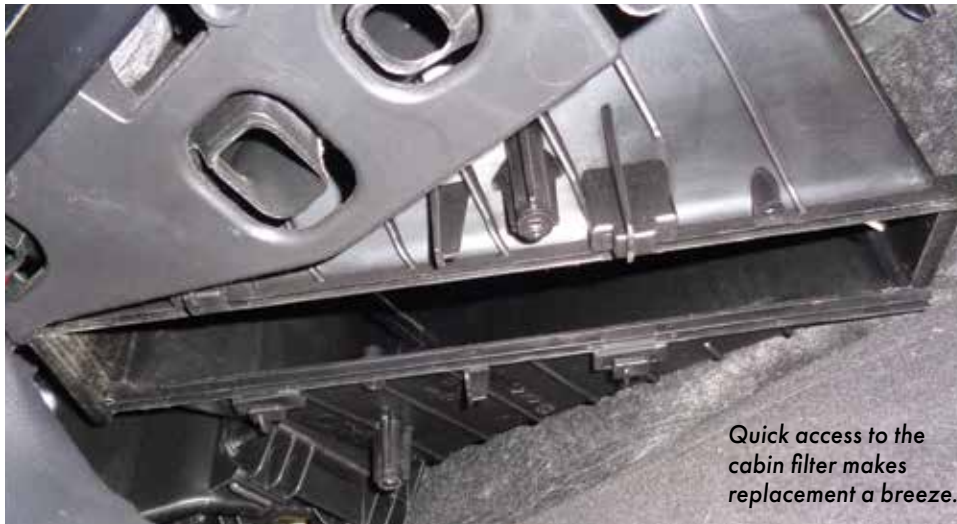
Quick access to the cabin filter makes replacement a breeze.

The cabin filter on most Audi models is located under the passenger side knee bar. Replacement can be done in minutes with only a lower cover to remove and a slide lock cover to access the filter. Be sure to clean up after replacing the filter; excess leaves and plant material usually fall out of the blower casing when the filter is removed.
