HIGH MILEAGE VOLVOS

Broken shifter rocker arm on 2001-XC70/V70/XC90/S60/S40/V50/C30/C70 Volvo equipped with Geartronic automatic transmissions.

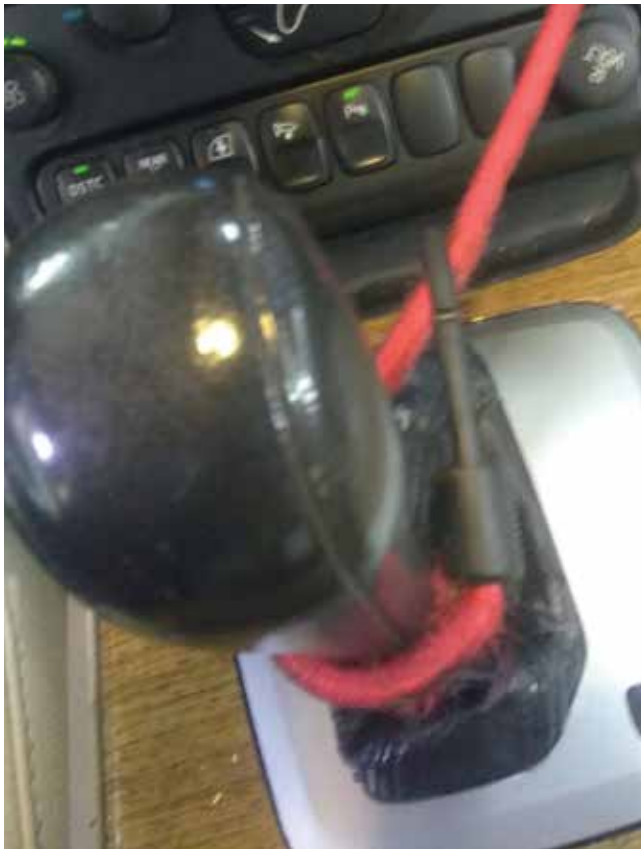
In most cases this condition is caused by a part of the shifter's rocker arm or claw assembly being cracked or broken.

If you have a customer bring a Volvo in with a rope tied to the shifter to keep it from popping out of Drive, your customer probably needs to have the shift rocker arm assembly replaced.

Now you will be able to see the rocker arm in all its broken or cracked glory.

View of the broken rocker arm

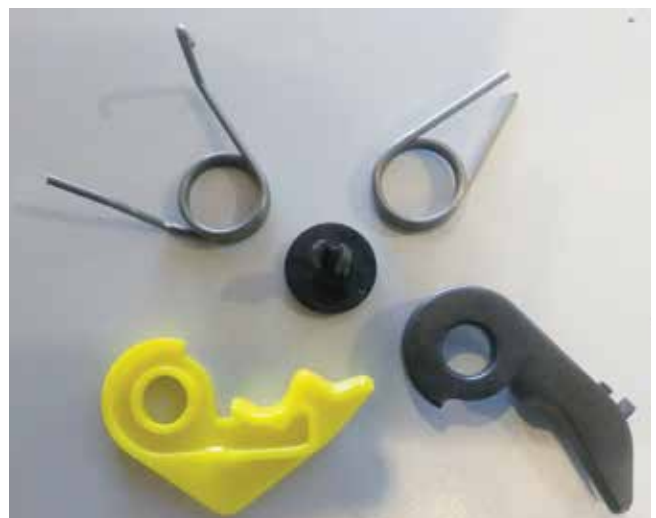
Volvo has a parts kit (No. 9463559) available that includes all the parts you will need to properly repair this condition.

And in most cases the shifter can be repaired with an inexpensive parts kit that is available from your local Volvo dealer's parts department. The Volvo part number is 9463559.

At this point if nothing else is broken but the rocker claw parts (usually the yellow claw part), you can proceed to change out the parts that are included in the parts kit 9463559.

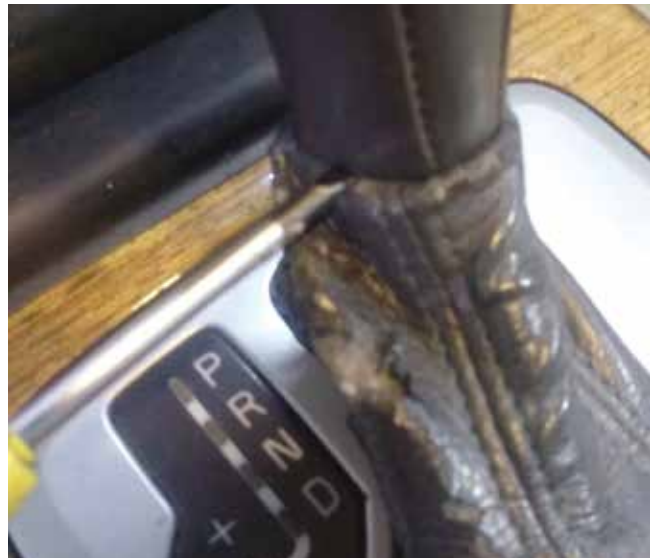
Insert a small screwdriver between the boot and the gear selector lever knob to access the lock bracket.

Insert a small screwdriver between the boot and the gear selector lever knob to access the lock bracket. Carefully pry the screwdriver forward so that the lock bracket detaches from the gear selector lever knob.

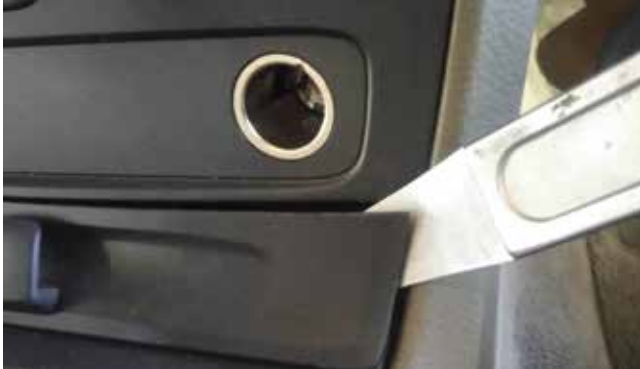
Pry out the panel at both ends. Use a "bone" or similar tool to pull the panel straight out.

Pry out the panel at both ends. Use a "bone" or similar tool to pull the panel straight out.

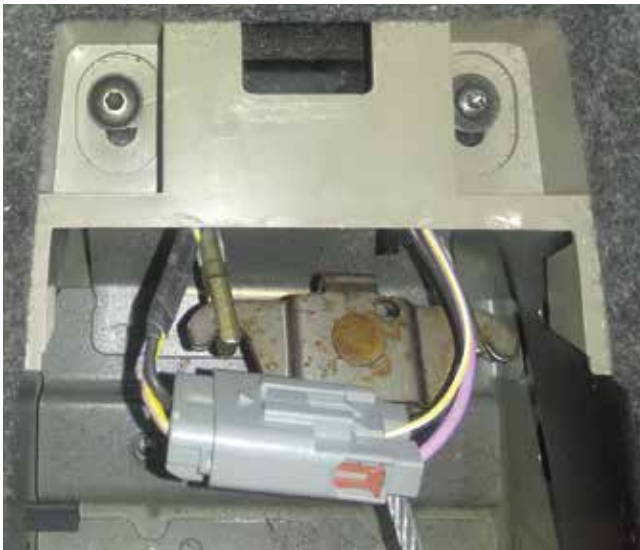
Open the arm rest and remove the contents and cover at the bottom that hides the two T25 screws, then remove them.

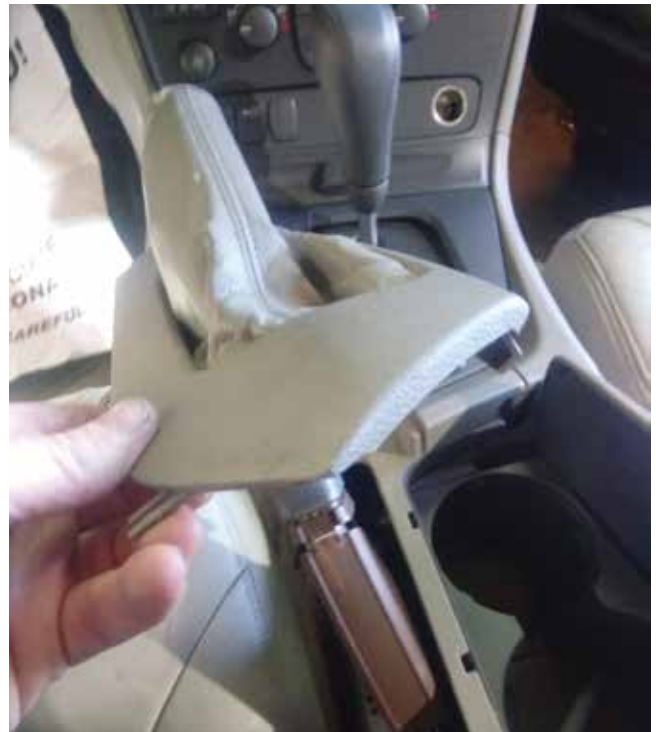
Pull the panel that has the boot for the parking brake towards the driver's seat and then pull the boot and cover over the parking brake handle to remove it.

Now pull the panel that has the boot for the parking brake towards the driver's seat and then pull the boot and cover over the parking brake handle to remove it.

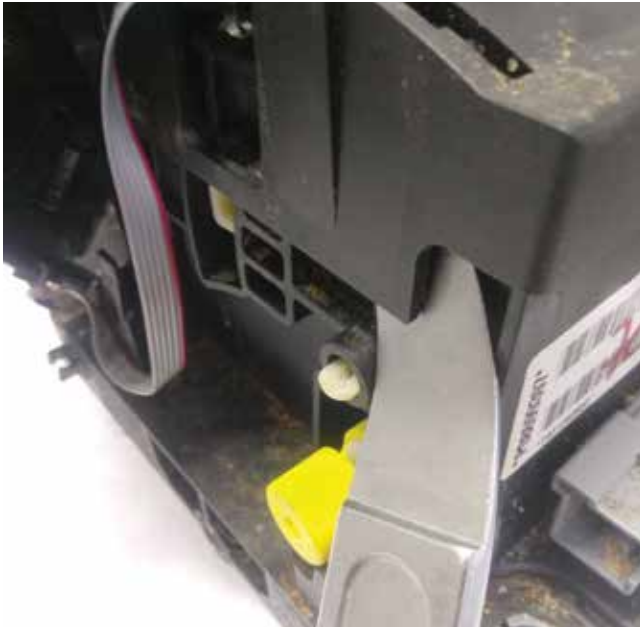
Use a panel tool to pry under the sides of the top cover at the back while pulling up at the rear.

Use a panel tool or small screwdriver to carefully pry under the sides of the top cover at the back while pulling up at the rear. Once it releases, pull it up and over to the side; you can leave the wire harness connected.

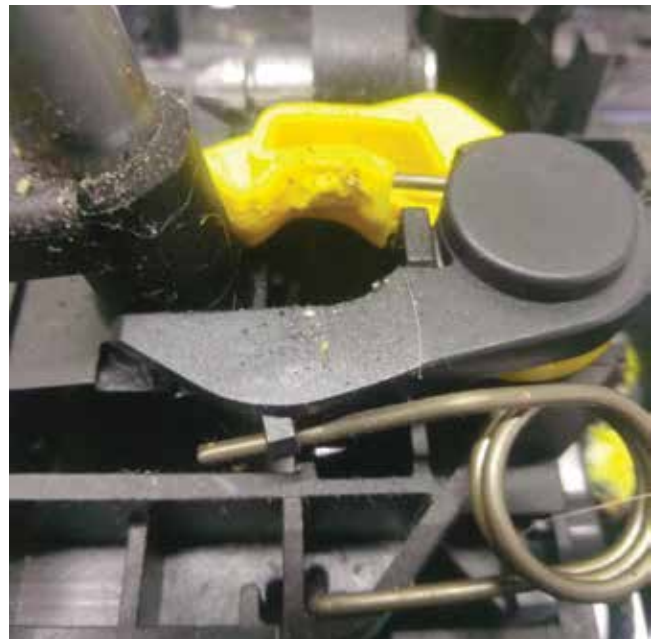
At this point if nothing else is broken but the rocker claw parts (usually the yellow claw part), you can proceed to change out the parts that are included in the parts kit 9463559.

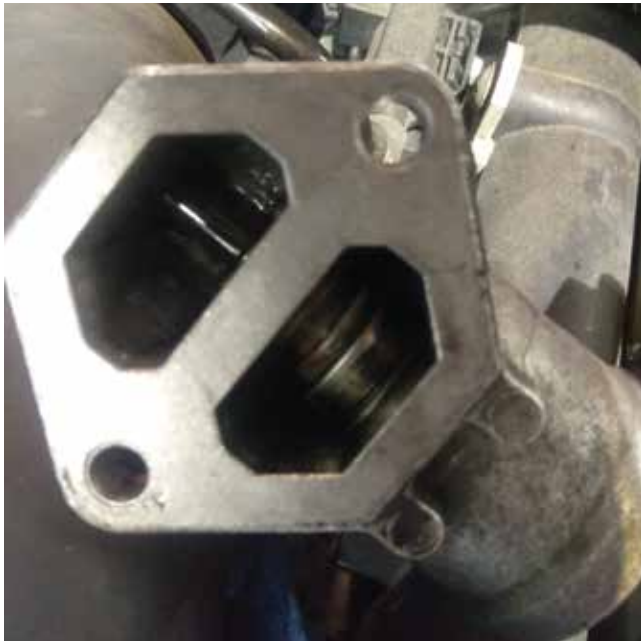
Next, always make checking for intake air leaks part of your test procedure; using a smoke tester is a great way to do this. If there are no leaks in the intake and no other smoking guns, you should remove the IAC valve and test it. If you have VIDA you can command the valve to operate in the Vehicle Communication tab.

Or you can bench test the valve by applying power and ground directly to the pins on the valve.

In most cases the valve will be full of carbon and will be stuck or sticking when you apply power. You could clean the valve and put it back on with a new gasket, but replacing the valve and gasket with new Volvo factory parts will make sure you have a repair you and your customer can count on.

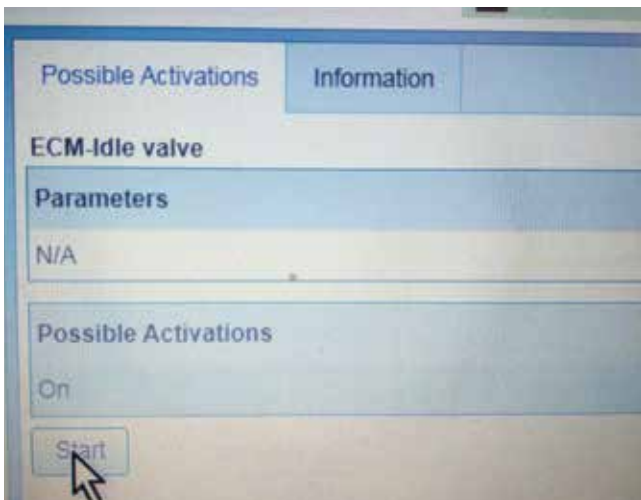
Using VIDA, you can command the valve to operate in the Vehicle Communication tab.

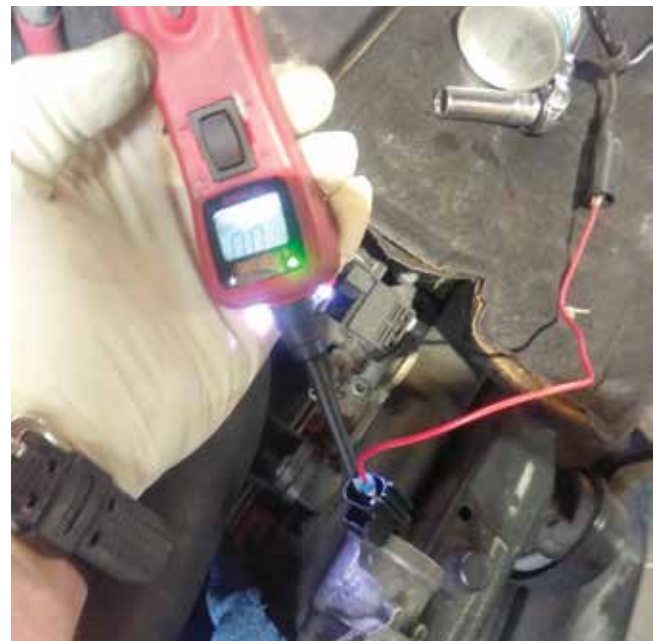
Bench test the valve by applying power and ground to the pins on the valve.

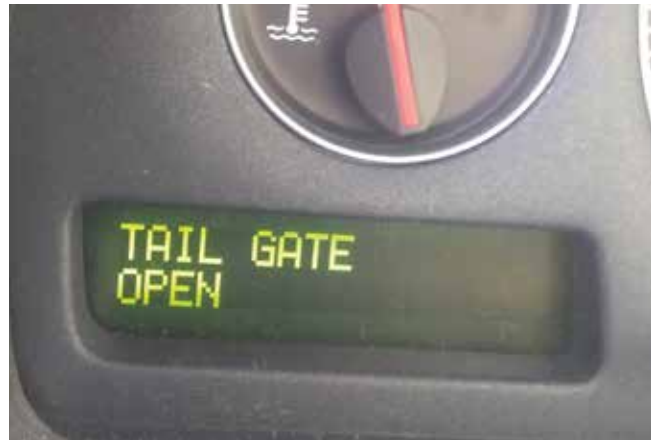
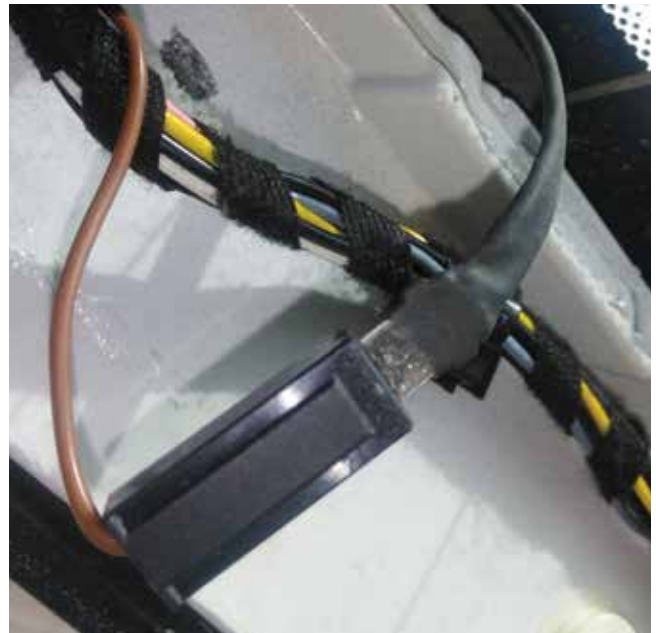
The tailgate micro switch, that tells the driver if the tailgate is open or not, gets its ground from the connector on the right side of the defroster grid.

The ground wire for the rear window defroster grid/glass break detector comes from the right side of the grid and runs through the tailgate harness and down to a body ground point (31/72) behind the battery.

The pink powered wire comes from the connector on the REM, the ground wire gets its ground for the connector on the left side of the rear window glass break detector. This is a thin wire that is part of the rear window defroster grid. The left side connector gets its ground from the other side of the defroster grid after it passes through the grid.

In most cases there will be a break in the ground wire inside the tailgate wire harness near the point where the harness bends inside the body near the roof. But in some rare cases a break in the grid in the rear window glass can be the culprit.
