UNDERSTANDING PORSCHE BRAKES

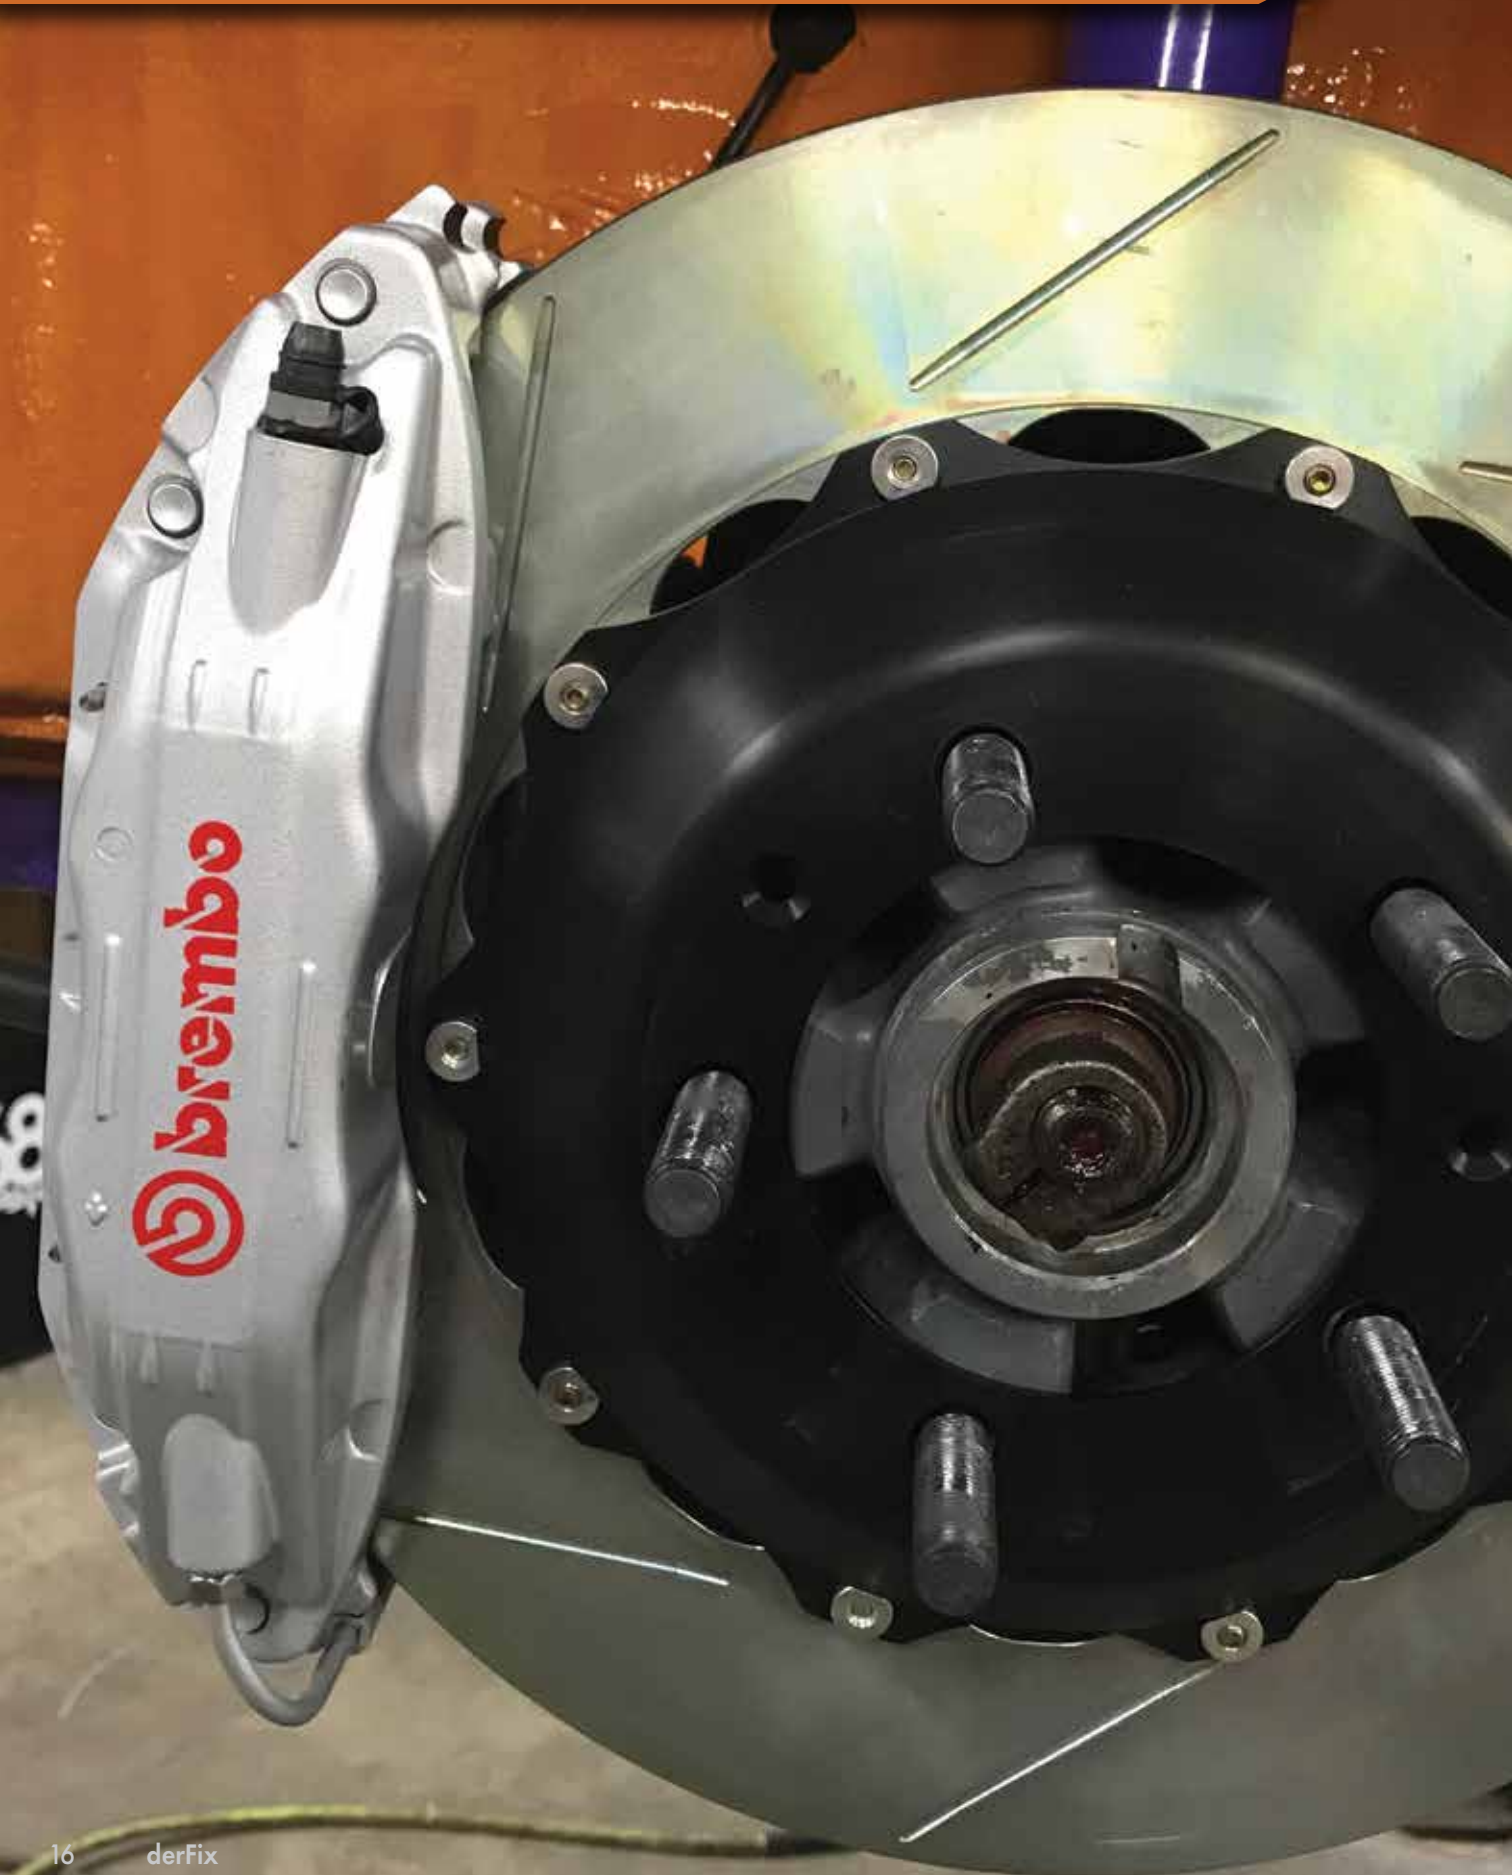
Opposite Page: Does any road going 911 need this much braking? Doubtful, but sometimes the upgrades are as much for appearance as they are for functionality.

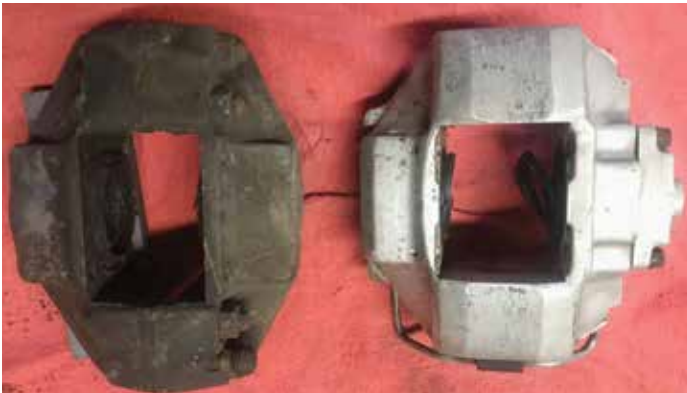
Aluminum is prettier than cast iron but weight reduction was the engineering principle behind the expensive S caliper option. As was Porsche's custom, brakes could be upgraded throughout the various Porsche 911 line rather easily. Picky customers could also order virtually any braking caliper offered on any model directly from the factory.

While the light alloy calipers helped with the unsprung weight issue, they were considered a bit problematic due the softer alloy allowing the body of the caliper to flex as the pads were applied, rendering the feel of the brake pedal spongy. This was helped to an extent by re-designing the caliper to be made from one piece as opposed to two halves which were bolted together. While this helped with the soft pedal issue, the aluminum calipers were ultimately abandoned and replaced by cast iron units of the same size specifications.

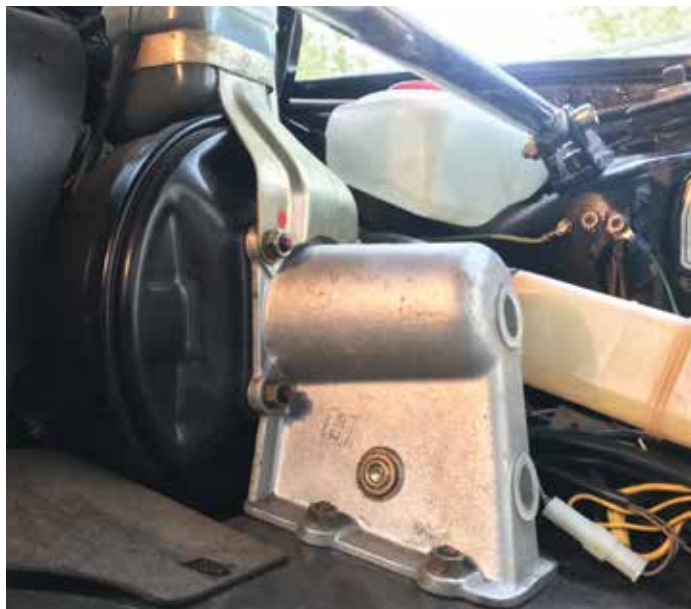
Difficult to access! The master cylinder is on the opposite side of the booster.

The 911, however, presented a bit of an engineering challenge when it came to adding on a conventional vacuum booster.

The source of the vacuum, being the engine, had to come all the way from the rear of the car (where the engine lives) up to the front trunk area, close to the pedal assembly. There wasn't much room for this brake assist unit as the front trunk was already quite small.

Instead, a rather complex linkage system was run at an angle up from the pedals to the booster through the floor of the front trunk. This booster and master cylinder assembly had to be mounted backwards from a more conventional layout. Replacing the master cylinder provides a bit of a challenge as space is at a premium in this area.

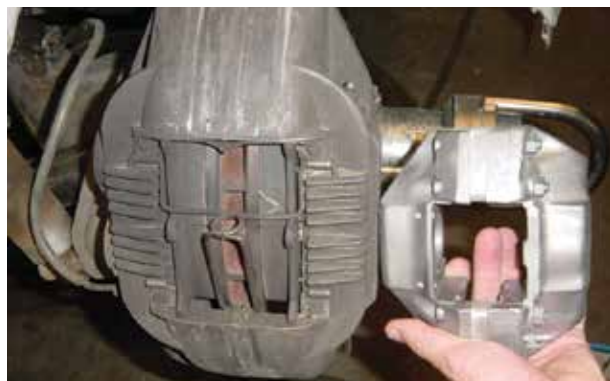
The 935 race caliper on the left dwarfs the "Big Brake" option of its day on the right.

Braking systems are an area where bigger can be better. The larger the brake calipers and rotors, the harder they can be used without overheating. As the Porsche models evolved, disc brake systems got larger and more pistons were added to the caliper, giving huge amounts of braking power to their most powerful models. All this was made possible largely due to innovations in materials. Now a monstrous, six-piston caliper can be as light as a much smaller, cast iron, two-piston unit found when disc brakes were first introduced.
