AUDI CRANKCASE VENTILATION AND SECONDARY AIR INJECTION

By: Peter Caro
Redds Automotive

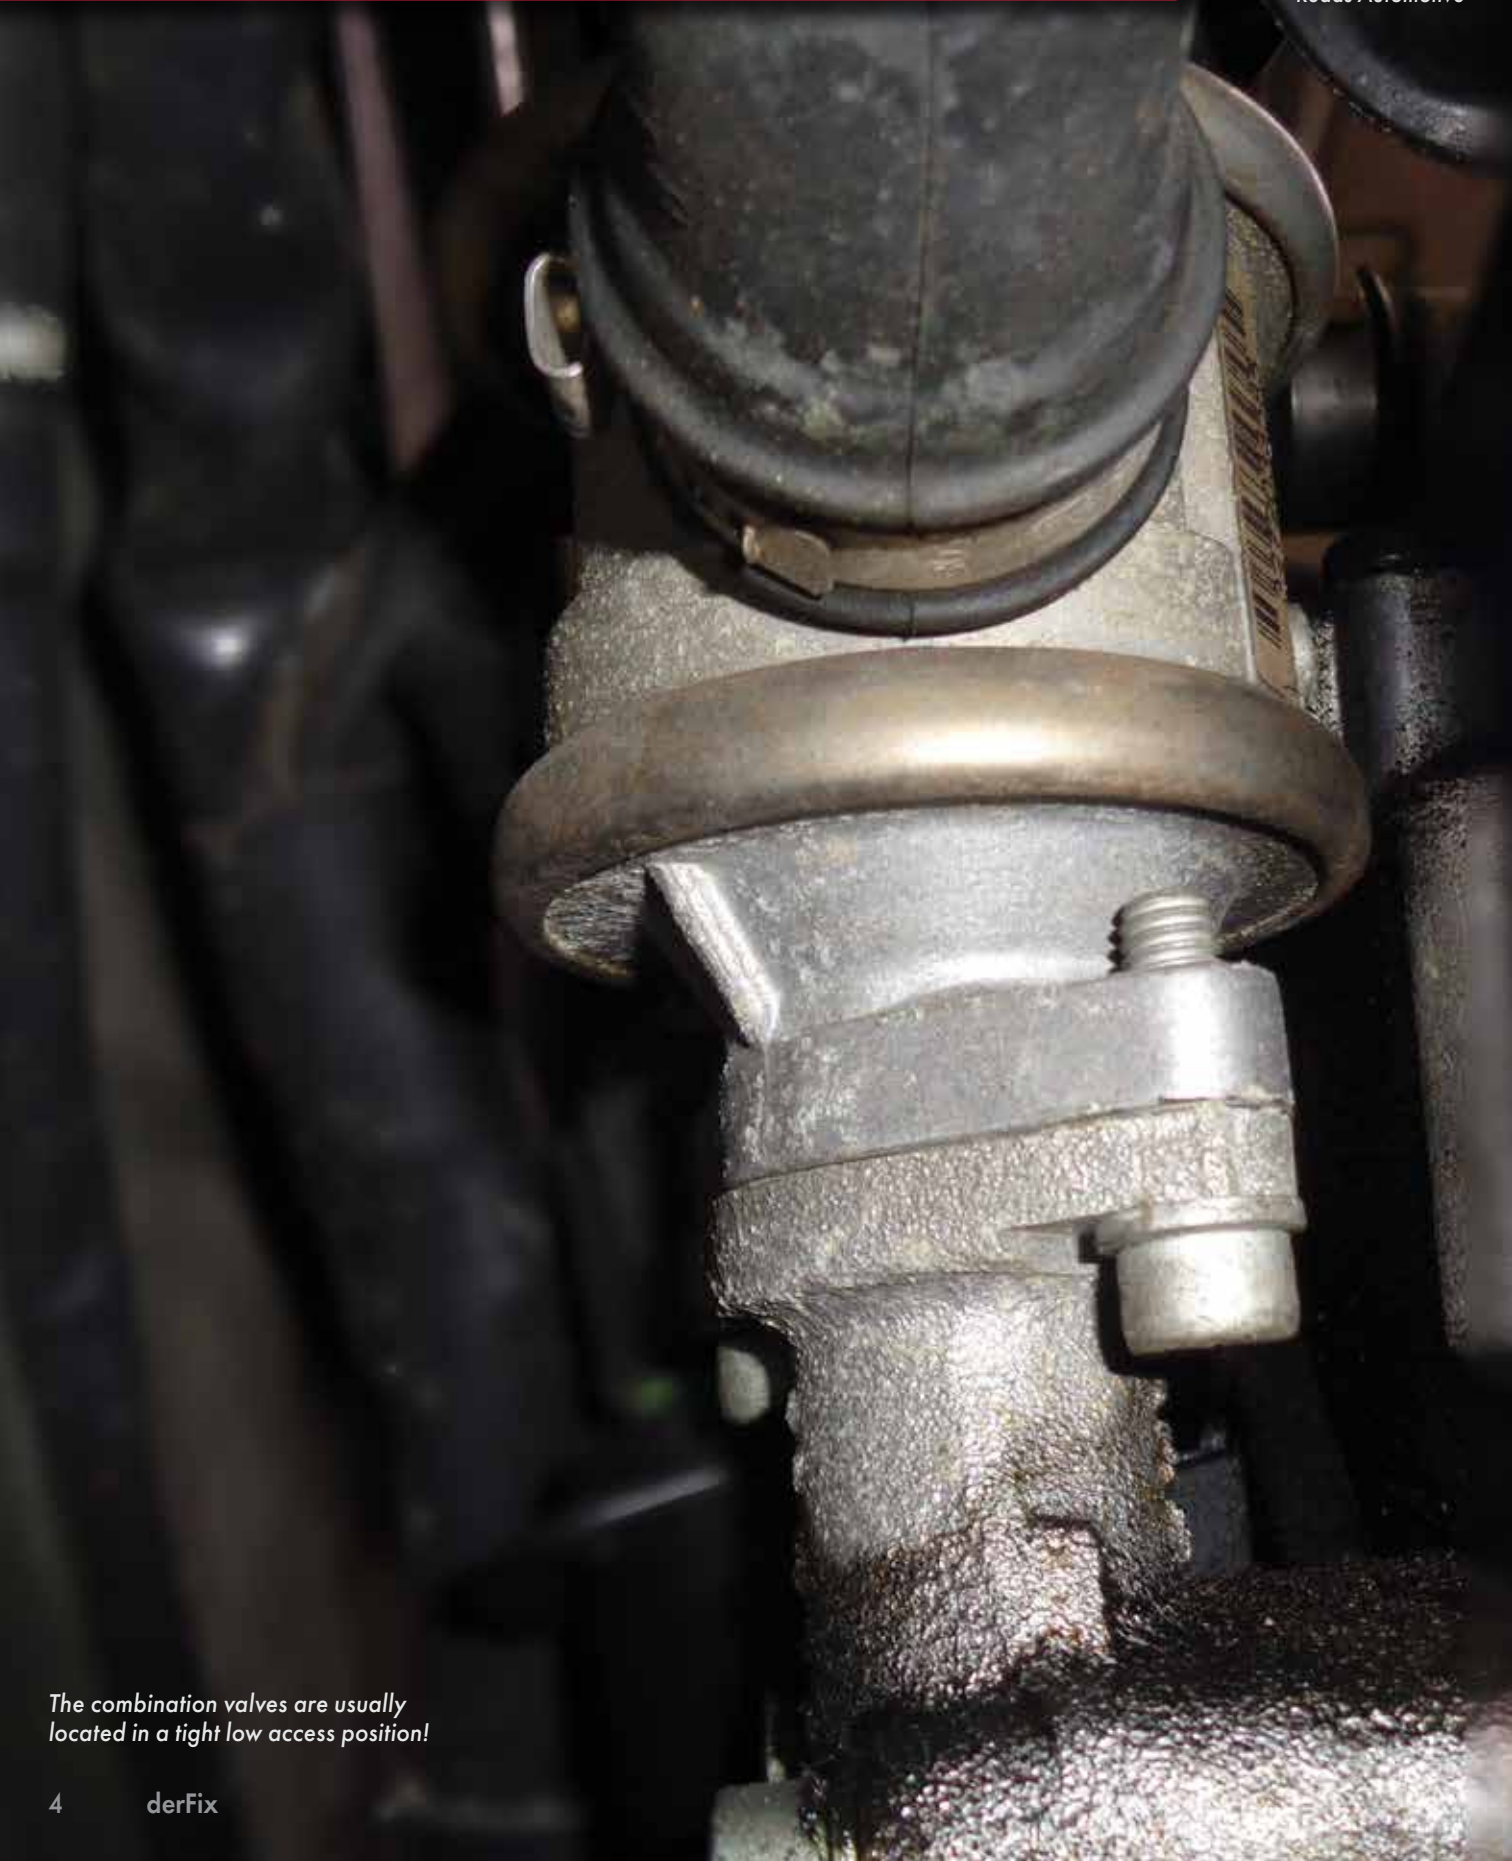
The combination valves are usually located in a tight low access position!

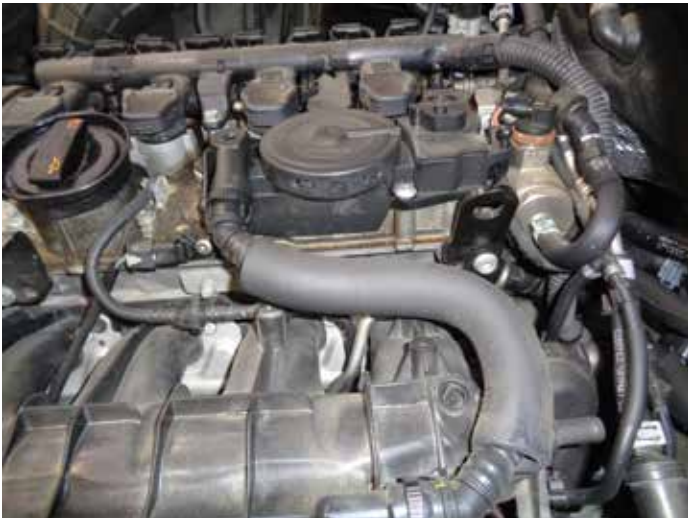
On the 2.0t engine always properly torque the fasteners securing the crankcase ventilation valve to the cylinder head. The cover is aluminum and will strip out if installed incorrectly.

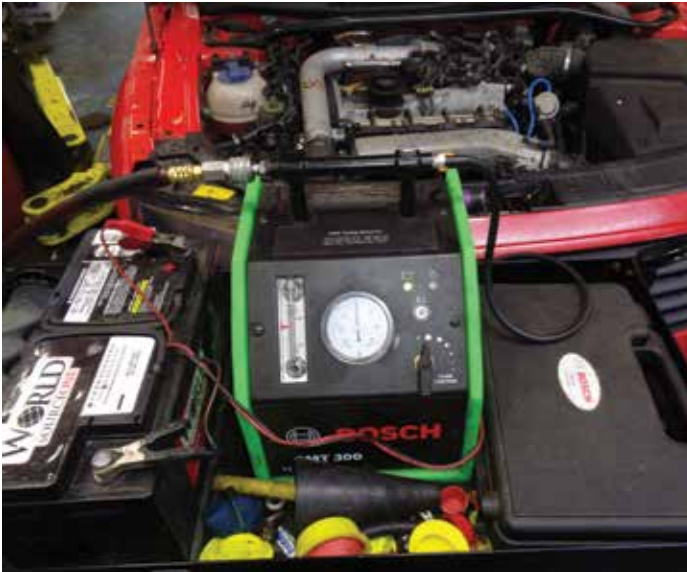
Having a smoke machine can make the difference between diagnostic darts and a definitive diagnosis.

necessity. These PCV systems must be completely leak-free to operate properly. Any small leak or damaged breather line will affect fuel trim values. Due to the complex routing of breather lines and connections there are many possible failure points. A smoke machine makes it easy to pinpoint leaks in almost any system.

Hook the smoke machine to the intake boot or any accessible point on the intake manifold. This lets the smoke travel through the entire intake tract as well as the vehicle's crankcase. During

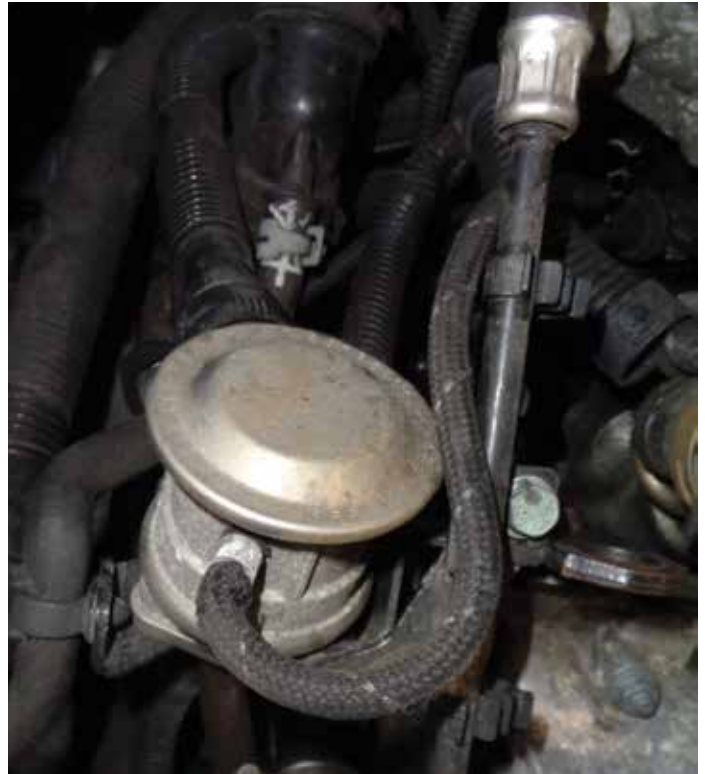
This vacuum line appears OK, however it is torn underneath the cloth covering. It's smart to replace every piece of older cloth vacuum line you may come across.

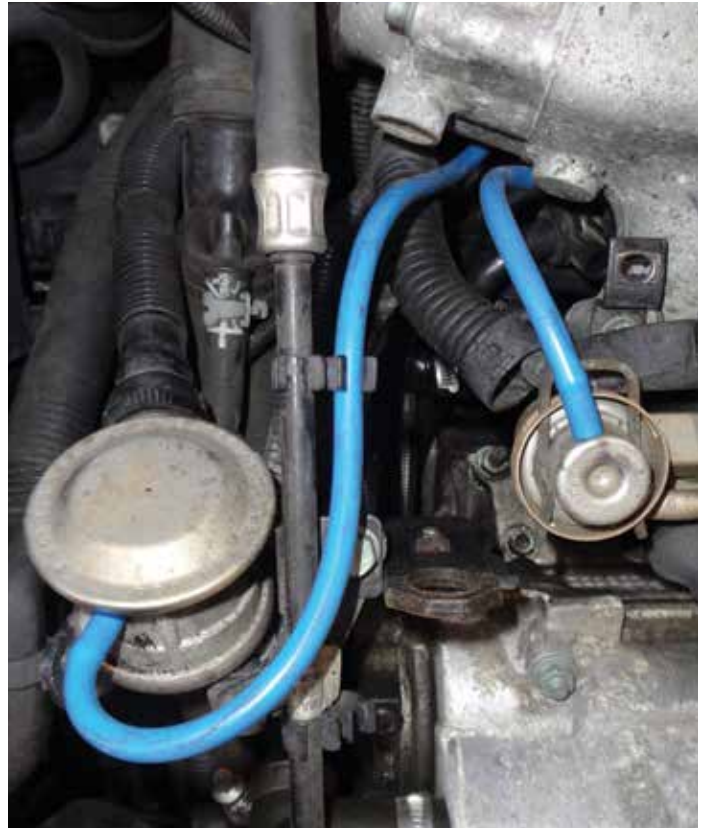
New rubber lines leave no guessing if there are leaks present.

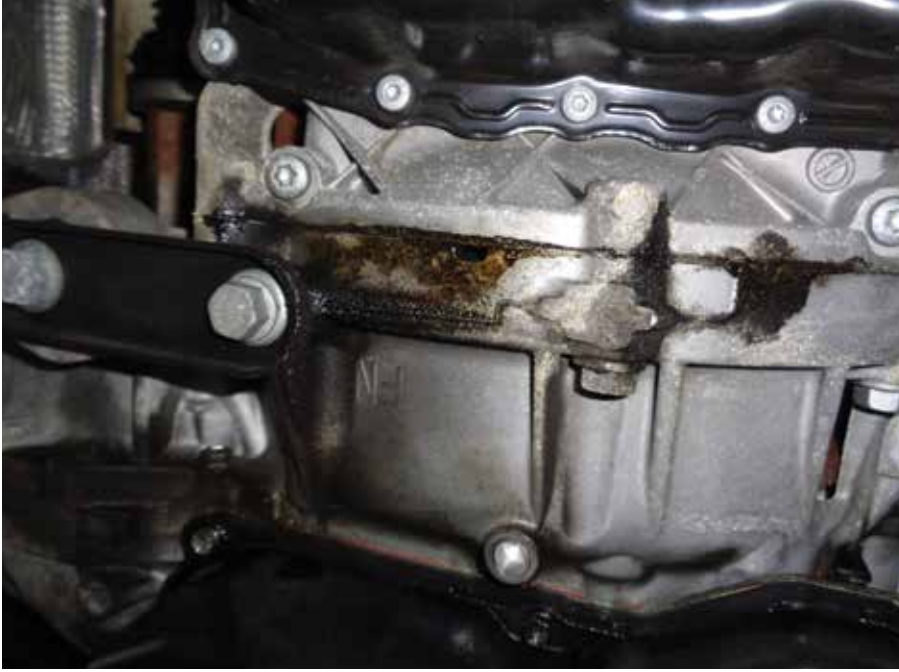
This is a clear sign of a leaking rear crank seal. This will lead to vacuum leaks and poor engine running if left too long.

Don't forget to inspect engine seals for leaking during the smoke test. Yes, the rear crankshaft seal commonly leaks crankcase vacuum and oil. In most cases, the rear main becomes completely separated, allowing extensive unmetered air to leak past.

On most Audi models, it's possible to see smoke leaks from the passenger side upper bell housing area after removing the side access cover on the transmission. Oil leaks from below are also a dead giveaway at a failed rear crankshaft seal. It's also possible to spray carb cleaner into the bell housing

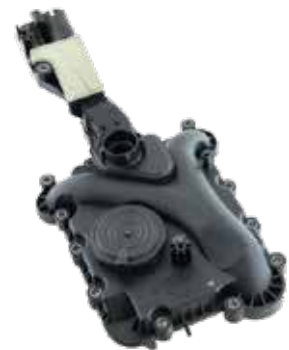
The crankcase valve assembly is quite large on the newer V-6 engines. Be careful during installation not to damage the sealing edge.

Many 2010-2016 V-6 models suffered from crankcase valve failures, and updated valves have been implemented. These commonly set rich faults when they fail. On the Audi 3.2 V-6 engine, the crankcase ventilation valve is located deep in the

Due to space constraints, the valve assembly is quite literally buried. It requires intake manifold or supercharger removal, followed by fuel rail removal, to fully access the crankcase valve. In V-6 engines equipped with variable intake runners, these must be removed as well. When re-installing, be sure to clock runner position correctly and run basic settings on them to verify proper function.

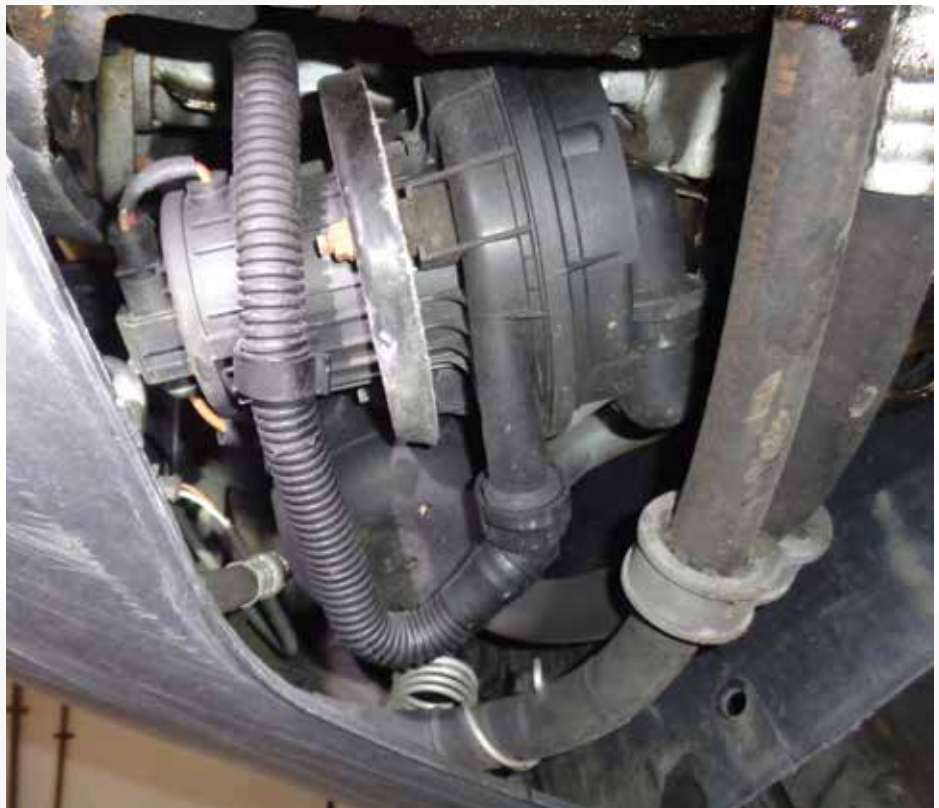
Without belly pan protection from the elements, this air pump stood little chance of survival.

In many higher-mileage Audi vehicles, the air pump eventually fails. Often they suffer from water ingress from broken inlet or outlet lines and rust or short out internally. On many air pumps,
