# AN INSIDE LOOK AT AUDI TURBOCHARGERS

By: Peter Caro  
Redds Automotive

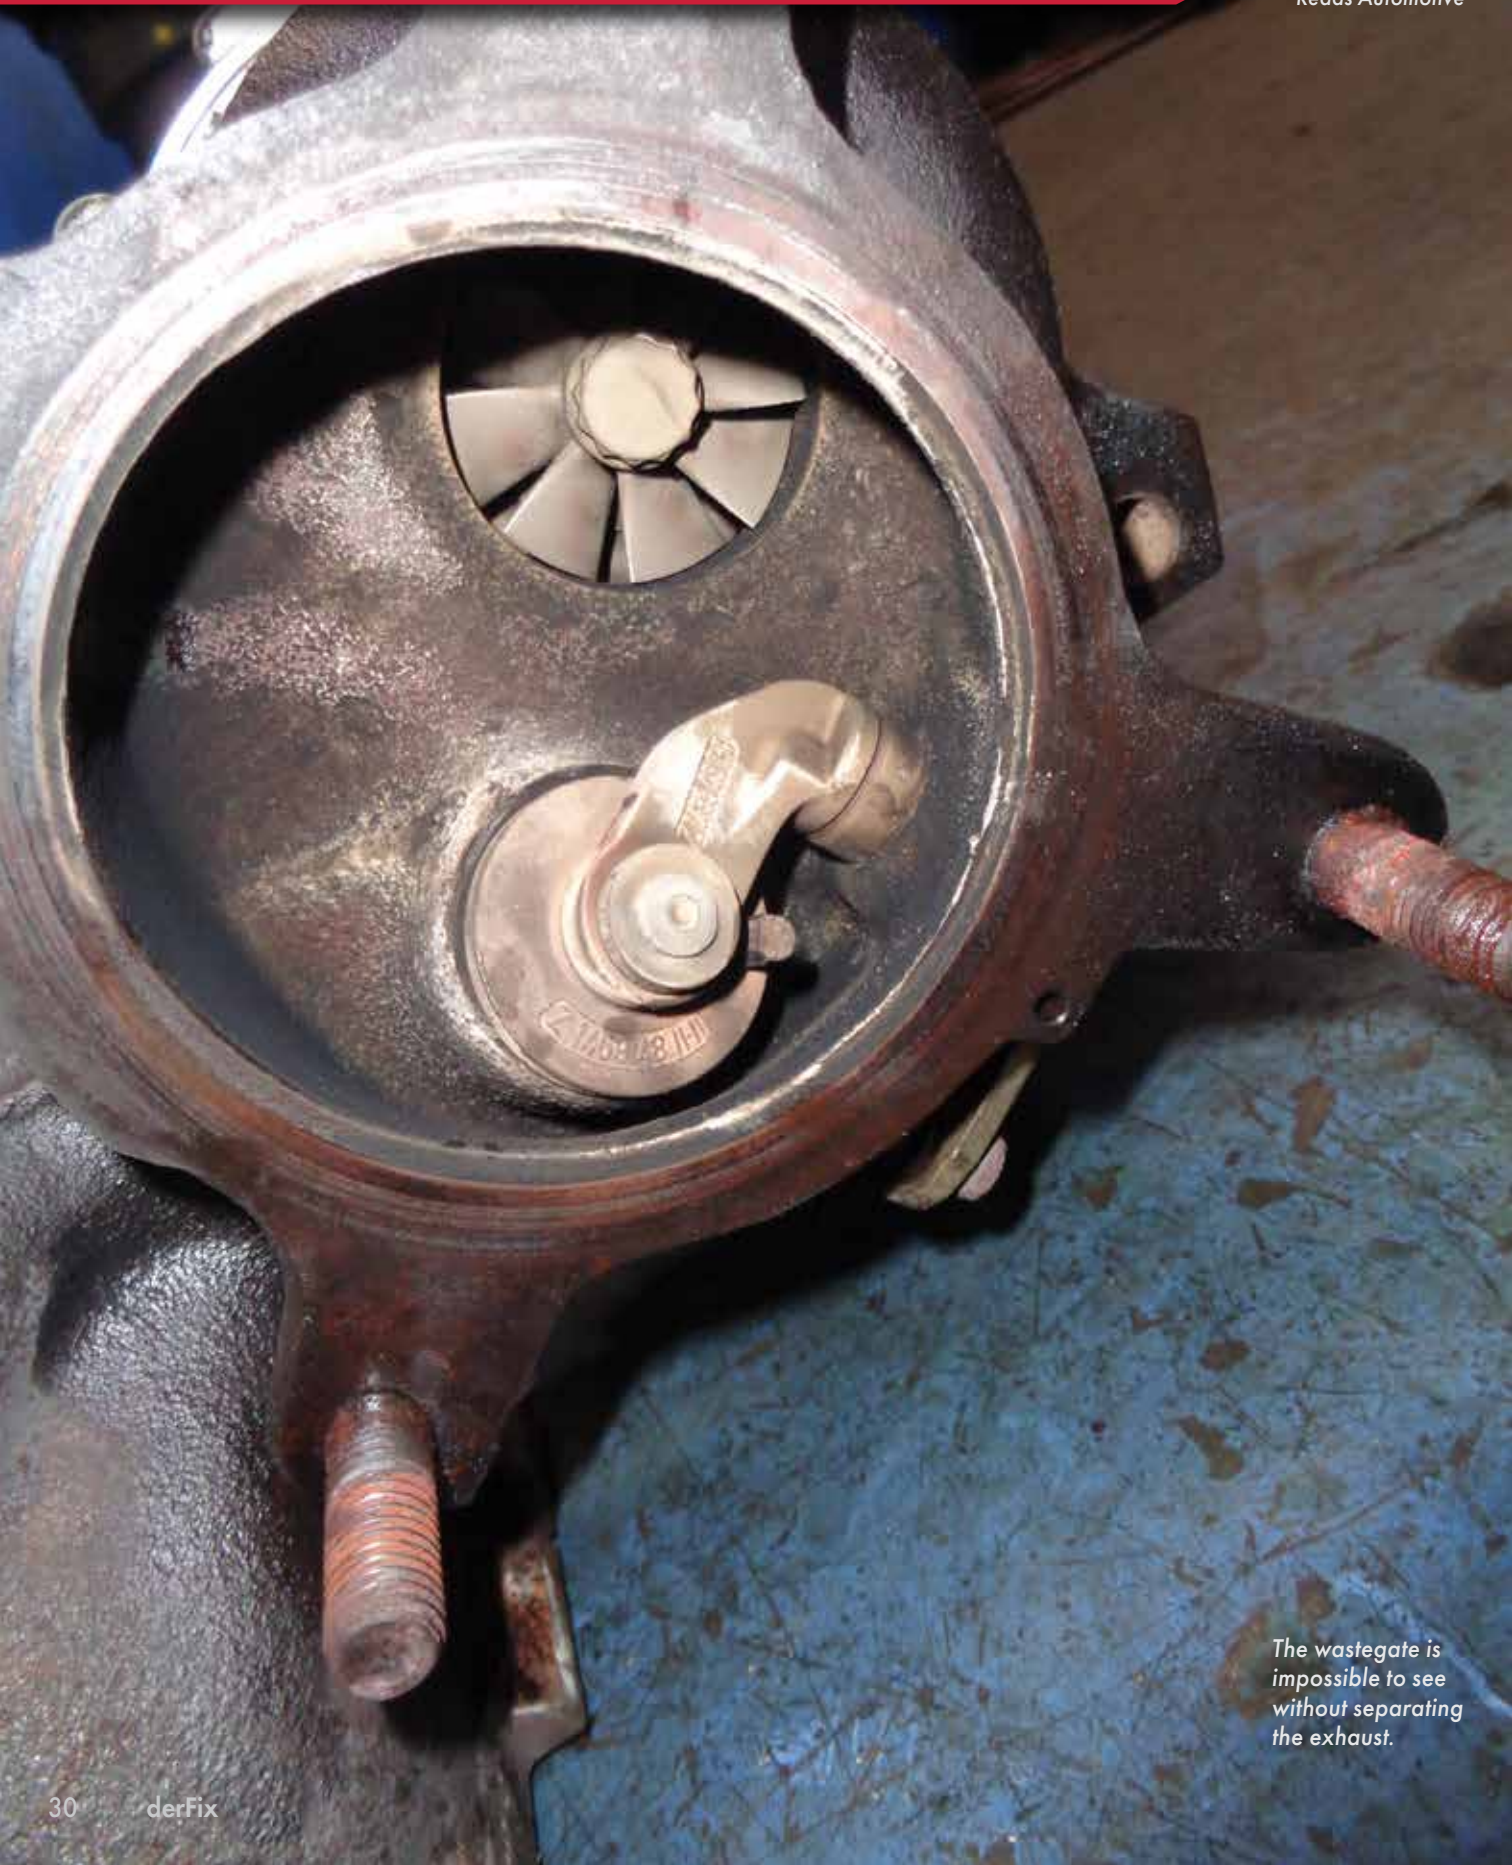
*The wastegate is impossible to see without separating the exhaust.*

Audi uses an internal wastegate design on their turbochargers. The primary advantage to this design is a smaller turbo package and simpler installation. The disadvantage of this design is, if a problem develops with the wastegate itself, the entire turbocharger may have to be replaced.

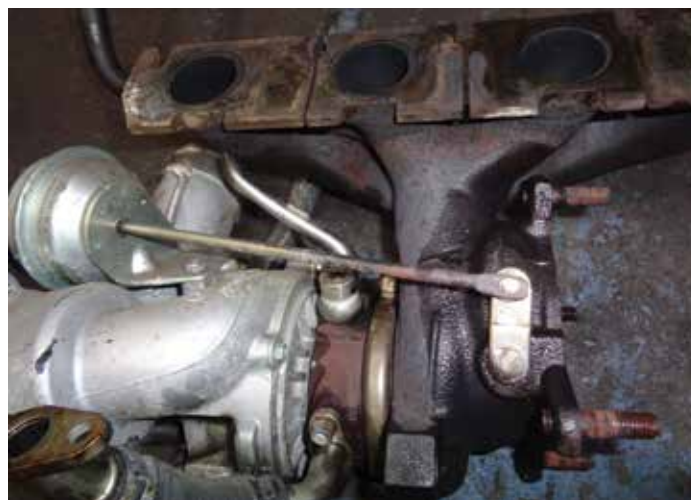
The actuator arm is only visible with a mirror or from underneath the vehicle when installed.

Depending on the engine model, a vacuum or pressure-operated wastegate actuator may be used to operate the wastegate itself. If diagnosing a low-boost complaint, this is a good first step in solving the problem. By applying vacuum or pressure with a small vacuum pump at the actuator connection, it's possible to visually watch the wastegate arm for proper movement. Arm movement should be smooth through the entire range to the end stop.

On many 2.0t models, the wastegate actuating arm can actually seize at the turbo housing pivot, not allowing proper movement. This is becoming more common on higher mileage vehicles and generally requires turbo replacement. It may be possible to free up the wastegate arm by using penetrant at the pivot point if it seizes. However, this is not a permanent fix and should only be used for diagnosis.

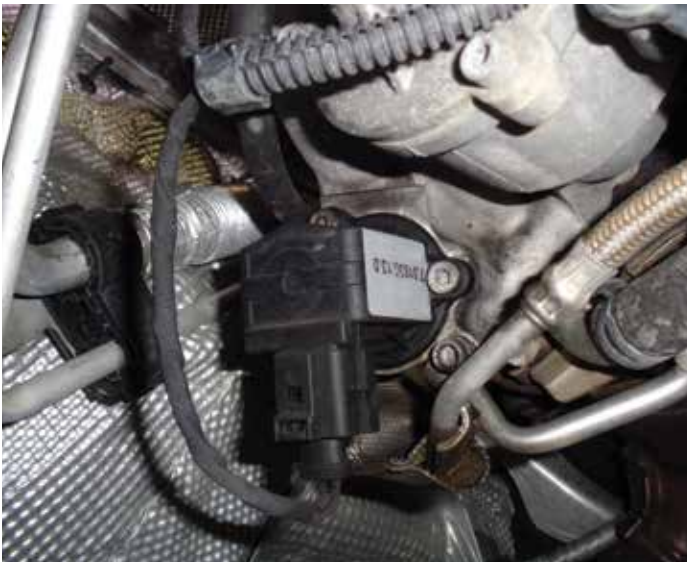
*The diverter valve is easily removed and inspected from underneath the vehicle.*

Eventually, a failed diverter valve will set a low-boost pressure fault. A failed diverter valve will not set a fault specifically pertaining to a torn diaphragm. During diagnosis, the only way to check a valve is to remove and carefully inspect it for damage. Checking the diverter valve for proper function is an important step when diagnosing low-boost faults or complaints.

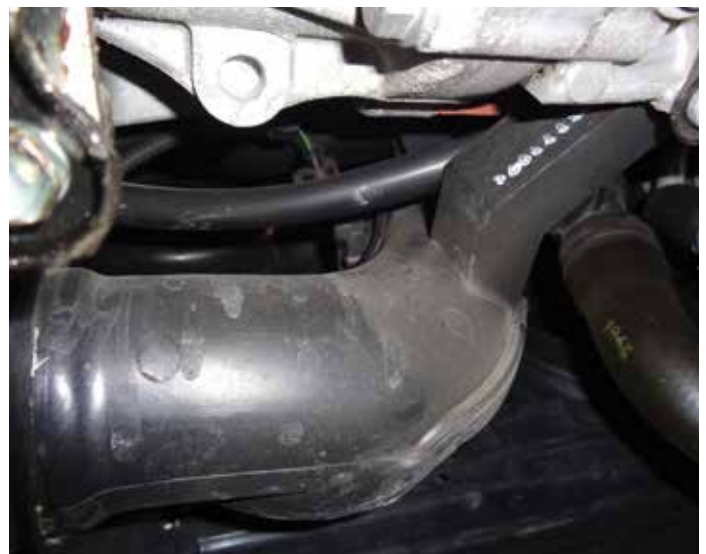
*This boost pipe is commonly damaged during removal.*

Another commonly damaged component is the charge air pipe connected to the throttle body on 2.0t engine models. This is a plastic charge pipe with multiple mounting points. If removed improperly or haphazardly, damage and boost leaks occur.

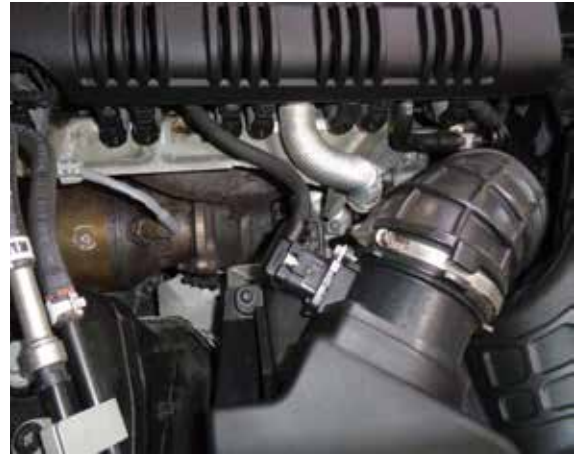
Turbo access from the top of the engine is limited.

On an Audi fitted with the 2.0t engine, turbocharger access can be accomplished by removing the air box assembly. This

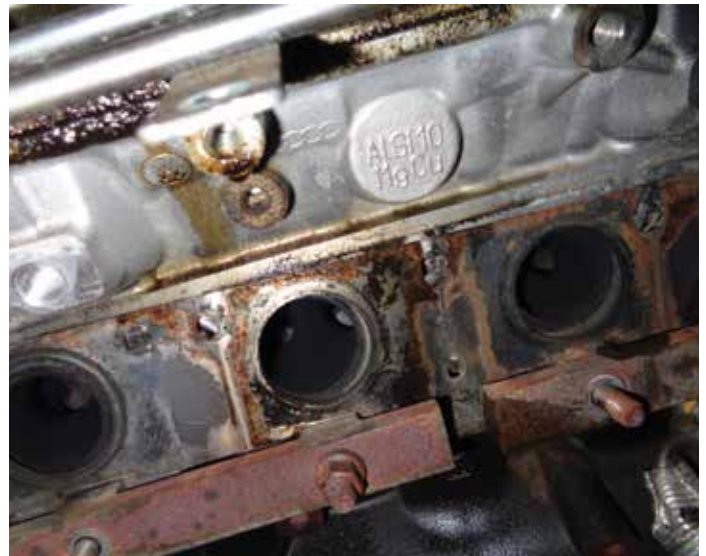
Access is particularly tight for the lower inner manifold bolts.

- Only the upper securing nuts must be fully removed. The turbocharger assembly sits on a supporting bracket held in place by the lower exhaust manifold bolts.
- Loosening the lower manifold bolts slightly will allow the turbocharger assembly to be lifted off its supporting bracket to be removed.

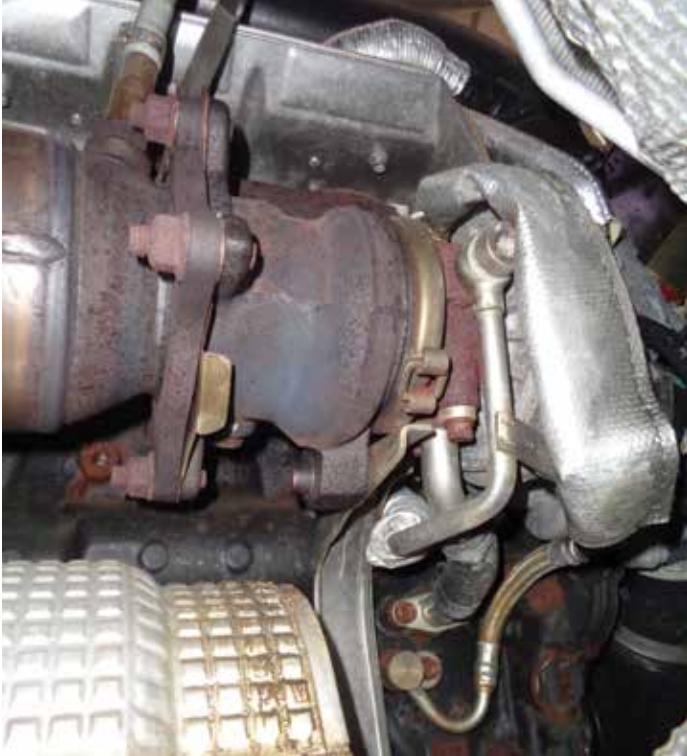
*It may be necessary to heat stubborn exhaust hardware to aid in removal.*

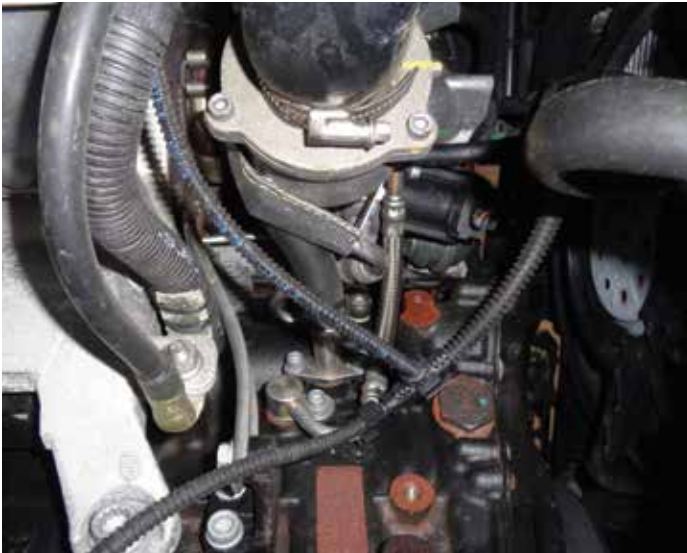
*Be careful not to kink or damage any feed lines during turbo removal.*

From under the vehicle, removal is straightforward. Remove all boost tubes connected to the turbo. Remove the turbo support bracket. Remove all coolant and oil feed and drain lines. Always replace all sealing rings and gaskets during this process. With the use of metal gaskets in certain applications,
