PORSCHE BRAKES

LESSONS LEARNED FROM THE RACE TRACK

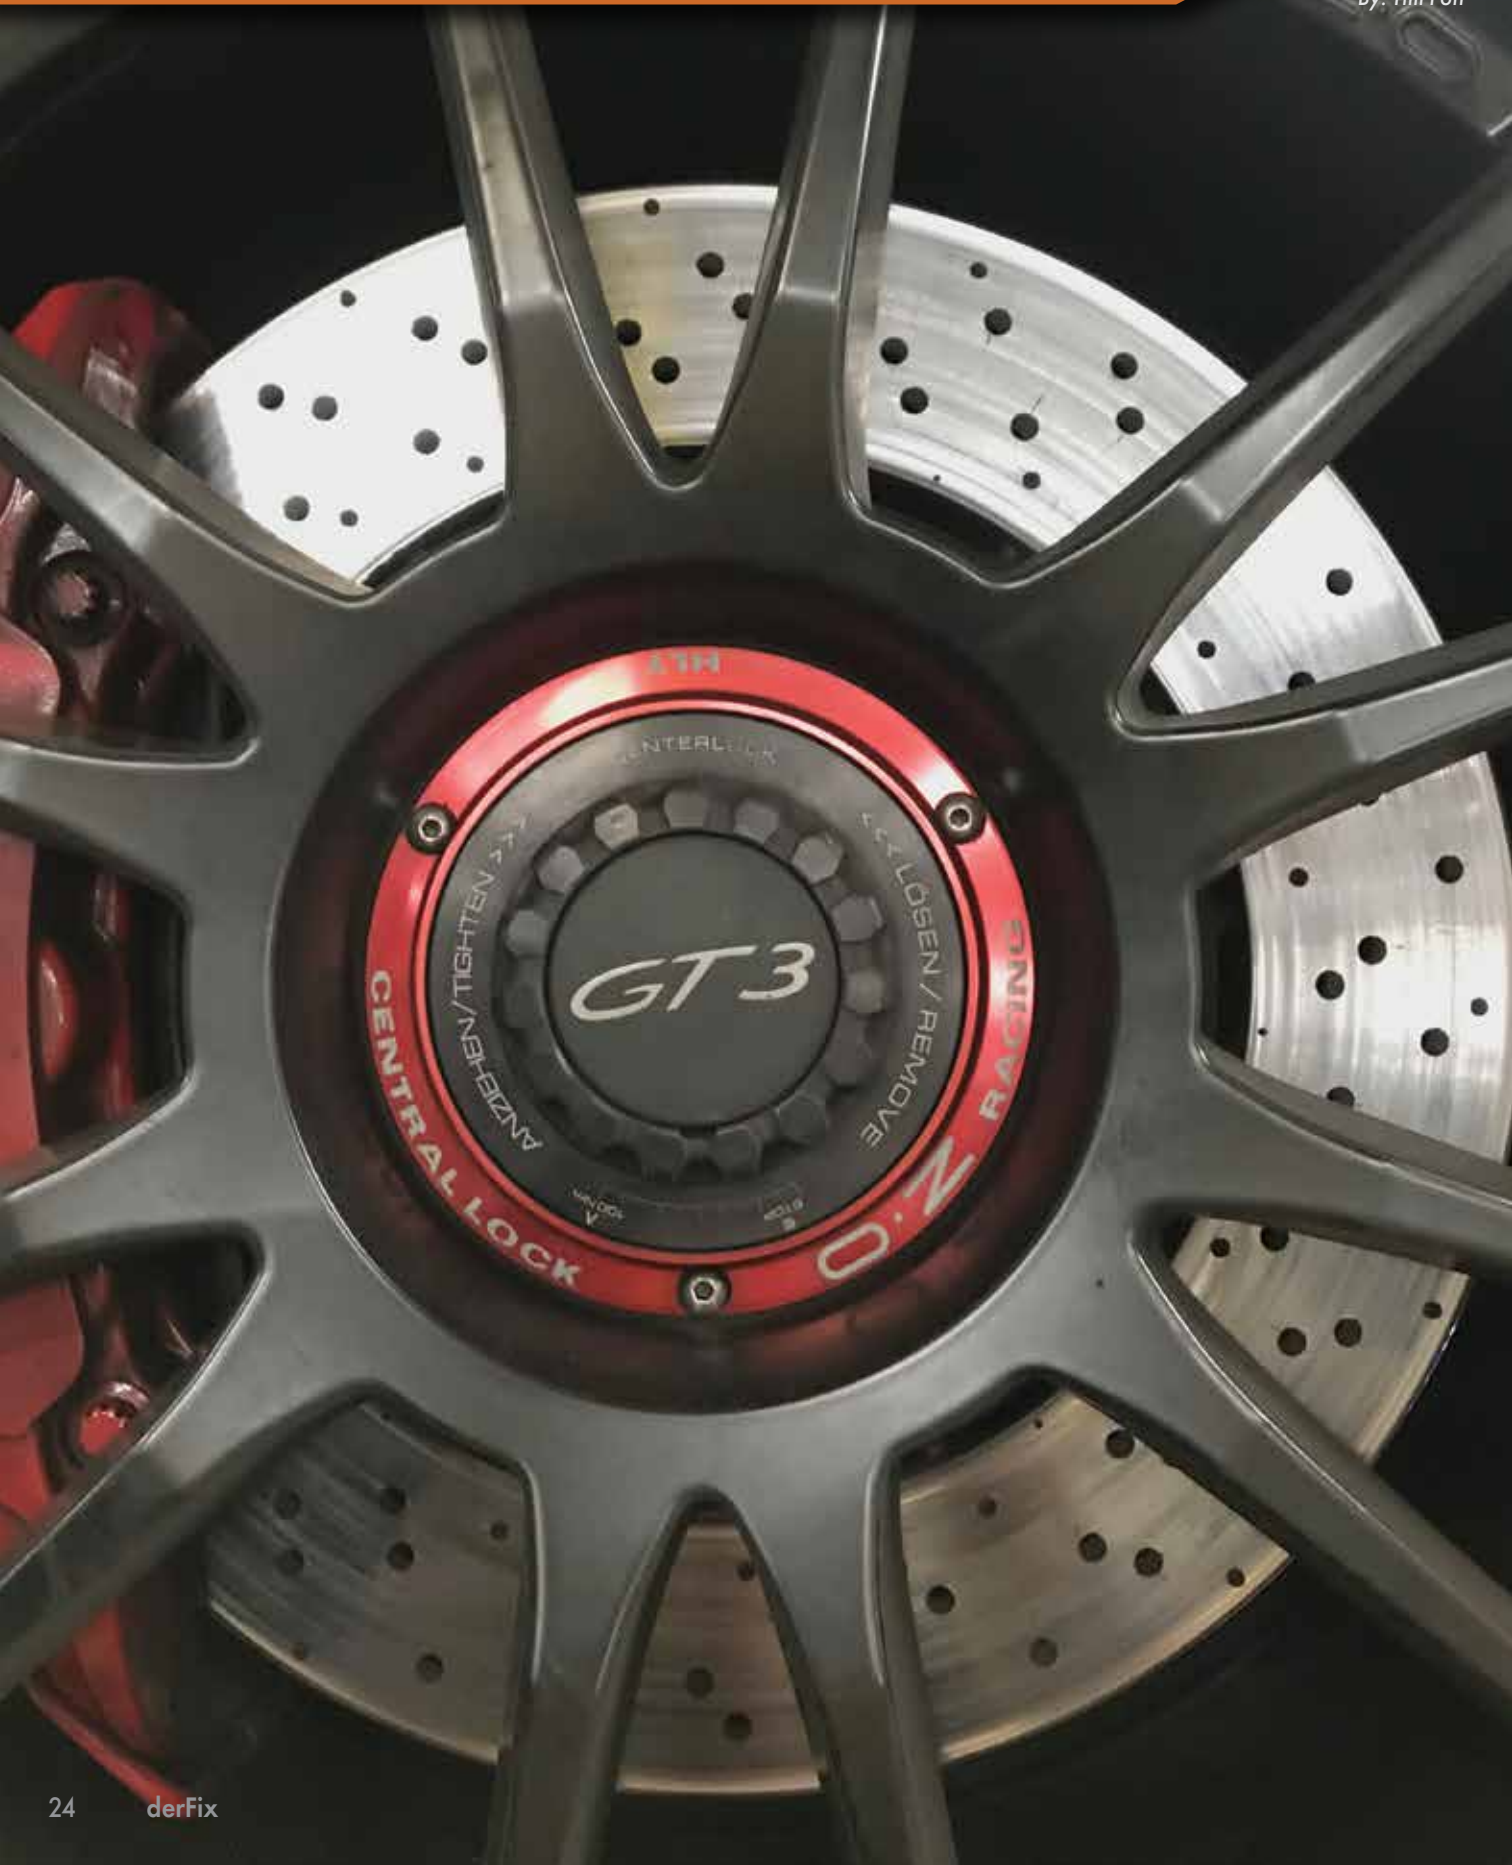
Opposite Page: While center lock hubs are cool to look at, did you know they are limited to a specific number of times they can be removed and re-torqued before the entire assembly needs to be replaced?

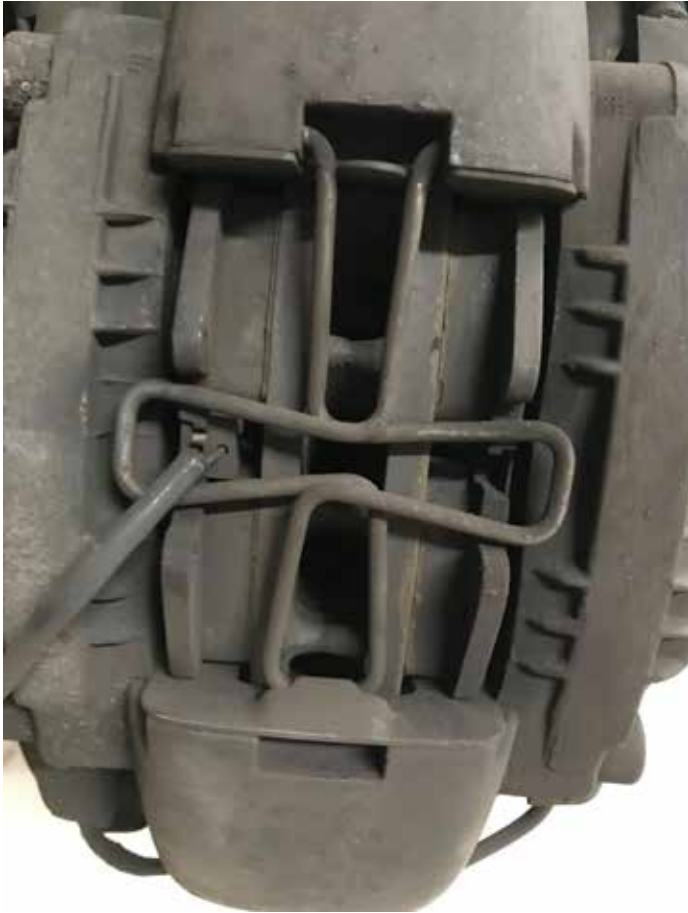
Measuring and noting pad thickness is important but it is one of many steps of a thorough brake inspection.

All brake jobs should begin with a thorough evaluation of all the components. Most shops have their own brake inspection form. If you don't have one, get one and customize it for your specific needs. Always start with a road test and note any pulling conditions, unusual noises, firmness of the pedal, pedal effort and vibrations or pulsations coming through the brake pedal. Once on the hoist be certain to remove all wheels. Estimating brake pad wear by looking through the spokes of wheels will not necessarily give you an accurate assessment of brake pads and rotors.

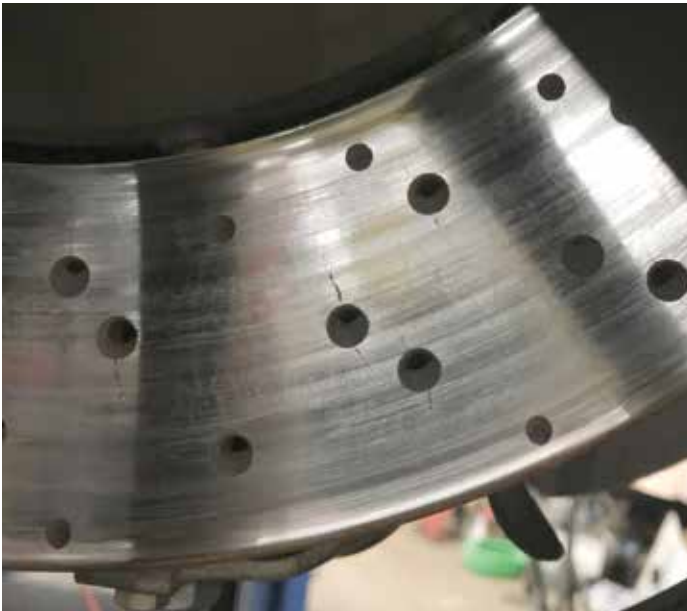
Some cracking is permissible! Refer to service bulletins for assessing whether a rotor with some cracking can be re-used. Standards are higher for cars used in competition.

Pay special attention to the surface of the rotors and note any cracking that might be developing. Most modern rotors are now cross drilled which aid in cooling and the release of gasses that burn off brake pad binding material. The holes are also a great place for cracks to be propagating. However just because a crack is developing does not mean the rotor should wind up in the recycling bin, especially on street-driven cars.

There are technical service bulletins that specifically describe the allowable depth, length and location of any cracks that might be developing. Always follow the specifications while

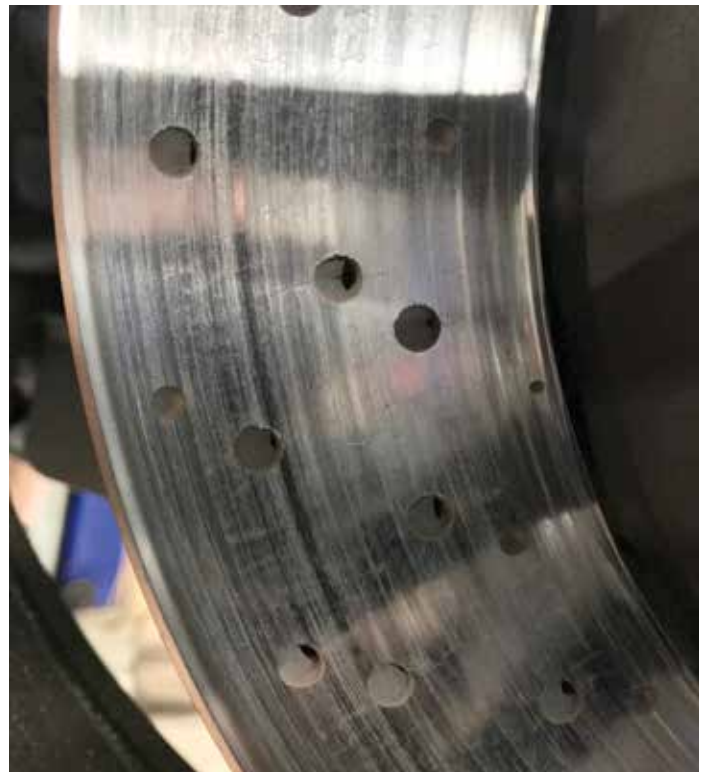
Some of these holes have become completely filled with rust and brake material, rendering them ineffective.

Another benefit for cross drilling is its ability to aid in cooling as well as the holes providing another pathway for heat to escape the surface of the rotor. The downfall of cross drilling is that often these holes become blocked either from brake pad and rotor material as it wears off the surface, or they can simply become filled with rust.

Once most of the holes are blocked the benefits are obviously negated. Cleaning the holes by running an appropriate size drill through them is an appropriate method for restoring their proper function. This is a simple but time consuming process and it is sometimes challenging to justify its value to your customer.

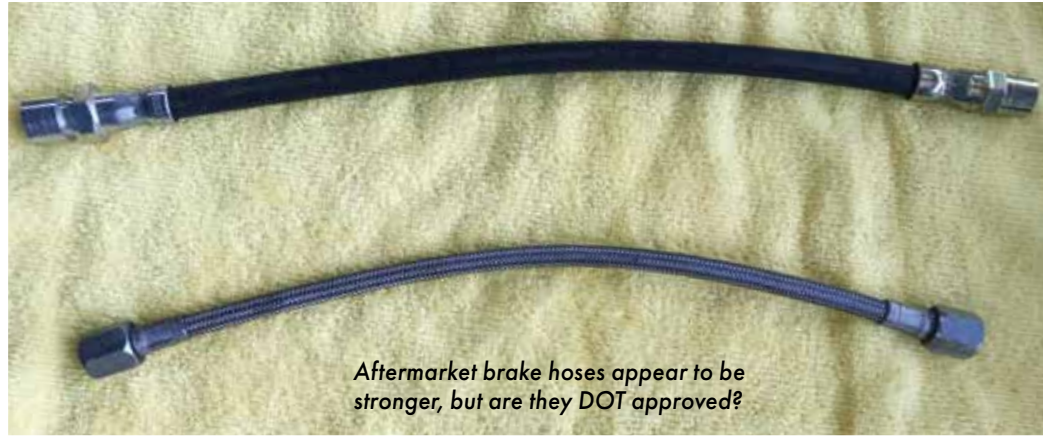
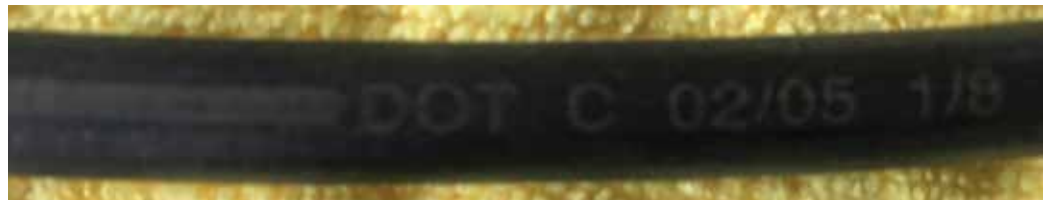
A close look at this photo shows the DOT stamp, certifying that it has been tested and meets minimum standards.

The stock rubber hoses should be considered for replacement based on inspection as well as service history or aging. Any abrasion or cracking of the outermost rubber layer is reason

for replacement. Inspect carefully the area where the rubber connects to the steel, threaded component as this is a common failure point.
