VW 01M TRANSMISSION 65535 ERROR

By: Augie Ferron

GOLF/JETTA/NEW BEETLE
1VWXV02.0226

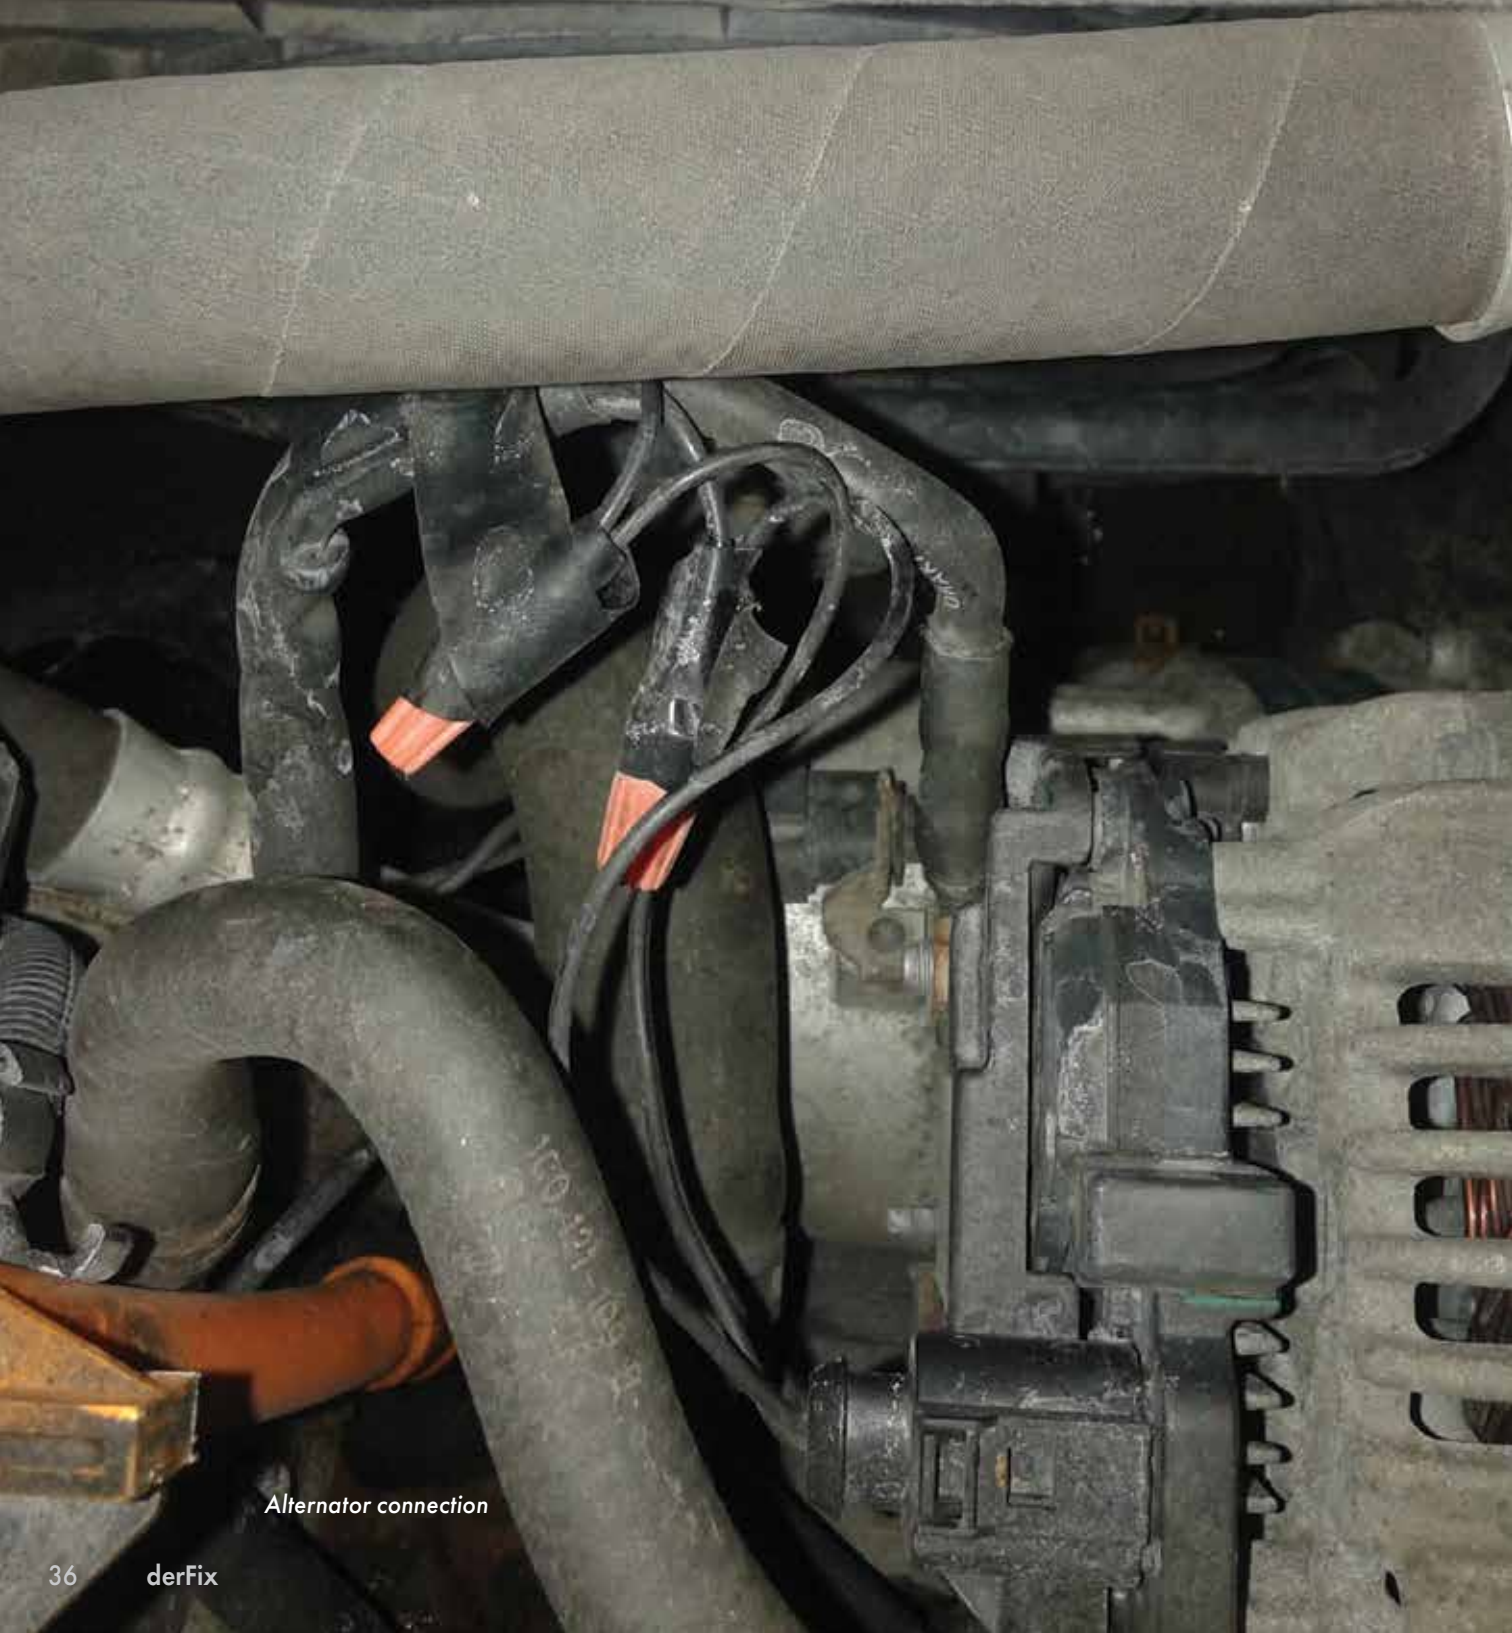
Alternator connection

You may find indications of previous sub-standard repair. For instance, here Marett connections were never used to attach the harness to the voltage regulator. The possibility of the wires connected to the incorrect positions was 50-50. The correct repair is performed by using "crimp and shrink" connectors.

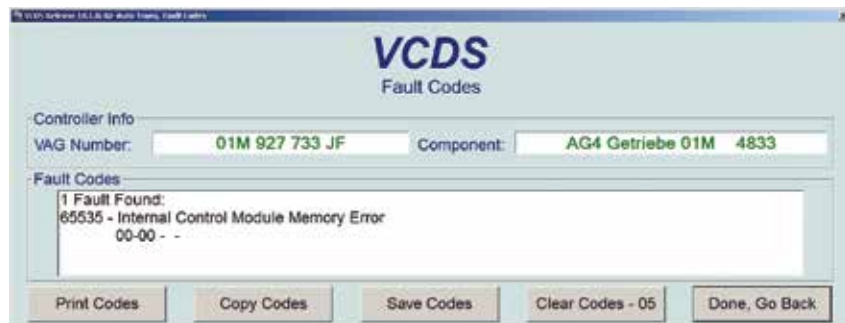
The 65535 error is a "data corruption fault code" and can also be attributed to a hardware malfunction. The list of possible causes is endless but for all intents and purposes, can narrow this fault down to these possibilities in the automotive field:

The 65535 error in most cases will never delete and if that fault was previously recorded, will return quickly if deleted. In this specific situation, the 65535 error will also mask other errors that would not be generally recorded. Consider 65535 as a fatal controller fault and requiring replacement. In some and not all cases "Internal Control Module Memory Error" may not even record any errors; therefore consider 65535 as one of multiple suspects.

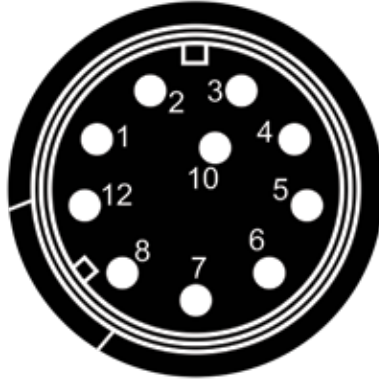
TCM connection

Pin 1 = B+ supply to solenoids 1, 2, 3, 4, 5, 7 and Temperature Sensor
Pin 2 = B+ supply to solenoid 6
Pin 3 = B- signal to solenoid 1
Pin 4 = B- signal to solenoid 2
Pin 5 = B- signal to solenoid 3
Pin 6 = B- signal to solenoid 4
Pin 7 = B- signal to solenoid 5
Pin 8 = B- signal to solenoid 6
Pin 10 = B- signal to solenoid 7
Pin 12 = Temperature signal return

Using the TCM Connection image and PIN location description, the harness and solenoids can be measured in-vehicle to determine if all the solenoids are connected and the harness is intact. Follow the next series of steps to double check the replacement components before assembly.

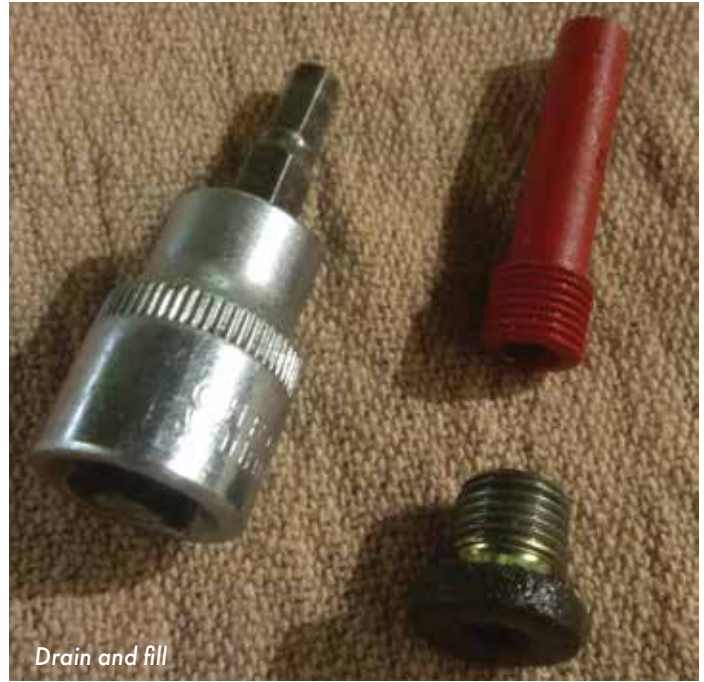
Drain and fill

On this type of system, the drain plug can be removed (replace the gasket) and the plastic spill port is removed as well.

Generally, measuring the volume

of oil is a good idea and saved for later inspection with the customer.

Thread the oil spill port gently and attach the plug. The oil fill tube can be gently unlocked for access to fill the transmission.

That is why the fluid is measured; the correct volume can be added quickly.

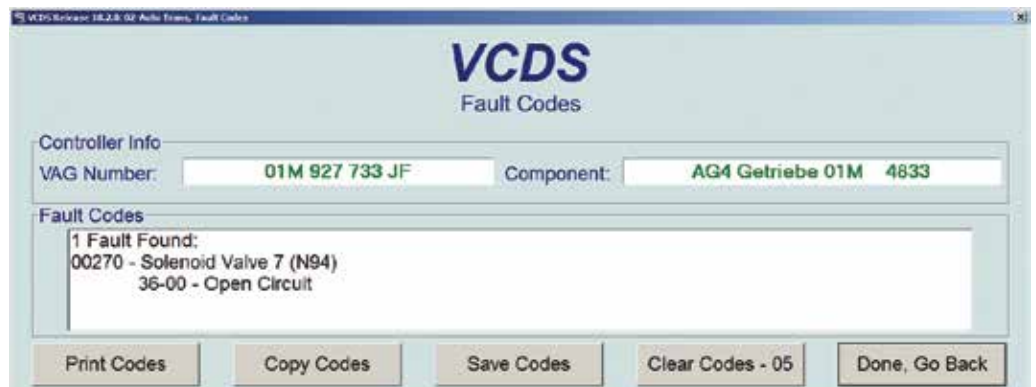
Solenoid 7 fault

What if the car is still on the hoist and solenoid 7 has an open circuit?

Pins 1 and 10 are measured and the value is open circuit, so a replacement harness and solenoid are the fix here.

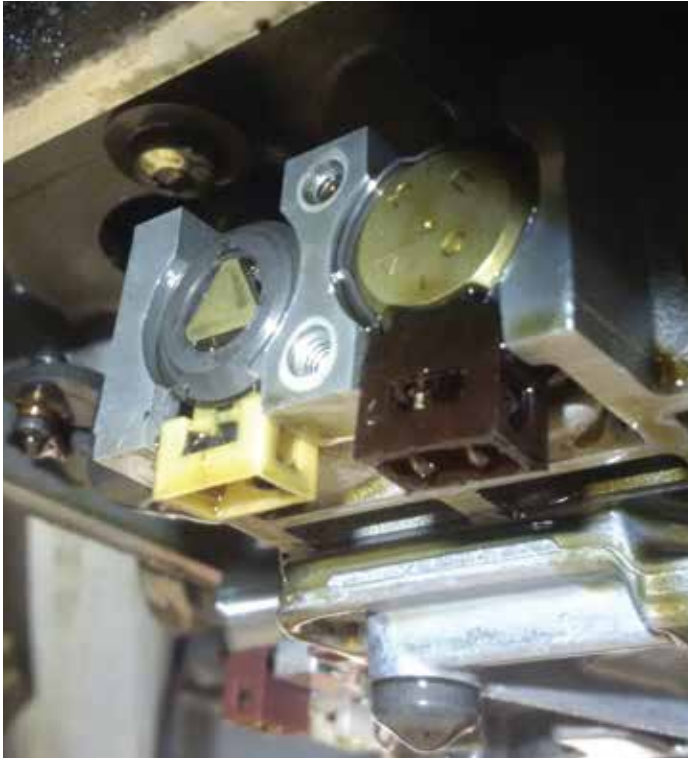
1. The drain plug and spill port is removed, capturing the fluid.
2. Pan removed and harness disconnected at solenoid 7.
3. Measured from the transmission end harness to the solenoid harness.
4. Found an open circuit in new harness.
5. Solenoid 7 is the one in white. (See image Solenoid 7 on the left.)

Note the temperature sensor attached to the foil strip below solenoid 7.

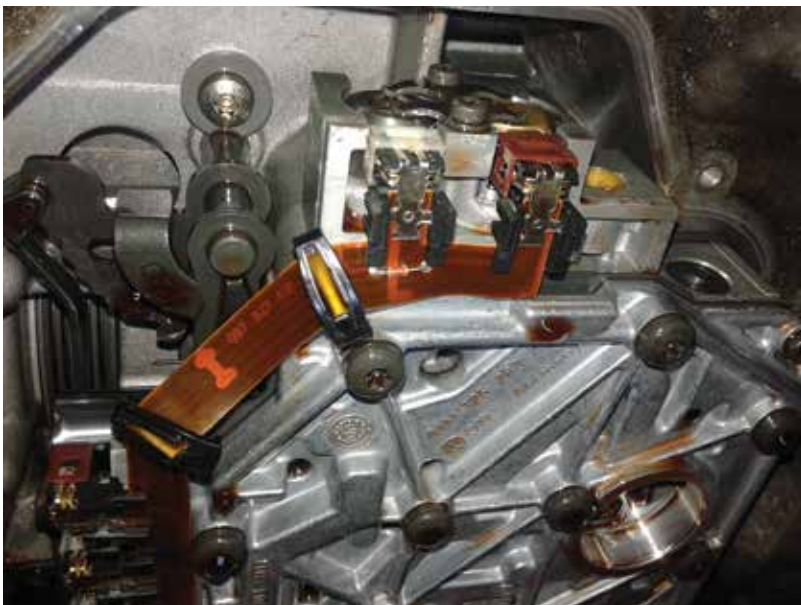
Harness test 2

Measure the replacement harness and ensure connectivity by using a snug fitting pair of wires (female) and correctly sized male end to the solenoid ends of replacement harness.

Replacement harness under test with made up harness to fit both ends.

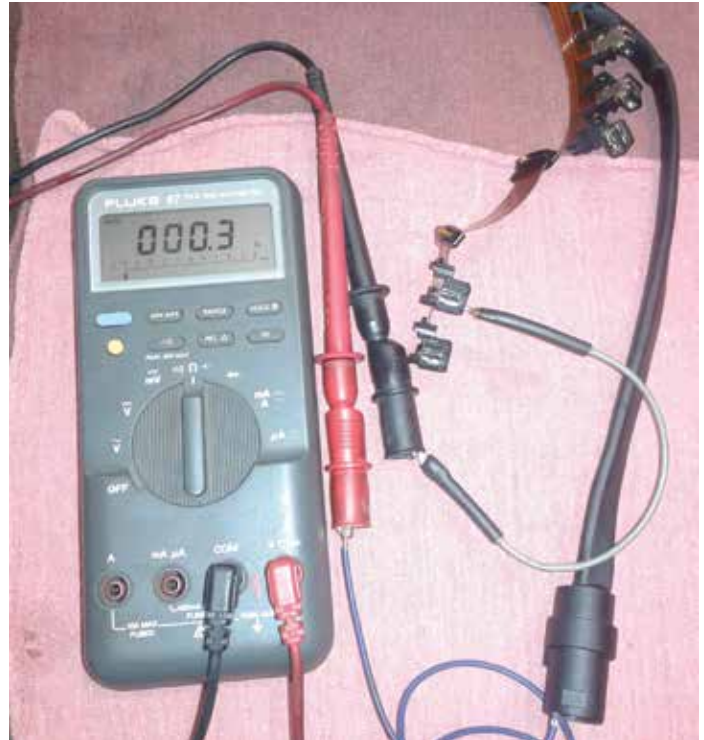
Harness test two

Since the two blue female wires fit the round pins, the next test is after the assembly onto the valve body. The test can be done in-vehicle using the same pin layout described earlier. Measure with an ohmmeter or with 12 volts.

Note: These are 12 volt solenoids and can be tested with a voltage supply to the correct B+ and B- connections. Audible clicking should be heard by applying power or ground intermittently to the individual solenoids.

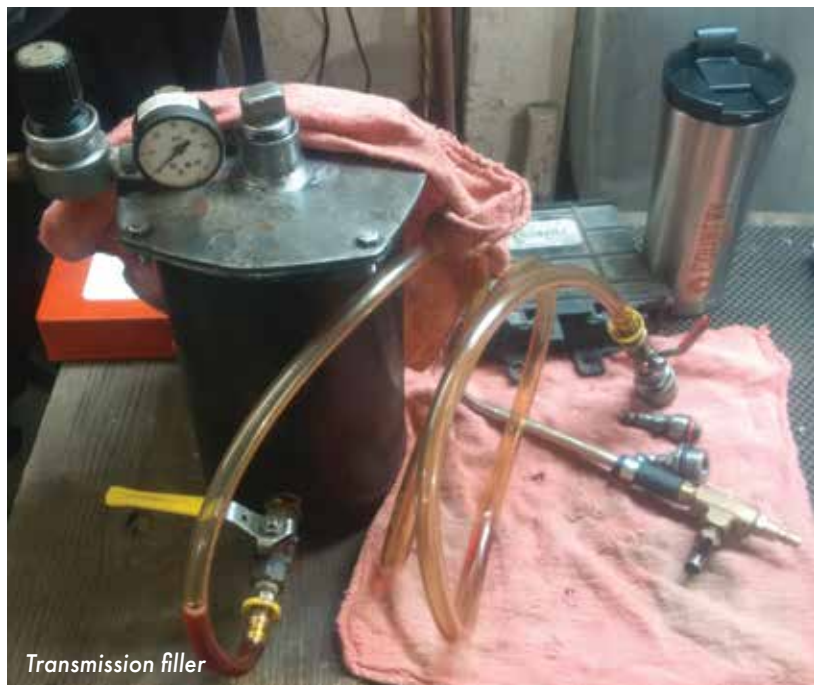
Transmission filler

How many ways to fill transmissions of this style? Gravity feed tends to be a bit slow, a hand pump is too much work but this one is air regulated with two ball valves.

That will also mean that, with the correct adapter and coupler, different styles of fill ports can be fitted to one basic tool. 5 psi is enough pressure and

the ball valves control the volume of fluid when force feeding through small ports.

The control of each ball valve also allows the fill side to remain closed but the spill side open to watch for the drip at the temperature with VCDS. ■
