Technical Knowledge for Volkswagen®, Audi®
and Porsche® Service Professionals

Audi Crankcase Ventilation and Secondary Air Injection

Understanding Porsche 9A1 Oiling Systems

Getting Those VW Frame Dimensions Exactly Right

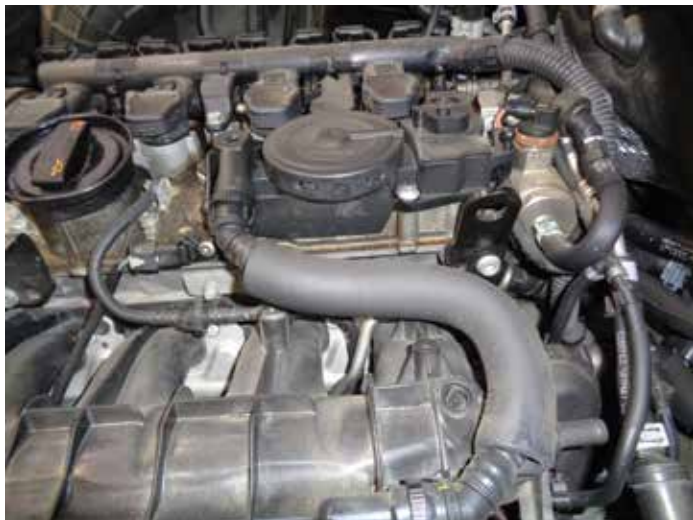
On the 2.0t engine always properly torque the fasteners securing the crankcase ventilation valve to the cylinder head. The cover is aluminum and will strip out if installed incorrectly.

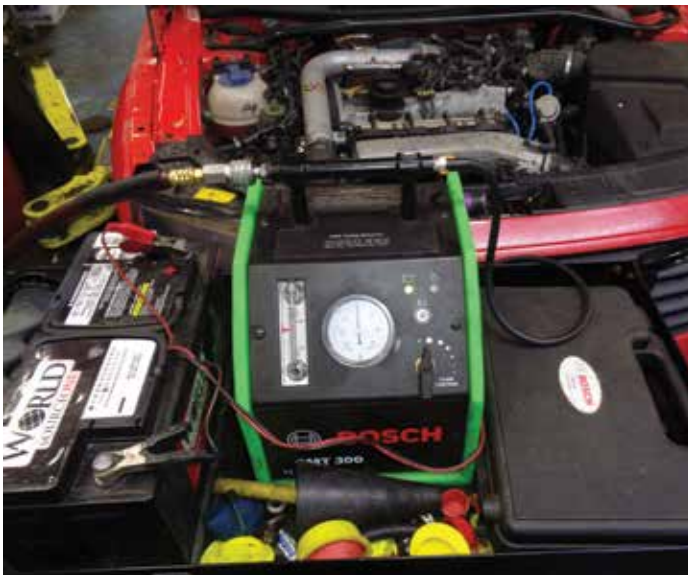
Having a smoke machine can make the difference between diagnostic darts and a definitive diagnosis.

necessity. These PCV systems must be completely leak-free to operate properly. Any small leak or damaged breather line will affect fuel trim values. Due to the complex routing of breather lines and connections there are many possible failure points. A smoke machine makes it easy to pinpoint leaks in almost any system.

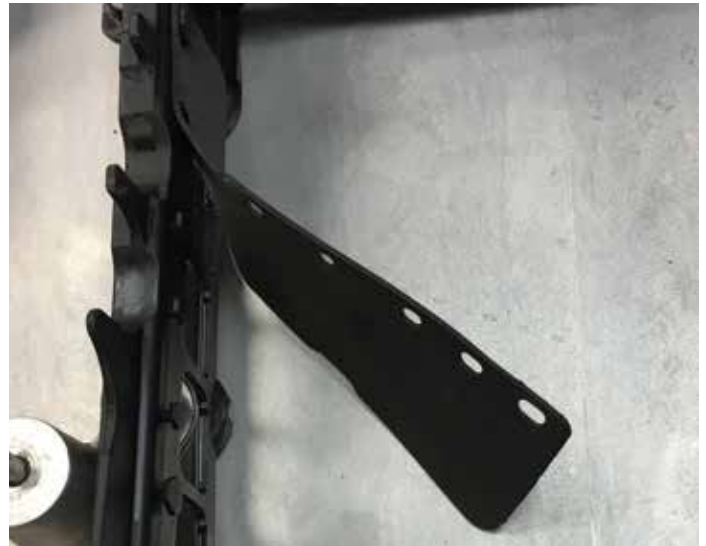
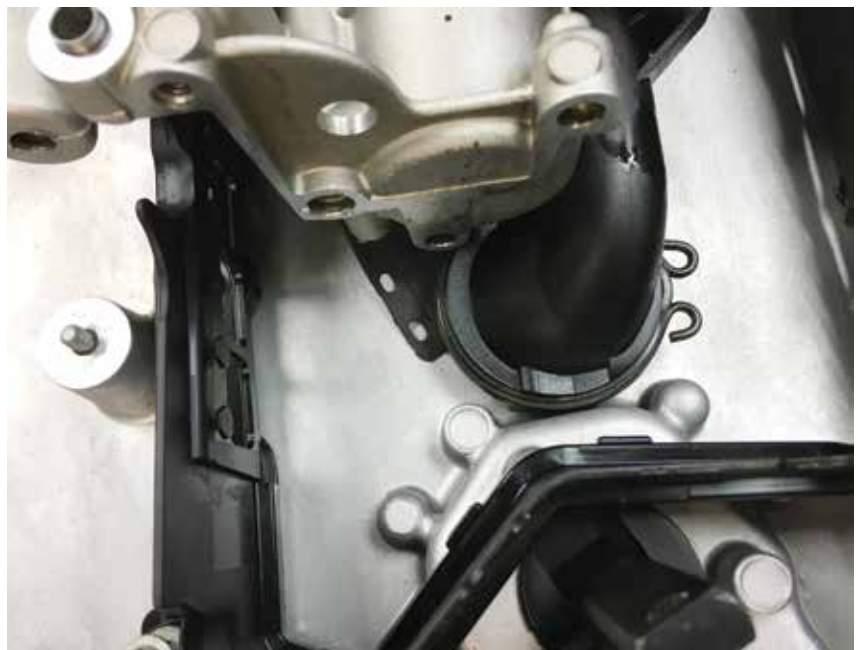
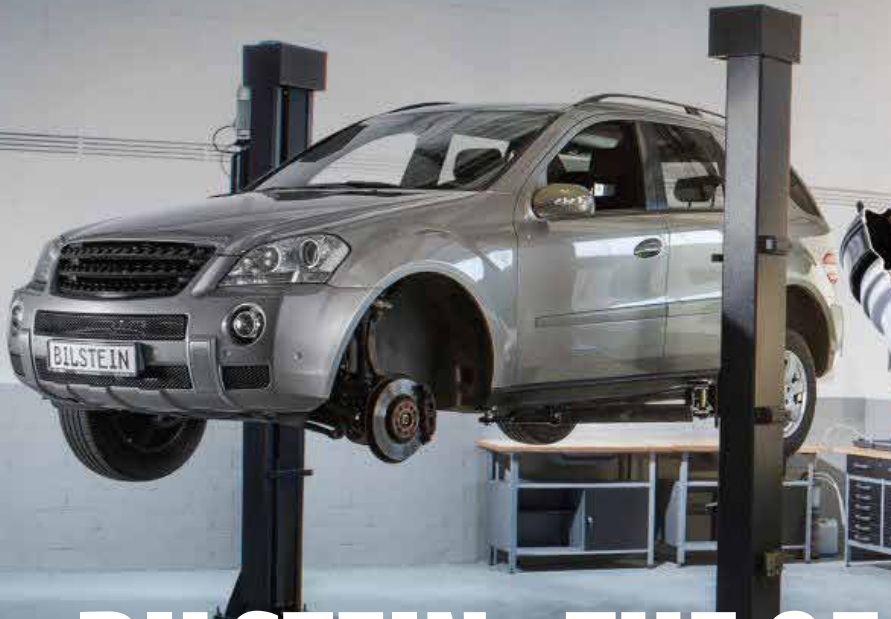
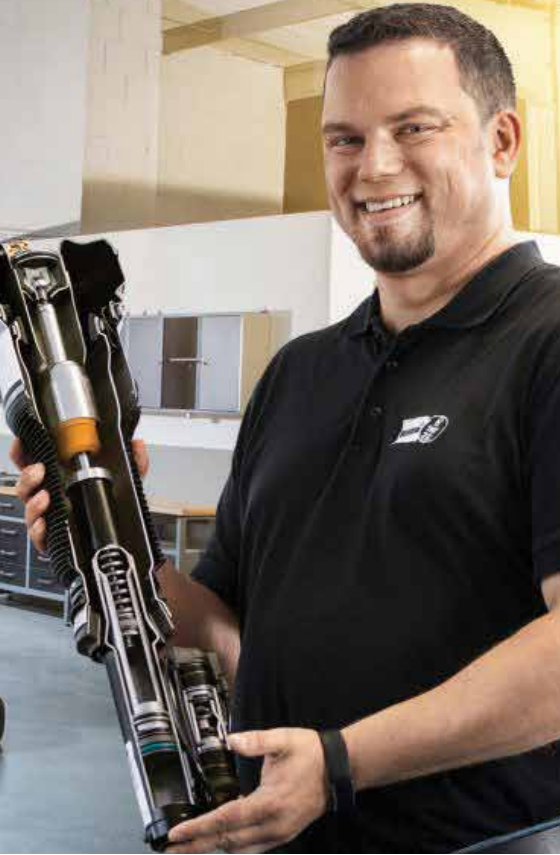
In engines that have failed due to lack of lubrication, observation has shown that baffles had come loose on several of these posts and were partially obstructing the oil intake. Thus as the driver negotiated a turn the loose baffle would partially obstruct the oil suction screen.

Here, in the above right photo, you can see an oil baffle that has almost completely broken free from its mounting. At this point the baffle would almost certainly completely block the oil suction inlet screen. The oil pan gets a shiny rub mark on it where the suction screen is located.

In the next photo you can see a mocked up pump and you can see how the baffle can get sucked into the screen. It happens very quickly and the resultant damage is almost always catastrophic.

As a result, some shops are now recommending that all 9A1 engine customers allow them to remove the pan and examine the doors. If only one or two holes are not connected it is possible to use aircraft safety wire on each end of the baffle.

The previous part number for the bulkhead was 9A1 107 243 75. Earlier in model year 2018 the Porsche part number changed to 9A1 107 243 01. A more comprehensive repair includes replacing the bulkhead with the new, upgraded part. ■

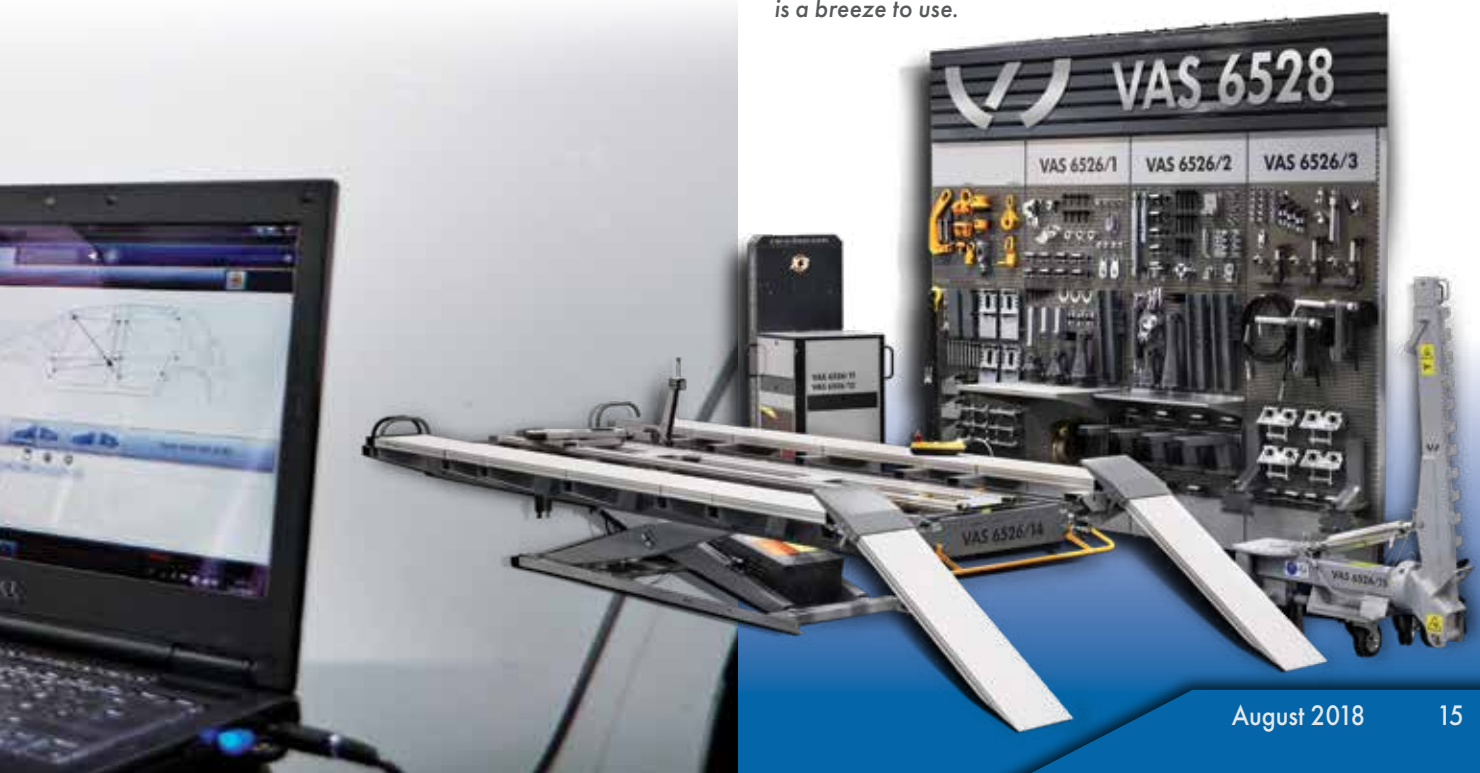
Below: Volkswagen-approved collision straightening and measuring systems feature state-of-the-art technology and sophisticated software to make measuring accurate and fast. And despite — strike that — because of all its built-in high-tech wizardry, the VAS_6528 bench and measuring system shown here is a breeze to use.

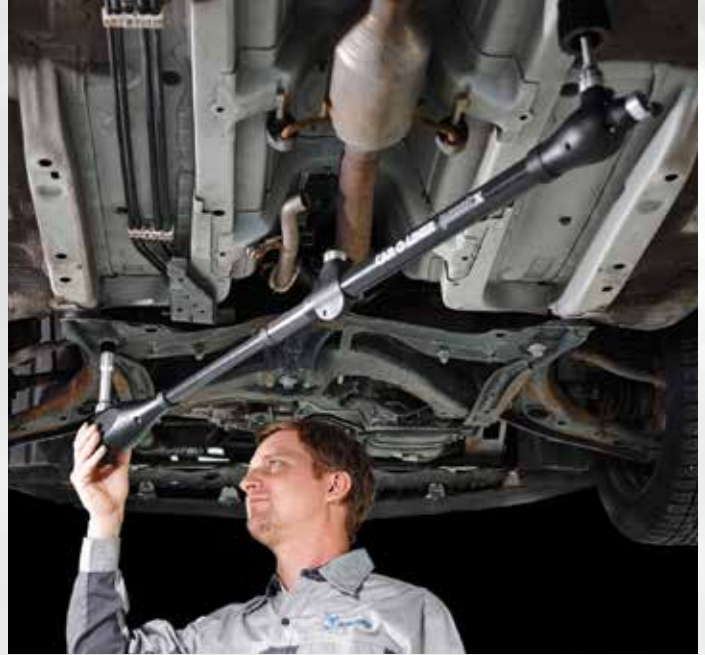
A powerful magnet holds one end of the PointX Diagnostic Measuring Tool onto the reference point. It is a one-man job to then swivel the other end 360 degrees to quickly measure the distance from one reference point to many different potential damage locations, without repositioning the magnetized end.

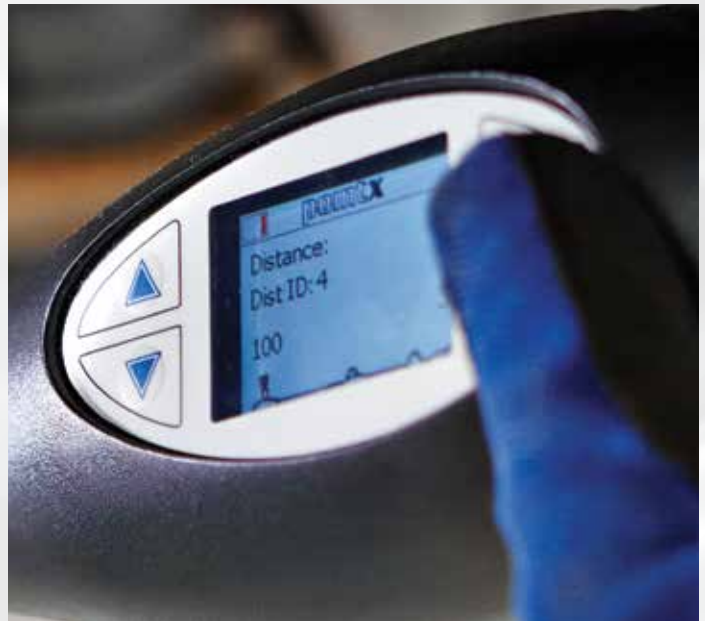
The PointX Measuring Adapter includes a display so you can see the measurement at the point you are targeting. Pressing a button near the display provides live, continuous monitoring of the measurement as you move from one point to the next.

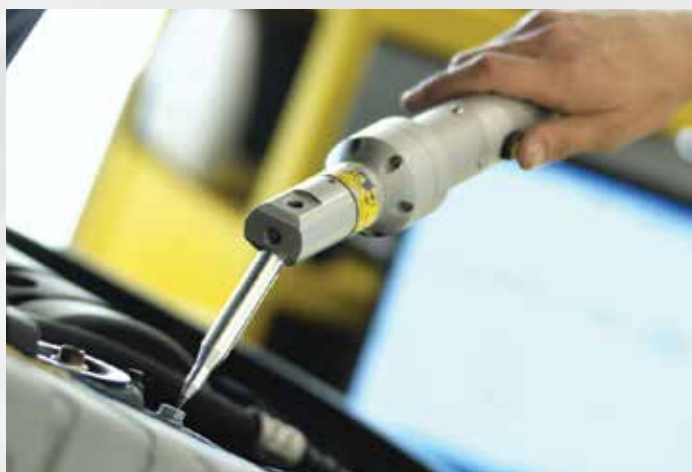
When you touch a point on the vehicle and press a button on the end of the articulating arm, the VW-approved Spanesi Touch electronic measuring system emits an audible chirp to let you know the point has successfully been measured.

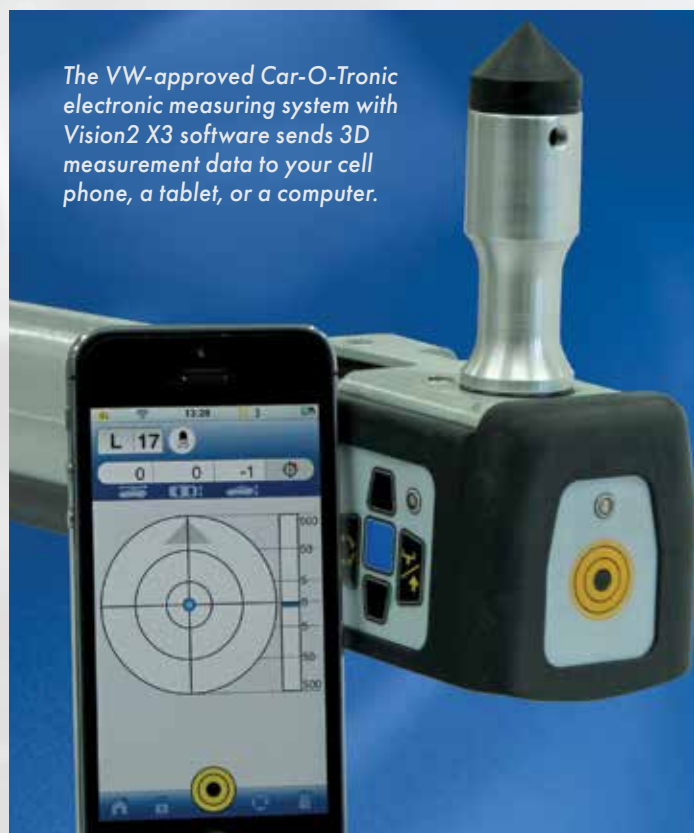
The VW-approved Car-O-Tronic electronic measuring system with Vision2 X3 software sends 3D measurement data to your cell phone, a tablet, or a computer.

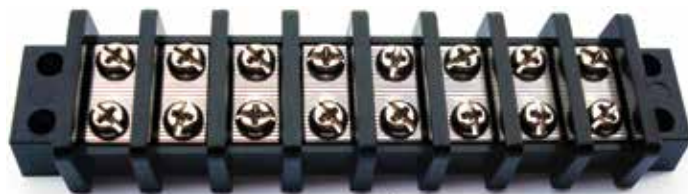
Strip block

You can attach a salvaged DLC and also connect a clean 12 volt power supply. This experiment has been performed many times for many reasons and with used VW Group controllers (VAG). What the network is comprised of:

An Audi A4 (RB4) instrument cluster	(vintage 2002)
A VW Passat 2.8L engine controller	(vintage 2002)
A Porsche Cayenne air bag controller	(vintage 2006)
A VW Jetta comfort control module	(vintage 2003)

This makes a Frankenstein network that can be connected to various scan tools. Proof is the connection to the DLC and verified with the Ross-Tech VCDS with an OBD II tool.

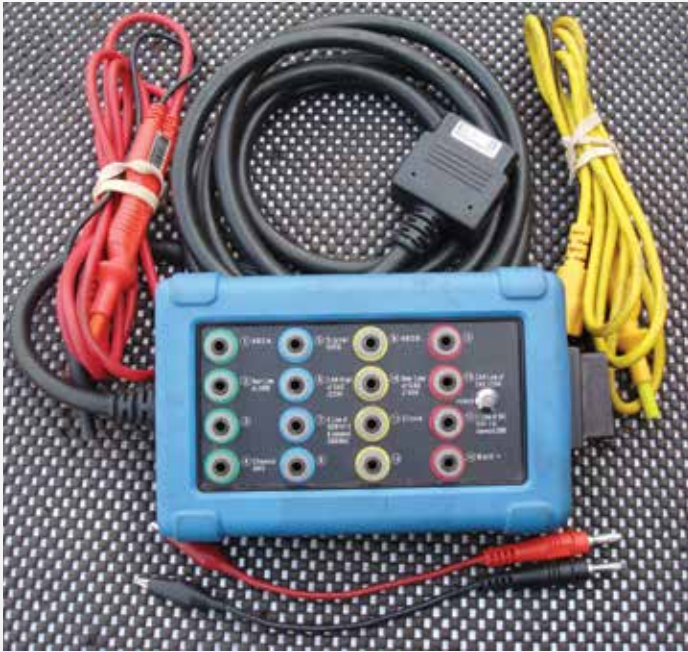
With a little thought, nearly anything from any make, model, or year can be active. This choice is VW Group (VAG) controllers. A DLC breakout box can also be used to help identify the active connection via diagnosis. That connection can be CAN, “K,” or “L” line, depending on the controller. The DLC box also offers a connection for an oscilloscope.

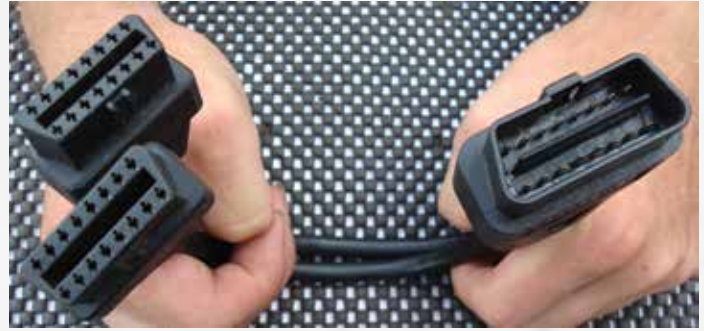
Splitter cable

communicate with the vehicle systems with one connection at the DLC splitter cable. The other (identical) end is attached to the J2534 device.

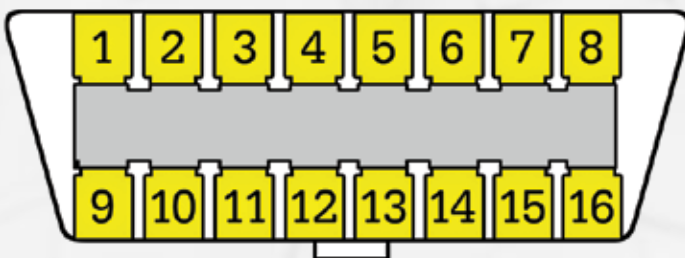
Pin	Signal	Description
2	J1850 Bus+	
3	Not in use	
4	CGND	Chassis ground
5	SGND	Signal ground
6	CAN High	J-2284
7	K-LINE	(ISO 9141-2 and ISO/DIS 14230-4)
10	J1850 Bus-	
11	Not in use	
14	CAN Low	J-2284
15	ISO 9141-2 L-LINE	(ISO 9141-2 & ISO/DIS 14230-4)
16	+12v	Battery power

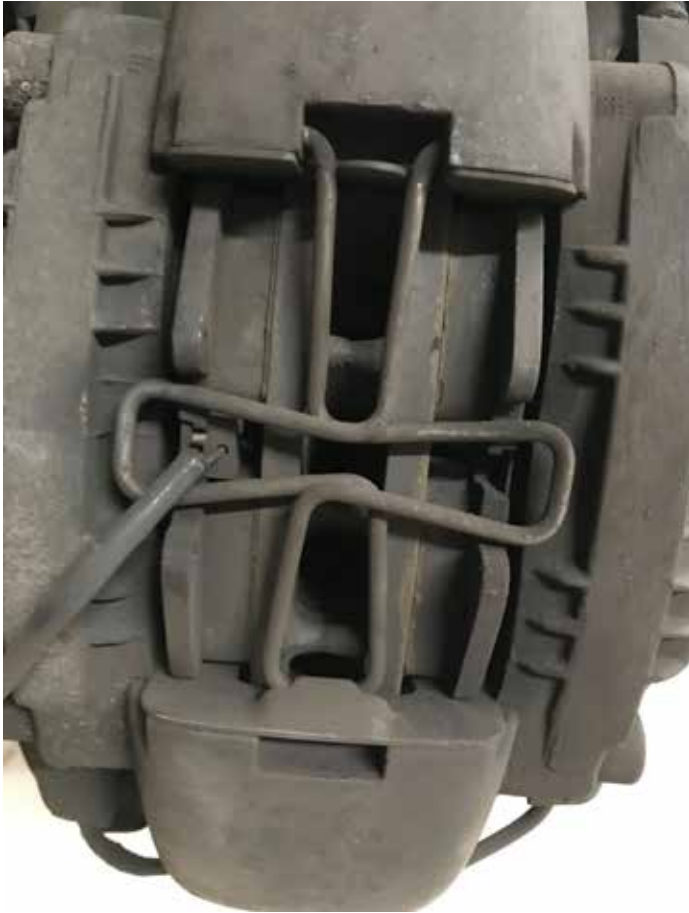
Measuring and noting pad thickness is important but it is one of many steps of a thorough brake inspection.

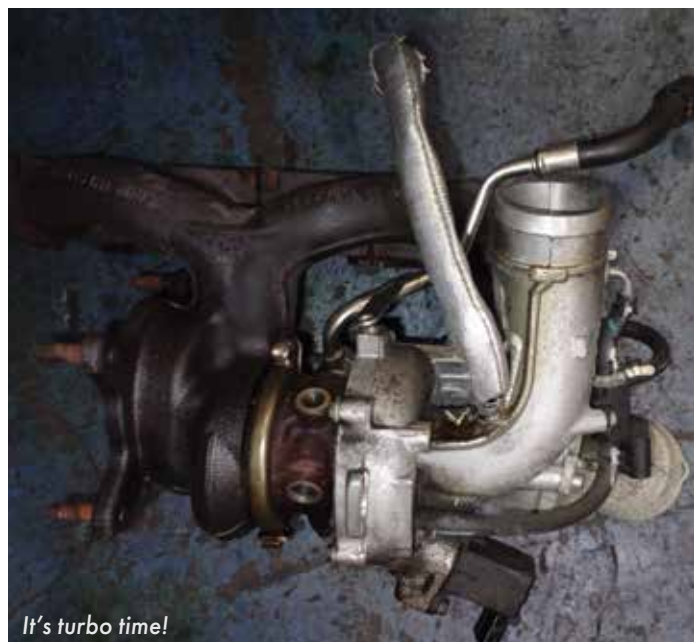
Audi uses an internal wastegate design on their turbochargers. The primary advantage to this design is a smaller turbo package and simpler installation. The disadvantage of this design is, if a problem develops with the wastegate itself, the entire turbocharger may have to be replaced.

Wastegate "rattle" can also be an issue on certain models. Customers may complain of an engine rattling sound when starting the vehicle or during deceleration. This is usually caused by wear at the connection from the actuator rod to the wastegate arm. This allows exhaust gas pulsations to move or "rattle" the wastegate seal. In extreme cases, the wastegate seal itself can become worn, allowing boost pressure to escape as well as creating a "rattling" sound. A worn wastegate can even set low boost faults.

Audi has released an updated securing clip for the wastegate arm connection. If diagnosing a rattling turbo, check to see if the clip has been updated, as this newer version will address most rattling issues.

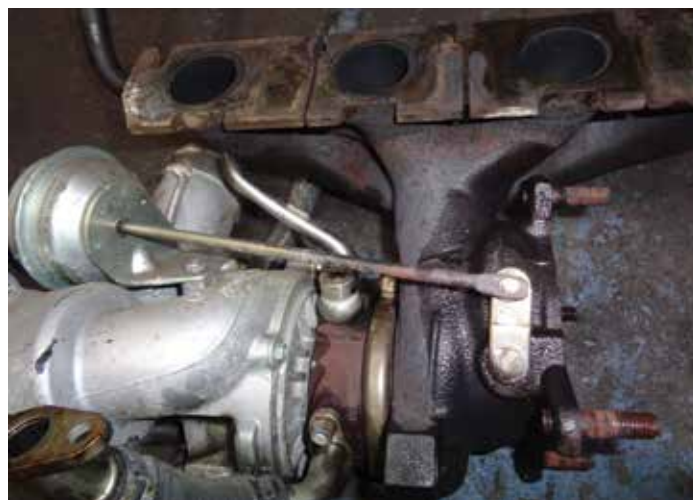
The actuator arm is only visible with a mirror or from underneath the vehicle when installed.

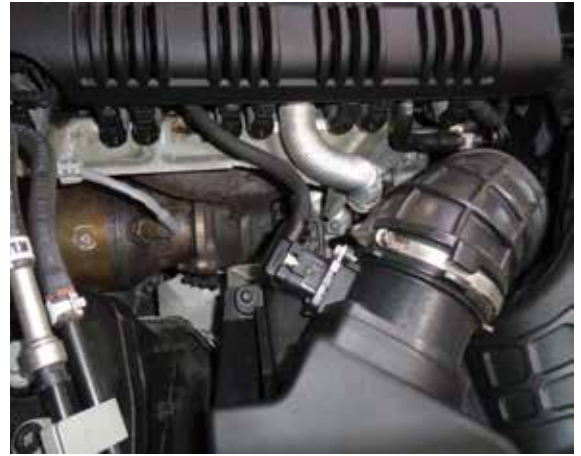
Turbo access from the top of the engine is limited.

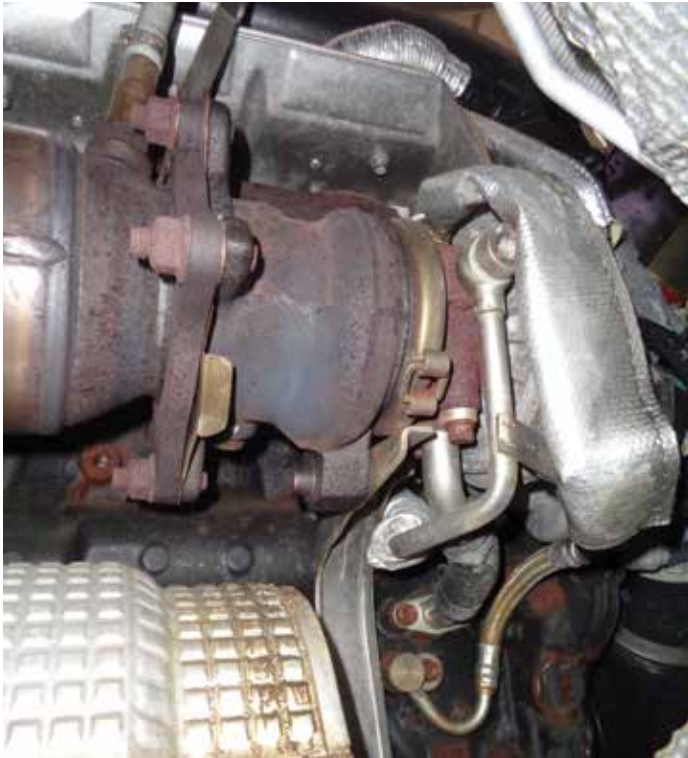
It may be necessary to heat stubborn exhaust hardware to aid in removal.

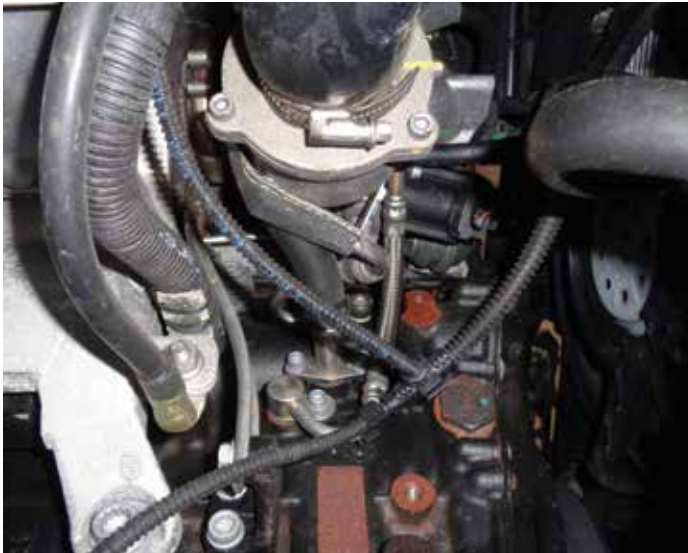
Be careful not to kink or damage any feed lines during turbo removal.

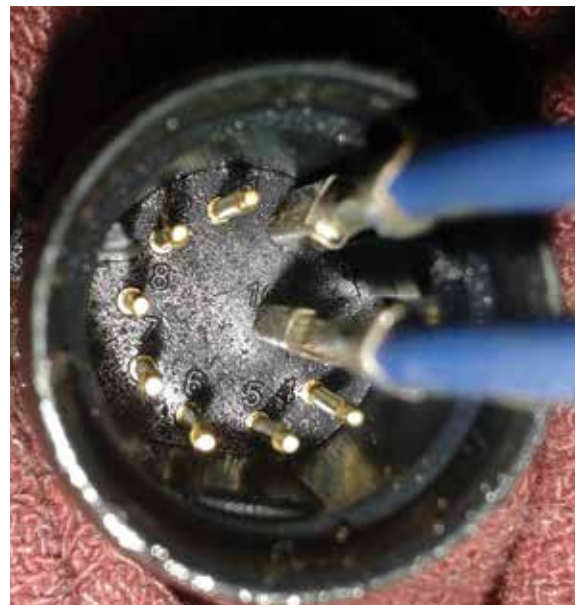
Harness test one

1. The drain plug and spill port is removed, capturing the fluid.
2. Pan removed and harness disconnected at solenoid 7.
3. Measured from the transmission end harness to the solenoid harness.
4. Found an open circuit in new harness.
5. Solenoid 7 is the one in white. (See image Solenoid 7 on the left.)

Note the temperature sensor attached to the foil strip below solenoid 7.
