CLASSIC VOLVO 240 SERVICE AND REPAIR TIPS

THIS ARTICLE WILL
BE ABOUT THE CARE
AND FEEDING OF THE
LEGENDARY VOLVO
240 SERIES CARS.

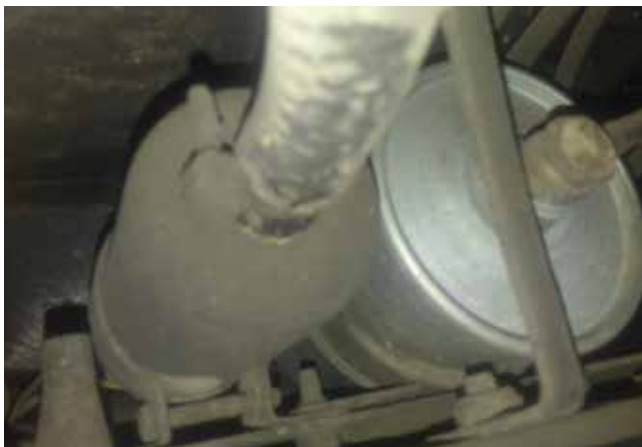
Main fuel pump

These pumps can take a lot and there are still 240s out there with original pumps on them. When these pumps fail they will usually lock up when the car is hot and may start pumping again when the car cools down.

1. MAIN FUEL PUMP FAILURE (MOST YEARS)

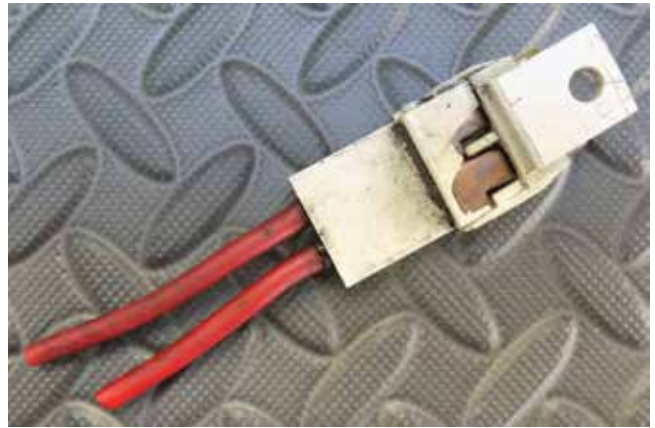
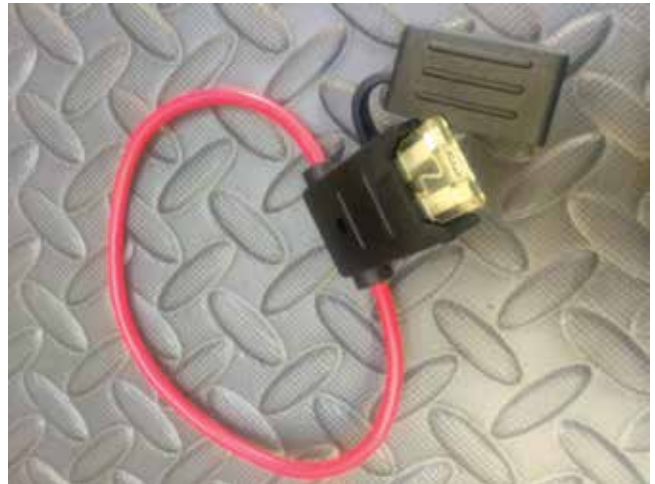
If you can't find a factory replacement fuse holder you should splice in a good quality water tight replacement with a new 25 amp fuse.

On some later 240s (1988 - 1991) with LH 2.2 Jetronic fuel injection, Volvo used a fuse holder with a 25 amp fuse, installed near the battery as a type of fusible link for the fuel system.

These fuse holders were unprotected from the elements, and over time, begin to corrode. As the contacts corrode they build resistance and heat, causing the housings to break down. This 25 amp fuse provides direct battery voltage at all times to the fuel pump relay, so check this first in a crank, no start situation.

If you can't source a factory replacement fuse holder, you should install a good quality, water-tight fuse holder, with a new fuse in its place.

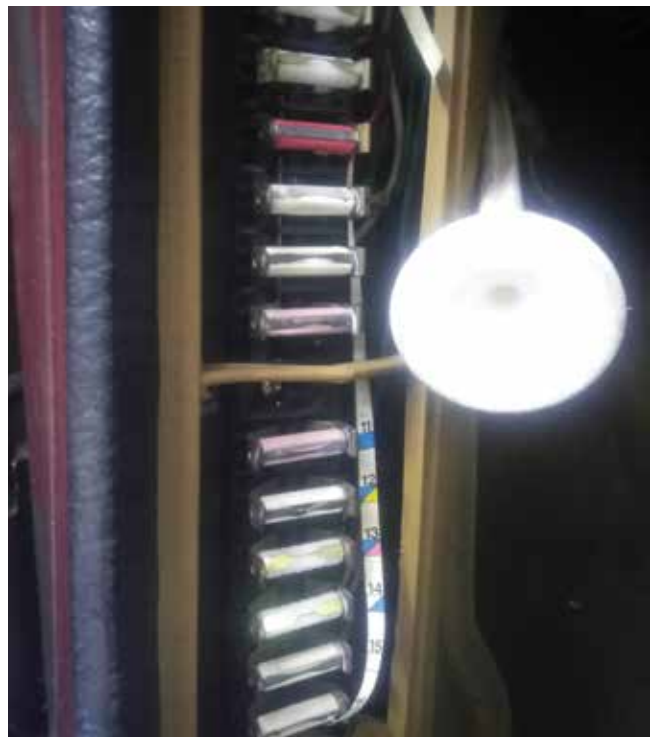
Fuse box

The main fuse box is located in the driver side kick panel and suffers from a few design flaws. First, the fuse box is susceptible to corrosion from water that can enter the interior and drip directly onto the fuses. Second, the small contact area of the European ceramic-style fuses also leads to corrosion due to electrolysis. You can prevent numerous problems associated with the fuse box by pulling all fuses and cleaning them annually.

When inspecting these fuses, use a flashlight and look closely for cracks at the ends of the fuses and for heavy corrosion in the holders.

If you encounter an intermittent or no start issue on your 240, you can often get going again by simply spinning the fuses in their holders, which re-establishes electrical contact.

When checking this type of ceramic fuse, the old rules don't always apply. Sure, they are very easy to see if they have been overloaded and are blown, but in a lot of cases the fuse that is causing a problem won't be blown.

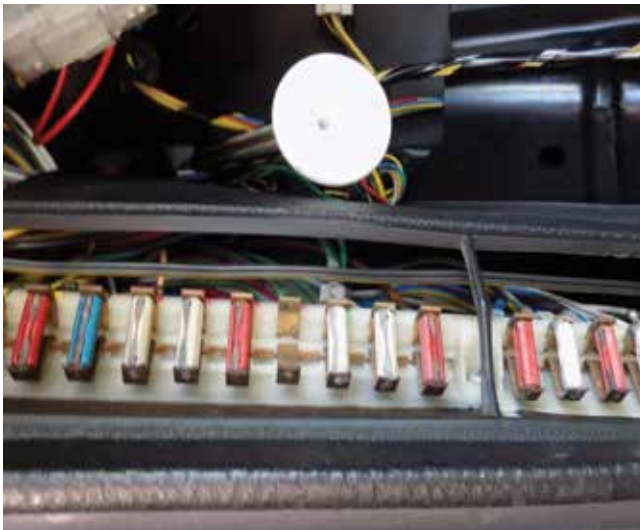
When you are testing these old-style ceramic fuses for a problem, don't always expect them to "look" like other fuses when they are bad. One of the more common problems can be intermittent open circuits caused by tiny cracks at the ends of the fuses.

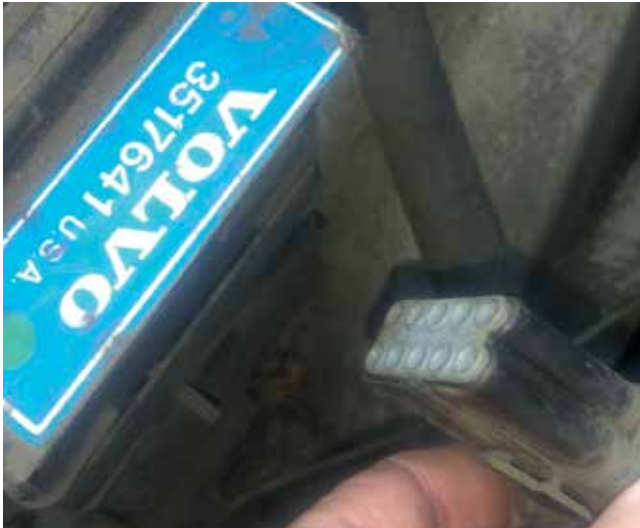
When you are checking out a 240 that has an active or intermittent no spark symptom, you should pay close attention to the connections and wire terminals at the ignition control unit located in the right front of the engine compartment. You can check the quality of the connection by wiggling the connector while remotely cranking the engine over with the key on position 2.

If you have a (1986 - 1989) Volvo 240 in your shop with an active or intermittent crank, no start symptom and you suspect a no spark condition, make sure to inspect the connector and pins on the ignition control unit located in the right front of the engine compartment next to the washer tank.

You can use a spark tester or a timing light to see if the spark comes back. If it does, pull off the main connector and clean and tighten the pin connectors.

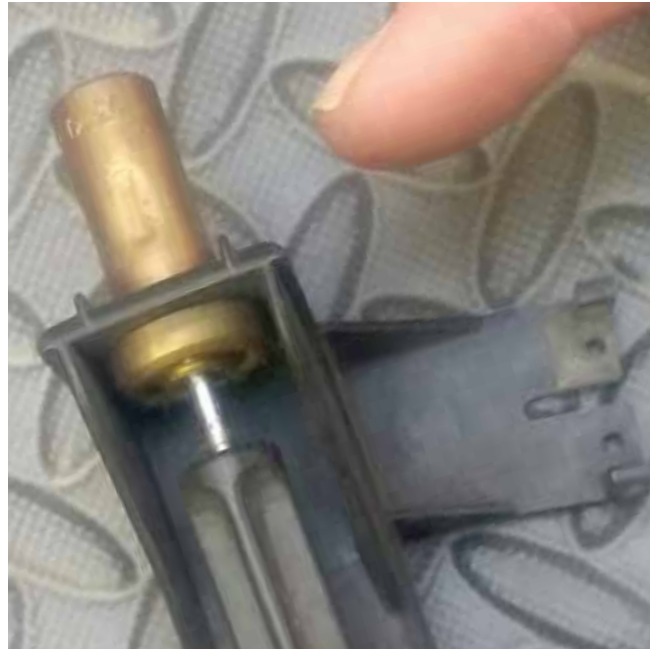
The air box thermostat should be in the closed position in most cases unless the ambient temperature is less than 50 degrees F. Usually the thermostatic valve will fail in the open position, causing hot air from the exhaust to be sucked through the air mass sensor at all times, causing inaccurate readings and damage to the air mass sensor itself.

The Volvo 240 uses a thermostatically controlled shutter valve in the air filter box. This thermostat regulates the flow of fresh and pre-heated air into the intake system. Pre-heated air comes into the air filter box through the aluminum pre-heat hose that is connected between the air filter box and the exhaust manifold or downpipe.

It is common for the thermostatic valve to fail in the pre-heated air (open) position. This routes superheated air through the Mass Air Flow sensor (air mass meter) at all times.

If this condition is allowed to continue for a long period of time, it will cause premature failure of the air mass sensor. It will also cause the engine to run very inefficiently as the engine management system will excessively lean out the fuel mixture in response to the hot air.

Check your system on a day when the ambient temperature is above 50 degrees F. The valve should be fully open to fresh air (not pre-heated). If it is open to the pre-heat side, then you should replace the thermostat. Also, if the valve fails to reach full extension at hot and cold extremes, replace it.

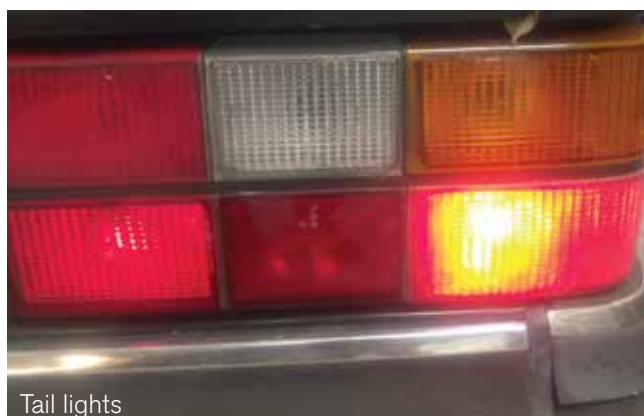
Tail lights

These tail lights are unique in that they use individual bulb sockets that get their power and ground from a flexible plastic circuit card that is embedded with copper.

Luckily most of the 240 sedan's tail light problems can be easily fixed by cleaning and tightening the connections at the main circuit card connector or just cleaning the contact surface of the card itself.

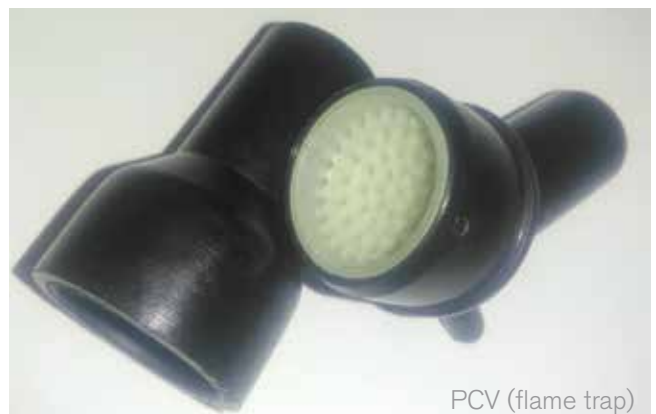
PCV (flame trap)

The Volvo 240 uses a simple yet effective design to recirculate the engine's excess crankcase vapors. Instead of the typical PCV valve used in most cars, the 240 uses a fitting with a screen and a vacuum fitting to draw crankcase gases back into the intake manifold.

These flame trap screens can clog up with carbon over the years and miles and cause excess pressure to start to push out oil seals and cause the engine to burn excess oil.

The flame trap should be changed and the vacuum fittings cleared every 30K miles. ●
