If It's Not One Thing It's Another

Tracking down the cause of one problem can lead to other issues. A speedometer repair on this BMW evolved into something deeper.

Imagine this 2001 BMW 740i in very good condition that's had some past TLC but had other recent shops "have a go at it." This adventure all starts with a question: "Can you get the speedometer working?"

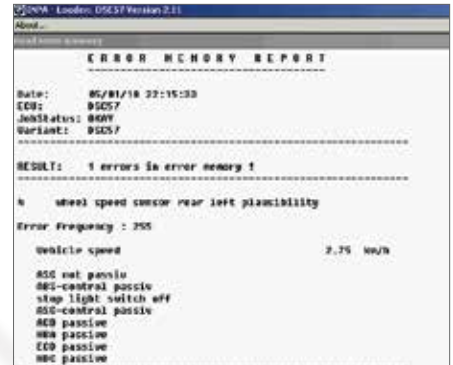
L/R sensor error

R/R ABS signal - Note that this signal was “stretched in DC mode.” This signal also sends the trip odometer data.

At the ABS controller, the sensor previously diagnosed by the dealer was tested with an oscilloscope and with the rear wheels spinning in Drive and at idle.

There is some good fortune at times when “repeat the test” offers a result that may confirm a suspicion. After the radiator replacement and during the road test, one new fault was recorded.

Fortunately for the vehicle owner, a new BMW replacement sensor for the R/R side was previously purchased. That sensor is now used for the L/R side.

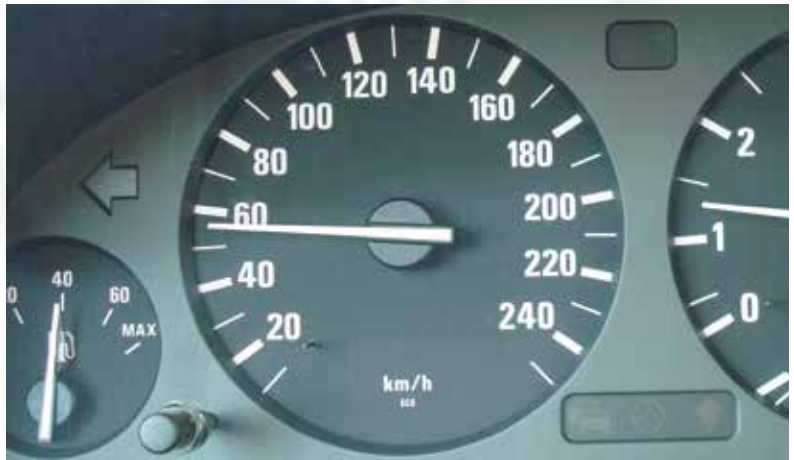
Operating Speedometer

With the new sensor installed, the following image offers some satisfaction that the “trauma” was worth it in the end. The primary question is answered.

A road test with INPA confirms the IKE reads the correct data with no faults.

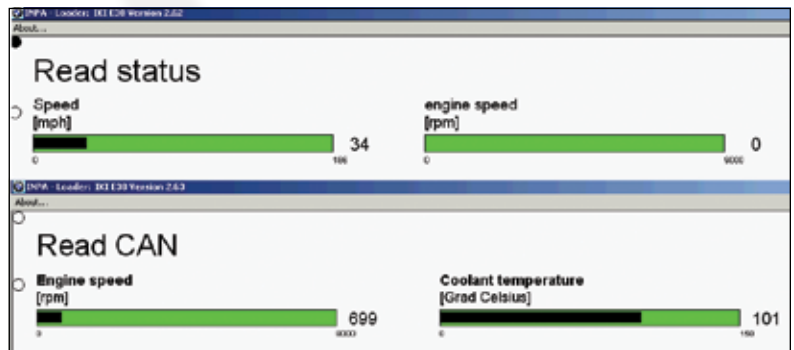
Merged speed test

Note that this INPA specific test offers road speed at the Instrument Cluster and is trimmed to fit this article. The image to the right indicates no rpm, but the “Read CAN” button was used to acquire rpm via CAN. At the IKE, the correct rpm signal is read within the lower image, off throttle and coasting.

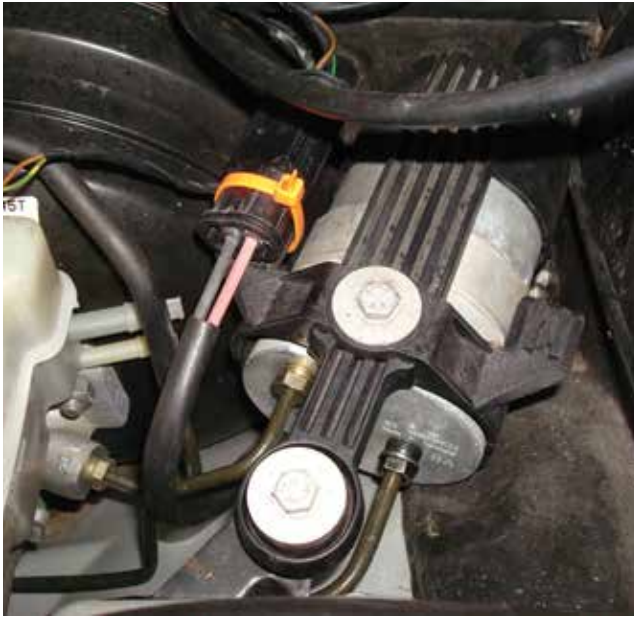
Installed pump

- In BMW terms, the device in question is called a pre-charge pump.
- The BMW number is 34516781435 with a heart attack when priced.
- The pre-charge pump operates under the following conditions:
 - Road speed greater than about 20 mph
 - Engine speed greater than 2000 rpm
 - Engine torque greater than 100 Nm

If the driver accelerates above the set conditions and the ABS warning lamps are ON and a fault code is set, it is a suggestion that the pre-charge pump is defective.

A sure test is to apply battery voltage to the heavy electrical connections at the pre-charge pump. A defective pump will likely NOT spin:

Bleed the fluid at the outlet side until no air is visible, then torque the line.

Reverse the connections to allow any trapped air back to the reservoir.

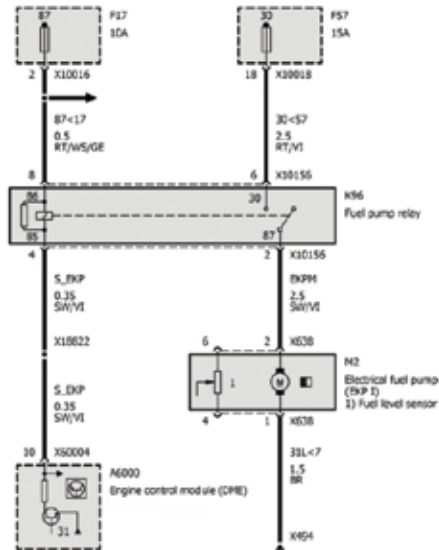
Fuel pump circuit

The BMW returned in a week or so for a no-start condition. With a fuel pressure gauge and by cycling the ignition key, no fuel pressure was evident. A 30 amp fuse was found to be burned, using a schematic.

A replacement fuse at F57 did enable fuel pressure to return, the engine ran with no faults but – for the uninitiated there is another mystery. There is a reason that seemingly points to a failing fuel pump. Can the fuel pump and entire circuit be measured? Can the pump be monitored?

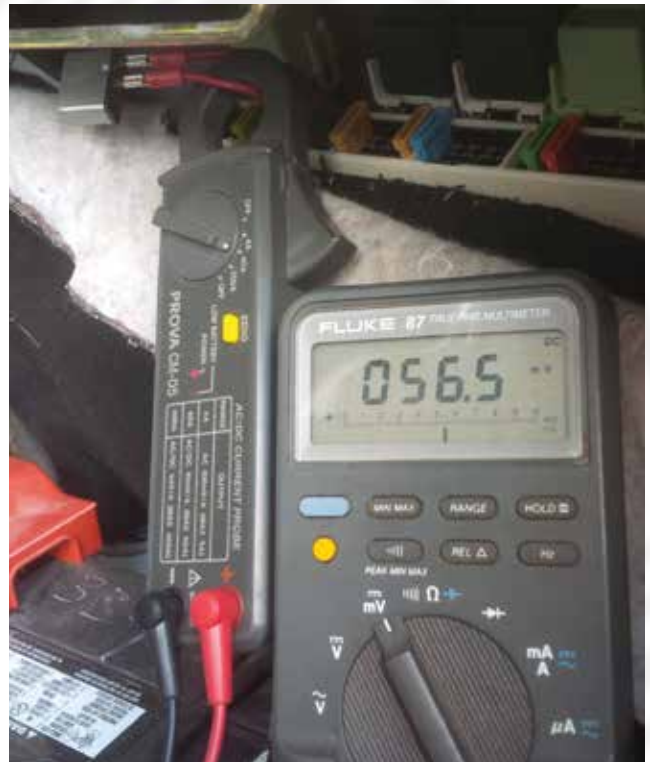
Amp clamp 01

This image of the Fluke meter and a simple amp clamp offers some information with a 30 amp re-setting fuse to protect the circuit at F57.

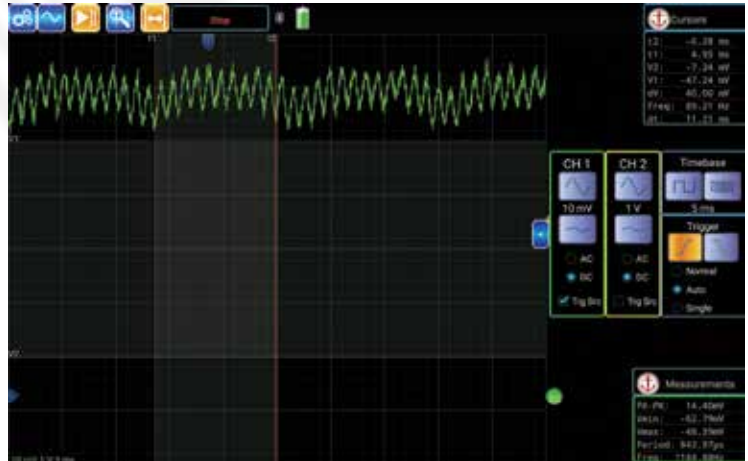
Original pump

Some research on this pump indicates 10 commutators.

The fuel pump calculation is as follows:

60,000 milliseconds (ms) divided by
11.21 ms = 5352.36 rpm < Suspect rpm
