FALL/WINTER 2018

# VOLVO TECHTIPS

Information for the Independent Volvo Specialist

# IGNITION LOCK REPLACEMENT 1999 - 2009 S80/V70/ XC90

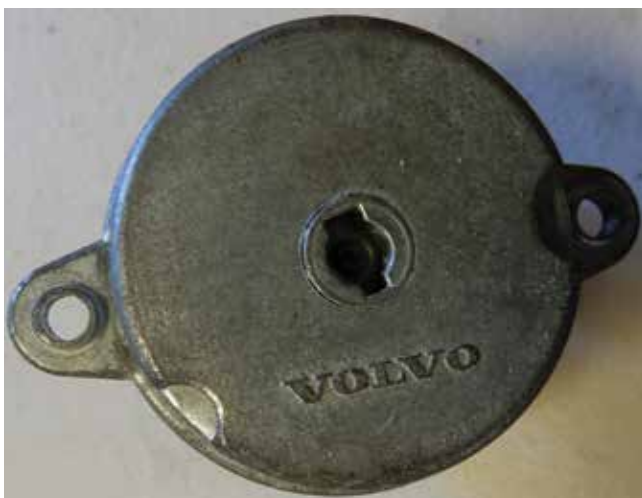
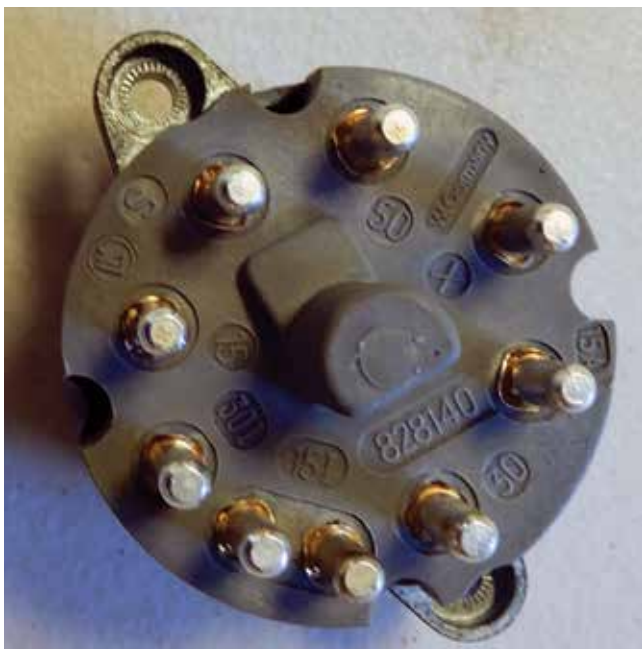
Electrical portion of ignition switch

The electrical switch also wears out, creating a no-start condition or electrical problems. In some instances this electrical switch can get jammed and cause the key not to turn. Make sure to check before replacing the complete ignition lock assembly.

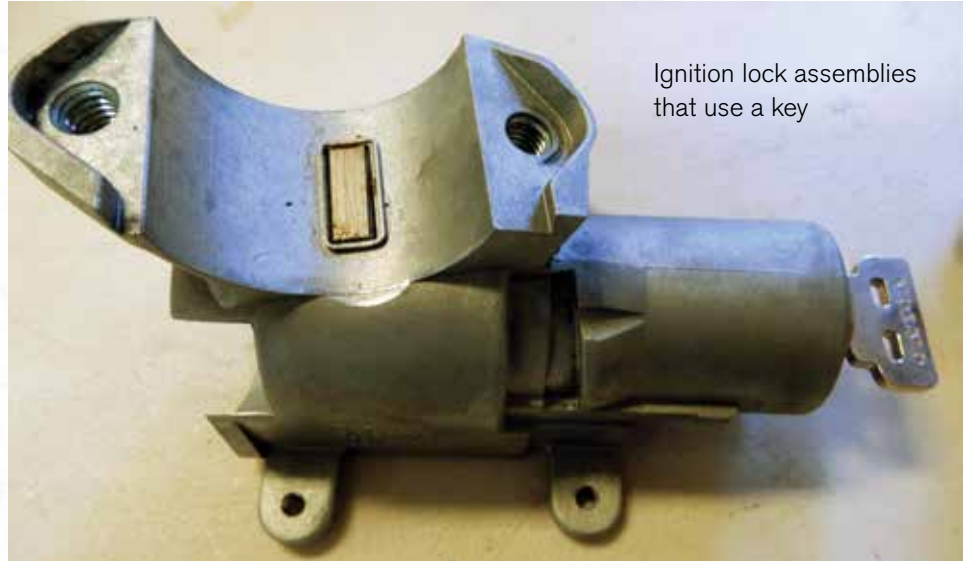
Ignition lock assemblies that use a key

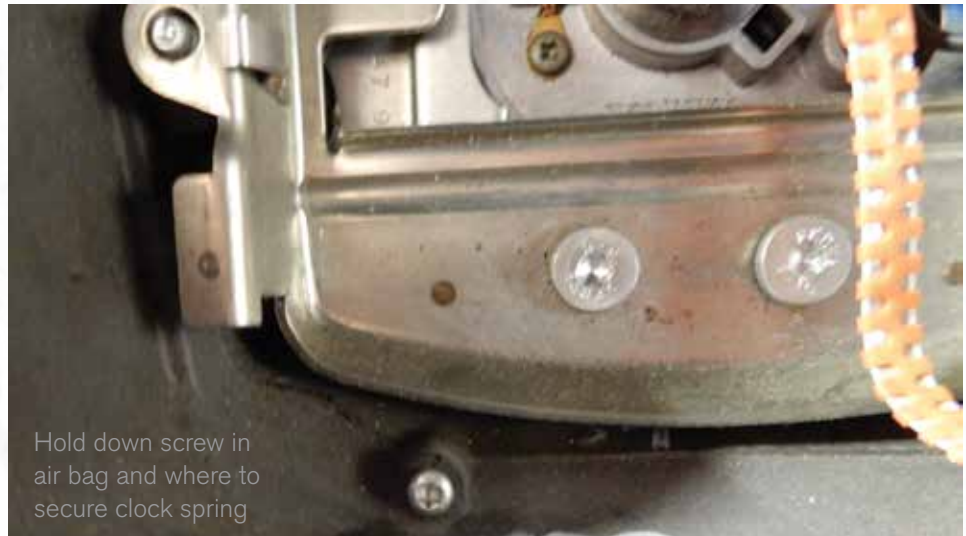
Hold down screw in air bag and where to secure clock spring

Make sure to use the screw to hold down the clock spring that is supplied in the steering wheel. Not doing this can damage the clock spring. Make sure the steering wheel is pointed straight ahead and mark the steering wheel to the column so it is reassembled properly.

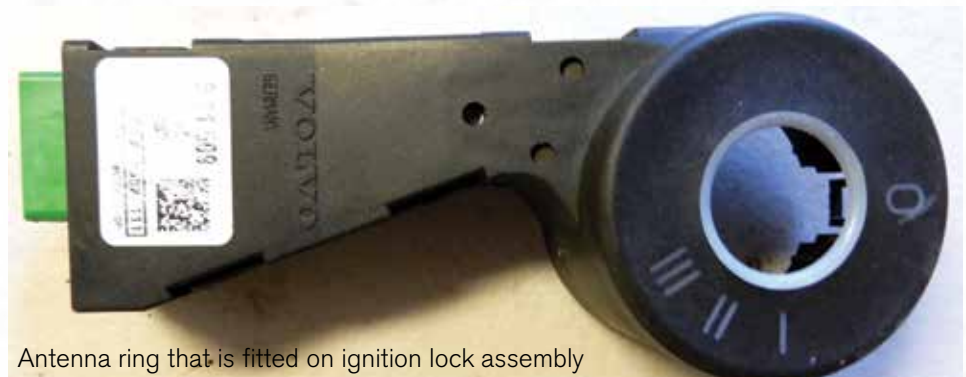
Antenna ring that is fitted on ignition lock assembly

Press in the snap connector and remove the antenna ring around the ignition lock and disconnect the electrical connector. Adjust the key to position 1 and remove the interlock cable from the shifter assembly. If for some reason the key will not move, it will be necessary to replace the cable for the interlock. Remove the screw that holds in the wiper switch and the turn signal/high low beam switch. The steering wheel module will need to be disconnected and removed.

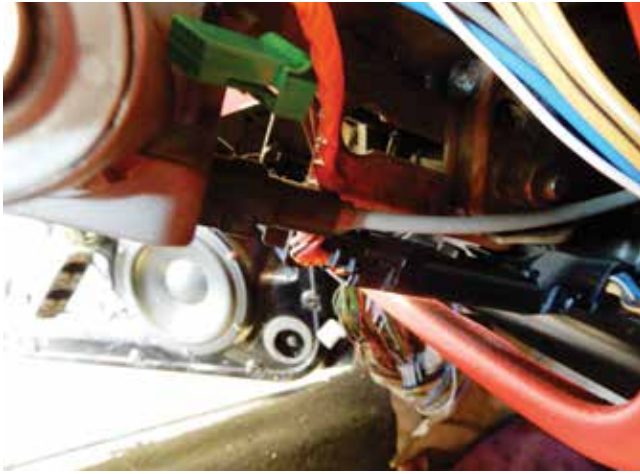
This shows the cable attached to ignition switch.

Once the ignition lock assembly is in place and tightened down, you can secure the cable into the lock from the shifter. Now we can connect wiring and install the antenna ring, turn signal

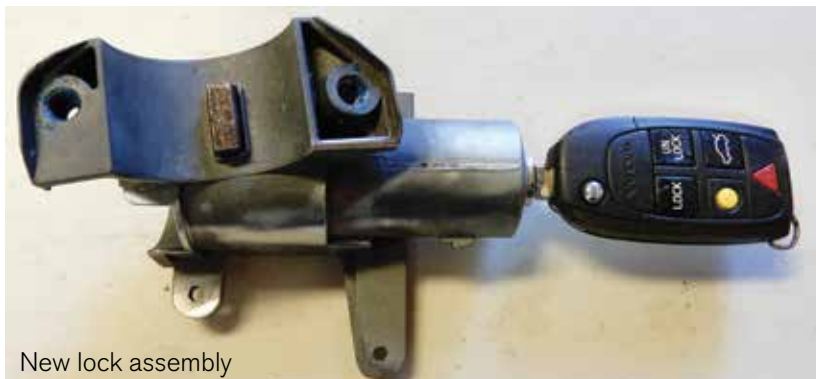
New lock assembly

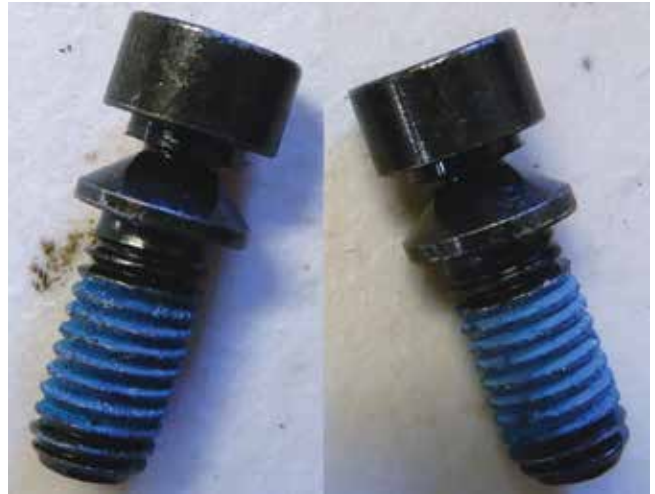
Here we have tamper proof bolts that hold in the lock assembly. The heads will break off when tightening.

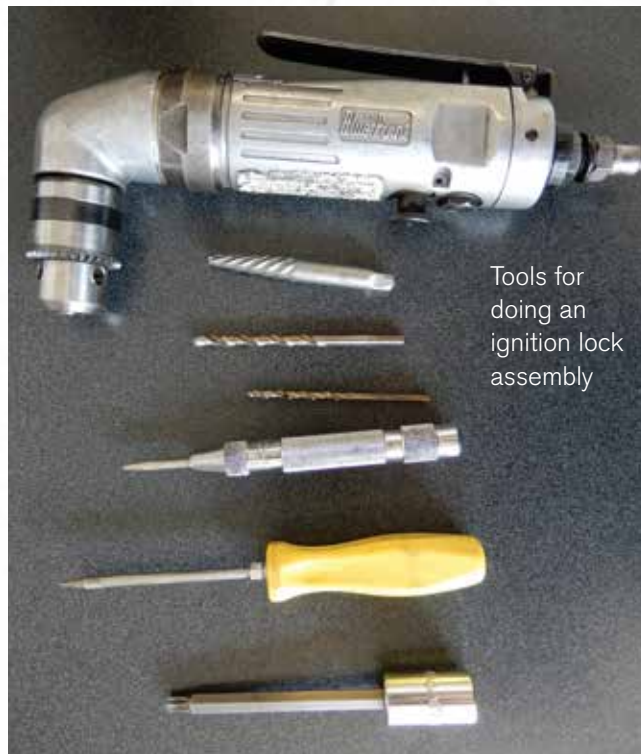
Tools for doing an ignition lock assembly

The following is the procedure for removing the ignition lock assembly from a Volvo XC90. Much like that in the S80, the mechanical ignition lock looks very similar. Tools you will need to replace the lock assembly are T25 and T20 Torx drivers, a socket for removing the steering wheel, and drill bits, drill, and center punch.

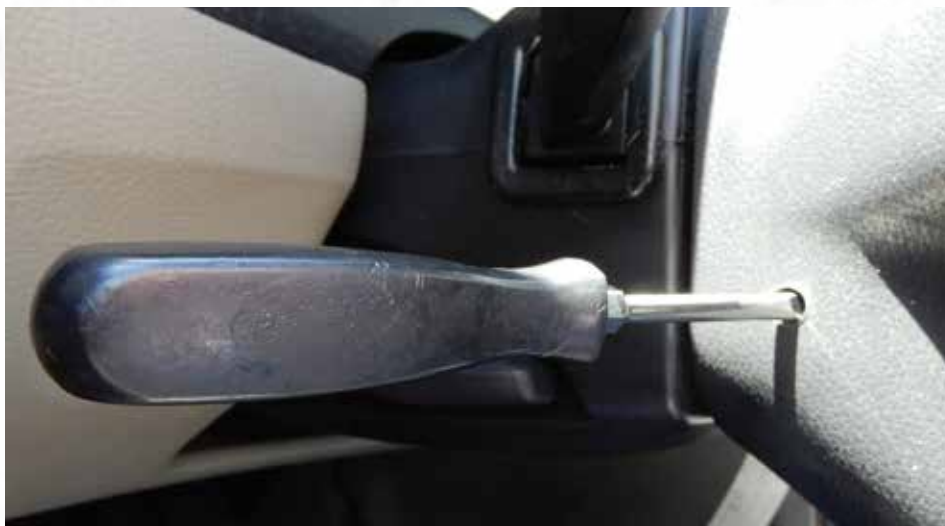
Screwdriver inserted in steering wheel to remove air bag

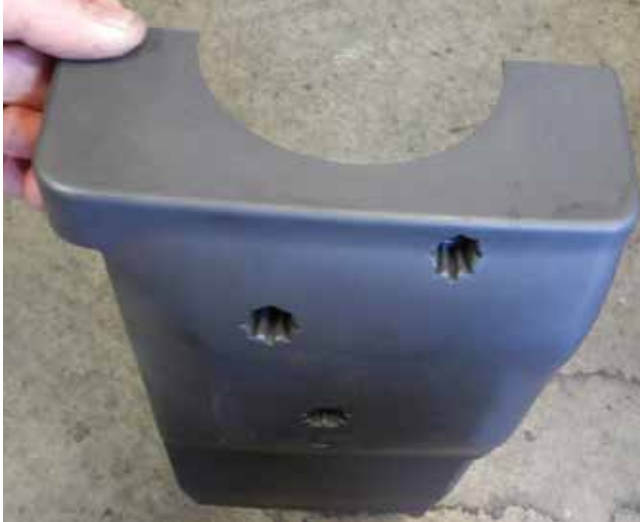
Covers around steering column.

Install the lower steering column cover with the three T25 Torx screws. Make sure not to trap any wires when installing the cover. Fold down the top cover and snap into place. Make sure that all rubber trim is in the correct

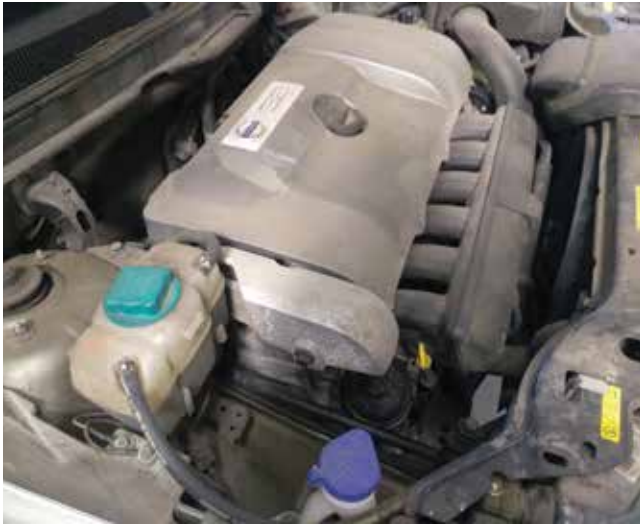
Rattle on acceleration from a stop on the 2006 - 2010 XC90 with the 3.2L SI six cylinder engine

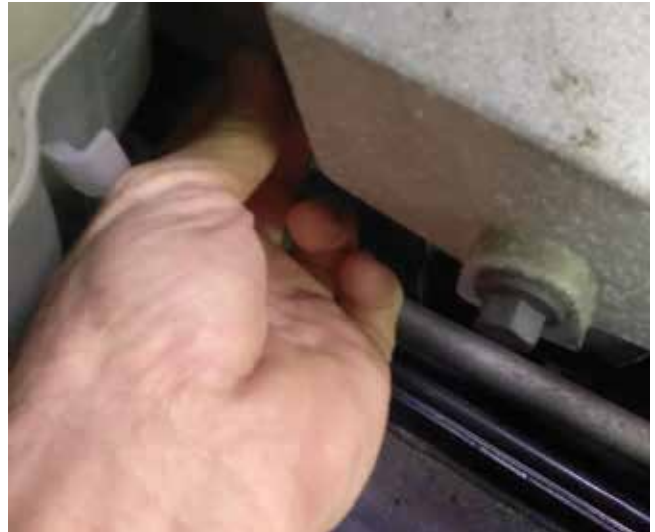
It can be very difficult to visually check the condition of the torque rod bushings while the rod is installed on the engine, since the bushings are under aluminum covers. The best way to check the bushings for wear is to just grasp the torque rod in the middle and shake it. When they are worn out the rod will rattle.

The best and simplest way to check the upper engine torque rod on a Volvo XC90 with the 3.2L SI engine is to simply grasp the bottom of the rod with two fingers and shake it. If the bushings at either end of the torque rod are worn and dried out it will feel loose and rattle when you shake it.

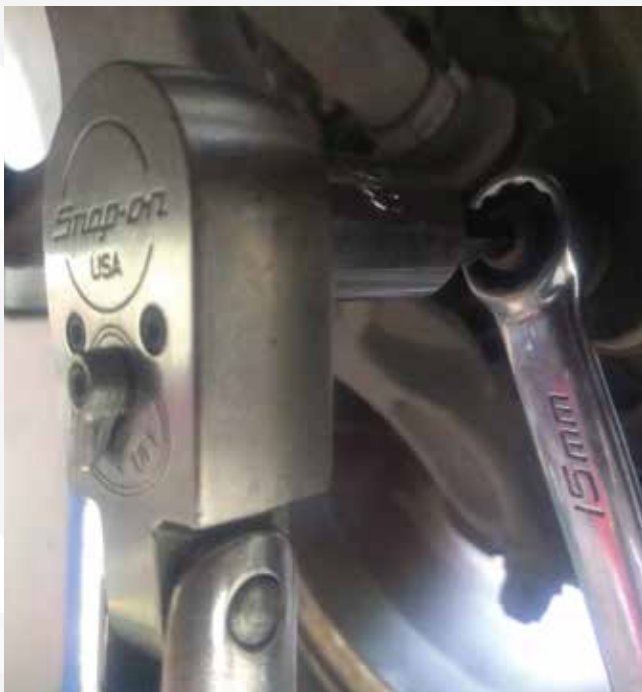
The best way to check for looseness and tighten sway bar end link nuts is to use a box or an open end wrench and hold the stud with either a Torx or Allen socket.

You can use a ratcheting box wrench to speed up this process.

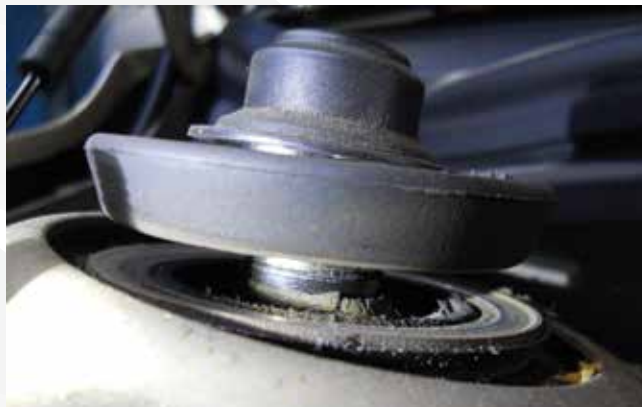
If you work on Volvo vehicles, you know what this part is and you have replaced a few broken ones. But the key is to recognize when the spring seat is about to fail and inform your customer before they hear that popping noise over bumps.

The best way to inspect these spring seats is with the car fully on the ground so that the struts are loaded. Use a flashlight to look under the strut washer and check to see if the seat is starting to crack or is completely torn. They don't always make noise when they are damaged or broken.

When you make a recommendation to your customer to replace the spring seats, always recommend them in pairs.

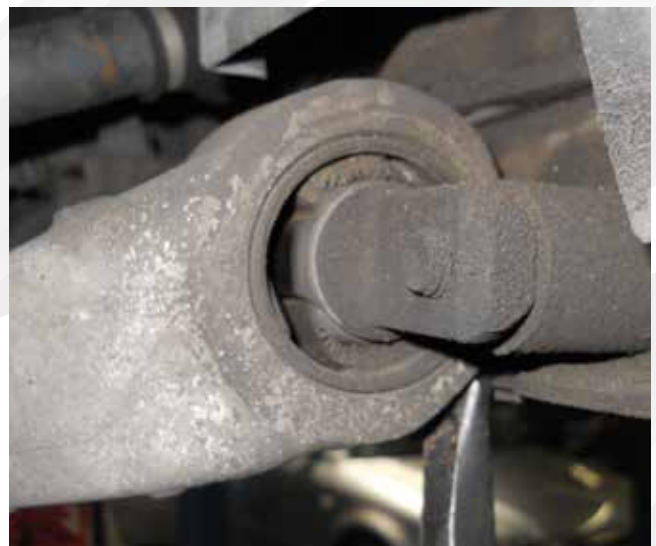
Front lower control arm bushings.

When these bushings break down and crack, they don't usually make noise themselves. But by allowing the suspension to move further than it was designed to, the worn lower control arm bushings can be responsible for a lot of front end noises.

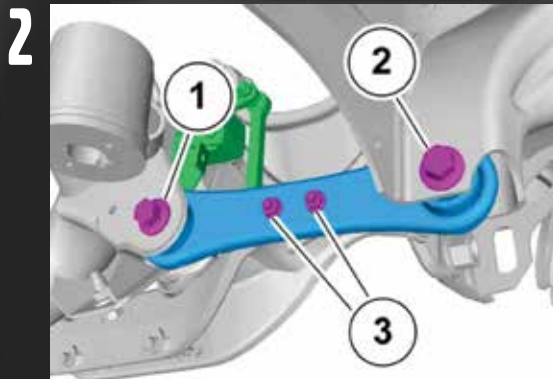
Remove the following components:  
 1. Torque: Tie rod to subframe, 110 Nm  
 2. Torque: Tie rod to longitudinal stay, 110 Nm  
 3. Torque: M6, 10 Nm

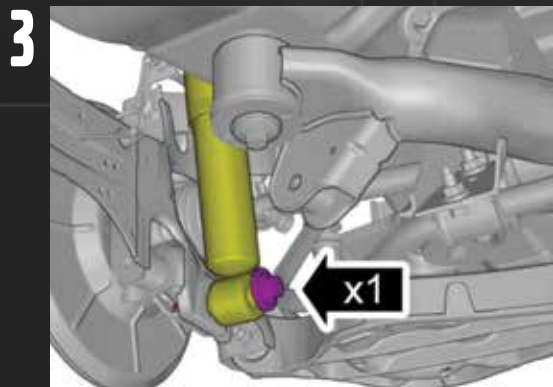
Rear shock absorber to wheel knuckle (Nivomat), 280 Nm

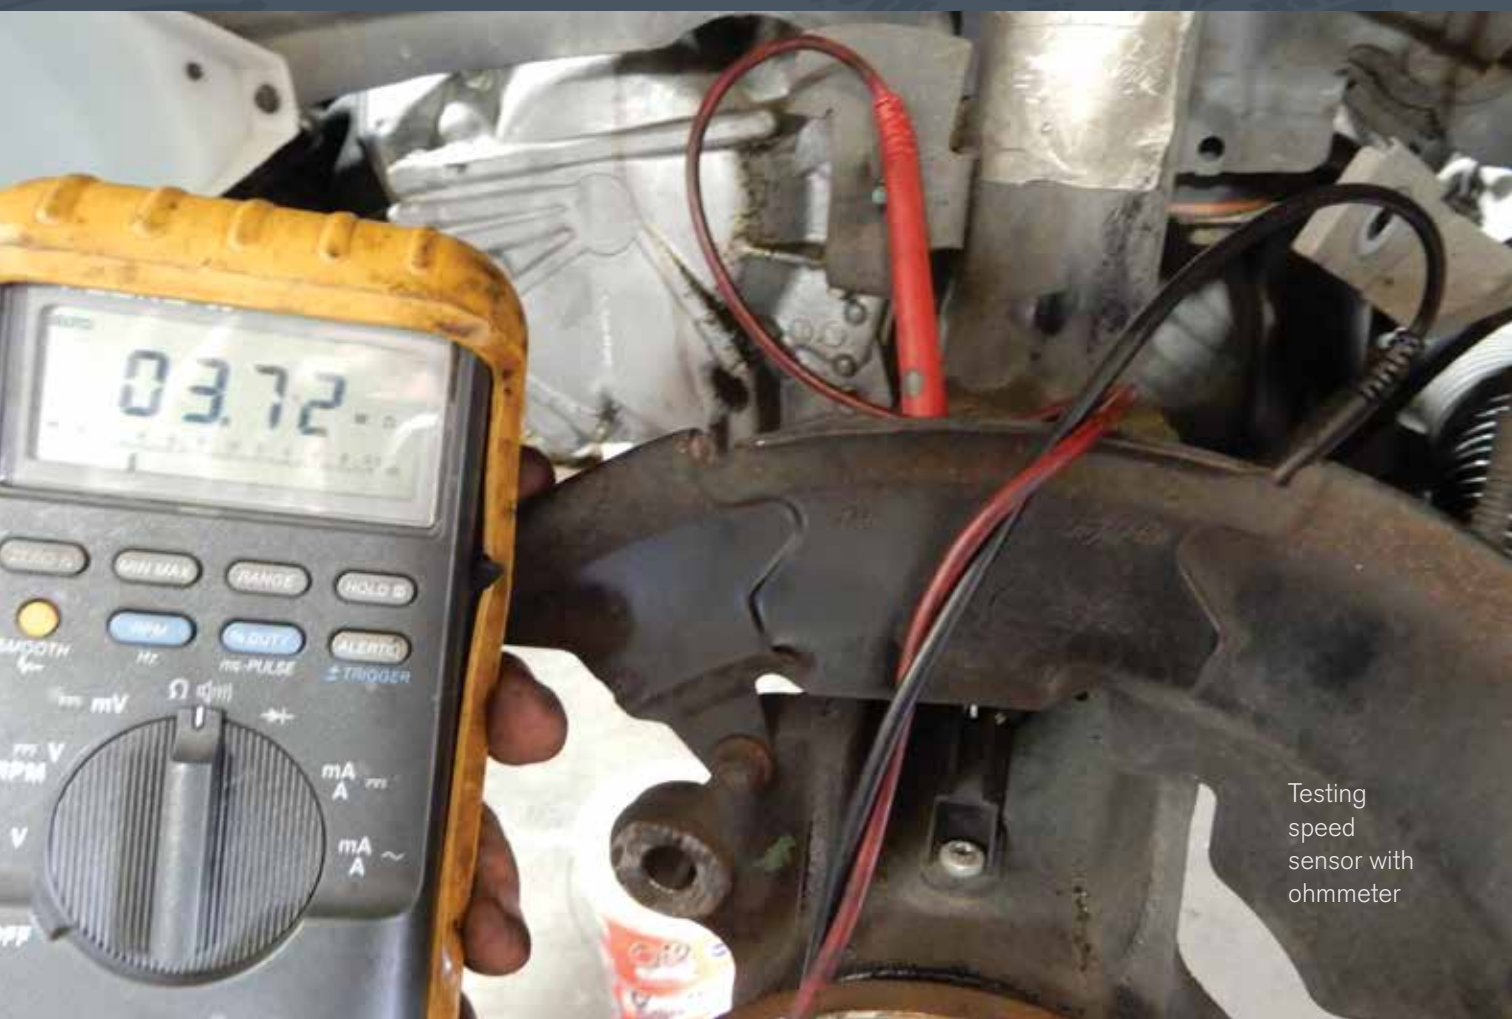
Testing  
speed  
sensor with  
ohmmeter

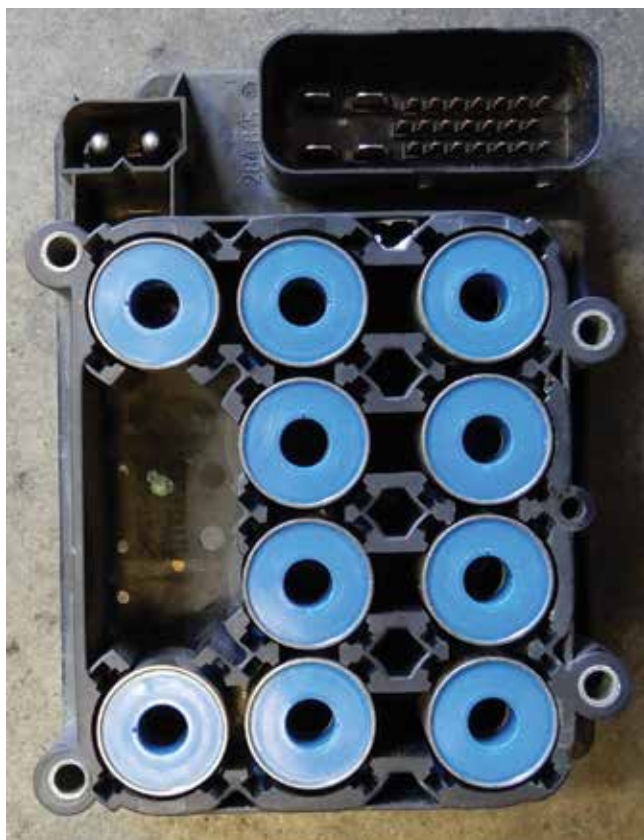
ABS control module and wheel sensor

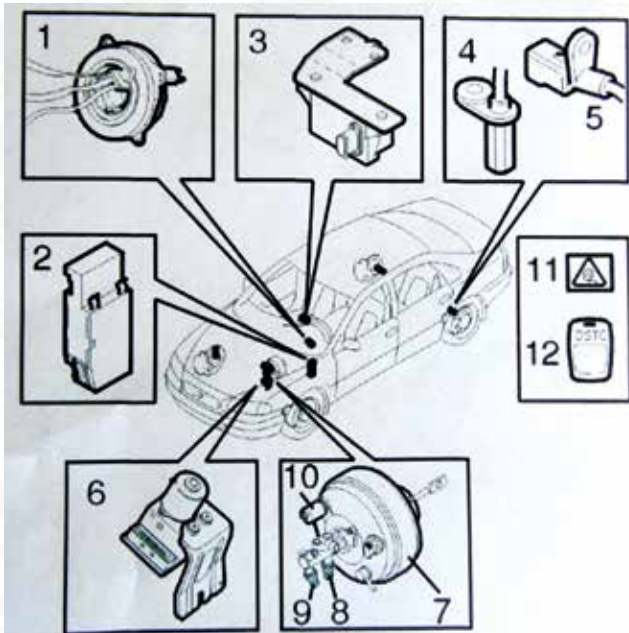
1. Contact reel/ steering angle sensor applies only to vehicles with DSTC (Dynamic Stability and Traction Control).
2. Control module for steering wheel angle sensor applies only to vehicles with DSTC.
3. Active yaw sensor applies only to vehicles with DSTC.
4. Front wheel sensor.
5. Rear wheel sensor.
6. ABS modulator with control module.
7. Servo unit.
8. Pressure sensor.
9. Pressure sensor.
10. Pedal position sensor.
11. Warning lamp.
12. Switch for DSTC.

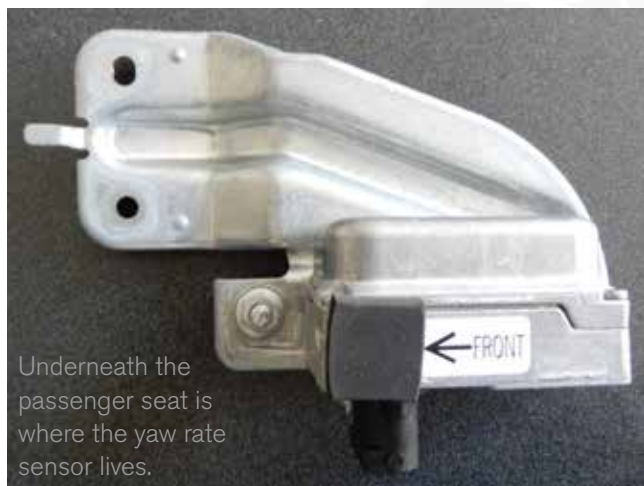
Underneath the passenger seat is where the yaw rate sensor lives.

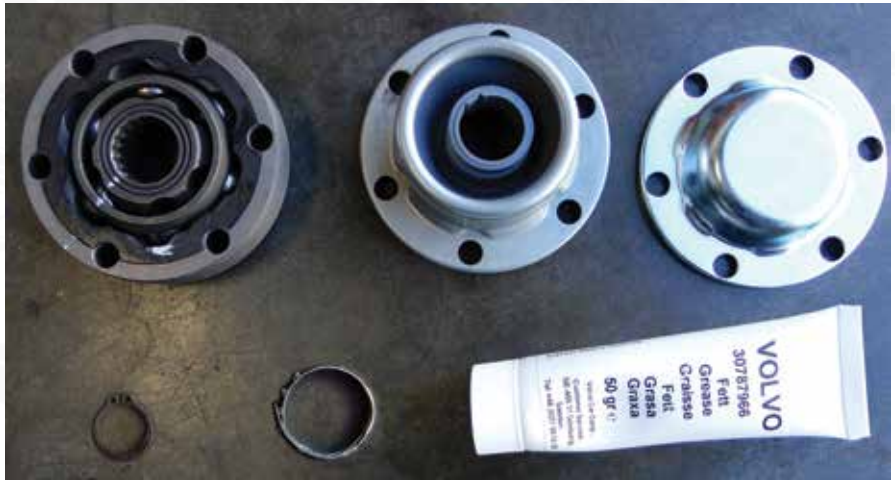
Propeller shaft universal joint

The driveshaft or propeller shaft can sometimes make a clunking sound, rattling or even a scraping noise when driving, or when moving from Park to Reverse or forward gears. This is a sure sign of wear and deterioration on the universal joints and/or center support bearing. Excessive vibration while driving can also be a driveshaft problem. Driveshafts are finely balanced before installation to make sure there is no vibration. A vibration in the driveshaft can also cause other parts on a Volvo to fail, so it's very important to check the vehicle carefully when vibration is present.

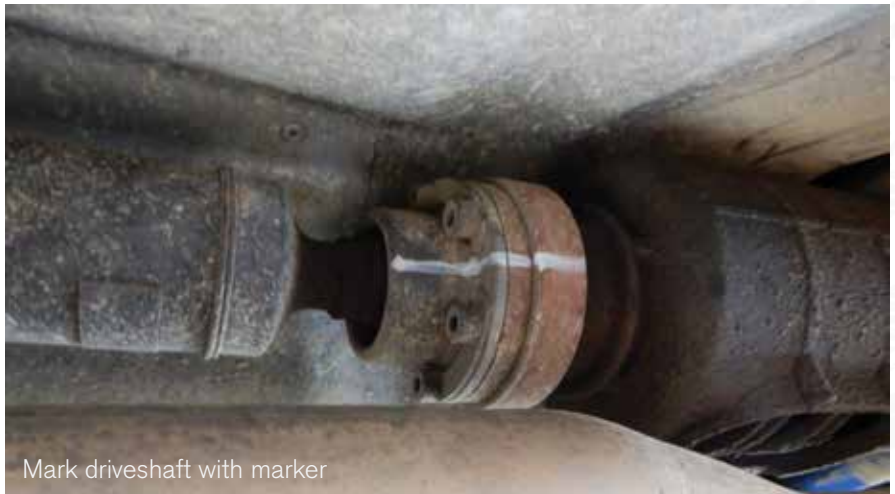
Mark driveshaft with marker

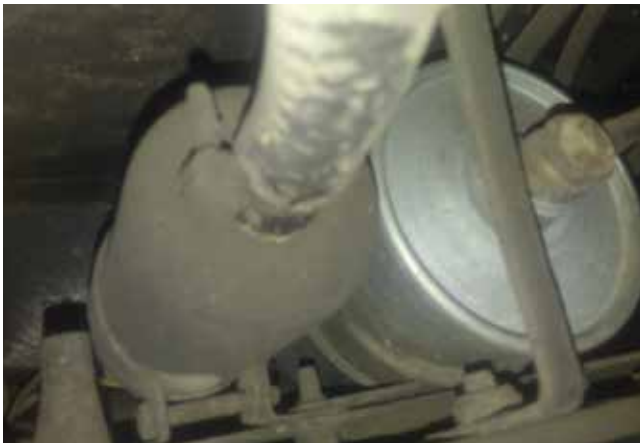
Main fuel pump

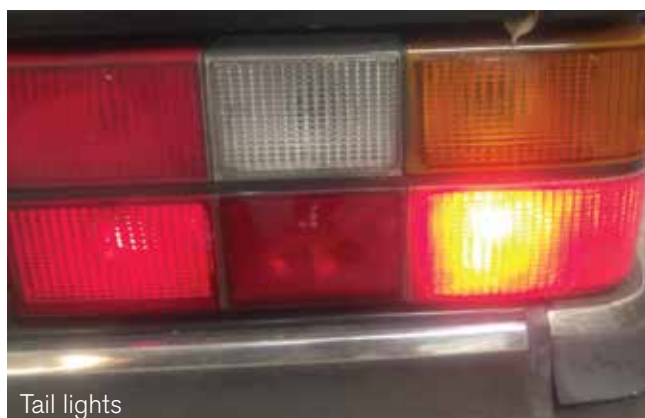
Tail lights

These tail lights are unique in that they use individual bulb sockets that get their power and ground from a flexible plastic circuit card that is embedded with copper.

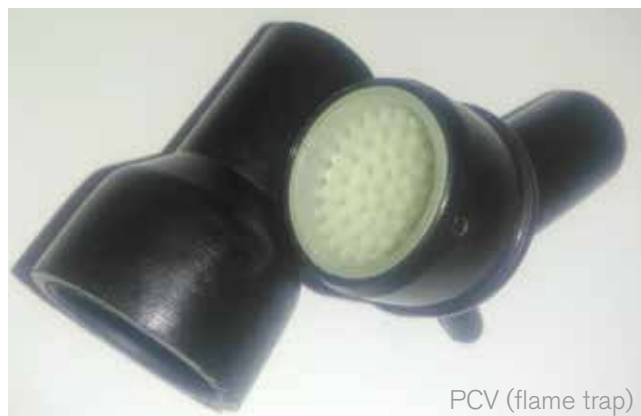
PCV (flame trap)

The flame trap should be changed and the vacuum fittings cleared every 30K miles. ●
