2009 VW TIGUAN LEAKS AND HEATING WOES

By: Augie Ferron

2.0L TFSI
Automatic
Transmission
AWD

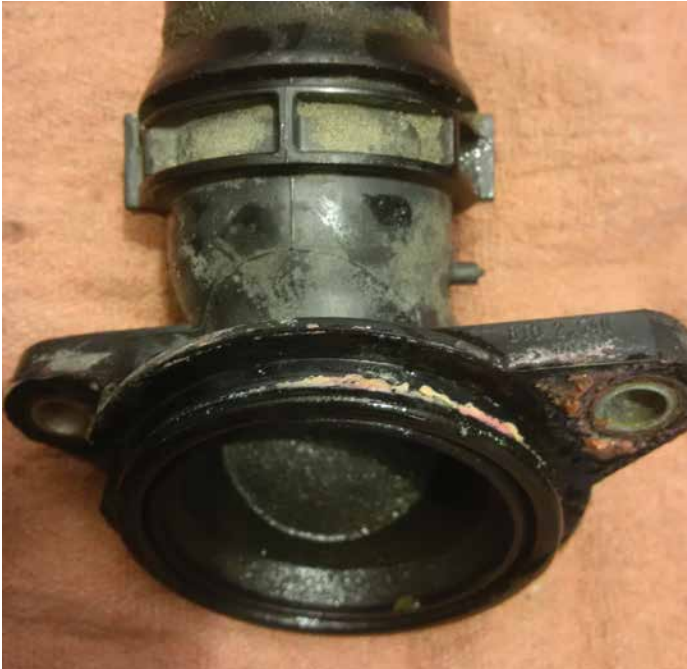
Pressure fit o-ring on edge

This version is one style that will certainly leak over time especially during expansion and contracting of the assembly(s). Make sure the mounting bolts are replaced and all other plumbing is secured correctly during assembly.

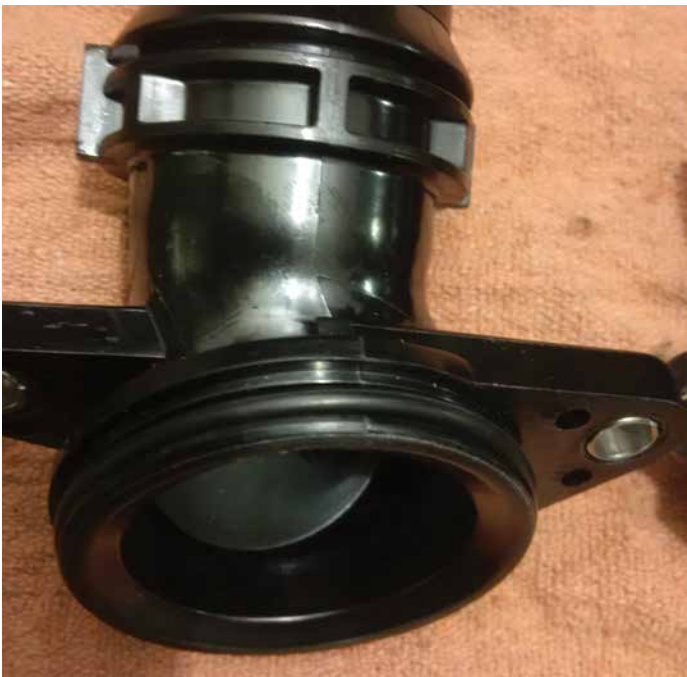
New housing with o-ring in groove

This new style of coupling is a marked improvement to keep the o-ring in place during the expansion and contraction of the engine and plastic assemblies. The key to this is also finding the correct o-ring at the radiator hose coupling. It MUST be replaced or expect a leak in the near future.

For the moment, this new version is still holding up well after a year of service with combined city and highway driving.

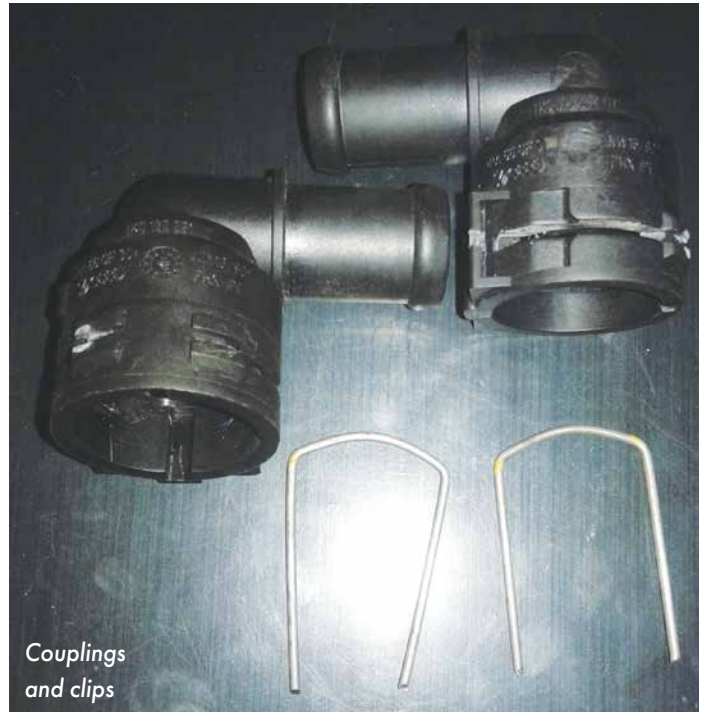
The VW coupler part numbers: 1K0 122 291 "J" and 1K0 122 291 "H."

Measuring the couplers and adding some clear hose with brass connections offers a view of force feeding the heated fluid. The brass couplings were attached using quality garden style or washing machine hoses.

Couplings and clips

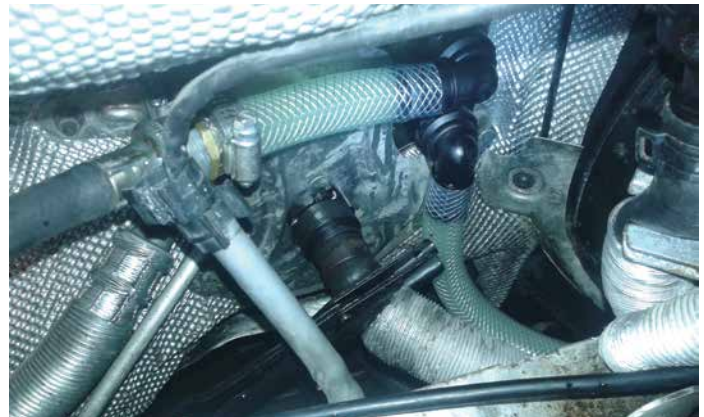
The threaded garden hose brass couplings kept everything simple to swap the lines over for a reverse flush. Note again that the fluid is heated. The heater is arranged so that it is insulated from the plastic pail and secured from the pump. The heating element does get HOT and MUST be immersed in the fluid. The element MUST not glow (increase the fluid level).

Couplings to core

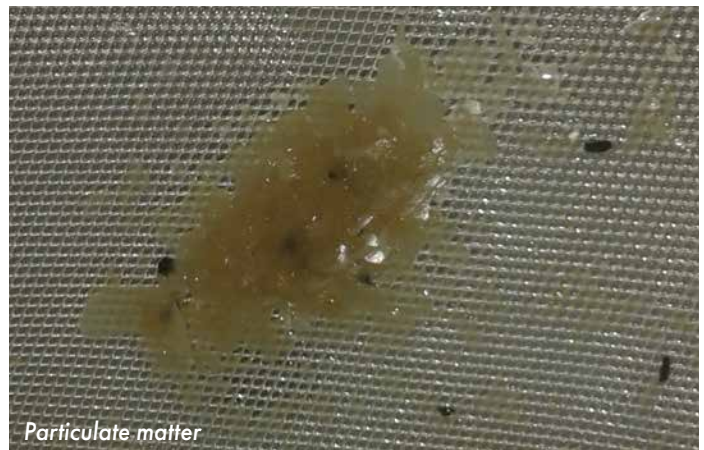
The pump and flow design allows heated fluid to be pushed into the core and returned fluid filtered into the meshed screen for inspection. With some time, the next image shows what was ejected from the core about an hour into the flush procedure. Reverse flushing the chemical solution also produced more contaminants over the course of three hours.

With time, this particulate matter did build and felt more like a slime and with enough heat and fluid, would spread on the meshed filter.

Particulate matter

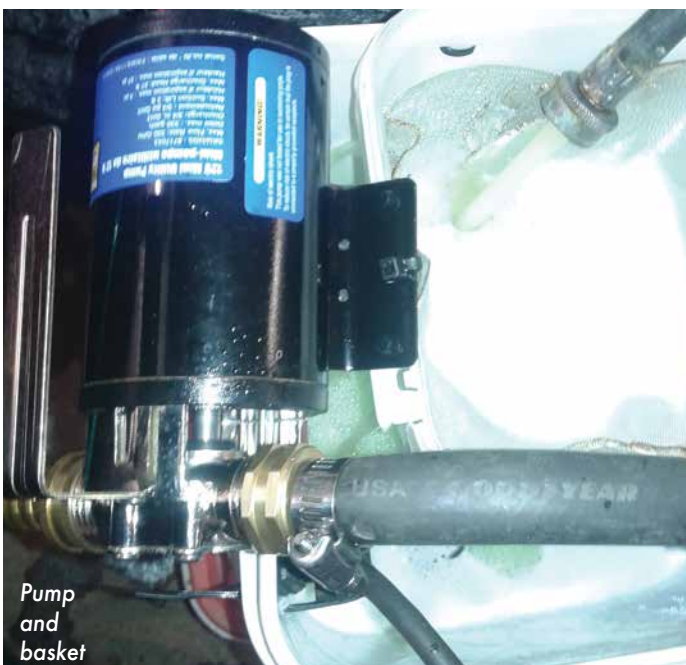
The test and idea was to push fluid with a 12V water pump (reversing flow occasionally) and maintaining the flow for about 3 hours. This was decided because there was little "babysitting" and whatever was captured in the return screen should help indicate what was restricting the coolant flow within the core. The test is personal time and mostly experimental. I was rather proud of the design with hand made retaining clips.

Pump and basket

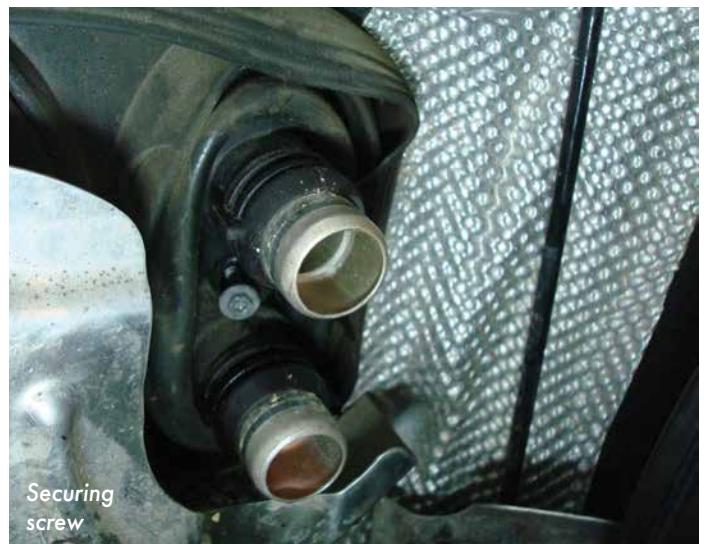
Start with a cool engine, reservoir cap removed and clip the heater hoses. The next image indicates one screw to be removed. Don't lose it!

Remove the lower driver's side cover and open the fuse box door. There is one screw to remove to drop/remove the footwell

Securing screw

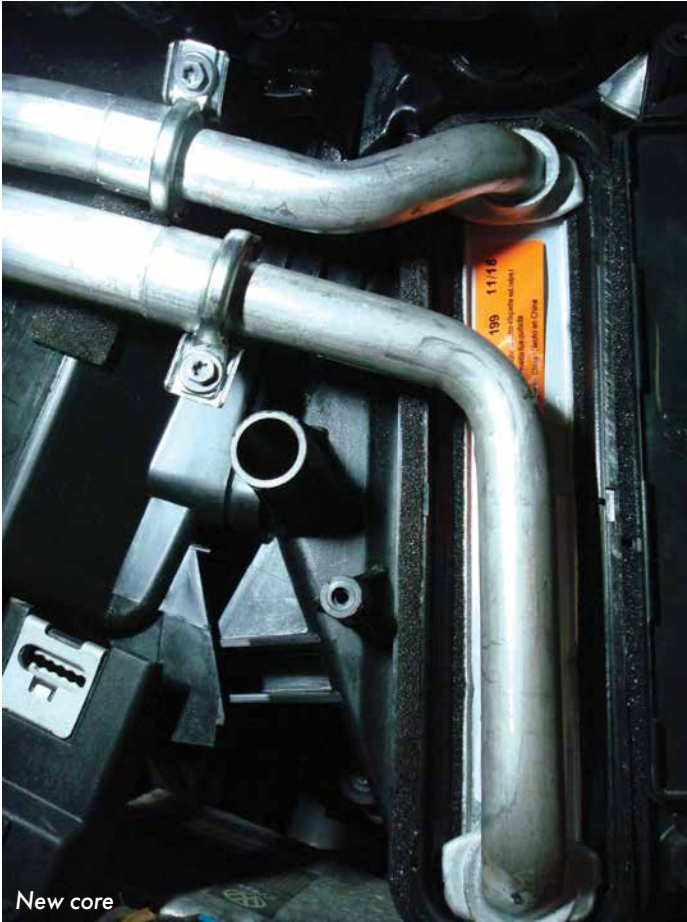
New core

Re-check for faults and set adaptations/basic settings for the HVAC.

Remember to replace the coolant to G13 and measure the temperature on both side vents during the road test.

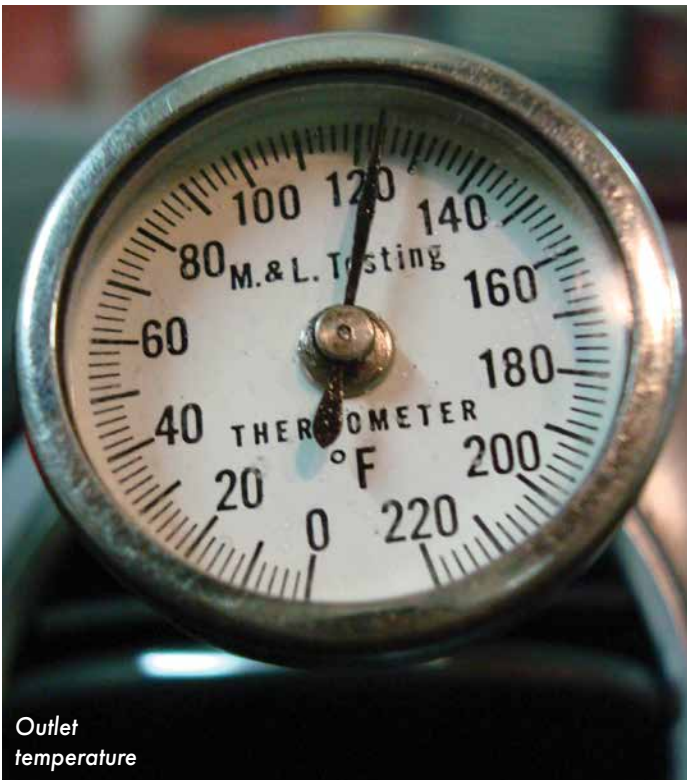
The driver (my kid) complained during one of his trips and experienced a very cold interior on the right side. With a scan, adaptation/basic settings completed with the HVAC controller, we did reproduce the difference in temperature at the outlets. The difference was quite remarkable with the driver's side indicating 120 degrees F and the passenger's side indicating 70 degrees F.

Not much really changed and, if anything, this increased the outlet temperature by only a few degrees at the passenger side during an evening drive.

Outlet temperature

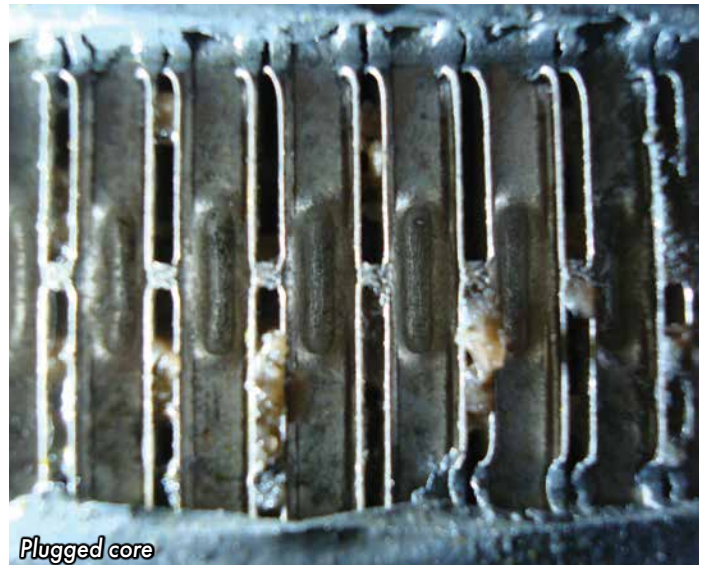
Cut open the core parallel to the tank and have a look inside. Inspect the goo or glue debris inside the core. Look at the bottom of the removed tank. It's not impressive by any means but great for customer show and tell.

Plugged core

It was faster to replace the core than attempting to flush/clear a poor design. A similar vehicle that is taking up space in the service bay while being flushed as in this example, is not profitable.
