AUDI REAR MAIN SEAL/OIL LEAKS

By: Peter Caro
Redds Automotive

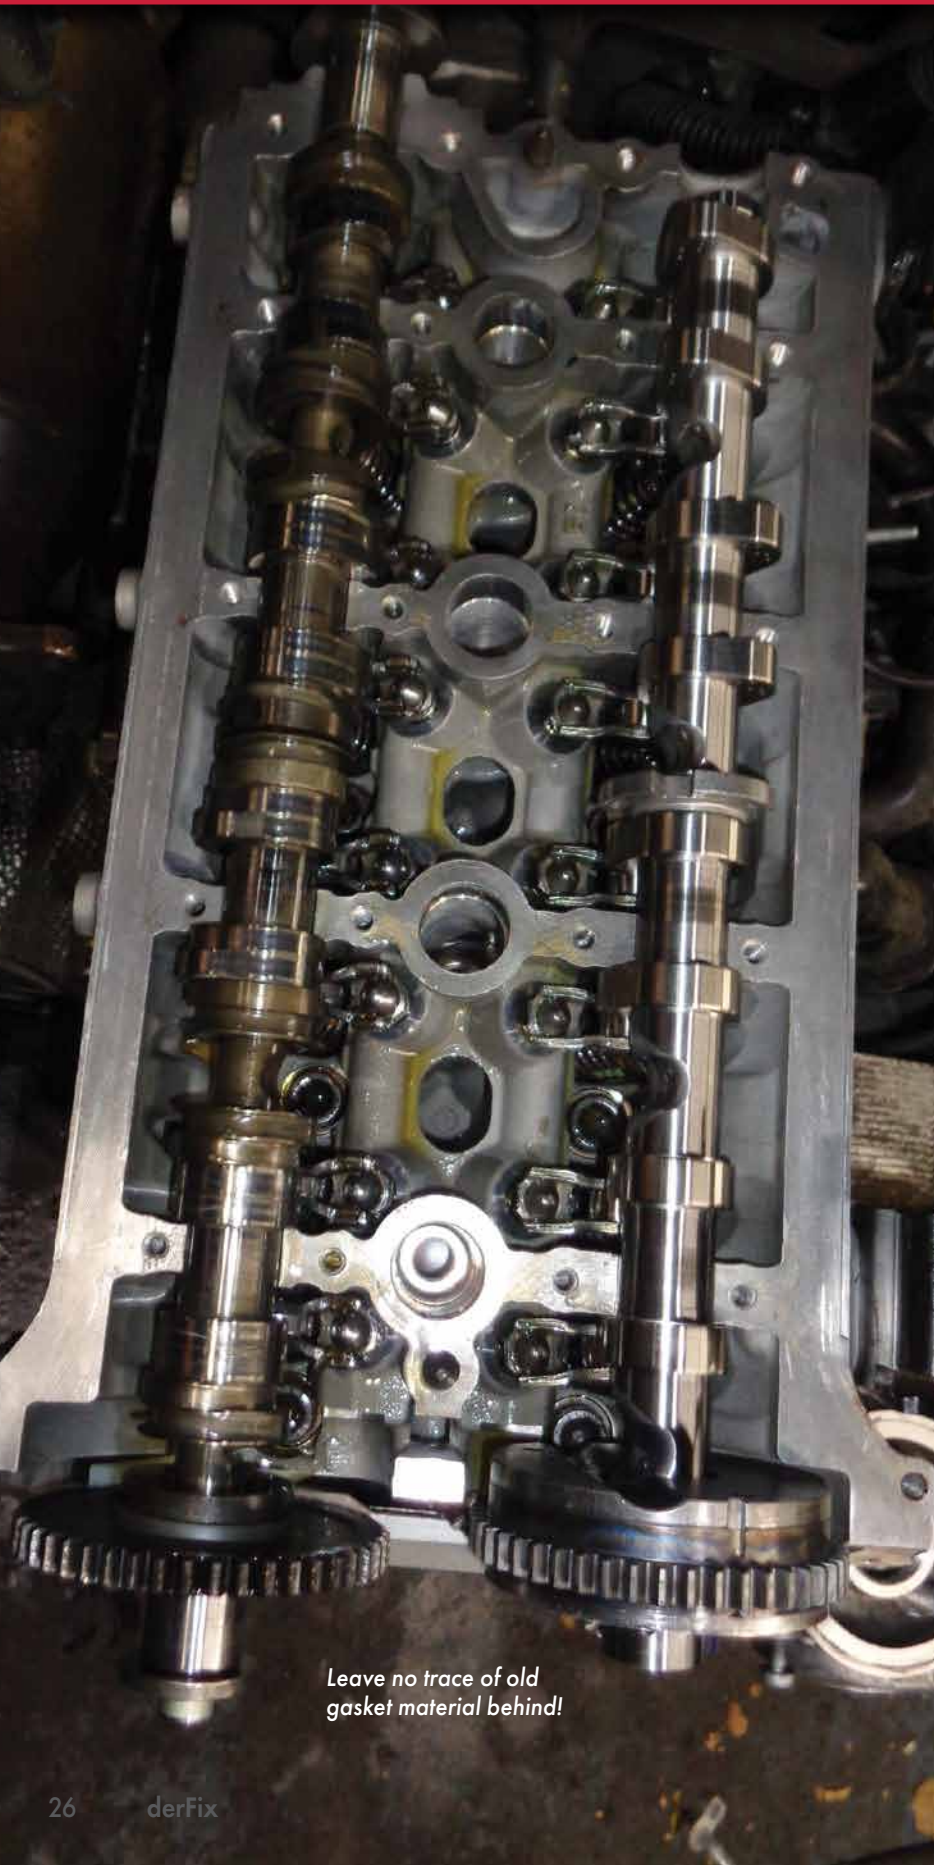
Leave no trace of old gasket material behind!

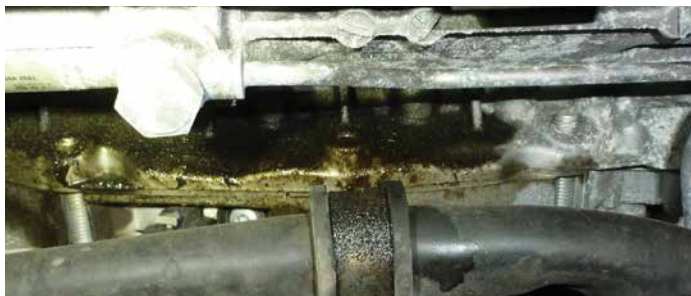
This oil leak could be from a number of different engine components; get out your mirror!

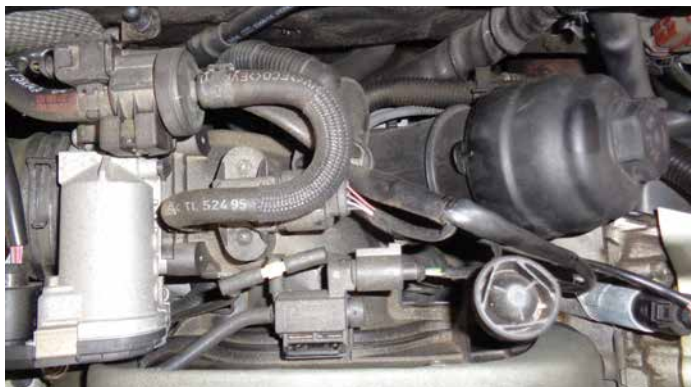
Always replace all the associated oil filter o-rings during service. You don't want a leak from the filter housing!

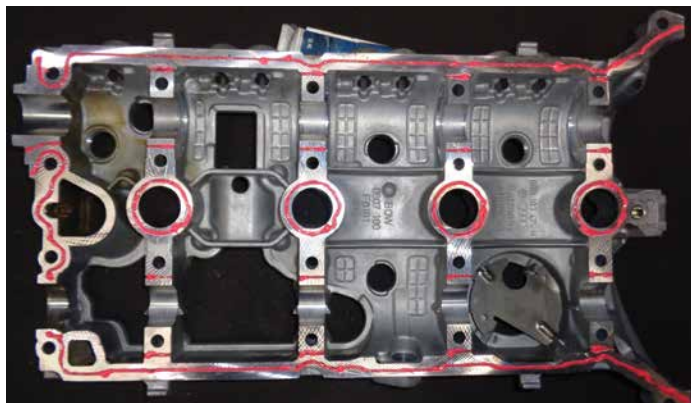
Only use approved anaerobic sealant, NOT RTV.

Audi uses an integrated cam cover design on their 2.0t engines. This design integrated the upper cam bearings into the cylinder head cover. These cam covers don't use a standard silicone based sealant. Rather, they rely on an anaerobic sealant to securely seal the cylinder head cover. Anaerobic sealant will only cure in the absence of oxygen. This is good for finely machined surfaces that require only minimal sealant to seal properly. Anaerobic sealant forms an almost plastic-like hardness that helps lock components together as well as form an extremely oil-resistant seal.

Unfortunately, with higher mileage, this anaerobic sealant can begin to degrade, forming oil leaks. Re-sealing a cam cover is a bit more labor intensive than a typical valve cover gasket replacement. Due to the cam cover holding intake and exhaust cams in place, it's critical that the camshafts don't move during removal. Also note that every bit of old sealant must be removed, and sealing surfaces must be completely clean before re-sealing. Carefully scraping the sealant grooves in the cover with a pocket screwdriver is the best way to remove the hardened sealant. Always be careful not to deeply scrape any aluminum sealing surfaces during the cleaning process, as this can create escape points for leaks.

When applying the sealant, remember that more is not always better. Excessive sealant can squish out of sealing channels and wreak havoc on engine components. Clogged oil pickups, damaged sensors, and even blocked oil passageways can occur! Don't be an uber luber. A fine layer of sealant 1–2 mm thick is generally all that is required to seal, due to tight sealing surface tolerances.

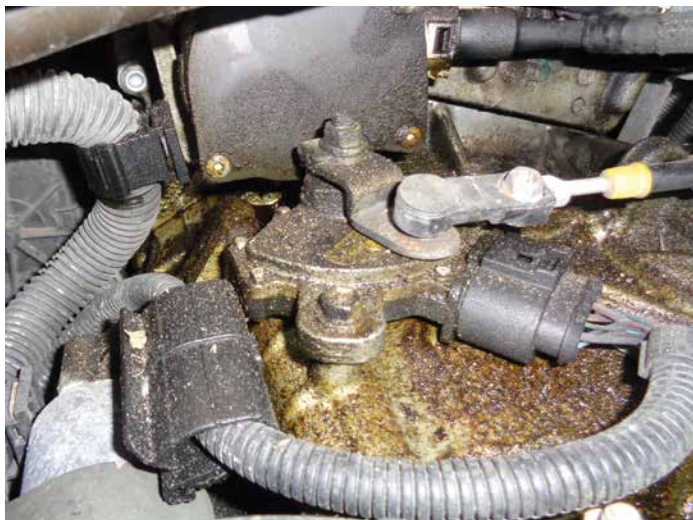
This VW 2.5L vacuum pump had covered half the engine and transmission in oil.

Don't forget to inspect the brake vacuum pump when diagnosing Audi's for oil leaks. Most modern Audi engines do not create much vacuum at idle. Therefore, vacuum pumps are necessary to supply adequate vacuum for the brake booster to work properly. Most vacuum pumps have an oil galley to supply lubricating oil to the rotating pump assembly. Eventually, this oil circulating through the vacuum pump begins to degrade the outer pump seal and leak externally.

A leaking vacuum pump is a pretty common sight among many manufacturers. If you have a leaking vacuum pump, it's a good idea to remove the vacuum supply to the brake booster and inspect the inside of the brake booster for oil contamination as well. Once oil gets into the brake booster, it quickly degrades the rubber seals inside. This can eventually lead to a vacuum loss at the booster itself. Losing power brakes is something no one is prepared for when driving.

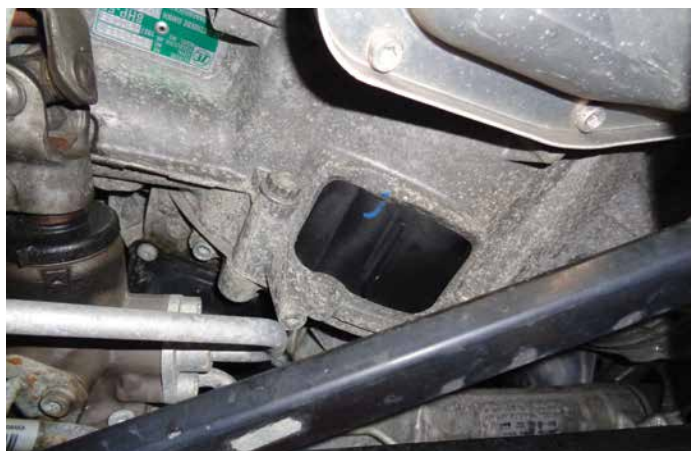
This lower cover is also used to access the torque converter fasteners.

Inspecting the rear main seal during smoke testing can be difficult. Even with a completely separated rear seal, the smoke escaping may not be readily visible. It's usually necessary to remove inspection plates on the transmission to get an eye on any escaping smoke from the bell housing area.

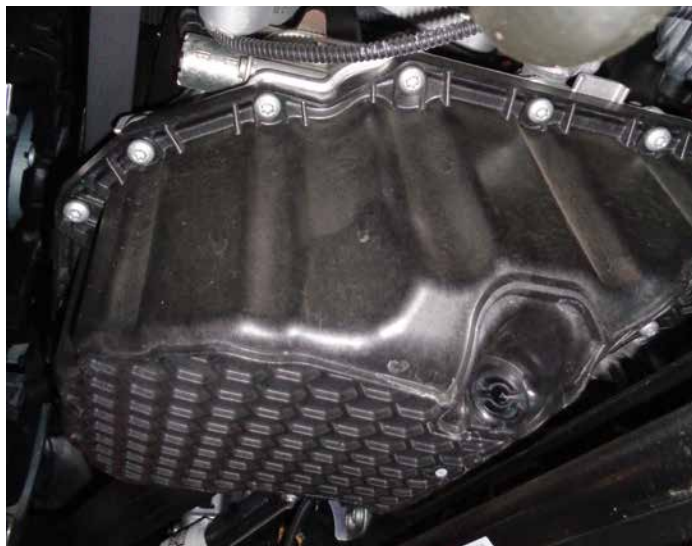
Many new Audi's have a plastic oil pan; it would not be a good idea to use a floor jack on these.

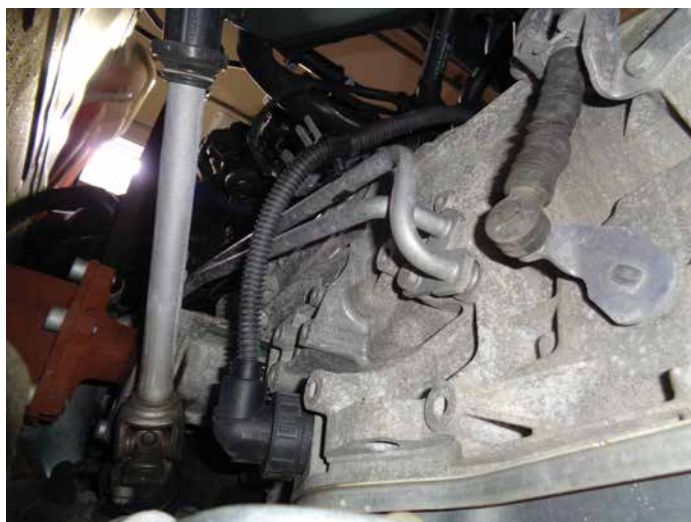
Here you can see the axle shaft, steering coupler, and most of the transmission connections that must be disconnected during trans removal.

In many Audi vehicles it's necessary to remove the lower sub-frame to gain clearance to remove the transmission. Using an upper engine support brace is the safest way to ensure the engine stays in place after removing the sub-frame and transmission. Spin jacks are quicker to use but not nearly as secure for this job. Better safe than sorry. When using a transmission jack to remove the trans from the vehicle, it's also wise to use a ratchet strap to secure the trans to the jack. This allows you to angle the trans side to side during removal, aiding in clearing the exhaust and body.
