AUDI DRIVELINE AND C-V BOOTS

By: Peter Caro
Redds Automotive

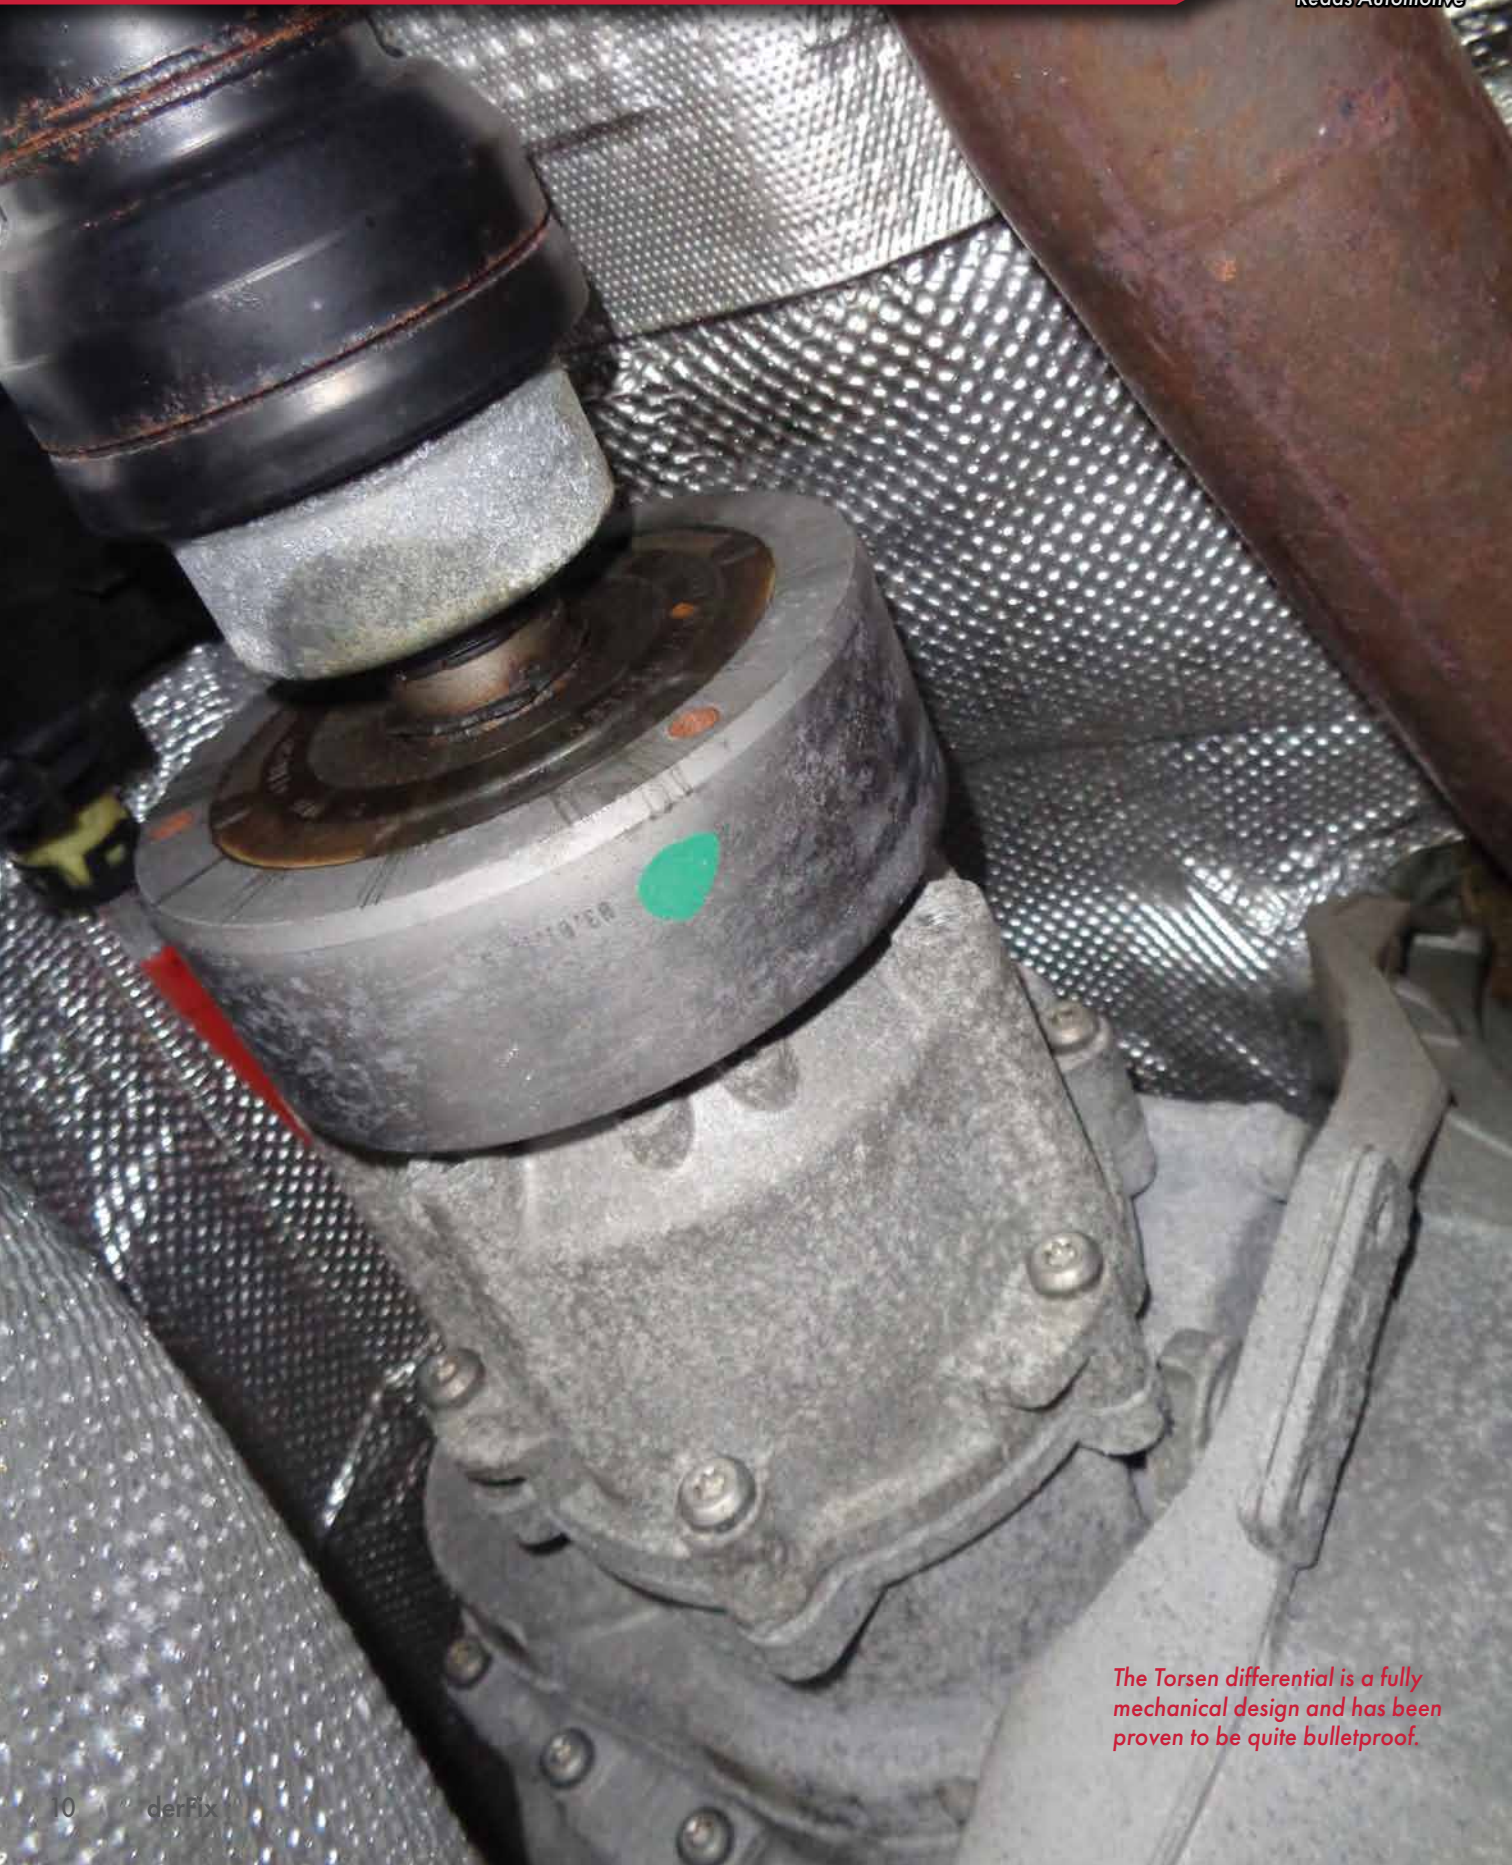
The Torsen differential is a fully mechanical design and has been proven to be quite bulletproof.

Audi Quattro vehicles use a torque sensing center differential on most larger models such as the Q7, A8, and A6 models.

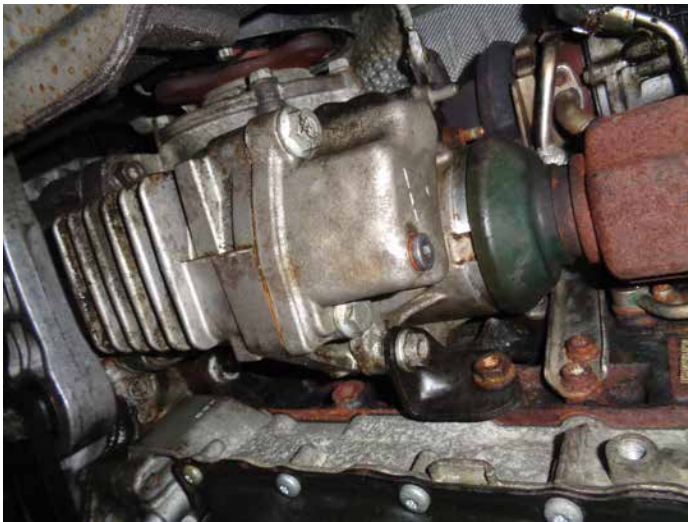
This is the front differential on an Audi A3 model. Note: It resides directly below the turbocharger.

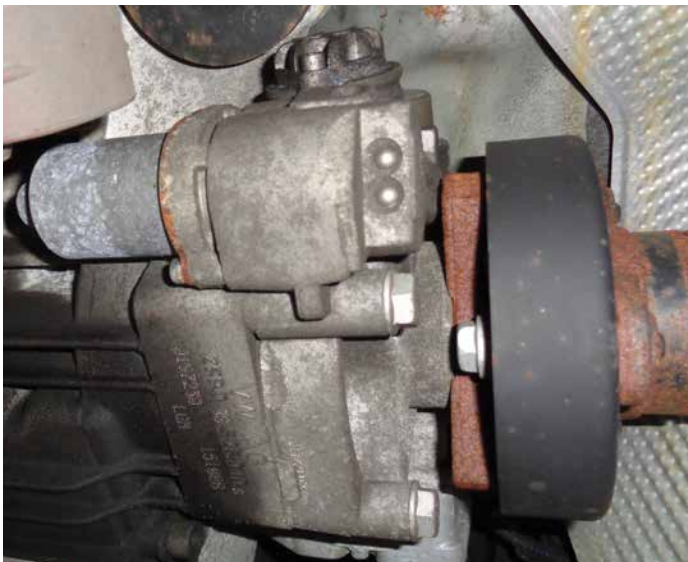
The filter can be tricky to remove and replace on some Audi vehicles.

The Haldex unit does require service from time to time. The clutch packs start to wear from use over time, and will begin to degrade as well as contaminate the oil supply. Audi recommends changing the Haldex fluid every 40 K miles if so equipped. Haldex- equipped vehicles also have a filter that can be accessed and replaced during service.

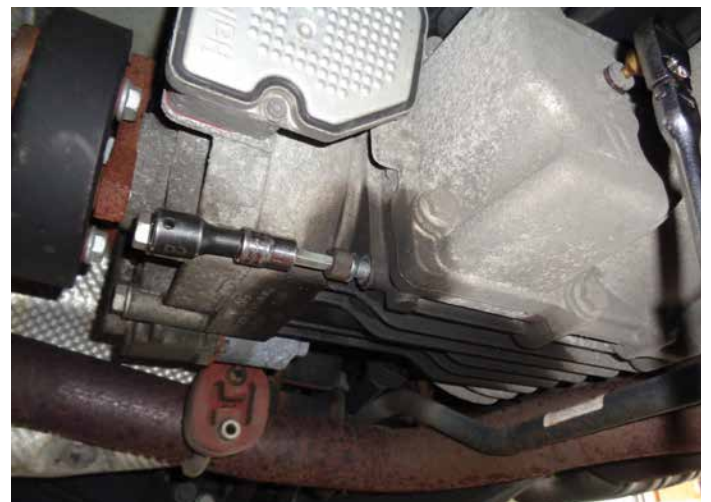
Don't confuse the rear differential drain with the easy-to-miss Haldex drain bolt.

When servicing the Haldex unit it's important to re-fill the unit with the proper amount of gear oil. These systems have very small passages that may take a few minutes to properly take on oil. Under-filling a Haldex unit is a sure-fire way to kill the clutch packs. Often the Haldex oil comes in a pre-measured tube per application. Use it all!

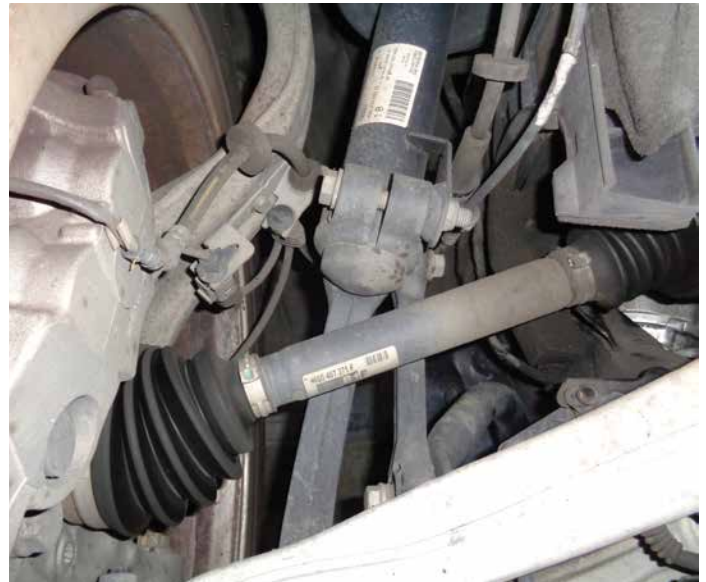
The front outer axle joint takes the most abuse out of all the driveline's components.

The axle shafts and driveshaft are fairly robust on Audi vehicles but do require inspection and service periodically. Front constant velocity (C-V) boots on Audi vehicles are the most common to need repairs. The front axles are constantly in motion and also flex the outer axle joints during turning and suspension movement. This constant flexing eventually takes its toll on the rubber C-V boot as the rubber ages. Once the rubber deteriorates enough, the boot begins to fling out the axle grease. Not only does this create a nice mess, but can quickly dry out the bearings in the C-V joint causing damage to the bearings and bearing surface.

Once the axle joint dries out from lack of lubricant, noise and vibration begins to set in. This is most commonly evidenced by a rhythmic "clicking" noise while turning. This noise is generally worse when making full steering lock maneuvers such as in a parking lot. Once the axles begin making noise, the damage has usually been done to the bearing assembly in the axle. It's possible to install new boots and grease, but be warned. The noise may not go away unless a new axle shaft assembly is fitted. This is why it is critical to spot a boot failing early before it ruins the axle.

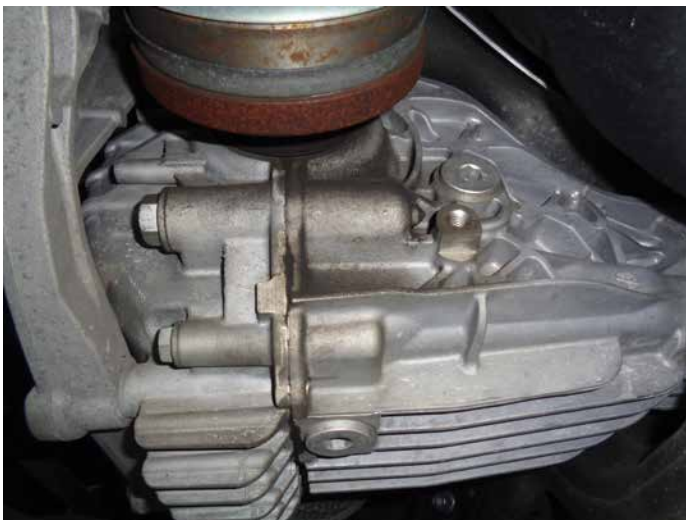
The drain and fill plugs are clearly visible on the passenger side of rear differential assembly.

The front and rear differentials of the vehicle require service periodically as well. These are straightforward services with 40 K mile replacement intervals for most Audi vehicles. Don't neglect these services, particularly the front transfer case, if so equipped. These lead a tough life close to the vehicle's exhaust system. The dark burnt color compared with the new fluid's golden hue is a good indicator of fluid that needs to be replaced.

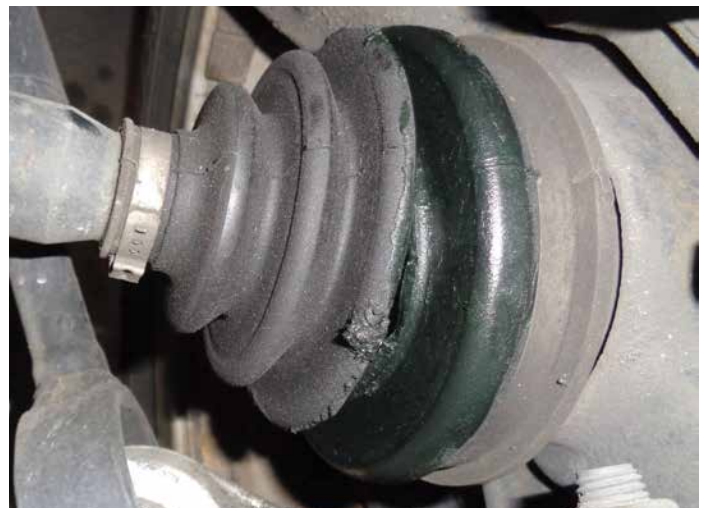
Dry rotting rubber in the gaiter is the most common cause for a C-V boot failure to occur.

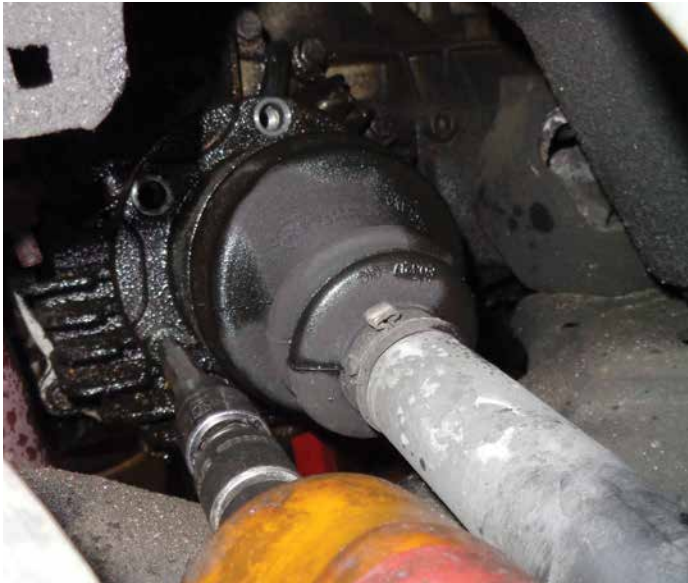
Although axle removal on an Audi may appear straightforward, it may be necessary to disconnect control arms to be able to remove the axle completely.

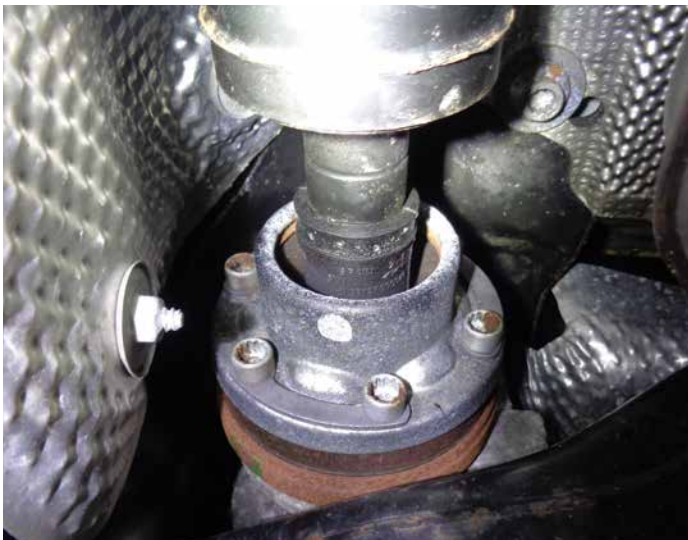
If removing the driveshaft from the vehicle for repair, it's smart to mark the driveshaft and output on the trans and re-install in the same position to avoid potential imbalance issues.

This same principle applies to the vehicle driveshaft. Occasionally, the universal joints on the driveshaft may become stiff with age, and resist movement. This can cause driveshaft vibration and noise. On higher-mileage Audi's, the center support bearing may begin to degrade as well. Once the supporting rubber degrades enough, the driveshaft will begin to vibrate excessively. This can be felt as a vibration in the seat back or through the floor of the vehicle. ■
