# TIGUAN ENGINE OIL LEAK

2009 Volkswagen Tiguan

2.0L TFSI Automatic Transmission AWD

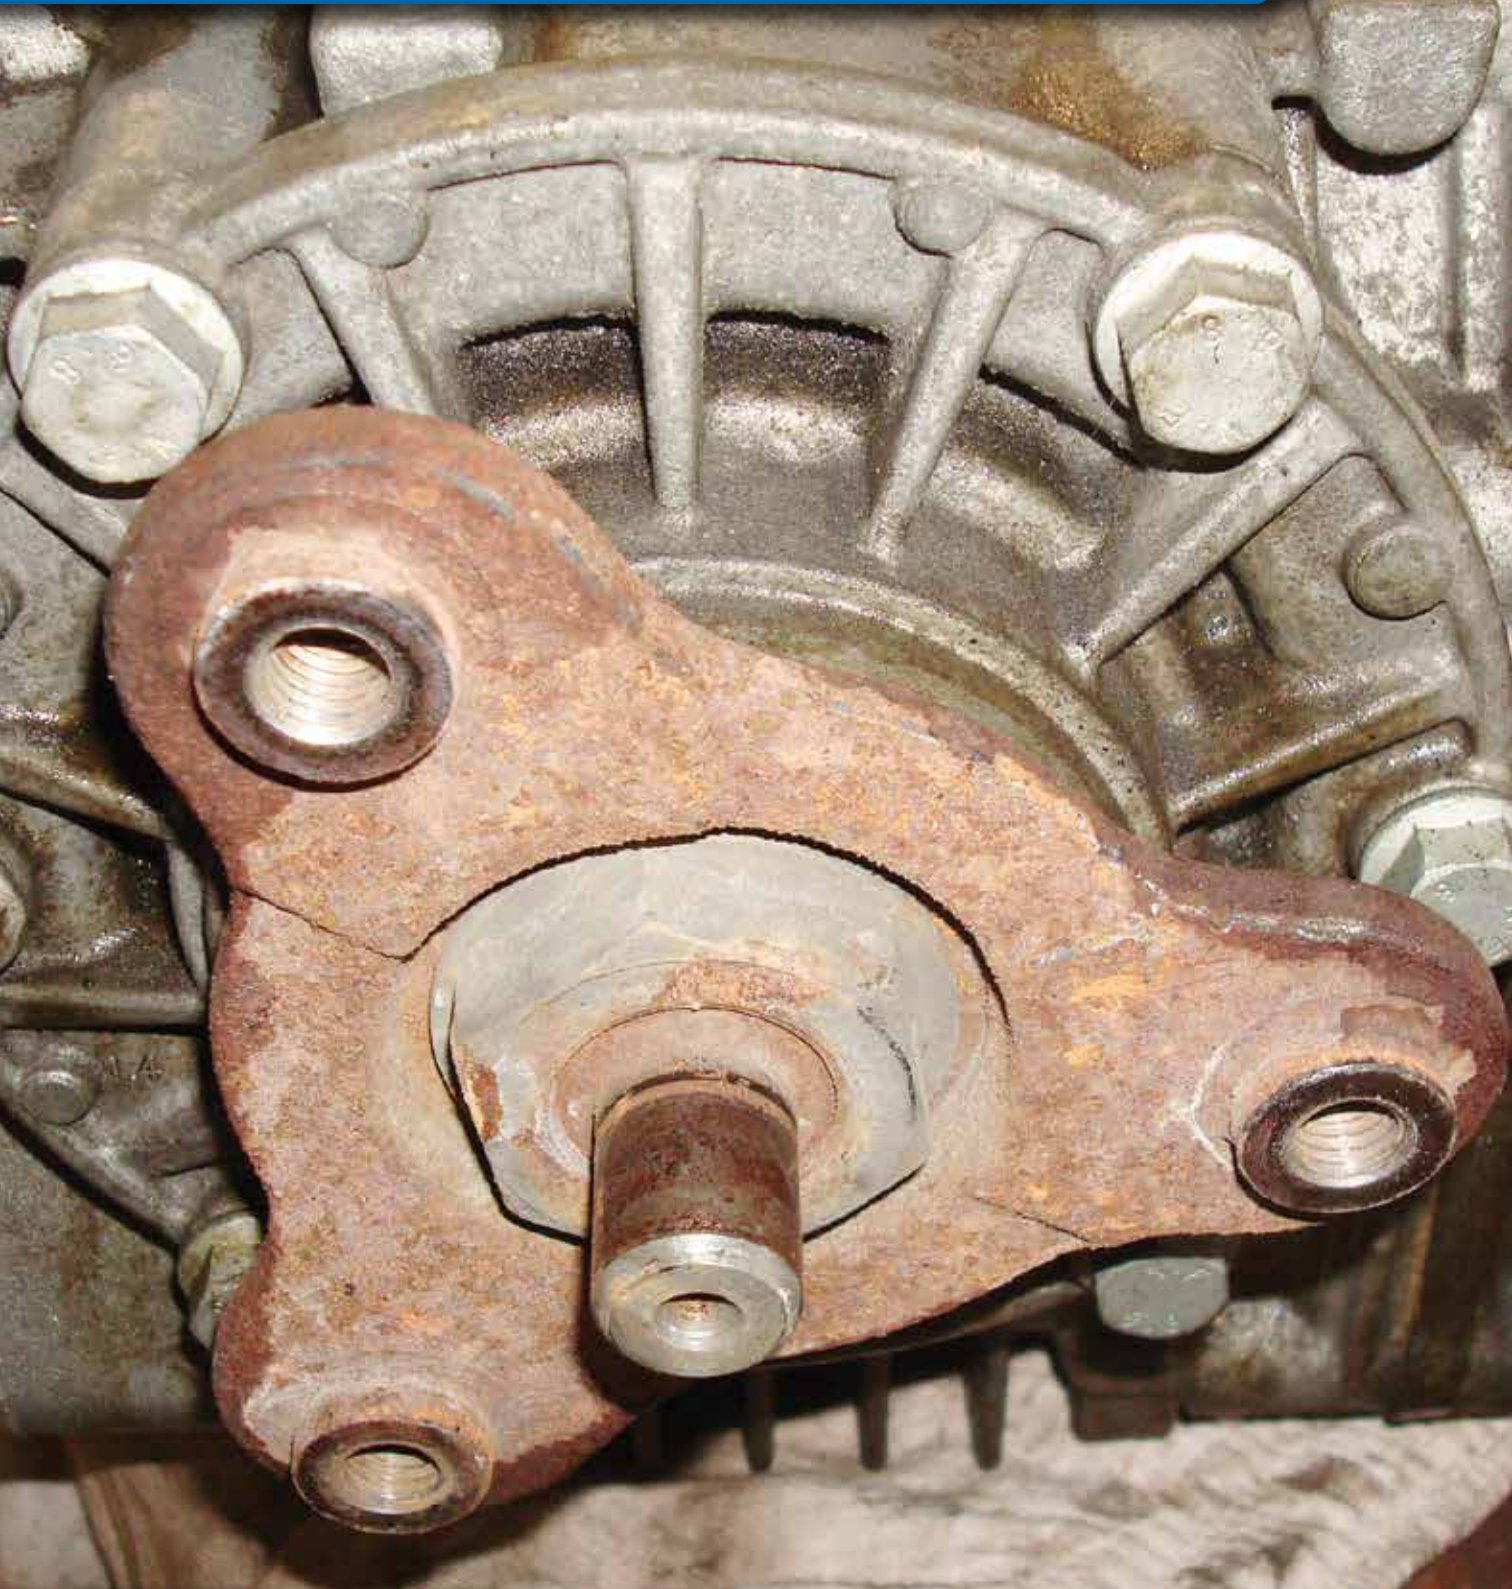
Crankshaft seal "unglued itself"

Rear drive shaft flange

Inspection proved the oil leak came from the crankshaft flange seal between the engine block and torque converter drive plate.

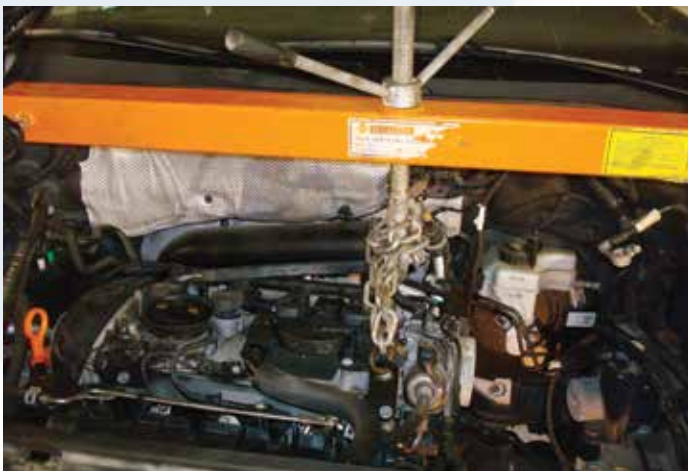
Engine lift bar

Prepare this model by loosening the axle bolts (one-time use), remove the front wheels, LF inner plastic liner, and remaining lower air induction tubes. Remember to replace all disturbed seals, o-rings or one-time use bolts. Prepare a safe and correctly fitting engine lift bar onto the fenders with rubber pads/insulators. The illustration indicates the correct position.

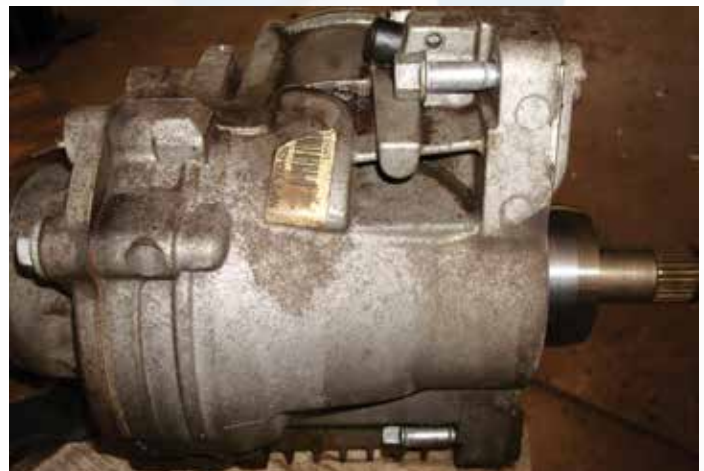
Bevel gear bolts before assembly

Remember that both mounts will "hang" the assembly for access and safety. Notice the next image and placement of the two inner bolts. There will be a high degree of appreciation when those bolts are in position during reassembly. Ensure the surfaces of the bevel gear and transmission are cleaned before assembly.

Remove the transmission center support mount attached to the subframe. Access the bevel gear bolts and notice their lengths. Remove the bevel gear assembly. At times, and depending on the model, a wedge is required to gently tilt the engine/transmission assembly for ease of access. Remove the wedge when the transmission is ready for removal.

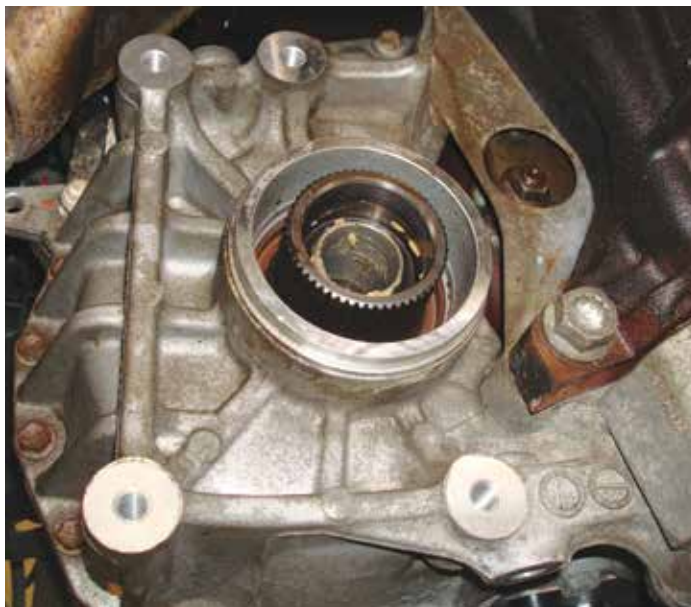
*Torque converter nuts*

Mark one torque converter stud and remove the remaining nuts while turning the crankshaft in direction of rotation.

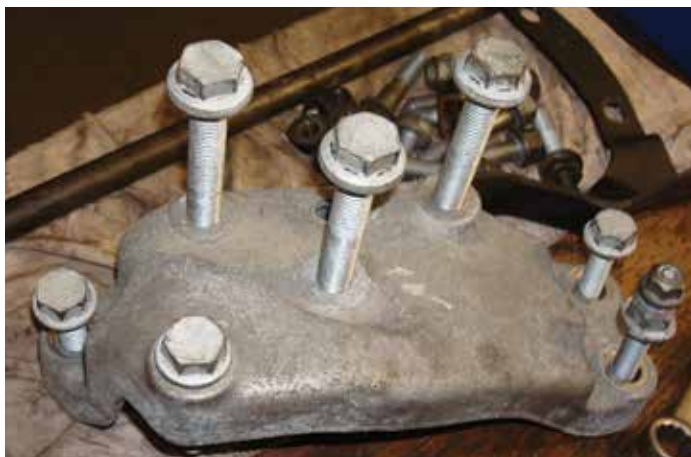
*Transmission mount and bolts*

With the correct amount of support, the transmission mount, cables, harnesses and grounds can be removed. Remove the mount as illustrated. Angle the transmission with the engine lift to clear the body with the transmission jack in unison. Hold the engine in that position with the support bar for correct alignment.

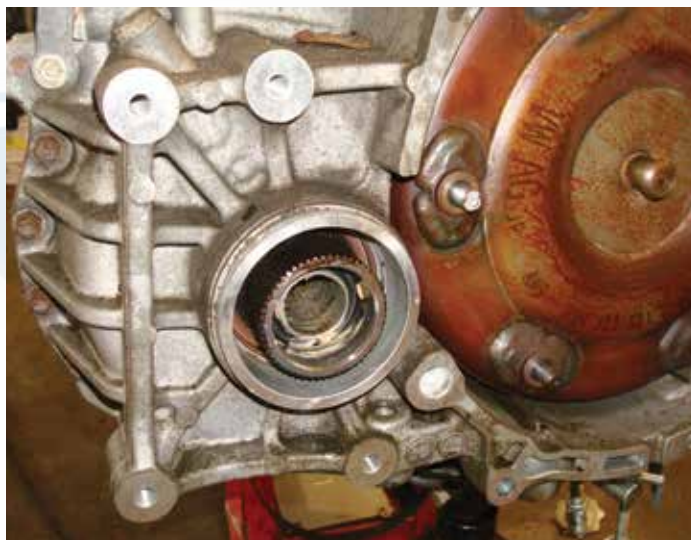
*Transmission removed*

Notice the white painted stud on the converter. Do not remove or disturb the torque converter. Do find a way to gently hold the converter in position. I used a wooden rod with spacer attached with bolts to the bell housing. This will ensure the correct position if the transmission needs to be rolled or moved to another position. If for any reason the torque converter is removed, the seal must be replaced.

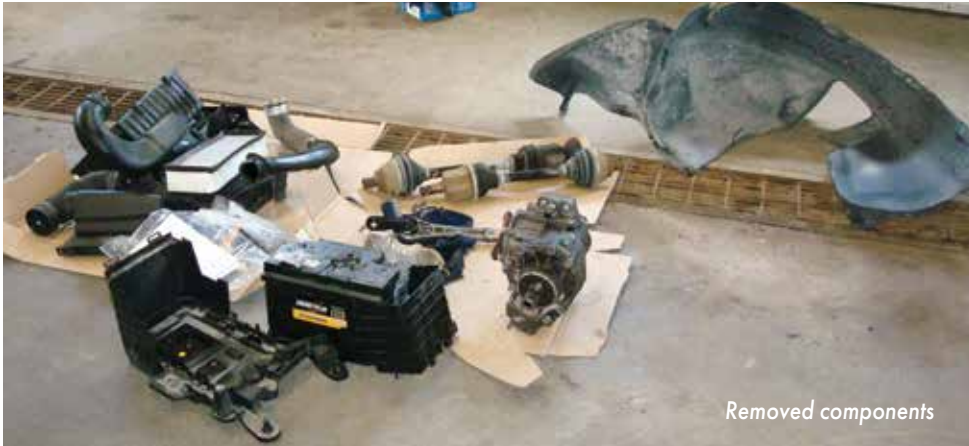
Crankshaft flange seal

Once the transmission drive plate is removed (mark it as well) and the crankshaft flange seal unbolted from the engine block, prepare/clean the block of old sealant, oil and any debris. Look at the original seal. It has "unglued itself."

**Note:** The entire block surface must be clean with no oil residue. The seal (PTFE) surface and crank surface must not have any oil present.

The crankshaft area should be cleaned/polished slightly with extremely fine pads similar to Scotchbrite.

Apply the sealant to the new sealing flange similar to that shown in the image. Ensure that the engine block surface is clean and dry or the sealant will not cure correctly and will eventually allow oil to migrate. It will take substantial force (with the supplied tool) to gently push the flange seal squarely onto the crankshaft to meet the prepared engine block surface. Use new bolts only.

**Note:** do not rotate the seal or the crankshaft for a minimum of one hour before and after final assembly with torque setup.

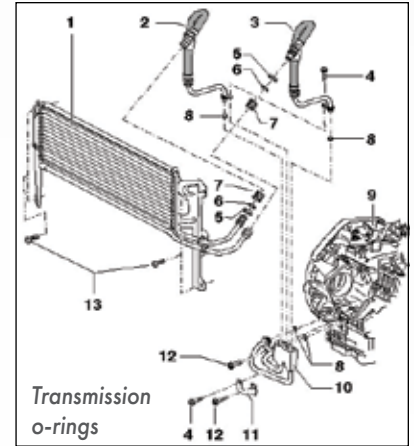
Torque sequence

The PTFE seal requires time to set up. Use the printed/repair information/specifications to torque using the proper sequence/value for the model you are working on.

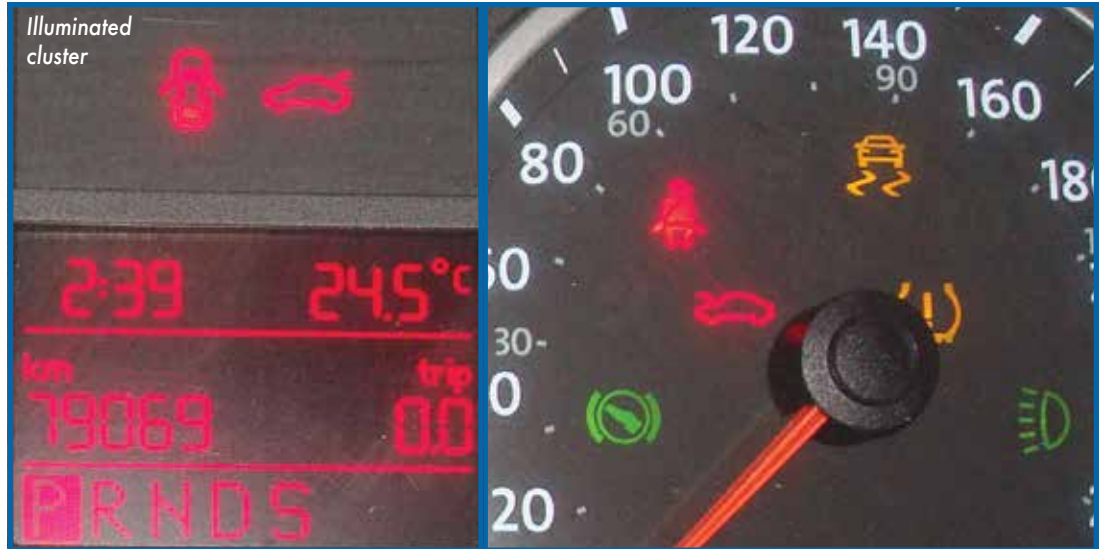
Transmission top-up

If this model has high mileage, this is a very good time to replace the transaxle fluid by removing the plastic fill/inspection plug. Capture all the fluid and calculate the amount of fluid removed. When complete, re-insert the plastic fill/inspection plug and inject 75 percent of the measured new fluid and attach the fill/inspection plug lightly.

Prepare VCDS, start the vehicle and enter Transmission Electronics. Start this test at ambient temperature. Have enough of the correct transmission oil on hand. Pay attention to the transmission fluid temperature within VCDS during the warming phase and with the fill/inspection plug removed. Watch the spill port and VDS at idle only. The measured value for temperature is group 006, field 1 for ATF Temperature sensor G93.

- Apply the forward and reverse gears a few times and test in Park with the plug in place.
- At idle and the plug removed with VCDS:  
Not dripping = Requires topping up at the required temperature.  
Dripping = Full at the required temperature. Make sure a new gasket is available and torque the plug. Check for leaks.
