VOLVO COOLING SYSTEMS, SERVICE AND REPAIR

REPLACING RADIATOR IN A 2004 XC70

REPLACING WATER PUMP ON 2003 S80 NON TURBO

HEATER CORE REPLACEMENT 2008 XC70

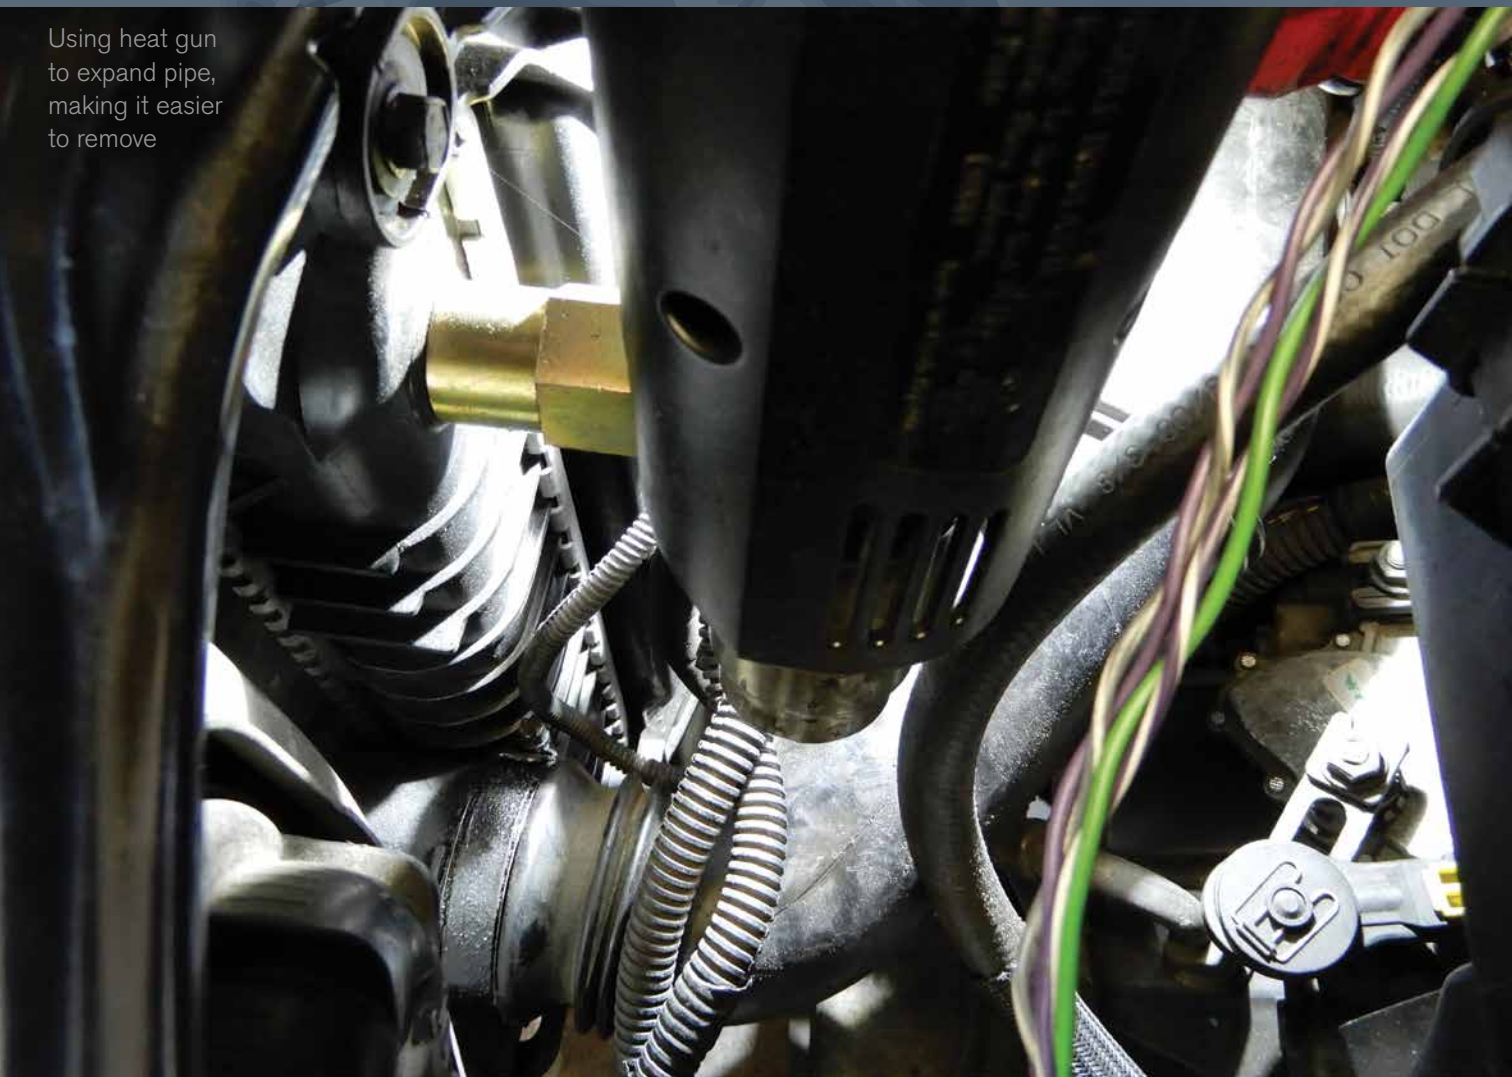
Using heat gun
to expand pipe,
making it easier
to remove

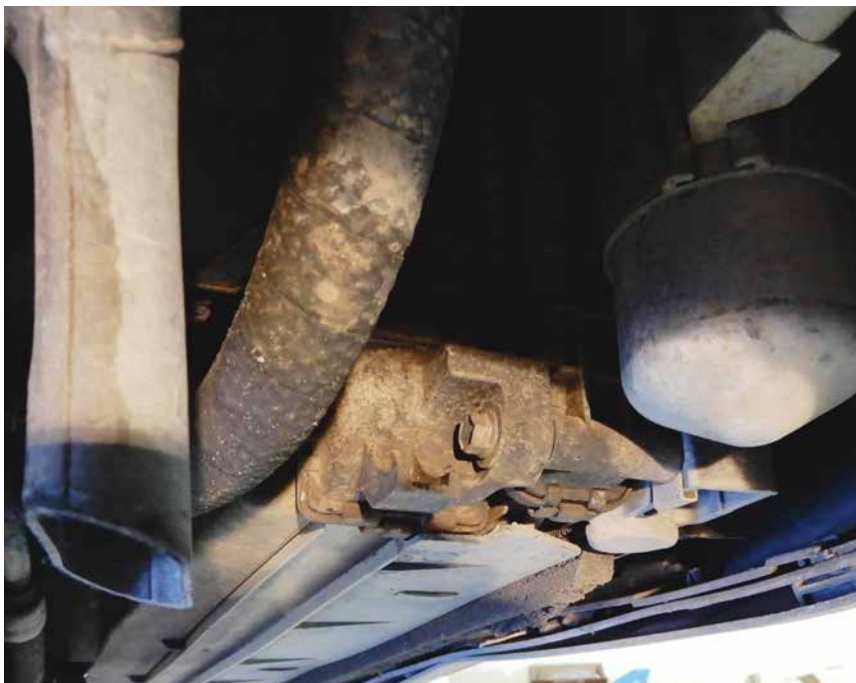
The two bolts at the bottom of the radiator, one on each side

Assemble the radiator with intercooler into the vehicle. Install it at an angle up at the driver's side then fit it with the air conditioning condenser. Push up level so that all three (radiator, intercooler and condenser) are together. Using a scissor jack can help in holding all together. Install the two radiator bolts 12 mm headed. Install the two bottom 10 mm bolts that hold all three units together. Start them but leave them loose until the other two at top are in place.

Raise the vehicle back up on the hoist and check to make sure there are no leaks from the radiator, hoses, and transmission lines. Tighten the two 10 mm long bolts already installed at the bottom of the radiator. Lower the vehicle and test drive. Let the vehicle cool down and check the coolant level again to make sure the tank is full.

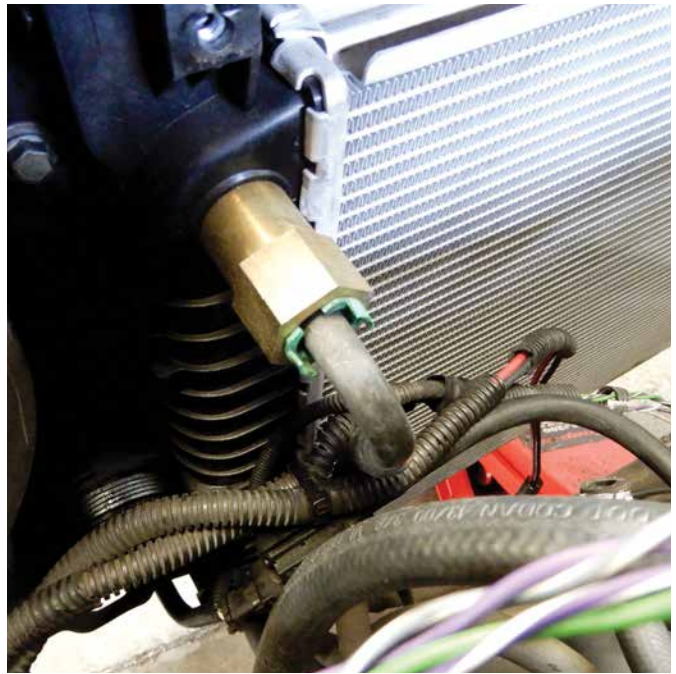
Transmission hose at radiator with green connector

Remove the transmission hoses, upper and lower, connected to radiator. Push in on green connectors and pull out. It is necessary to replace the connectors and O-rings on both hoses. Use Volvo Genuine Part number 9485149 and O-ring, 988840. Make sure to put a drip pan under the hoses to catch escaping fluids.

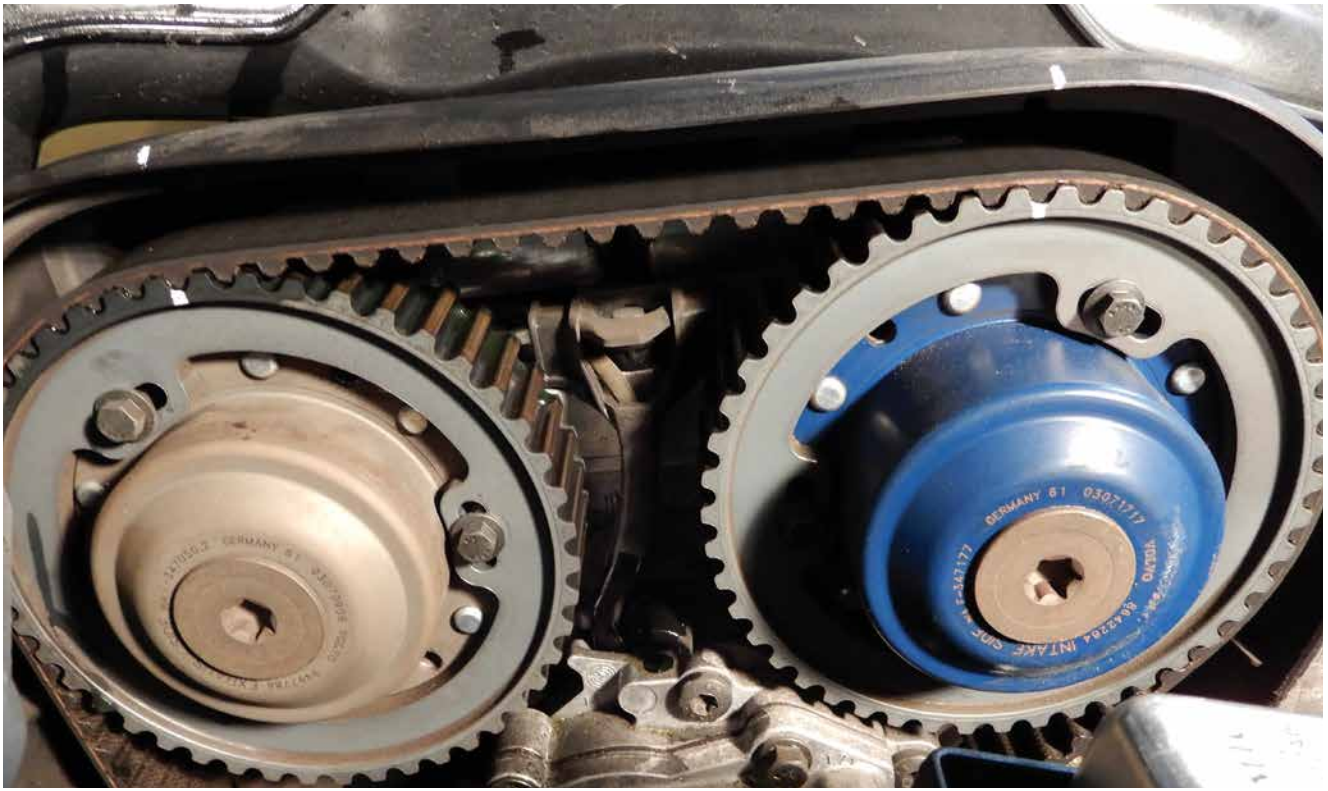
Timing marks lined up

Now that the cover is removed, the water pump is exposed. Jack the vehicle up or put the vehicle on a hoist and raise it up enough to remove the tire on the right side of the vehicle. Pull back the inner fender removing two 10 mm plastic nuts. Use a 30 mm socket with extension and turn the crankshaft clockwise until all timing marks are lined up.

Reinstall the timing belt, making sure that the timing marks are lined up. Route the belt around the crankshaft up to the intake camshaft over to the exhaust camshaft, down to the water pump and around the tensioner. With the tensioner loose, push the needle over just enough to slide the belt on. Check to make sure the marks are aligned. With a 6 mm Allen wrench, position the timing tensioner to the desired position, and tighten with a 12 mm wrench. Spin the engine over by hand to make sure the timing marks are aligned properly. Route the auxiliary belt correctly around all pulleys.

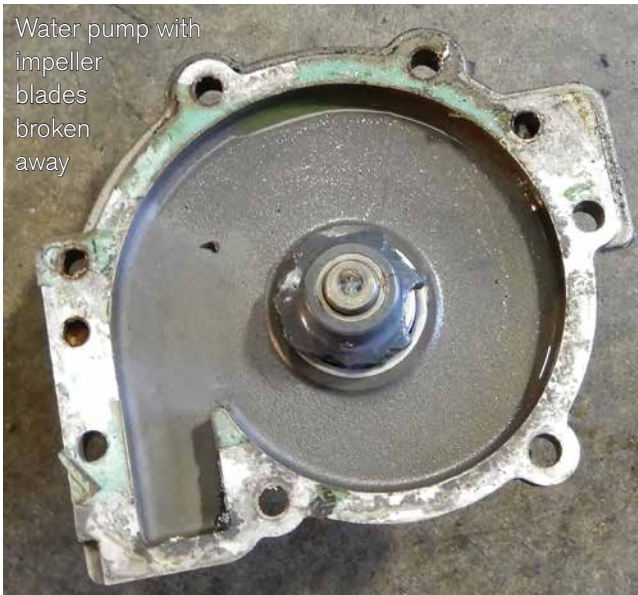
Water pump with impeller blades broken away

Now that the water pump is exposed, use a 10 mm socket to remove all seven bolts holding the water pump on. Tap on the pump to release it from the engine block. Remove the pump and inspect. If any impeller blades are missing or broken, or if the impeller just spins easily, this is the problem.

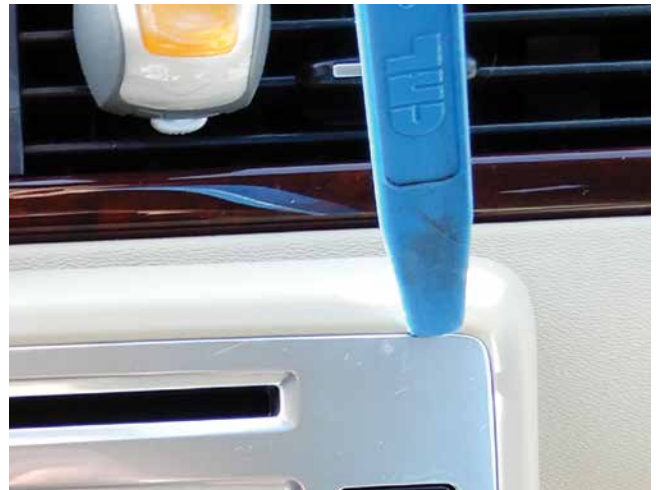
Tool inserted at trim of radio system

Inside the vehicle, the center console will need to come out. With a trim tool, remove the face plate around the infotainment system. This will expose the screws that will need to come out.

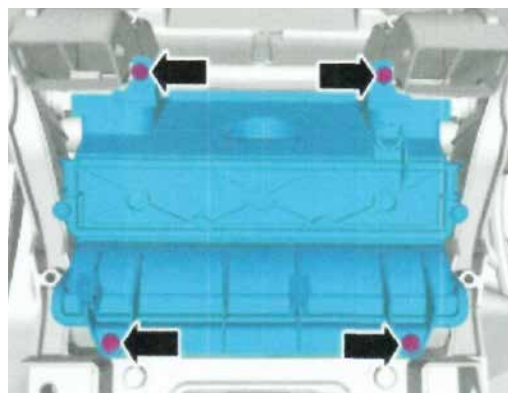
Covers at front and over coolant pipes

Now that the center console is out, remove the air ducting surrounding the heater box. Remove the four screws on the front cover and also the two screws covering the coolant pipes. This will give room to disconnect the coolant pipes going to the heater core.

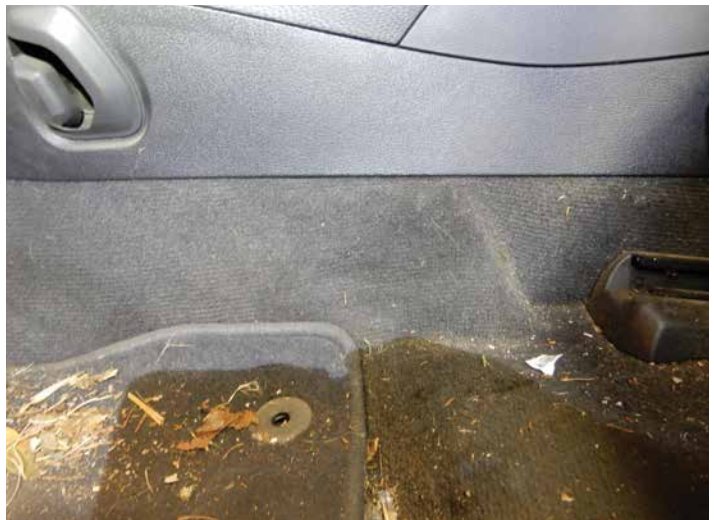
Side panels at bottom of console

Now, for removing the center console, move both front seat back as far as they will go. Remove both side panels; this will expose the screws to remove at the front of the console. Open up the console compartment and remove the rubber liner. Underneath there will be two T25 Torx fasteners that need to come out.
