VOLVO MOONROOF/ SUNROOF SERVICE, DIAGNOSIS AND REPAIR

INNER SUNROOF SHADE BINDING AND JAMMING 1999-2007 V70/XC70/S80/C70/ S60/XC90

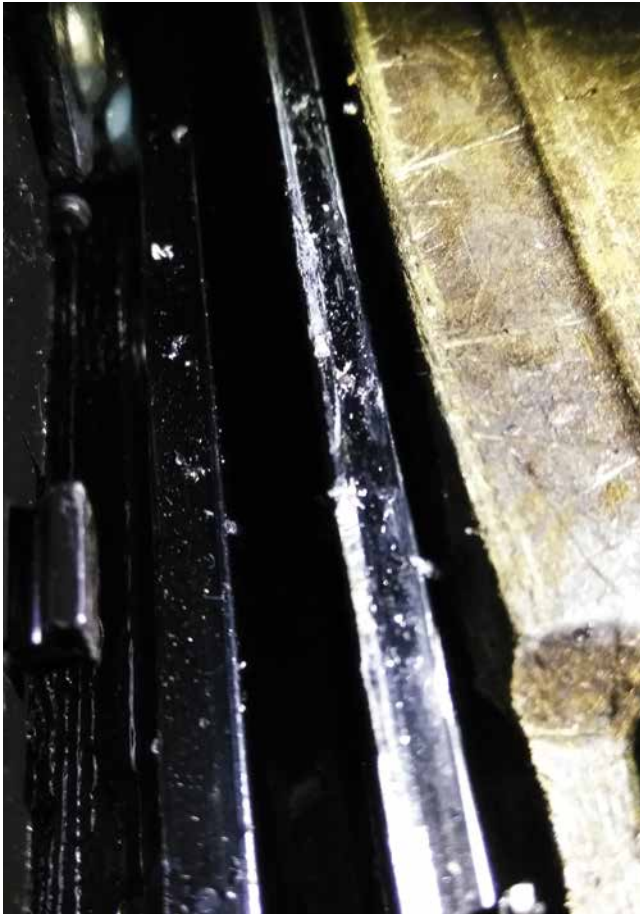
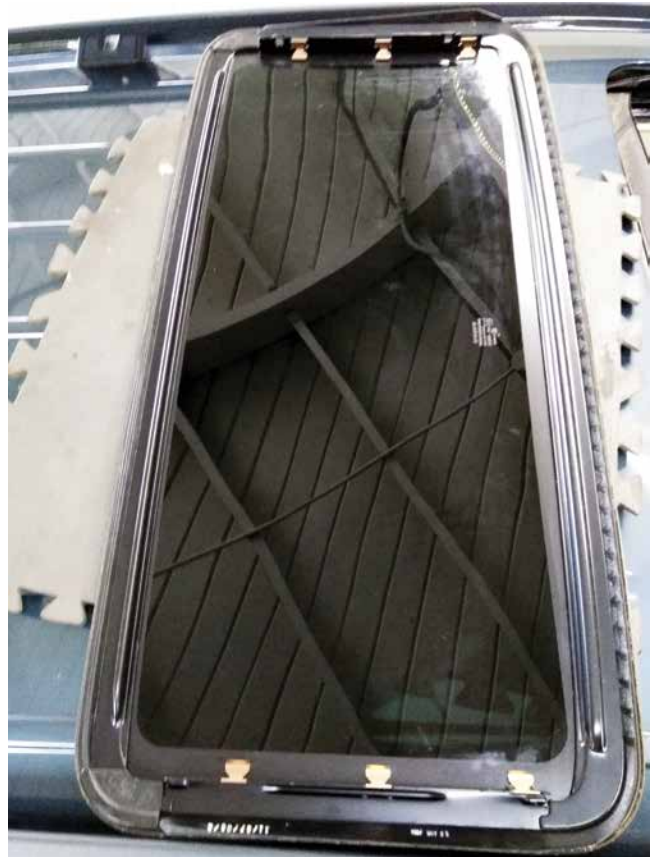
Have someone help you carefully remove the sunroof glass and lay it down somewhere safe.

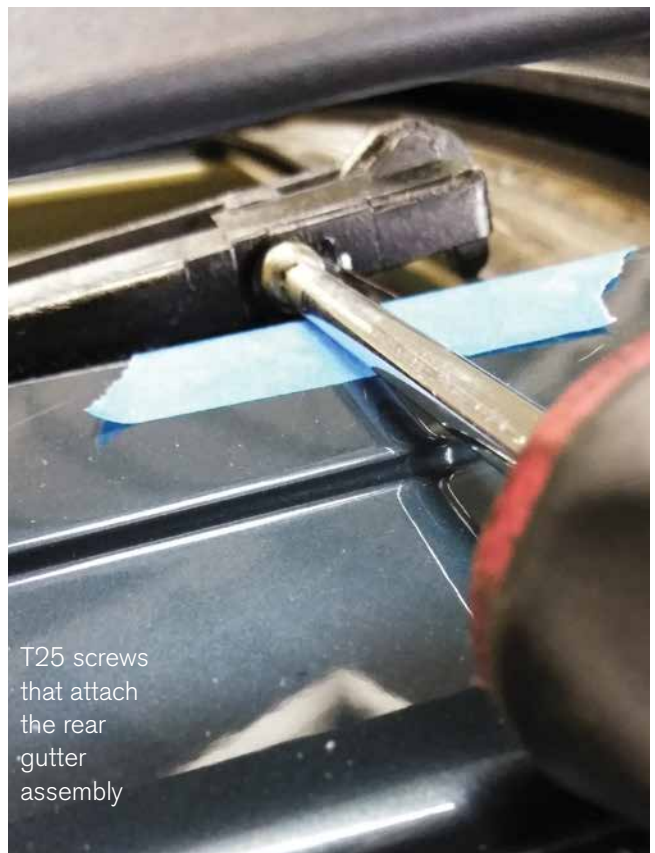
T25 screws that attach the rear gutter assembly

Find the two T25 screws that attach the rear gutter assembly; use some blue tape to protect the paint on the roof while you remove the screws.

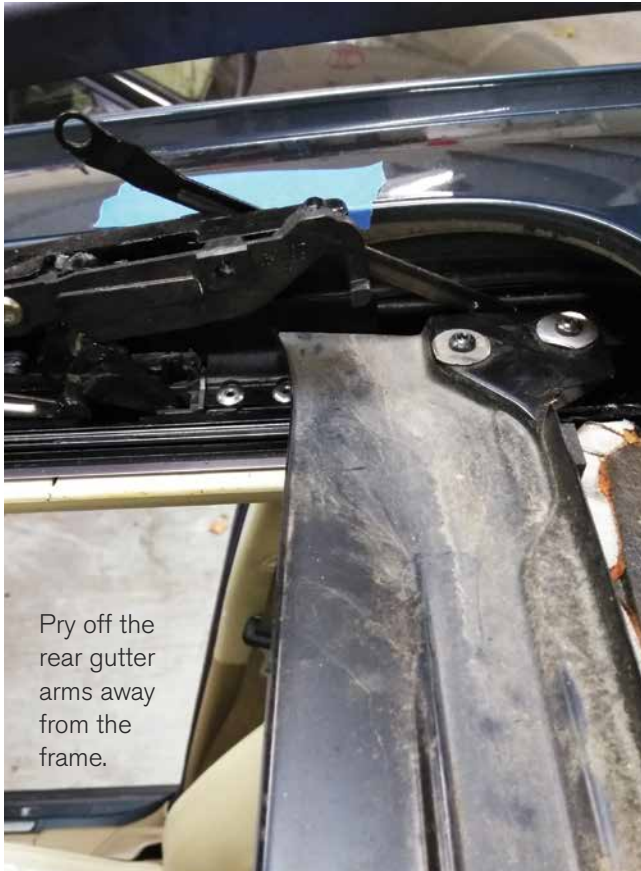
Pry off the rear gutter arms away from the frame.

Use a flat tip screwdriver to gently pry off the rear gutter arms away from the frame.

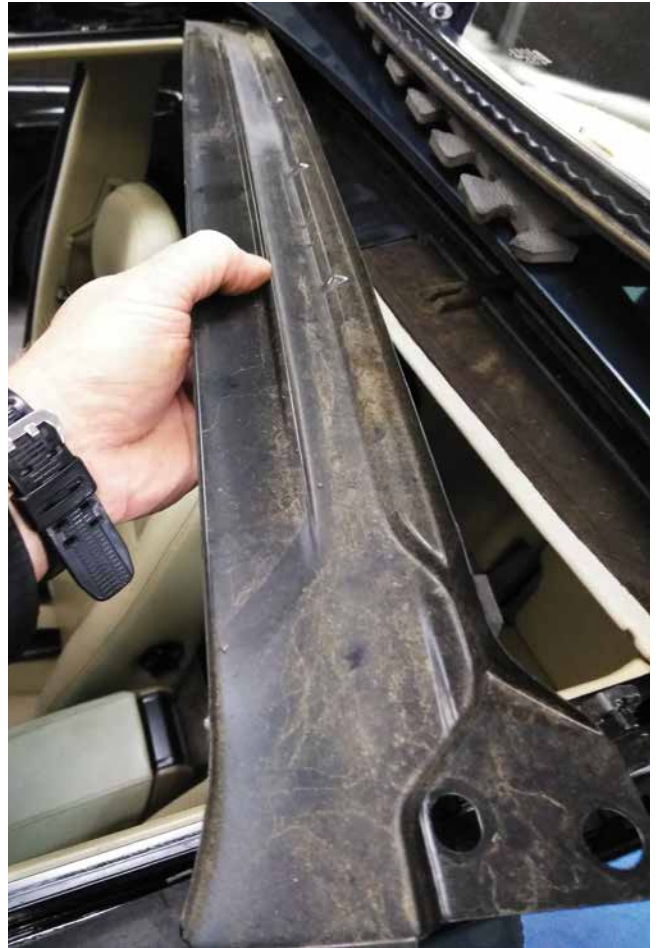
Remove the gutter channel.

When the four gutter screws are removed you can remove the gutter channel.

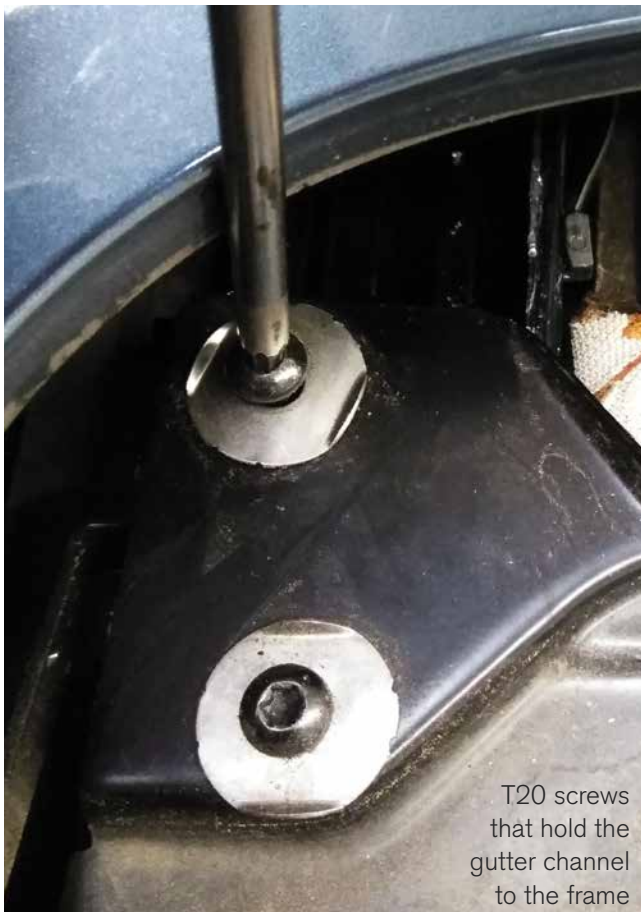
T20 screws that hold the gutter channel to the frame

Next, pull the rear gutter forward so you can access the four small T20 screws that hold the gutter channel to the frame.

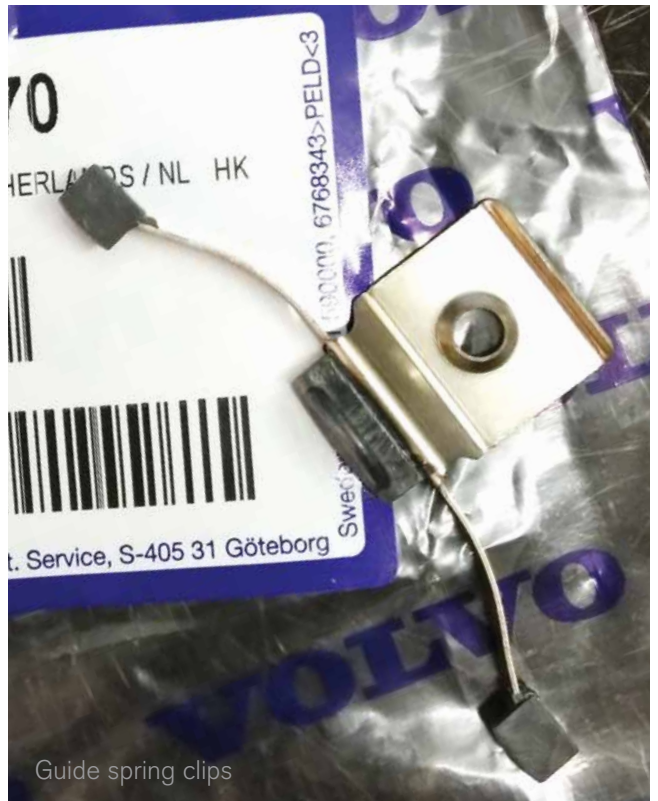
Guide spring clips

With the gutter removed, you can pull out the sunroof shade and replace the guide spring clips.

Place the sunroof shade on a very clean work area and remove the old spring clips. Use the new screws provided with the clips and install four new ones. The Volvo Genuine Part number is 9483170.

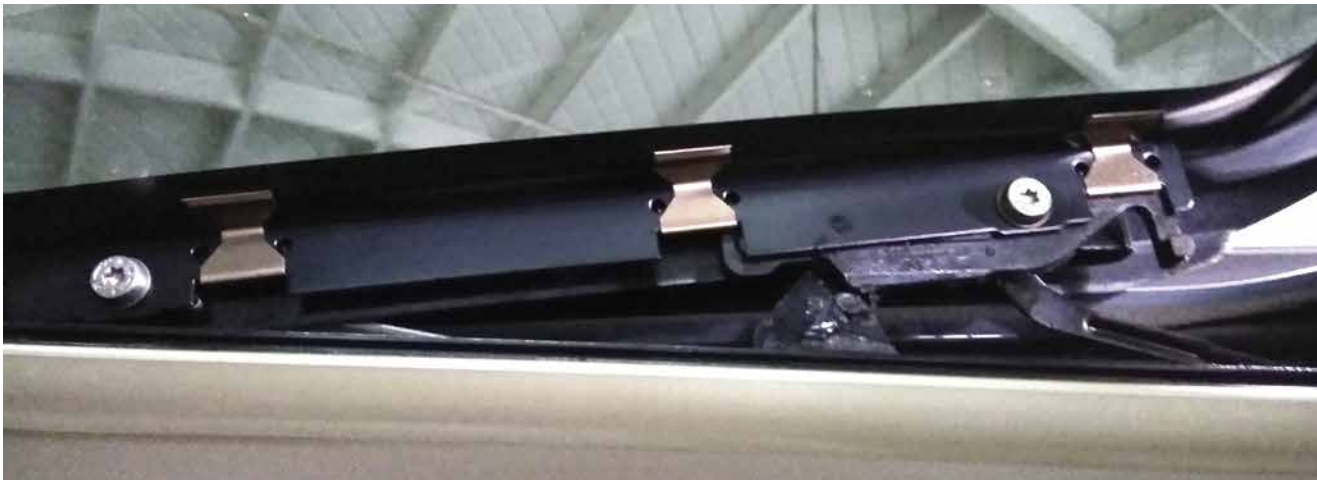
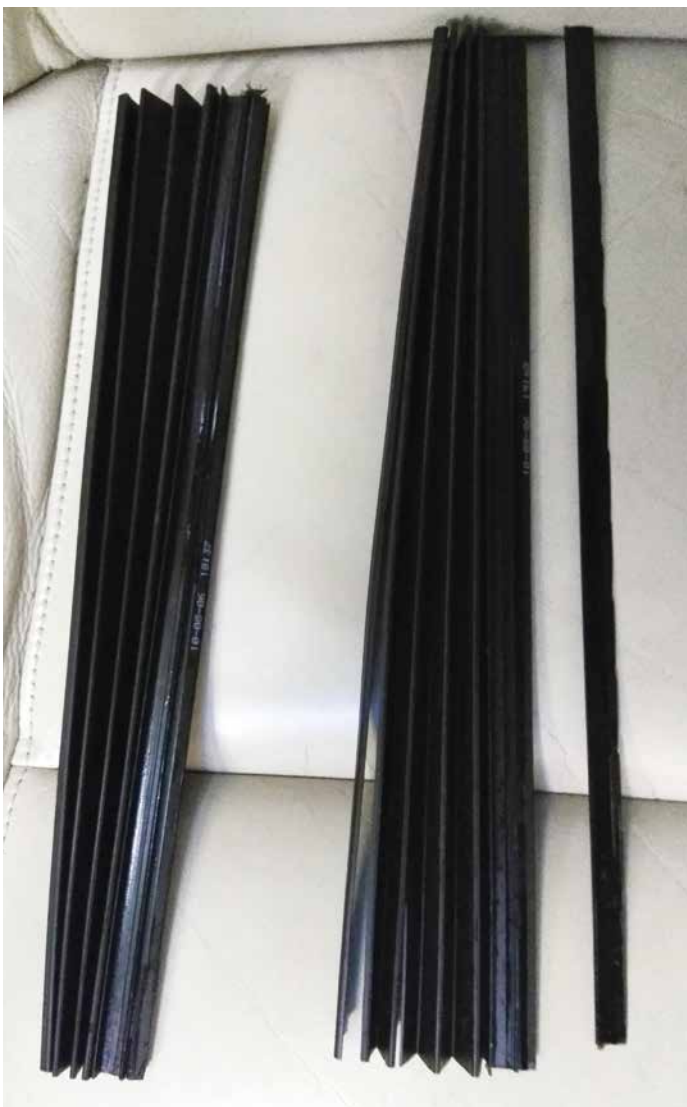
In most cases, Volvo sunroofs have blinds covering the left and right sides of the sunroof frames. You will have to remove them to access the frame screws for adjustment and removal of the sunroof glass. You should recommend new blinds if they are cracked or damaged, in order to prevent broken pieces from becoming jammed in the sunroof tracks.

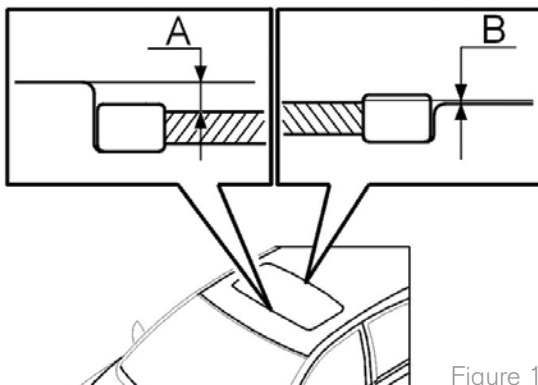
Figure 1

- Front edge:
The upper section of the glass should be set at one mm under the roof panel (dimension A in "Figure 1").
- Rear edge:
The upper section of the glass molding must be flush with or one mm above the roof panel (dimension B in "Figure 1").

Molding must be flush within one mm of the roofline when closed.
