WHAT THE HECK IS THAT NOISE?

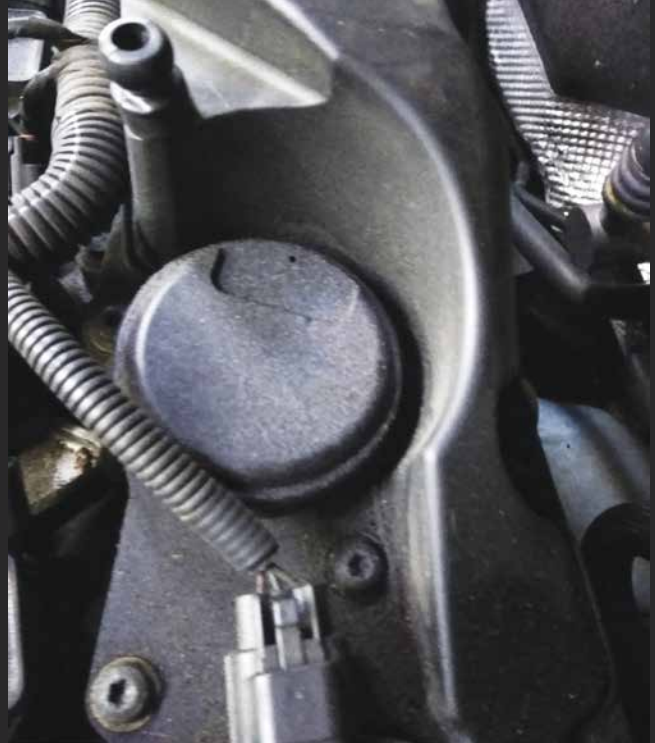
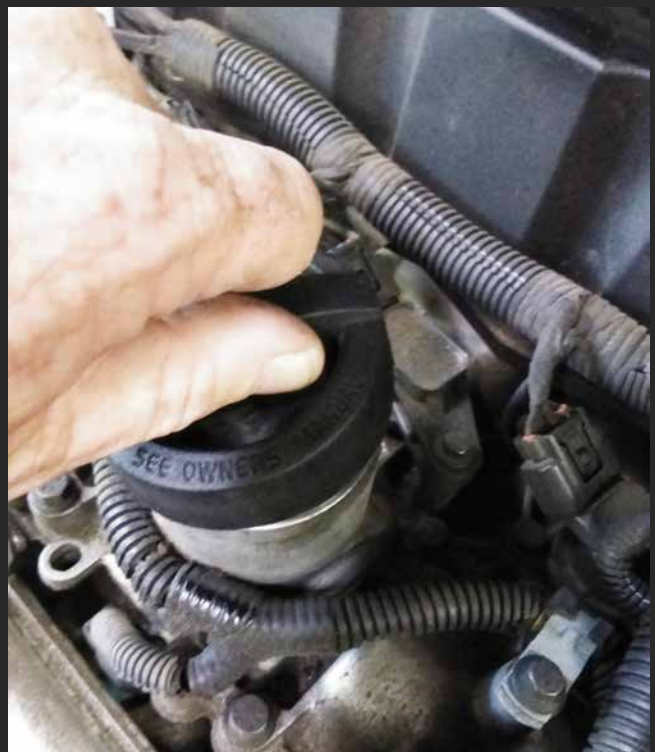
But one of the causes can be a ruptured diaphragm in the oil trap box, located on top of the valve cover at the rear of the engine.

Over time, the diaphragm in the oil trap can crack and start to make a whistle noise, especially at idle when the engine is warmed up.

The oil trap comes from Volvo as an entire assembly complete with a new seal installed in the base.

Make sure you use air to blow off any loose dirt or debris before you remove the old oil trap assembly.

All you will need to do the job is a Torx T30 socket and a pocket screwdriver to pop out the wire connector clips that are attached at the edges of the box. ●
