## VOLVO EVAP CASE STUDY (2002 VOLVO V70 2.4L TURBO) — CHECK ENGINE LIGHT ON FOR EMISSION RELATED CODES

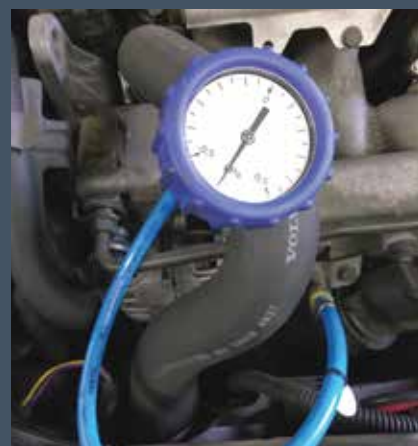
ECM - 130A (Air Leakage Intake System) could be caused by any unmetered air leak in the engine's intake system, a defective air mass sensor (not likely), or a blocked PCV system, which is very common and should be checked on every Volvo you service. A clogged PCV system can cause a lot of problems, but for it to set a code is rare.

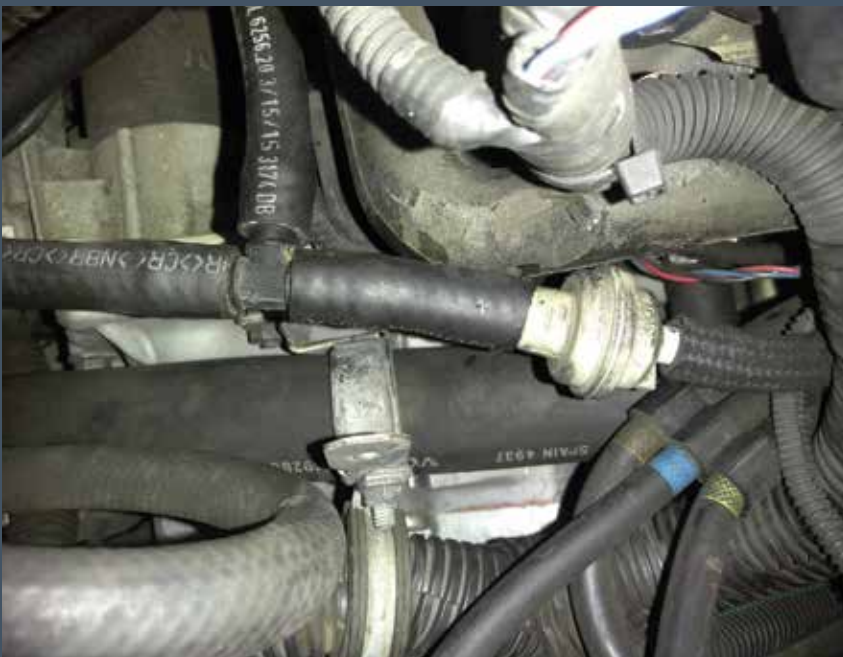
A good way to test the Volvo canister purge solenoid valve is to use a hand-held vacuum pump and apply vacuum to the connector side of the valve. If the valve bleeds off the vacuum, replace it.

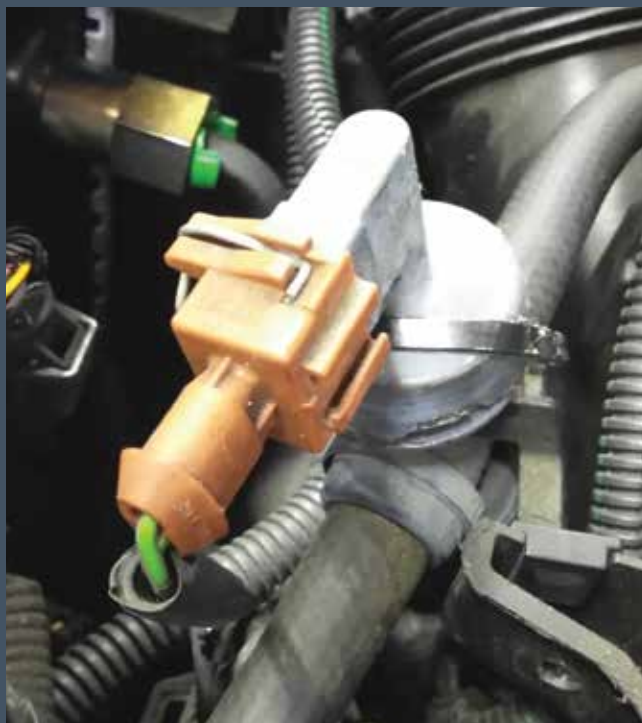
The hose that was used was aftermarket bulk fuel hose and was not designed to be used for this application. This kind of hose was designed to carry liquid under low to medium pressure; it was not made to stand up to engine vacuum, and is prone to get soft and kink in high heat conditions.

During the visual inspection under the hood, the technician noticed that a lot of the hoses for the EVAP purge valve and the brake vacuum pump check valve had recently been replaced.

Remember, when replacing hoses always replace them with the same type of hose that came on the car from the factory. Using just any hose could become a safety problem for your customers.

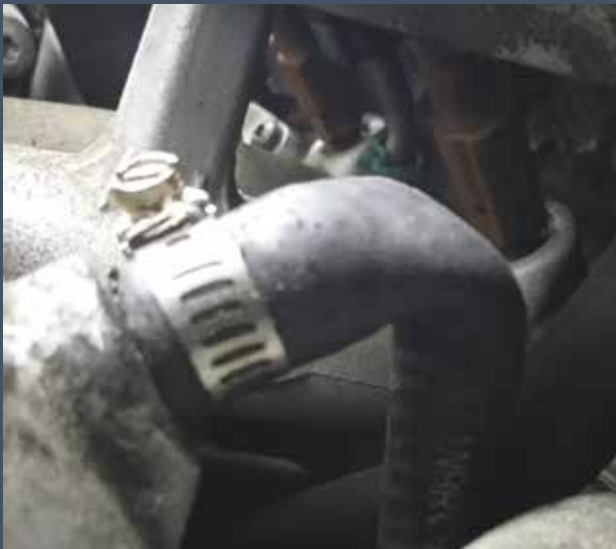
The cause of the vacuum pump cycling on and off turned out to be a cracked and leaking brake vacuum pump check valve.

The cause of the vacuum pump cycling on and off turned out to be a cracked and leaking brake vacuum pump check valve (note the zip tie that was holding it together).

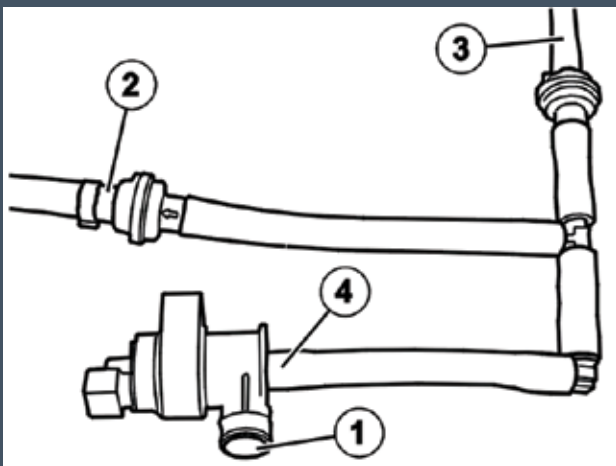
The first sign of trouble was at the hose that connects to the intake manifold. Since the hose was replaced with the wrong type of hose, it would soften and collapse as the engine warmed up, causing the flow to the EVAP and Brake Vacuum Assist to be cut off.

These anti-backfire valves are like air diodes; the vacuum only flows one way, which means that, with the valve installed backwards at position 3 in the diagram, fuel vapors from the canister would be bled off away from the intake manifold and into the turbo.

The first sign of trouble was at the hose that connects to the intake manifold. Since the hose was replaced with the wrong type of material, it would soften and collapse as the engine warmed up.

| 1 - Canister Purge Valve | 3 - Hose to turbo inlet |
| 2 - Hose to intake manifold | 4 - Hose to Purge valve |

When the technician was replacing the hoses and brake vacuum check valve on this car with new Volvo factory parts, he noticed that the anti-backfire valve in the hose that goes to the turbo inlet had been installed backwards. Yes folks, those little arrows mean something.
