# BMW Cooling System Overview

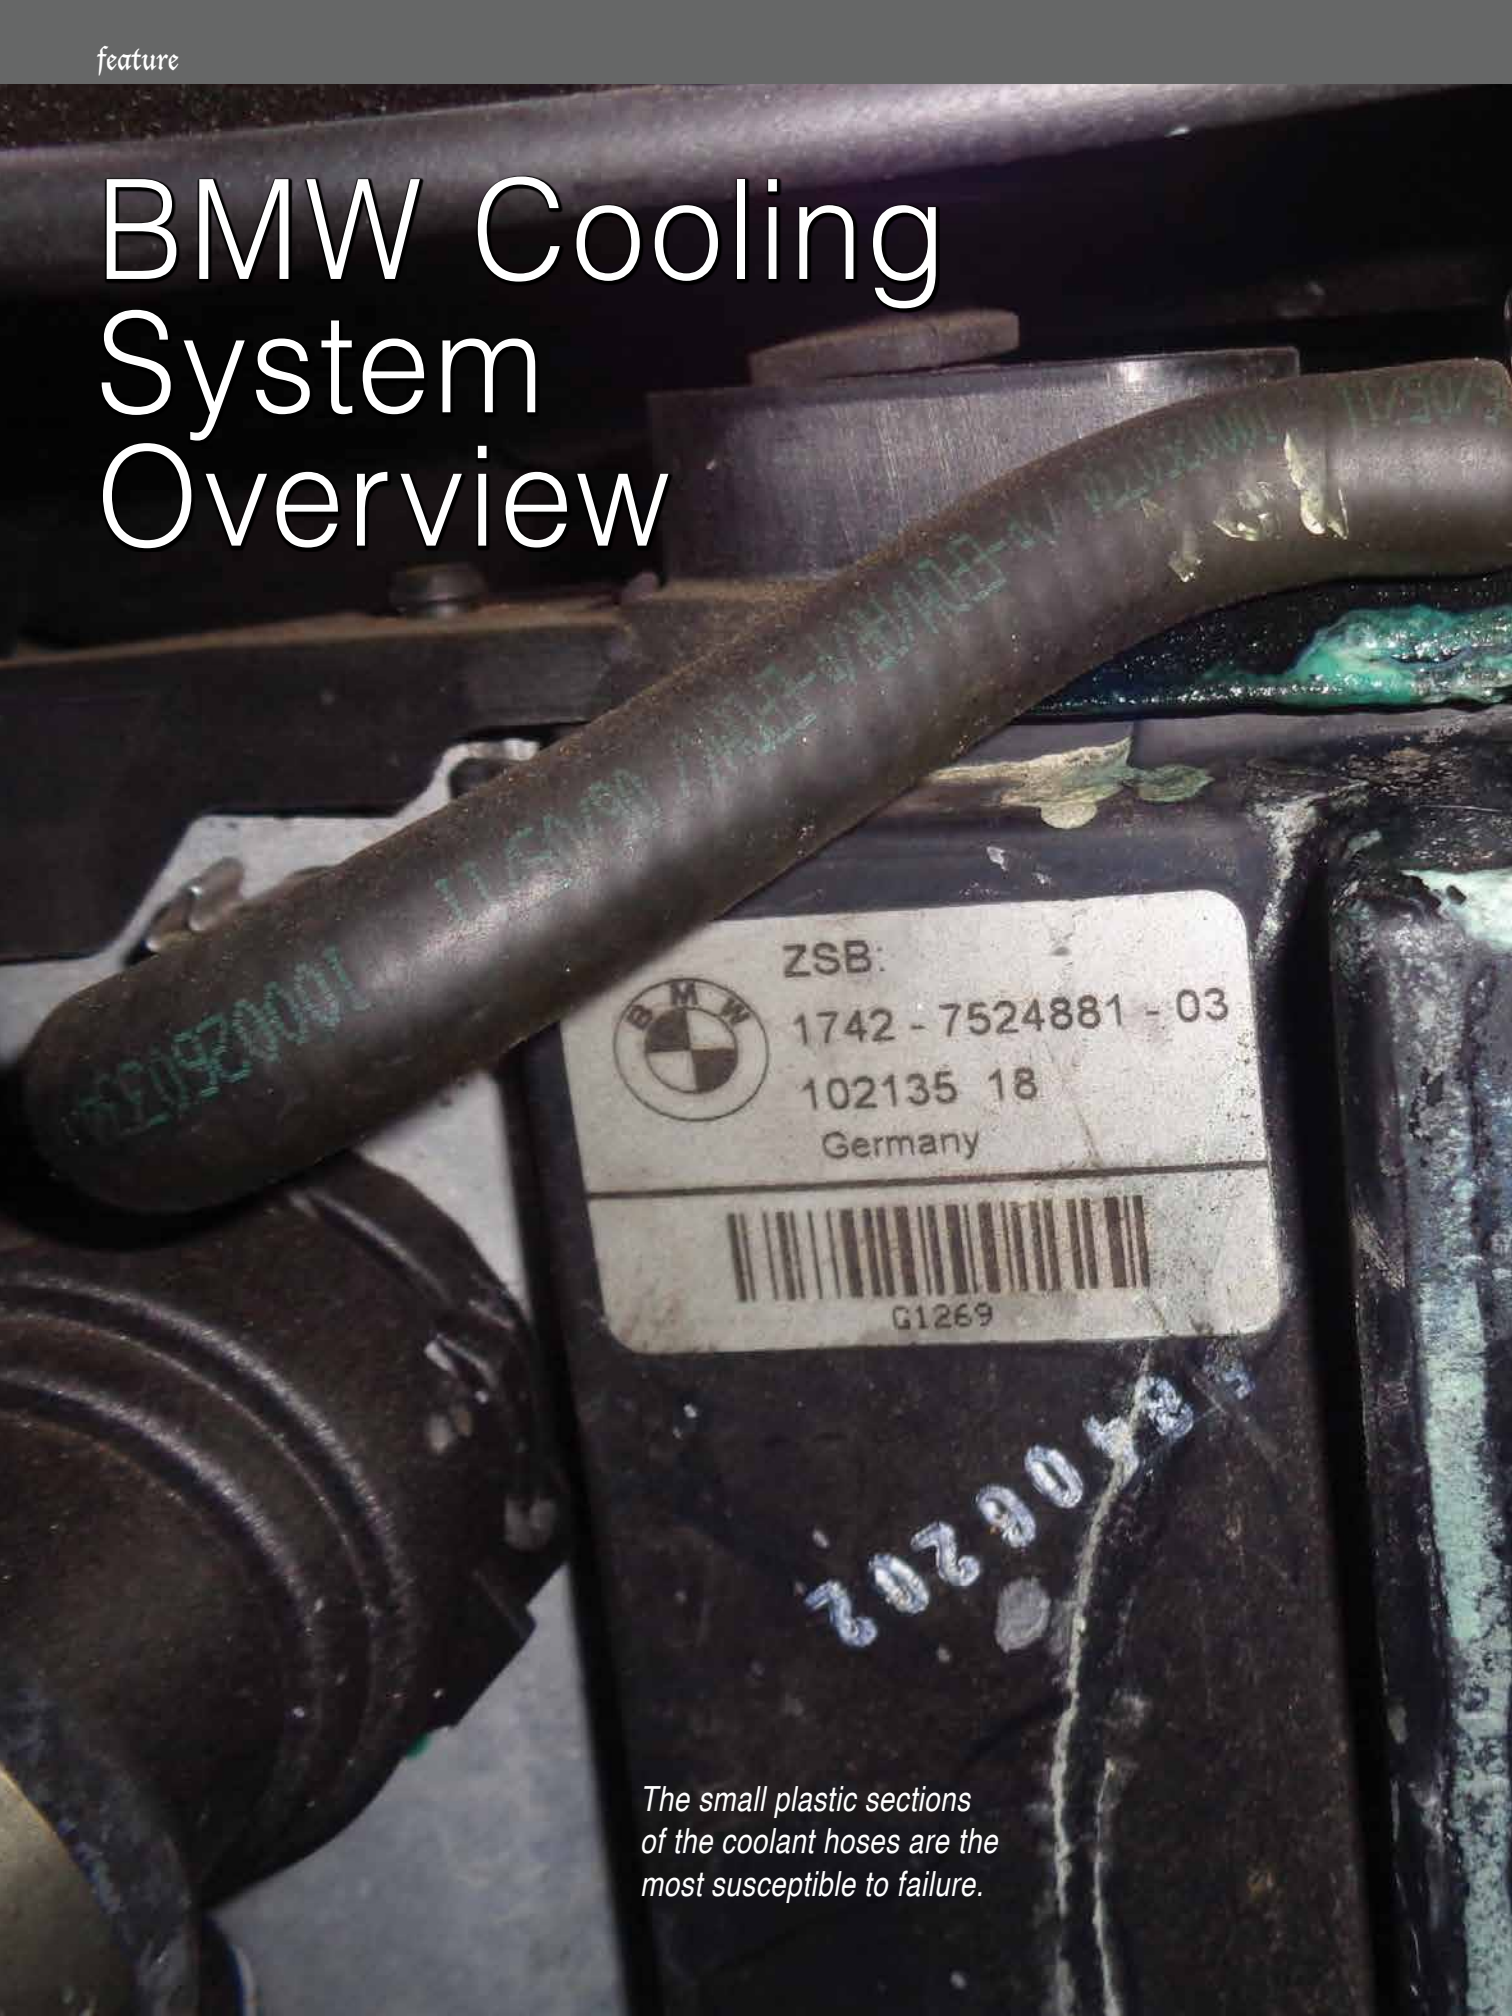
*The small plastic sections of the coolant hoses are the most susceptible to failure.*

BMW coolant hoses and coolant lines have a habit of failing too. Typically, the plastic becomes brittle from heat and eventually blows apart under pressure. Be cautious when moving these coolant lines during other repairs. They can be extremely fragile. The expansion tank hard line that runs across the top of the radiator on many BMWs is notorious for breaking.

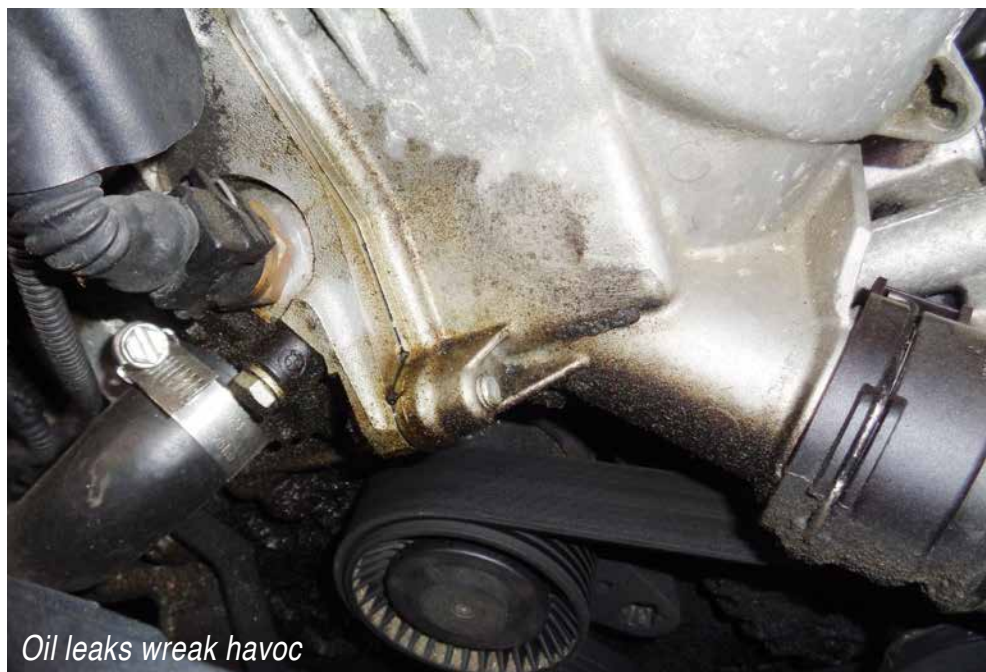
Many cooling system components are made of light-weight plastics, which eventually degrade over time. Constant heat cycling flexes and eventually weakens many of these components. Add hot coolant and oil to the mix, and these parts really take a beating. Keep this in mind when removing cooling system components during repair work. Any seal ring that has been removed during the repair should be replaced or at least inspected to verify its integrity. Coolant outlet flanges on E90 engines commonly fall apart during removal as they reside in the hot cylinder head and are also exposed to oil leaks.

Engine oil has the nasty habit of swelling rubber seals when allowed to leak. Some of the most common oil leaks on newer BMWs are from the valve cover gaskets as well as the oil filter stand gasket. Unfortunately, because these components sit at the top of the engine, oil can leak over the entire front area of the engine. This lets engine oil seep into coolant outlet seals, coolant hose seals, and many other sensors and gaskets as well as the primary drive belt.

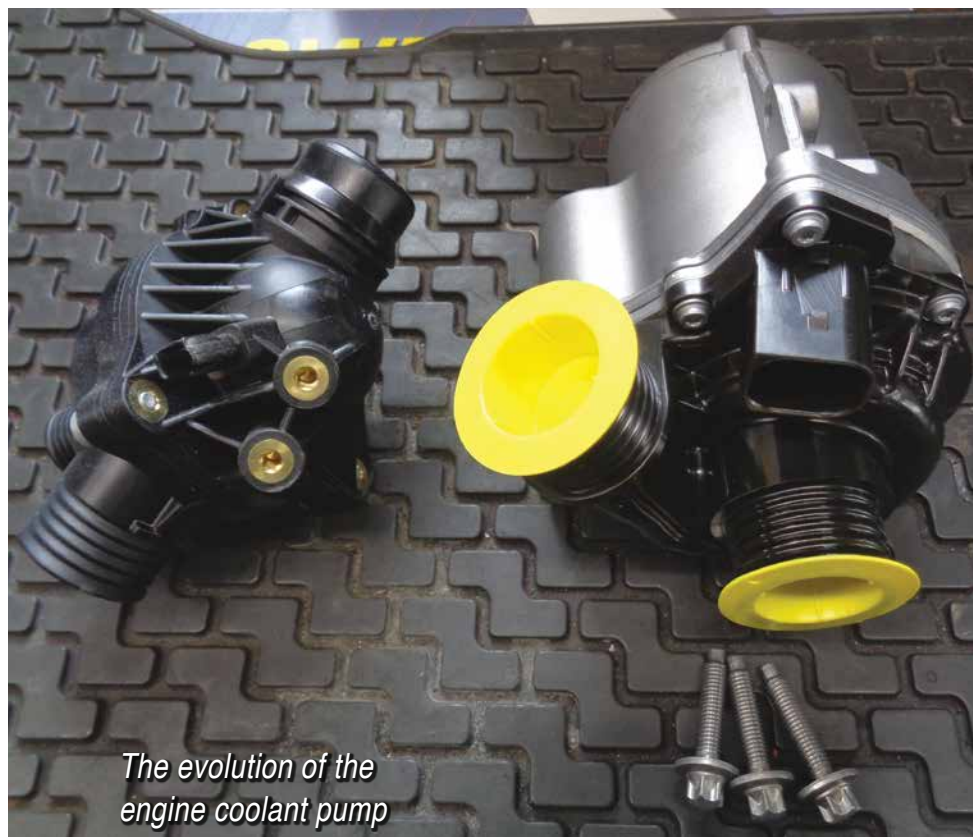
*The evolution of the engine coolant pump*

Since its introduction in the E90 generation, BMW began using electric coolant pumps on many models. The electric pump has many advantages over a standard drive belt run coolant pump. The most obvious advantage is lower drag on the engine from the accessory drive. This alone can slightly improve fuel economy.

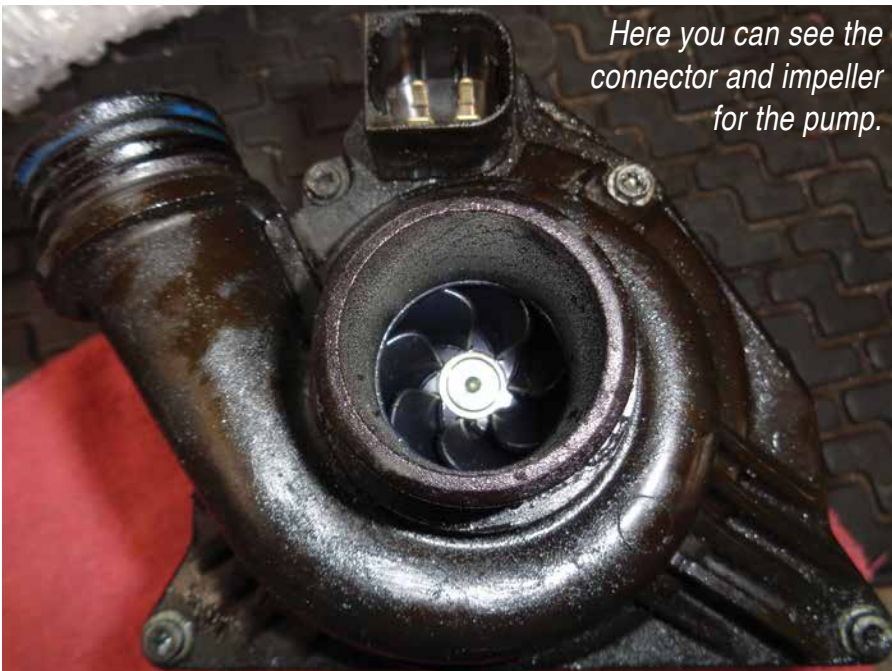
*Here you can see the connector and impeller for the pump.*

These pumps commonly fail from coolant contamination at the plug end of the pump. Once coolant reaches the electrical connector, the damage has probably been done to the pump. Coolant will quickly short circuit the electronics in the pump and destroy it. Close examination and cleaning of the electrical connector may be necessary after coolant pump replacement. It's also wise to inspect the coolant pump for blockage or damage from foreign material. This is rare, but a small piece of plastic or other foreign material can jam the pump impeller, impeding flow.

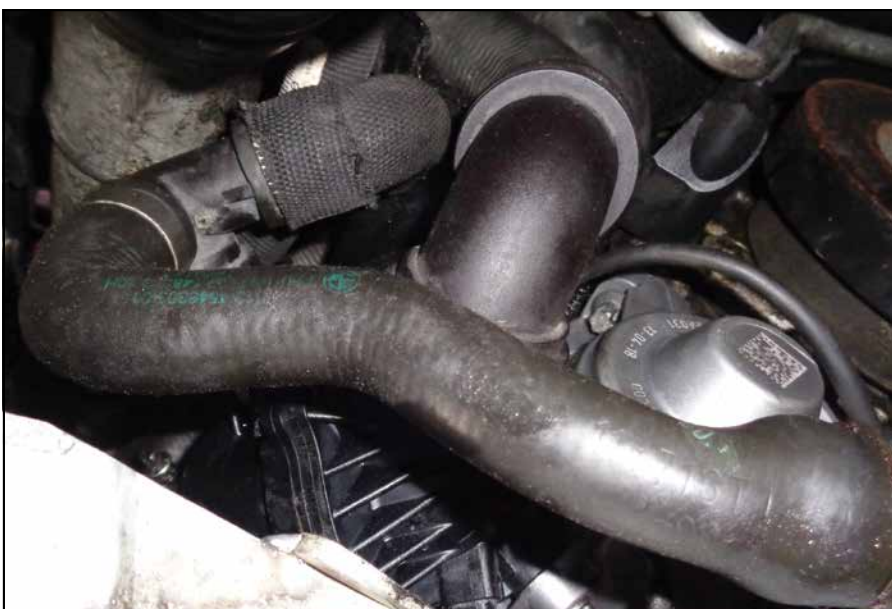
*Flexible drivers and universal sockets are a necessity here.*

Flexible drivers are the only way to access and successfully loosen the worm gear

clamps that secure the additional coolant lines at the pump and thermostat. If you are repairing an xDrive coolant pump, access is even more limited, and it may be necessary to remove the underbody brace and paneling on the passenger side wheel well to fully access the coolant hose connections.

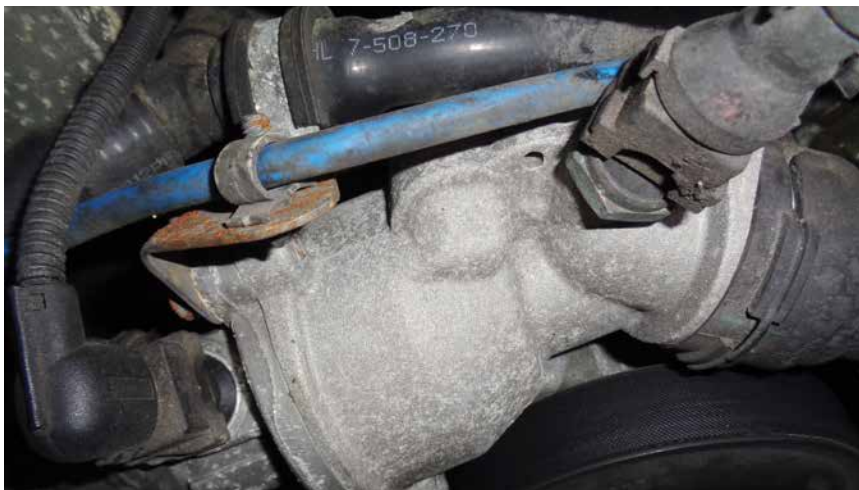
*BMW thermostats have been relatively unchanged for many years.*

BMW uses a standard thermostat design with the addition of a heater circuit integrated into the assembly. The heater is used to open the thermostat at a lower temperature, allowing for quicker warm-ups. The heater circuits are known to fail on these thermostats just like the old M54 thermostats. Faults are commonly stored in the DME as Thermostat Heater Circuit. In rare cases, the electrical connection seal at the thermostat can give out and begin wicking coolant through

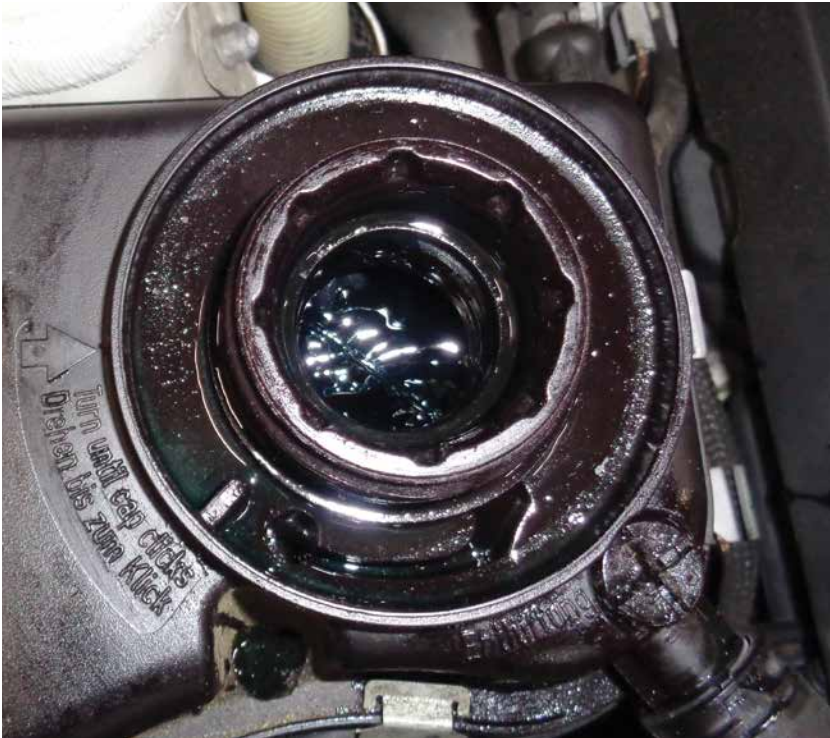
*The coolant pump can be heard to run and coolant flow can be visible at the expansion tank during the process.*

After any cooling system repairs are made to BMWs with electric coolant pumps, the system must be bled fully. BMW has included activations through the DME to run a bleeding procedure for the pump. This function runs the coolant pump at varying speeds to fully circulate coolant through the entire system. The bleeding procedure should be allowed to run for 5-10 minutes to complete fully.

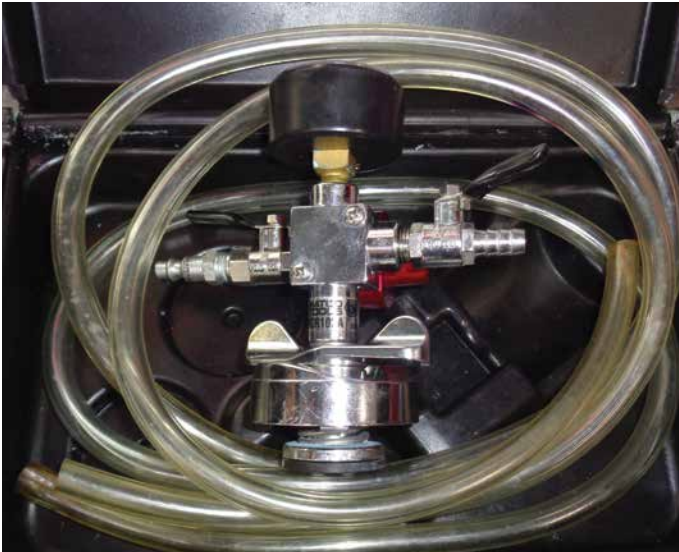
*Vacuum coolant fillers can be a big time saver, especially on hard to bleed engines.*

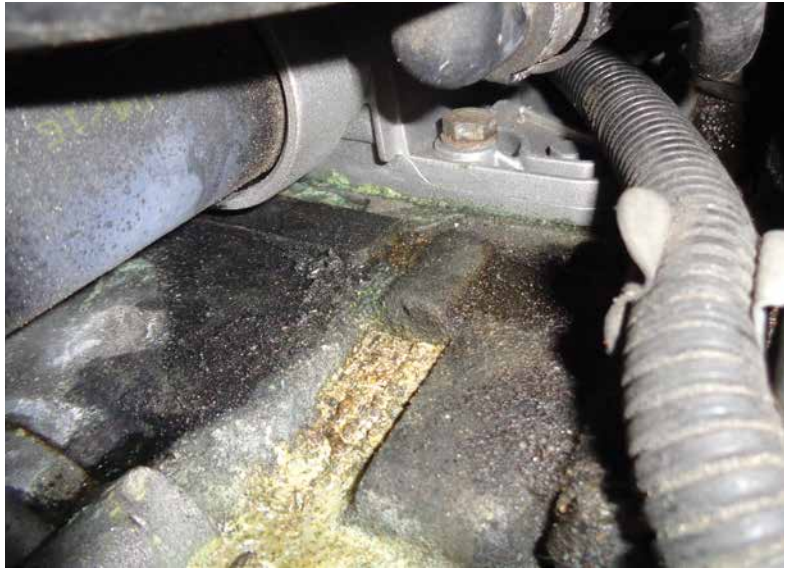
*The valley pan is a notorious location for coolant leaks.*

On The N62 V-8 engines, the valley between the cylinder heads contains a lot of coolant leak potential. There are small coolant return lines that leak. The valley pan gasket can leak, as can the large coolant transfer pipe running to the water pump. Get out your pressure tester and inspection mirror here when searching for coolant leaks. On turbocharged engines such as the N55, the coolant feed lines for the turbochargers are known to eventually degrade from heat. Once these fail, they can be a bear to replace.

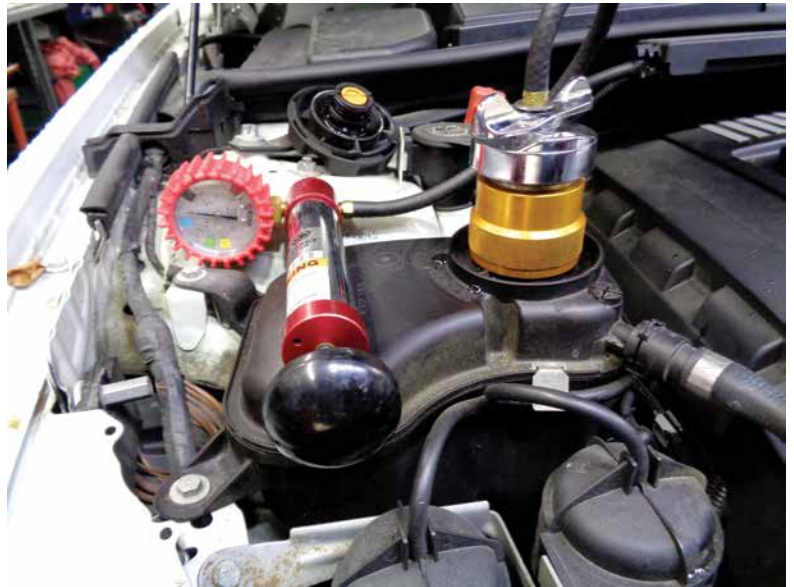
*A reliable coolant pressure tester with BMW adapters is an absolute necessity when chasing down leaks.*
