SAFETY FEATURES

DRAIN TUBES

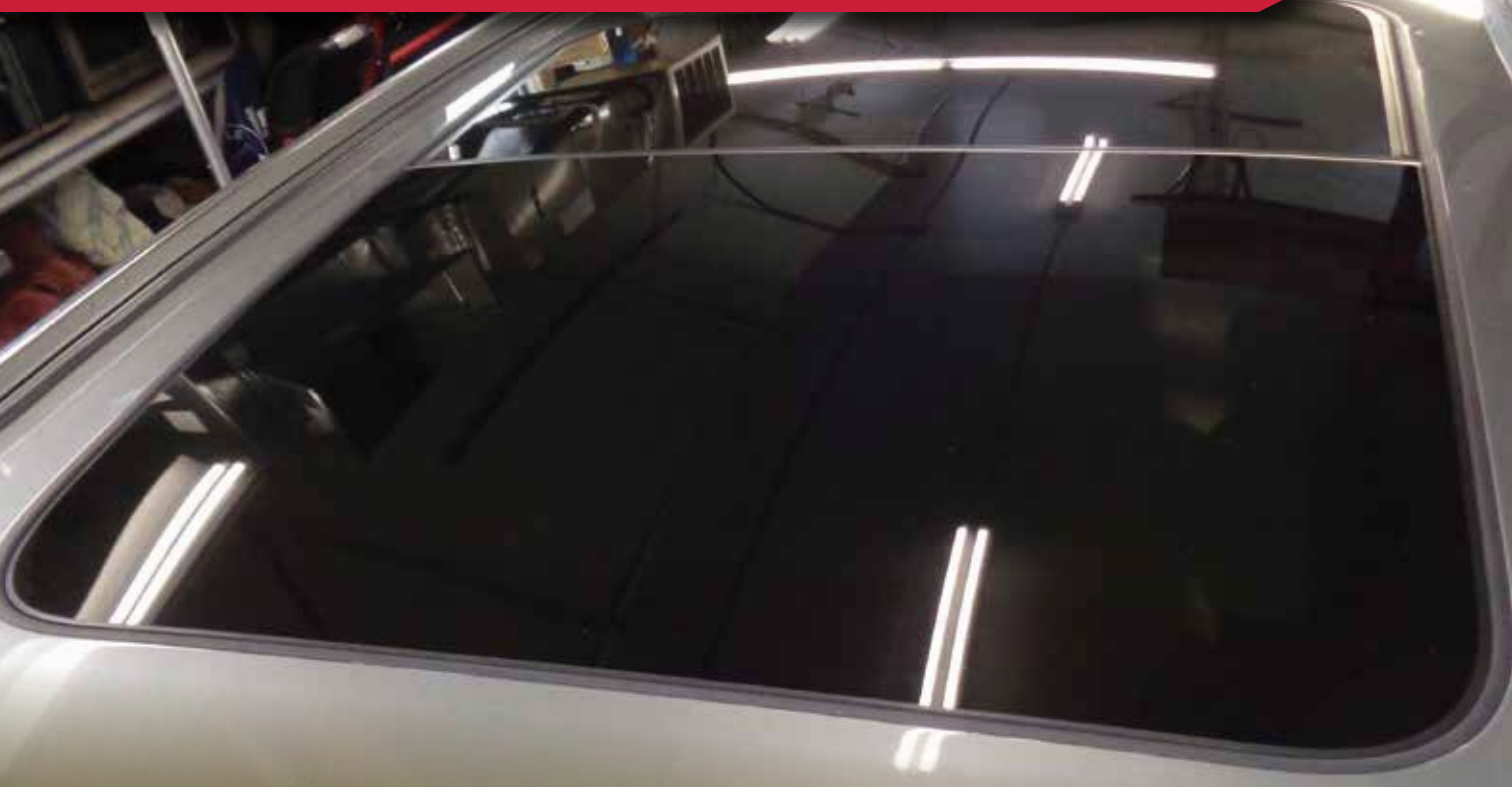
Shown above: Larger models such as Q5 and Q7 as well as Avant models may have panoramic sunroof options as well as motorized sun shades.

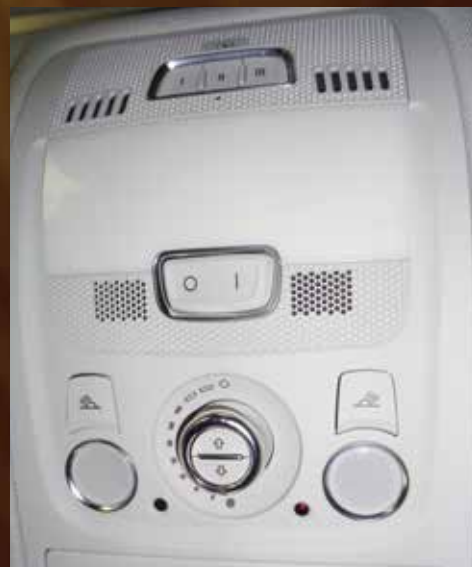
It may be necessary to remove the overhead console during repairs. Removal will allow access to the sunroof drive motor on most models.

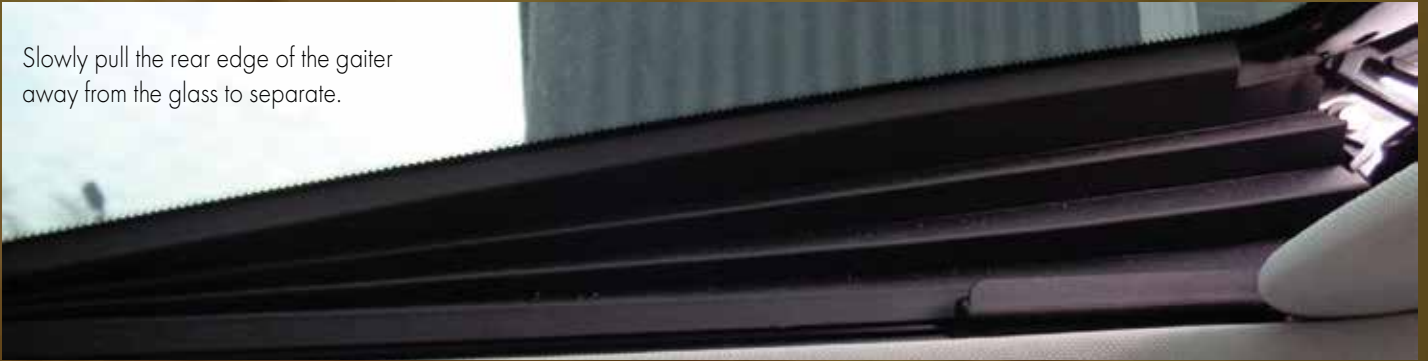
Slowly pull the rear edge of the gaiter away from the glass to separate.

The sunroof glass must be positioned well to function properly. A misaligned sunroof glass can cause water leaks, noise, and friction in the system, causing anti-trap activation. If the leading edge of the sunroof glass is too high, wind noise becomes a problem. Adjustment of the glass is fairly straightforward. First, set the sunroof to vent position. This allows greater access to the rubber gaiter. This needs to be separated from the glass carefully to access the mounting screws. Be careful. The rubber is quite thin and easy to tear while removing.

The rubber gaiter is a necessary addition to the sunroof for diverting rain water and minimizing noise. Once the gaiter is removed, lower the sunroof back to closed position. The front edge of the sunroof glass should be slightly lower than flush; 1 mm below the roof edge is a safe position. At the rear of the sunroof, the edge should be flush or slightly higher than the roofline. This sounds counterintuitive, but mounting the glass slightly lower in the front helps decrease noise and drag. After adjusting the glass position, don't forget to tilt the glass again and reinstall the gaiters on the glass.

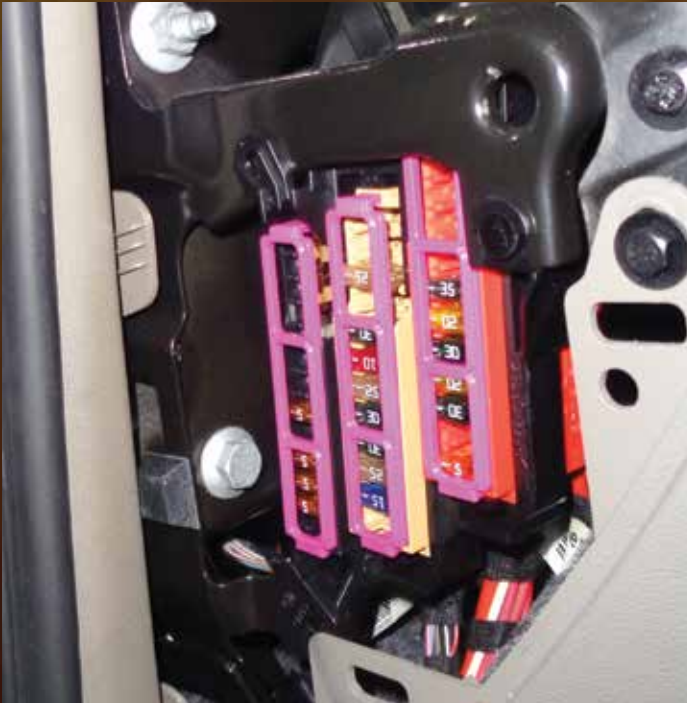
The primary interior fuse block, located at the base of the A-pillar is very susceptible to water damage if there are leaks at the sunroof drains.

Depending on where the Audi is driven and parked, plant matter, pollen, etc. tend to collect in drain locations. If left unchecked, this can block a drain tube completely, causing water intrusion into the cabin of the car. Water leaking down the A-pillar can be a problem on many Audi models, as a fuse block is located at the base of the A-pillar.

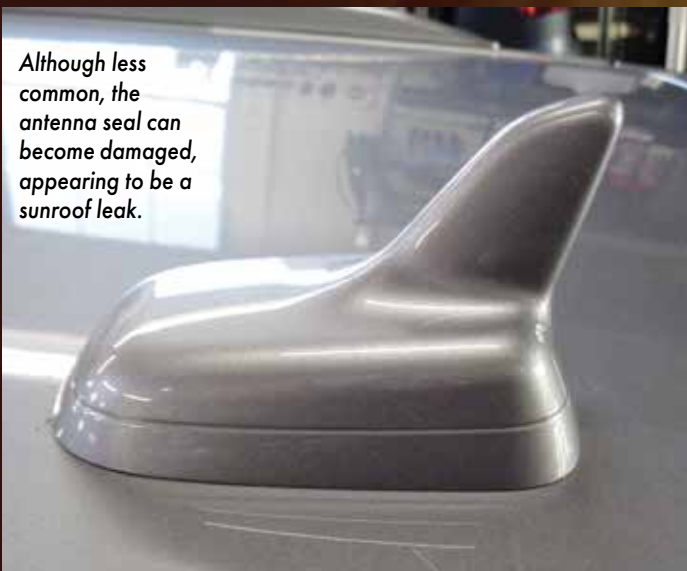
Although less common, the antenna seal can become damaged, appearing to be a sunroof leak.

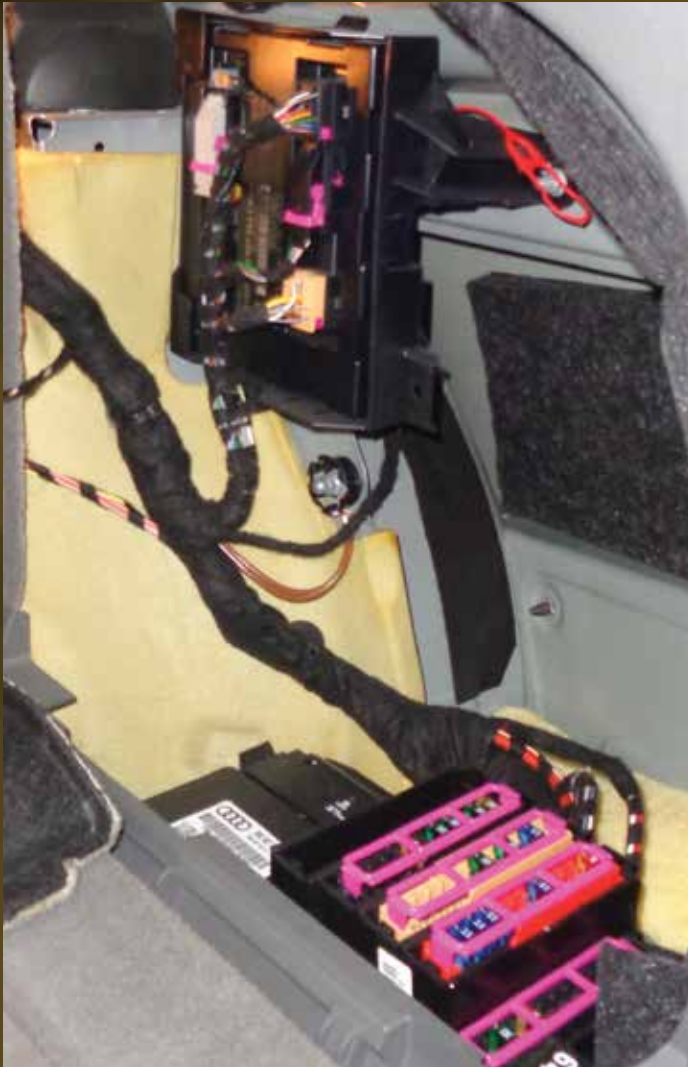
The vehicle battery and primary body control module are located in the right rear corner on this 2012 A4 Avant.

Problems with the rear sunroof drains are less common but can still be an issue, particularly with Avant models. If a rear sunroof drain becomes blocked, the most common outcome is water damage to modules located in the lower rear corners of the Audi. These are not cheap!

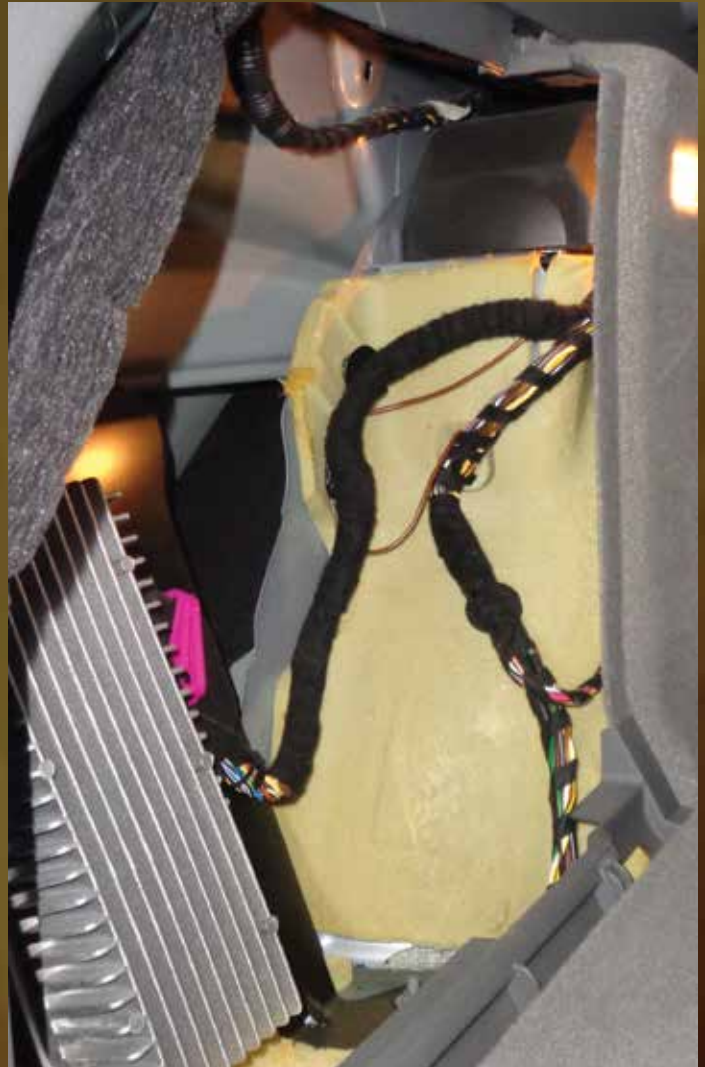
The audio amplifier location on an Avant model, located at the base of the C-pillar. This is prone to water ingress from clogged rear sunroof drains.

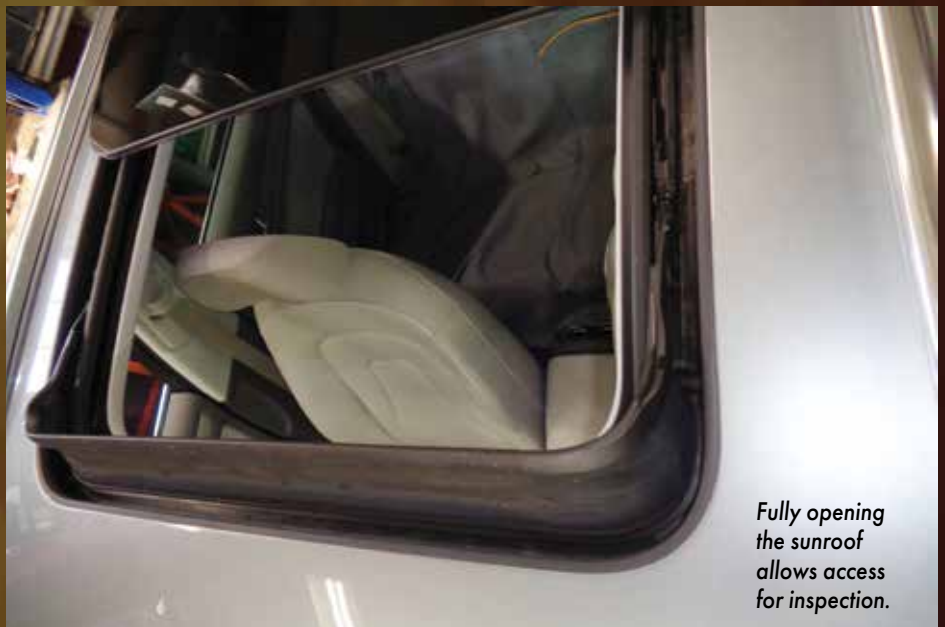
Fully opening the sunroof allows access for inspection.

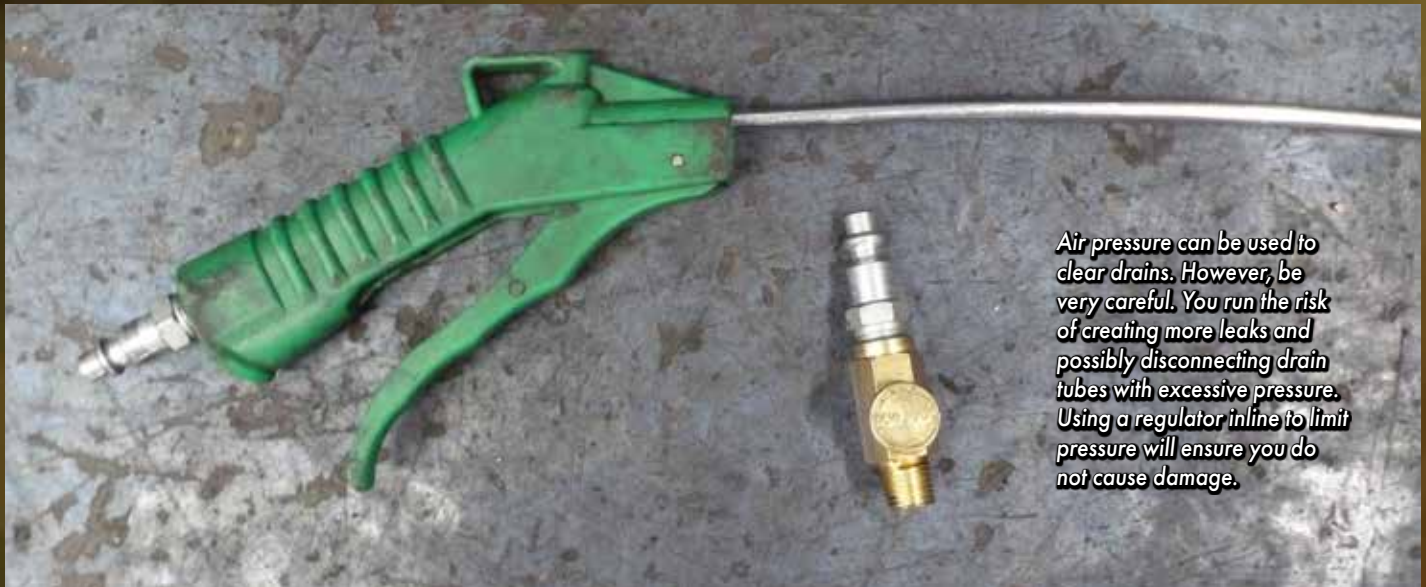
Air pressure can be used to clear drains. However, be very careful. You run the risk of creating more leaks and possibly disconnecting drain tubes with excessive pressure. Using a regulator inline to limit pressure will ensure you do not cause damage.

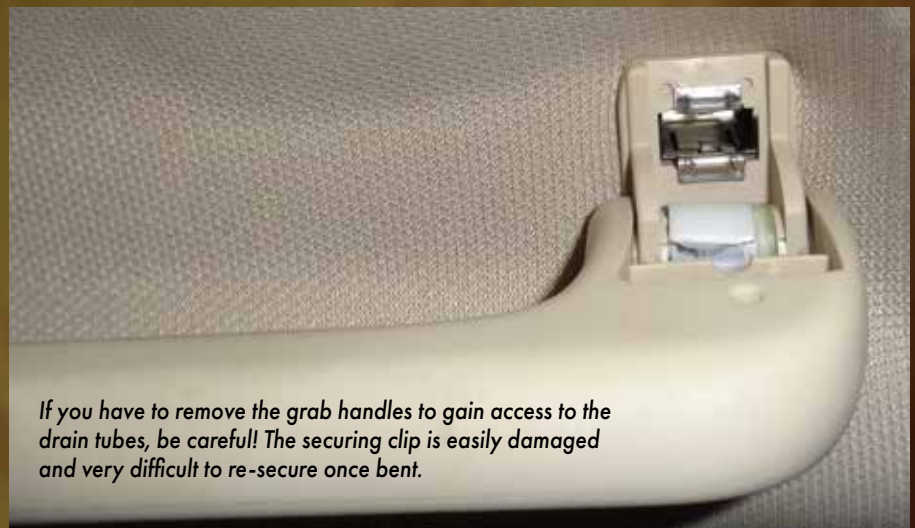
If you have to remove the grab handles to gain access to the drain tubes, be careful! The securing clip is easily damaged and very difficult to re-secure once bent.

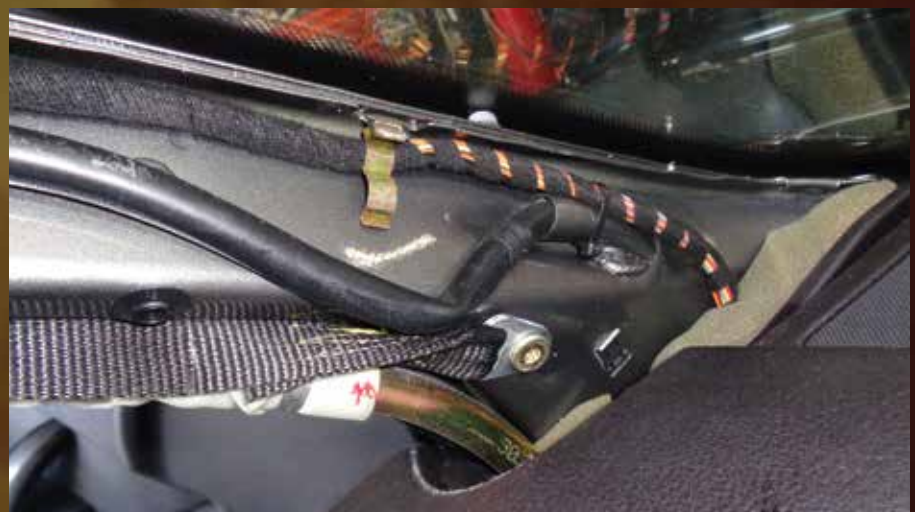
This pinched drain tube was caused by a previous repair and appeared to be a clogged tube until closer inspection. Note: This image is not on an Audi vehicle but still good information.

Often overlooked, the drain tube itself may cause issues with water ingress. The junction at the corners of the sunroof may shrink or swell and allow water to escape past the drain tube. This may appear to just be a clogged drain so further inspection will be necessary. Drain tubes can be removed and resealed, but it is best to replace them once damage to the sealing end has occurred.
