TechNews

March 2020

Electronic Automatic Transmission Diagnosis and Valve Body Replacement: Part ONE

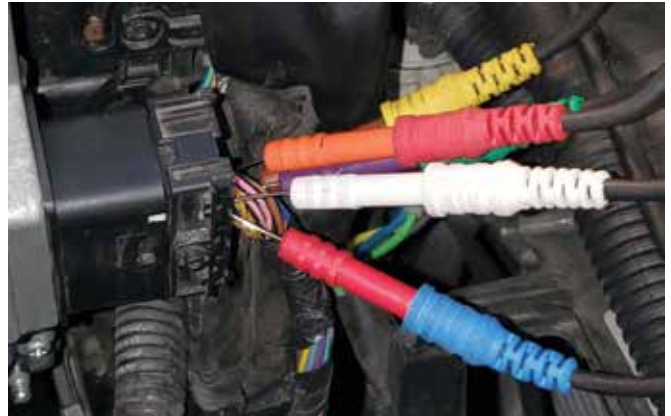
This image shows how relatively quick and easy it is to connect the scope leads to the needed solenoid and sensor circuits right at the TCM module.

On this vehicle, the TCM is conveniently located right next to the battery, with plenty of room to work. The benefit of testing the circuit here is that the technician is essentially testing and voltage dropping the complete circuit, including the wiring to the controller. That's fast and productive work.

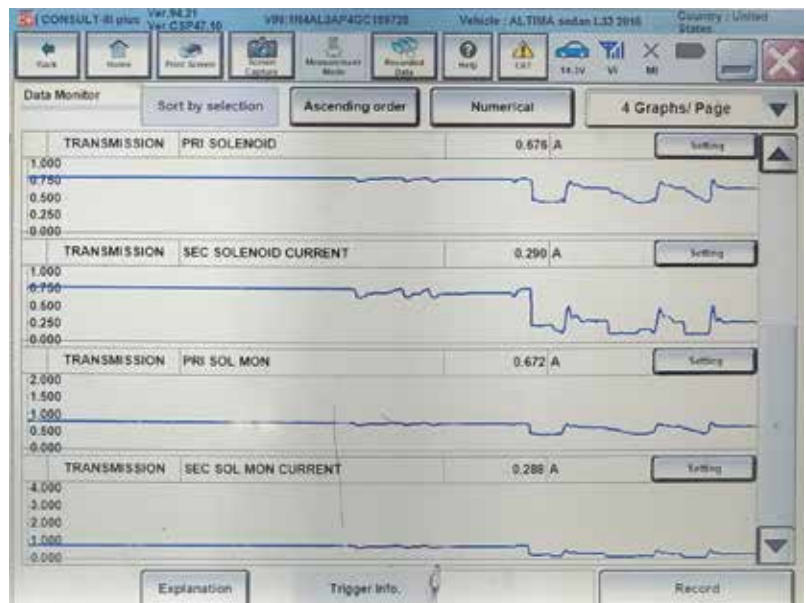
This shows the CONSULT III Plus displaying graphs of primary and secondary solenoid commanded target currents and the corresponding primary and secondary solenoid monitors.

Here we see the CONSULT III Plus transmission solenoid PIDs in data mode. Note that on this working vehicle, the target currents for both the primary and secondary solenoids are very close to those of their respective solenoid monitors. If these values don't track each other closely and within the pre-programmed tolerances, a DTC will set. It is sometimes preferable to watch this on a lab scope, or with the CONSULT III Plus in graphing mode.

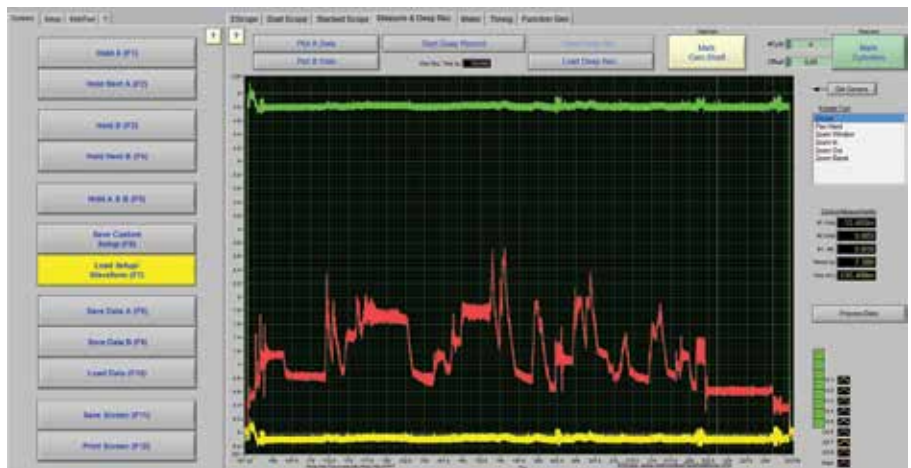
Here is a capture of the secondary pressure sensor test, with 5 volt reference (green trace) and ground (yellow trace), voltage drop and signal return activity (red trace), all on the same screen. Here you can see the whole sensor working with no voltage drop, indicating a healthy sensor circuit.

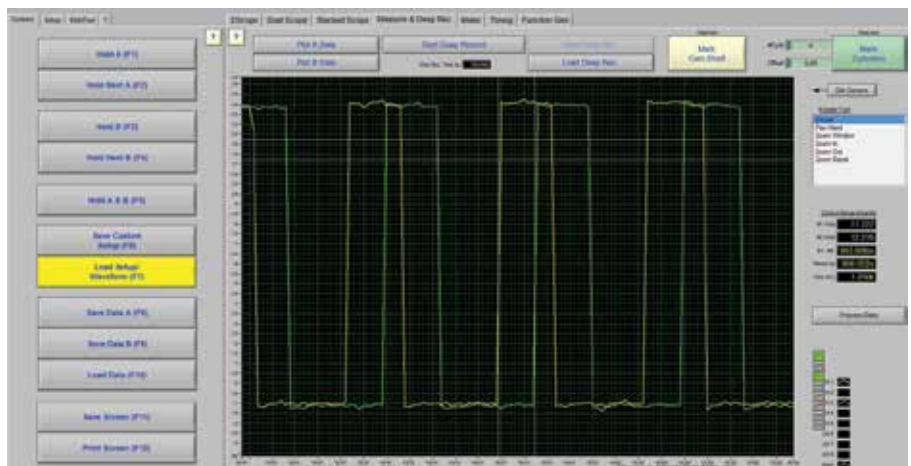
This shows the primary and secondary solenoids in duty-cycled operation. The voltage drop can easily be seen using this method.

The solenoids are pulse width modulated to control duty cycle required to direct sufficient pressurized transmission oil to the sheave pulleys. This is why you can observe that all three

solenoids are being driven and duty cycled at the same rate, at almost exactly the same time. The reaction time from command to movement of the sheaves is a mere 800 microseconds between each (less than one millisecond).

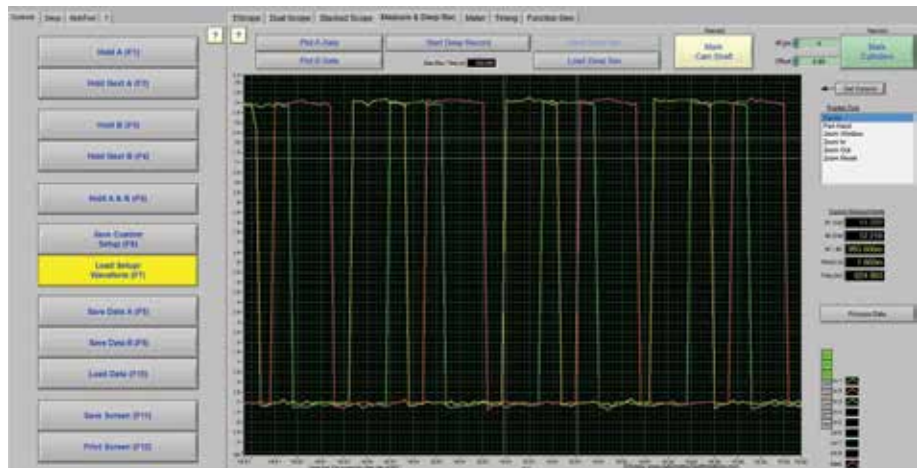
We can see how each solenoid, line pressure primary and secondary pulley control solenoids, are all very tightly controlled during operation of the transmission. In this capture, the duty cycle is about 56 percent.

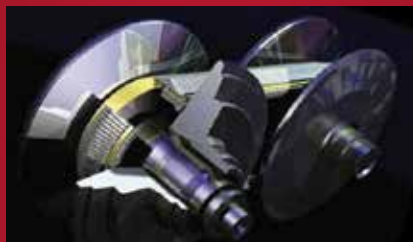
the primary pulley) actually does less physical work. This is because the rigidity of the belt and tapered edges which ride in the pulleys are actually what cause the friction needed to drive the driven pulley (the secondary pulley), which is connected to the final drive, then off to the wheels.

The push belt also has its little plates machined with beveled edges similar to those in a conventional V belt. This is the mechanism that allows the metal push belt to smoothly run up and down the beveled pulleys while they are being clamped and released by oil pressure to change gear ratios.

Most CVTs run what is known as a "Push Belt" or metal band, which is made up of about 400 little steel plate links, stacked together (think in-line, like a tractor tread kind of setup).

But when the push belt comes off of the curved part of the pulley, the little plates "snap back" together, causing an effect similar to that of a solid steel rod. This "rigidity" and the angular bevels on the plates allow the belt to push the driven pulley, rather than a conventional belt, which would essentially "drag or pull" the pulleys around, causing them to turn via friction. Hence the term "push belt."
