VOLVO TECHTIPS

Information for the Independent Volvo Specialist

**VOLVO INTAKE AIR LEAKS
VOLVO ALL WHEEL DRIVE VEHICLES
VOLVO XC90 V-8 ALTERNATOR REPLACEMENT**

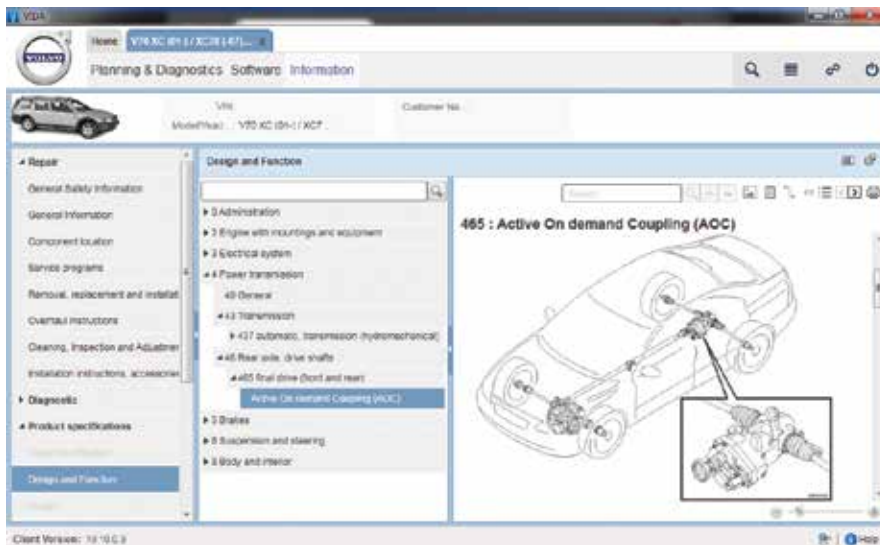
Layout on all wheel drive with Active on Demand (AOD)

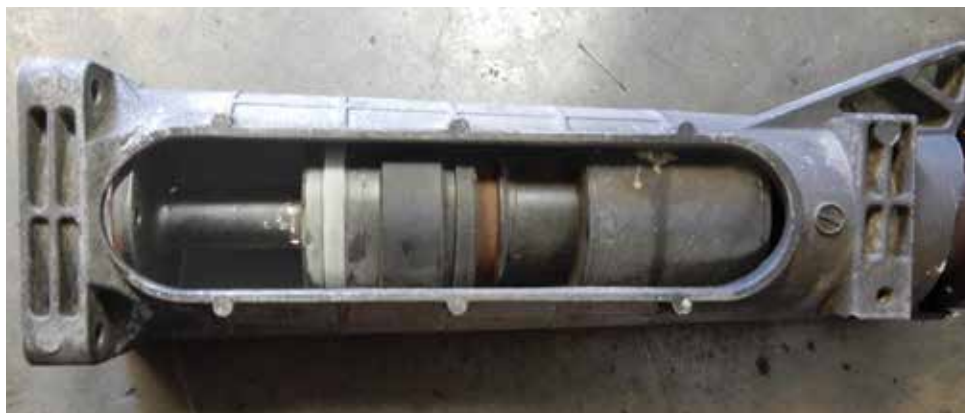
Viscous coupling

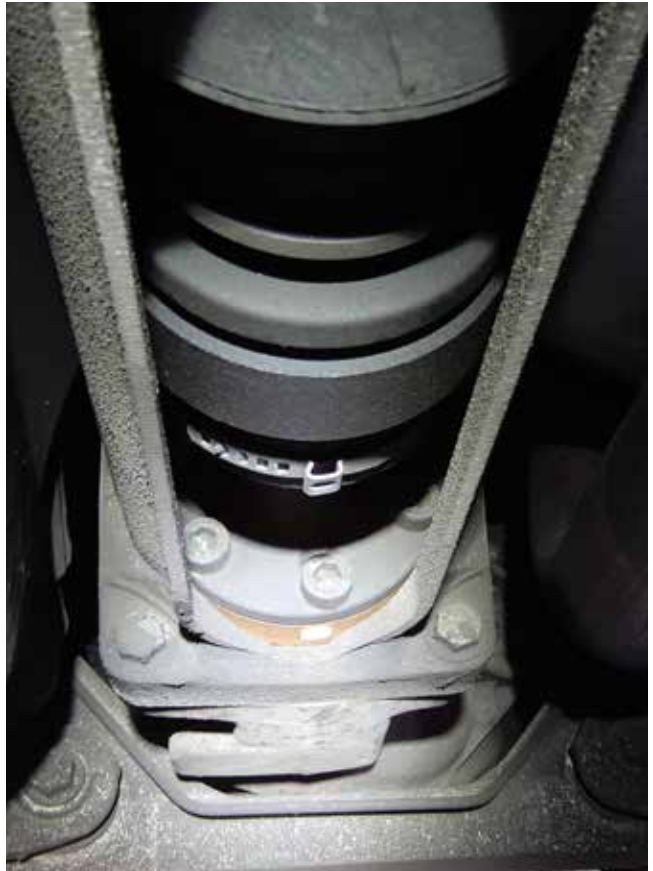
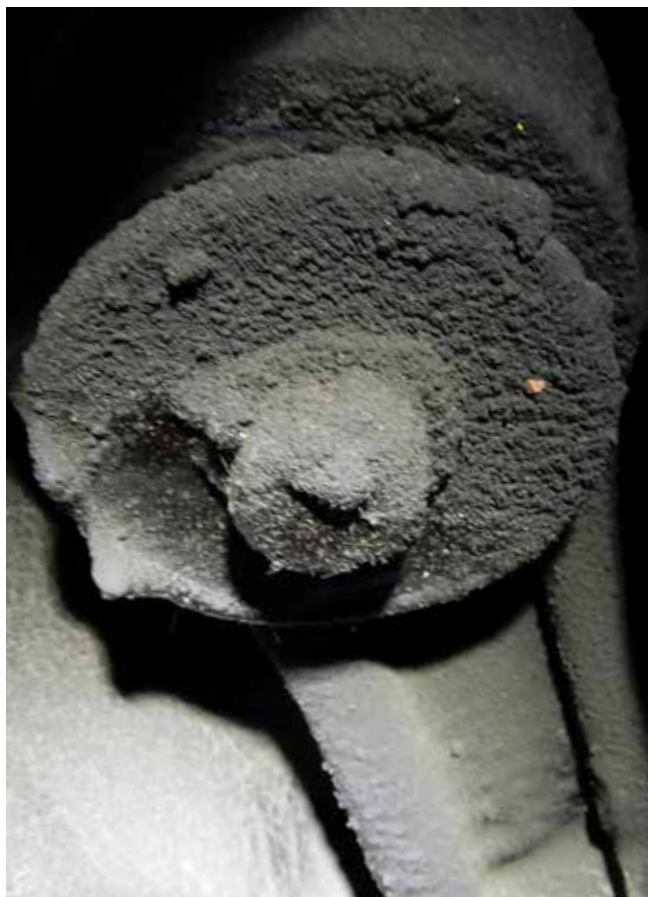
Mounting bolts at differential for viscous coupling

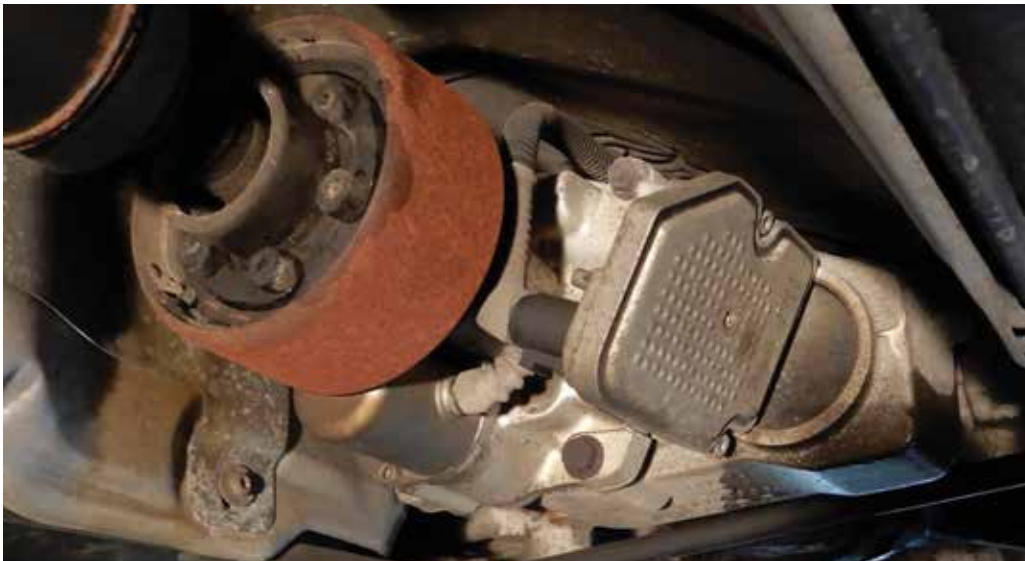
Rear differential 2003 Volvo XC70

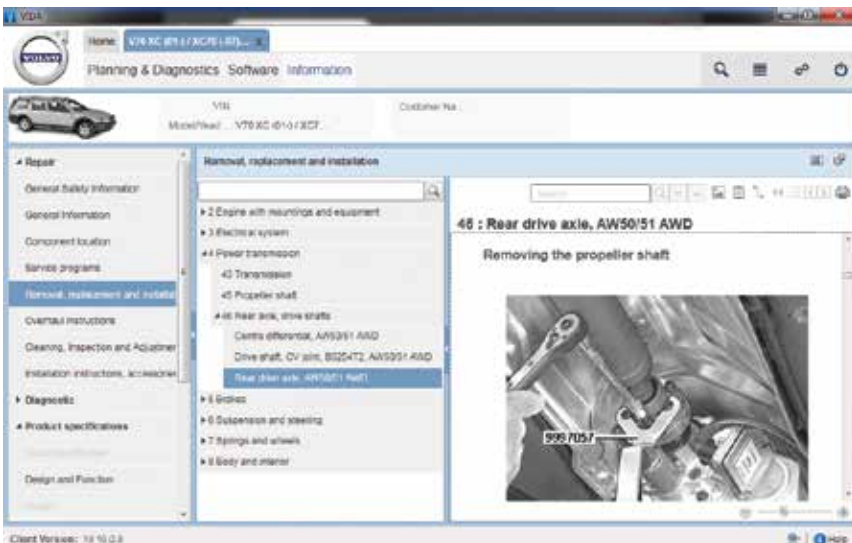
Holding driveshaft with Volvo tool and removing bolts

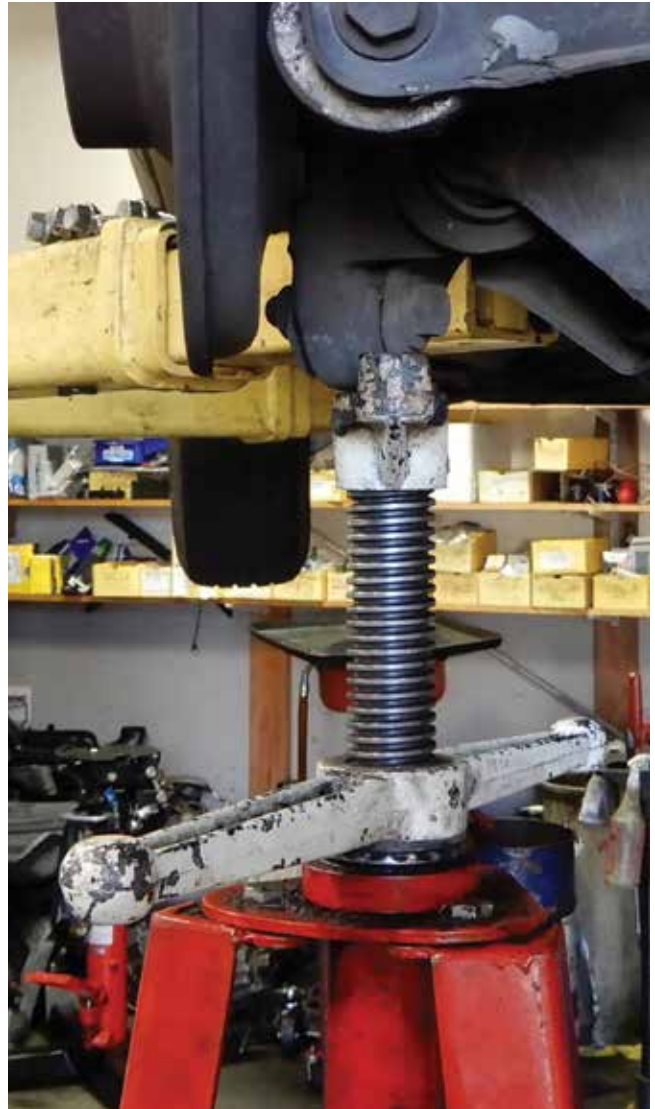
Jack under wheel hub assembly to install lower control arm.

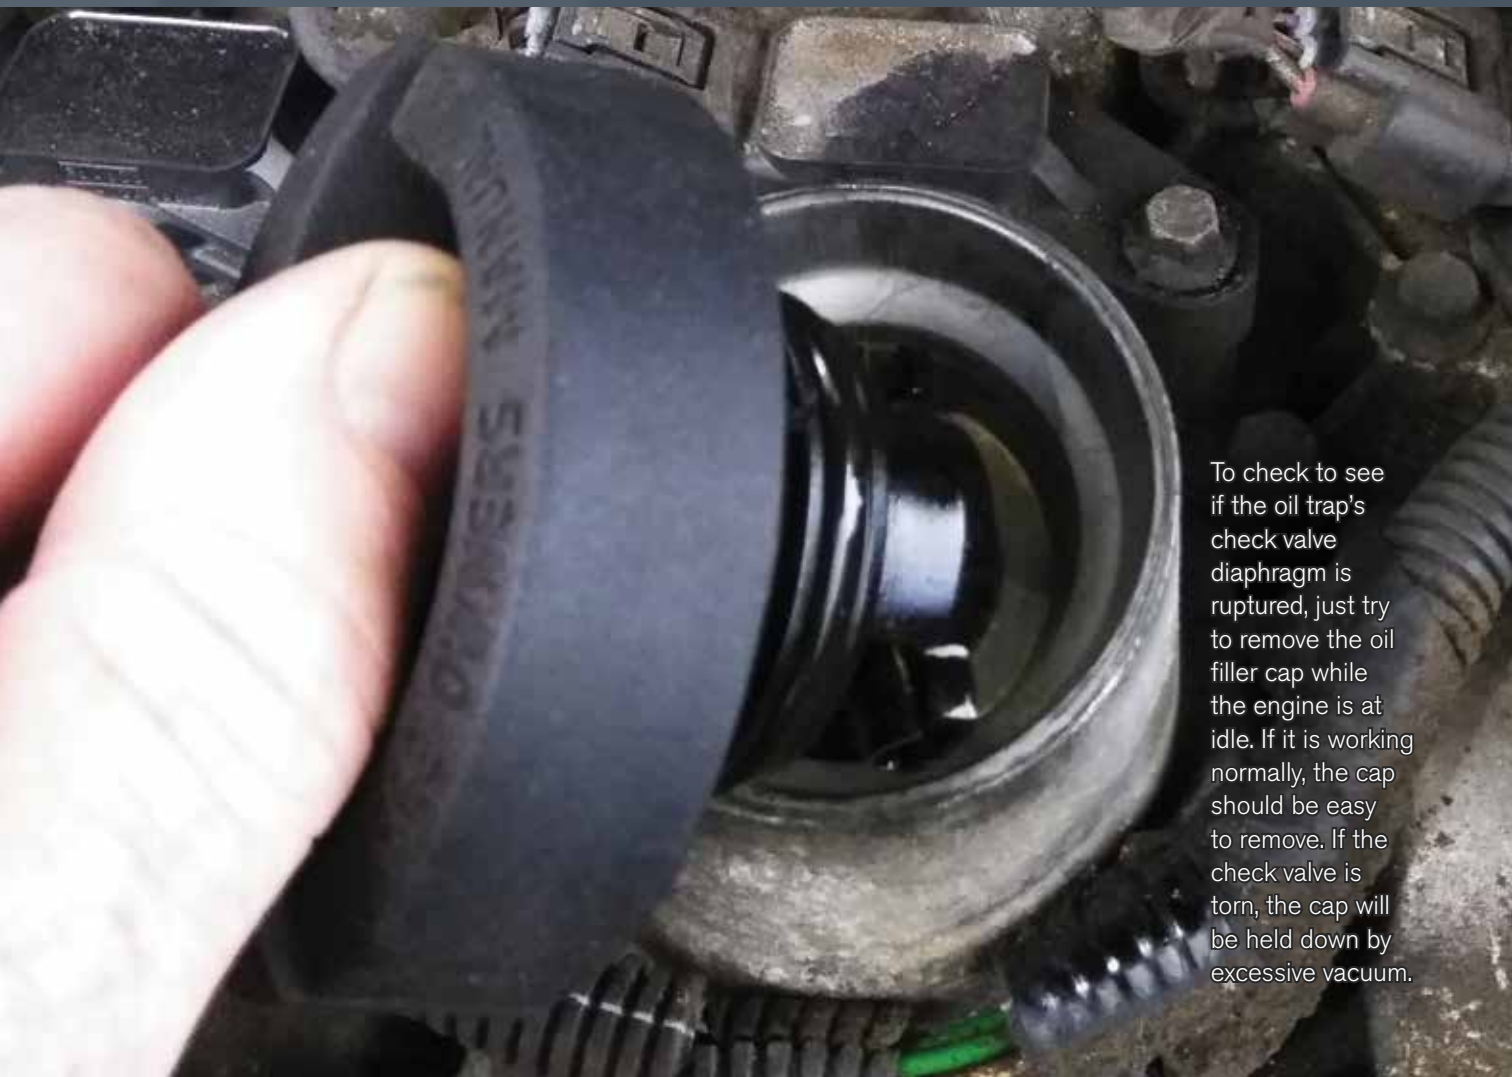
To check to see if the oil trap's check valve diaphragm is ruptured, just try to remove the oil filler cap while the engine is at idle. If it is working normally, the cap should be easy to remove. If the check valve is torn, the cap will be held down by excessive vacuum.

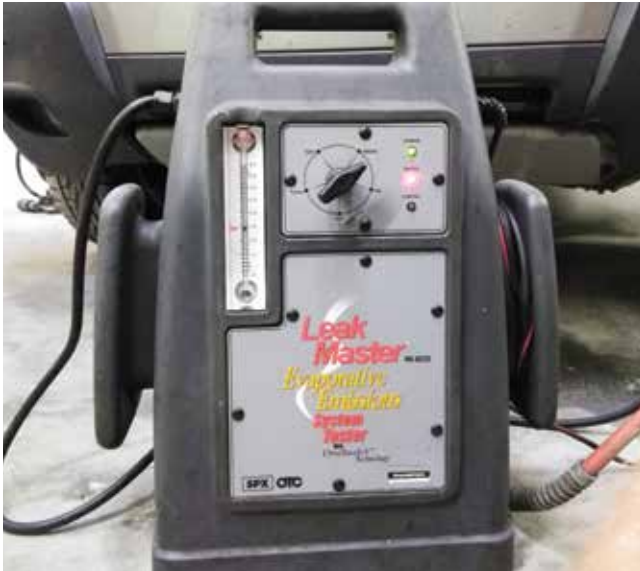
The most popular way to find vacuum leaks these days is to use a smoke machine. The best ones out there are set up with a pressure regulator to ensure that you do not cause any damage by applying too much pressure to a sealed system when testing.

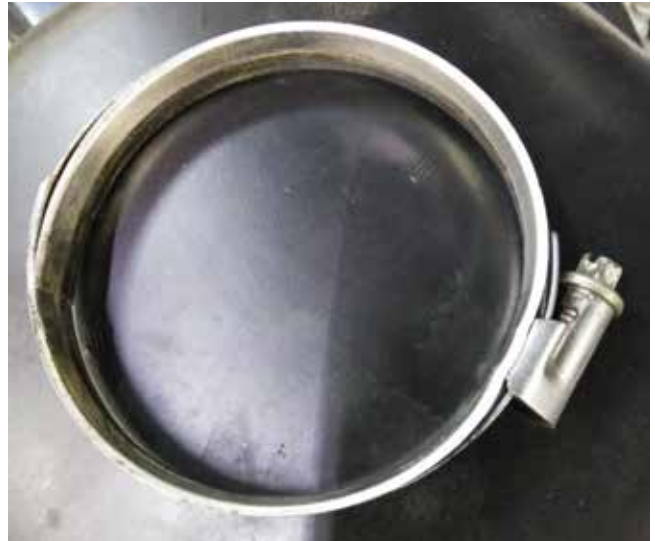
Have you ever heard that it is bad to reuse radiator hose clamps? Well, the same holds true with those large intake hose clamps, especially the ones that are exposed to high heat on a regular basis. The constant heating and cooling of the metal in the clamp can cause distortion over time and an old clamp may feel tight when it's really not.

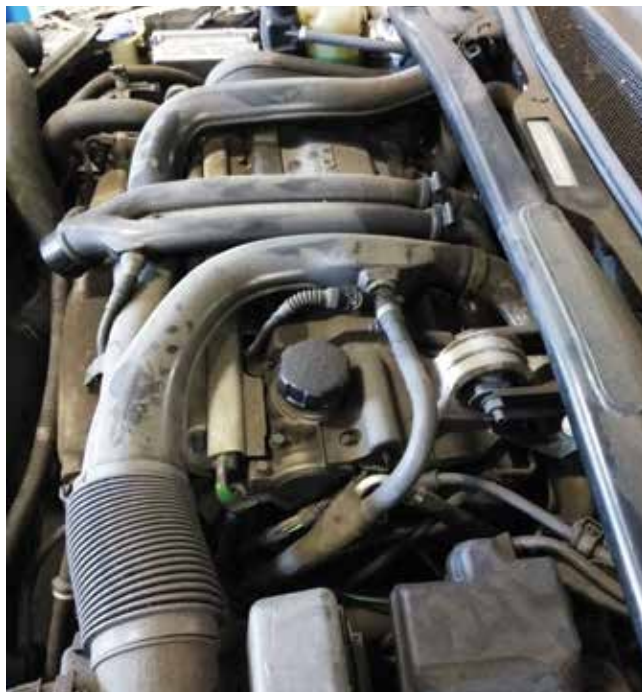
If you get one of these early T-6 twin turbo Volvos in your shop, make sure you check for air leaks after any service or repairs that involve removing the intake plumbing that runs across the top of the engine. They are prone to leak after the pipes are reassembled.

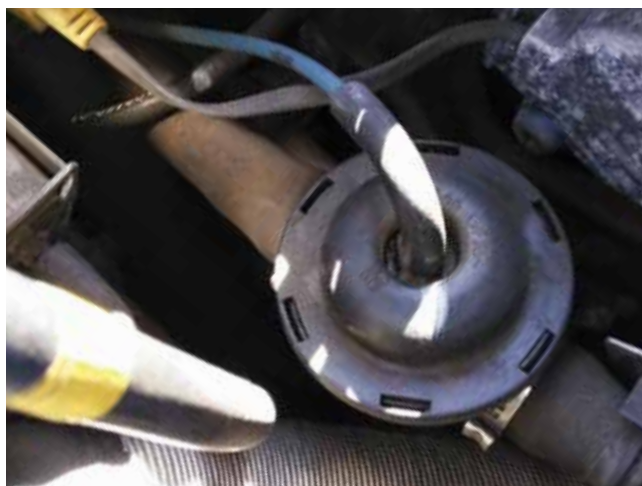
Pre-1998 Volvos are less affected by smaller vacuum leaks, but any unmeasured air leaks can affect the overall performance of these vintage cars. Make sure to inspect the small vacuum elbows since these will tend to deteriorate over time.

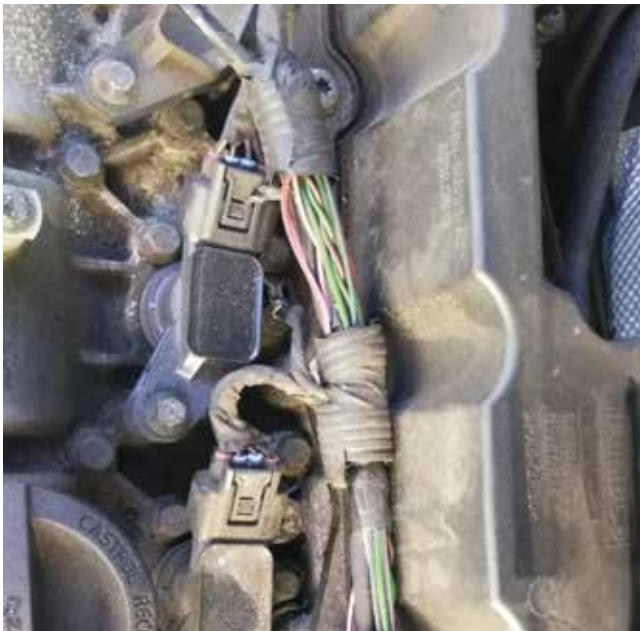
Some intake vacuum leaks can come from internal sources like a damaged or leaking oil trap diaphragm. A whining noise, and in some cases, a Check Engine light can be symptoms of a larger leak in this diaphragm.

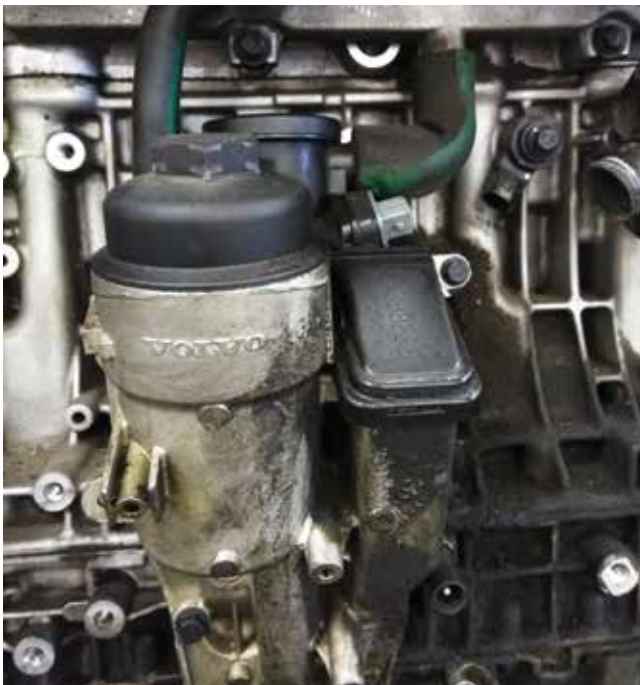
This assembly comes from Volvo in one piece that includes the oil filter cup, oil filter, oil trap, oil trap diaphragm, and PTC heater.

If you have a failed oil trap check valve, you can check it by carefully removing the oil filler cap while the engine is at idle. If the oil trap needs to be replaced, you will have a hard time removing the cap because, if the check valve is ruptured, the crankcase will be generating a lot of vacuum, holding the oil cap in place. ●

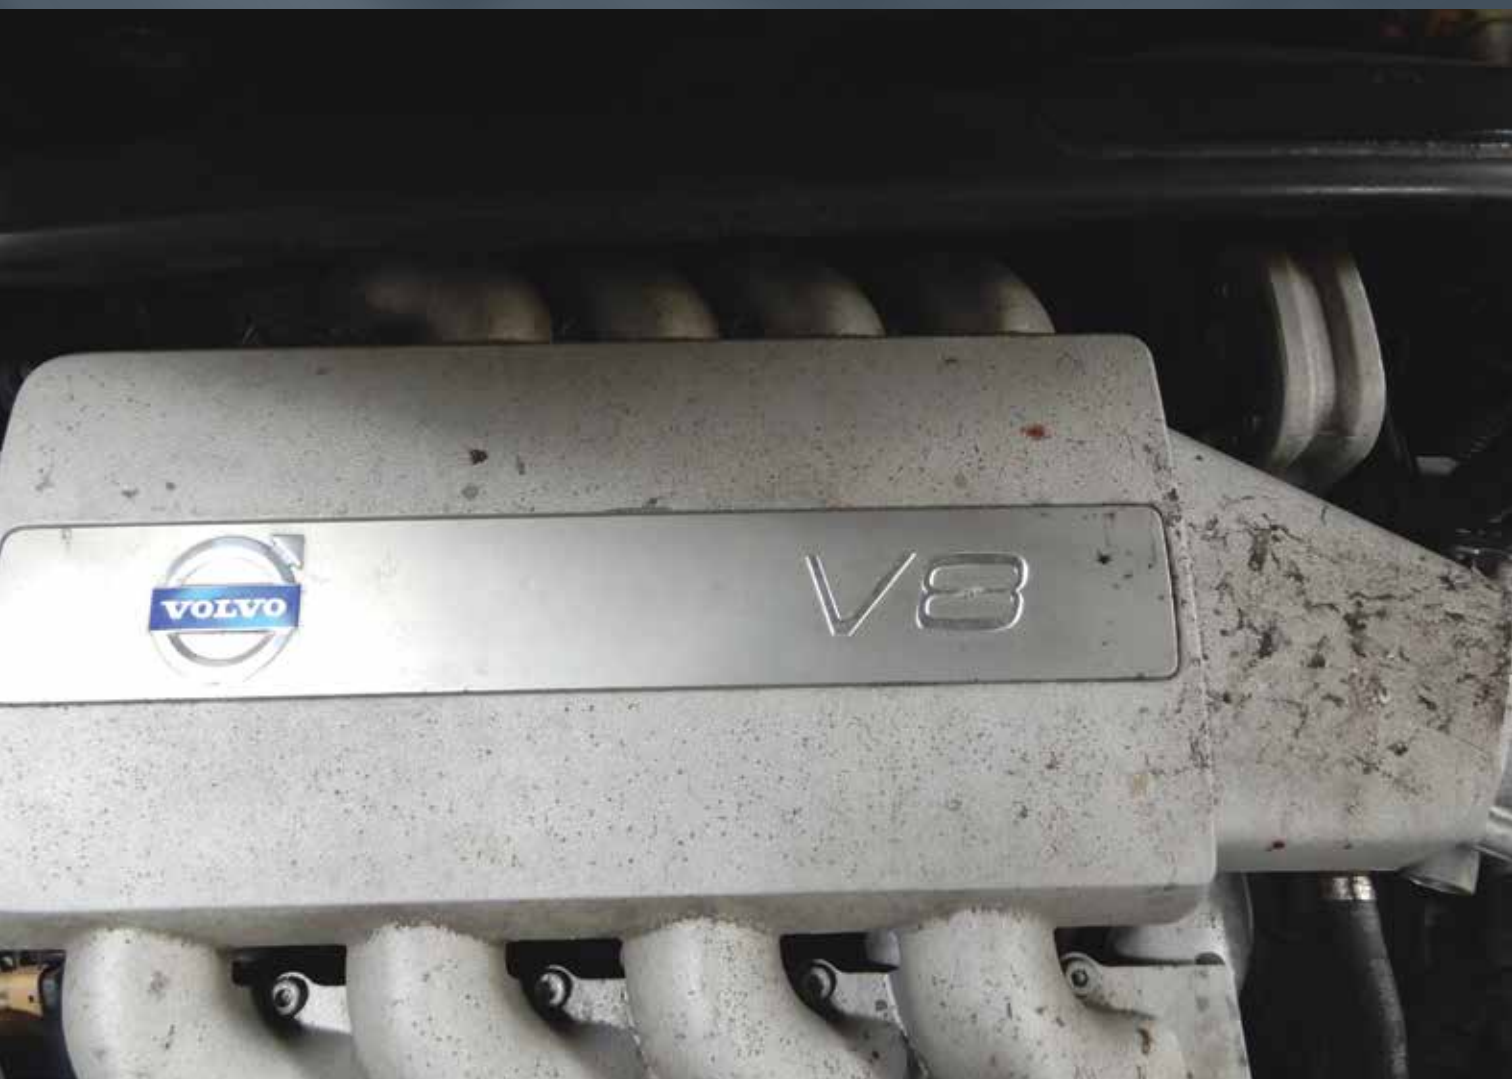
It's important to note that 2003-2004 V-8 models use a self-regulating alternator in which the current and voltage regulation systems are built into the alternator unit. Starting in 2005, the regulation is controlled by the ECU. The regulators are still inside of the alternator, but the current and voltage output are now controlled by the ECU instead of internally in the alternator.

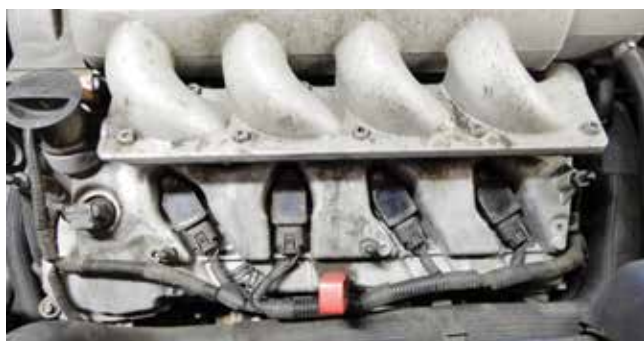
Top side of V-8 Volvo engine

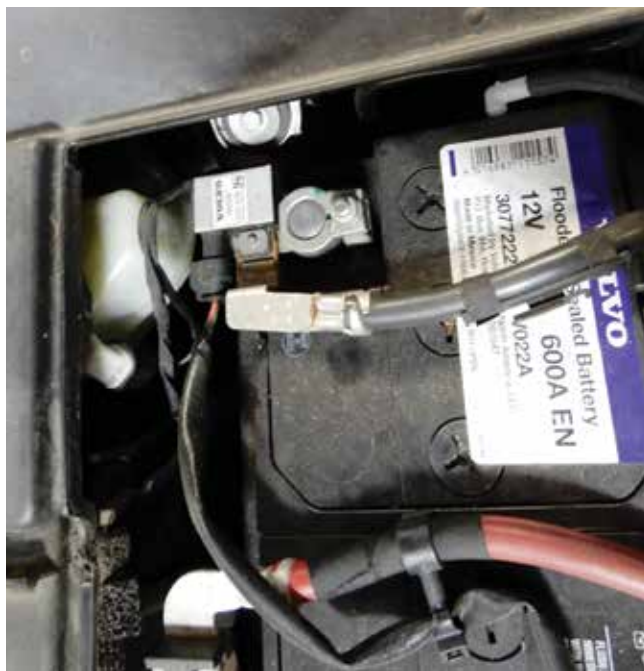
BMS sensor at negative battery cable

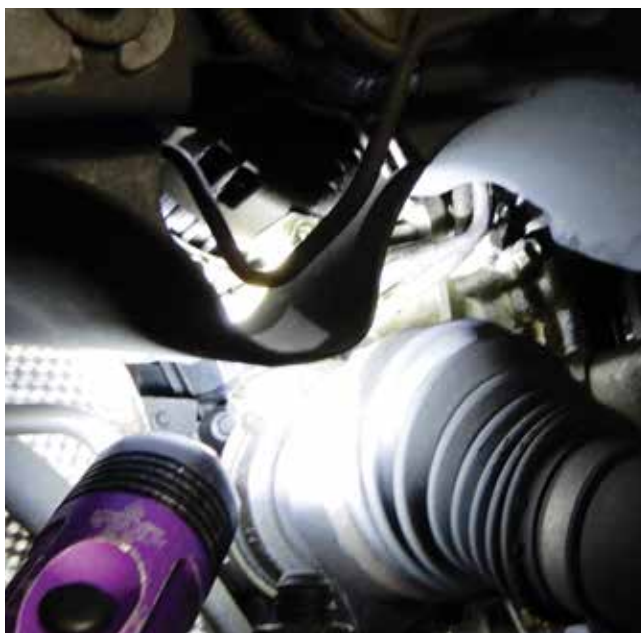
Plastic panel in wheel area

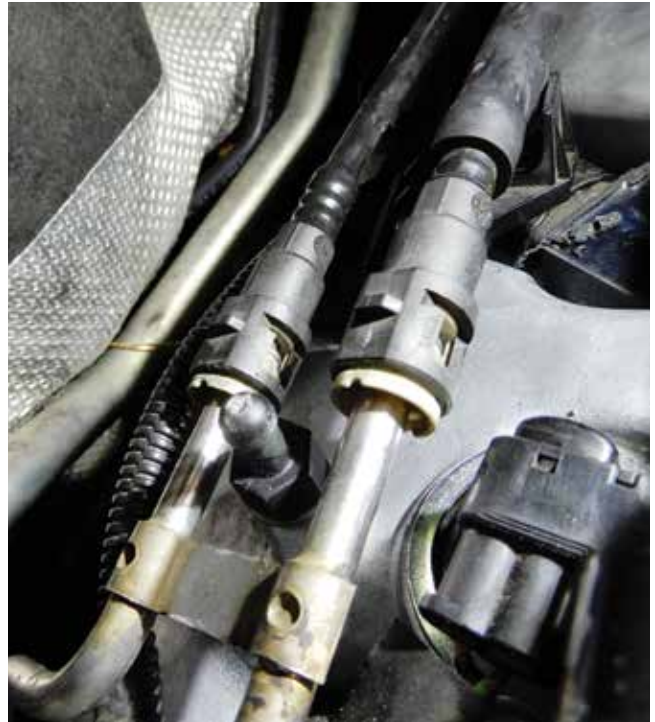
Fuel lines quick disconnect at top of valve cover

This is the most difficult part of the job. See the alternator hidden up there? Disconnect the fuel lines at the valve cover firewall side. The lines use quick connectors. Be sure to clean up any kind of fuel spill.

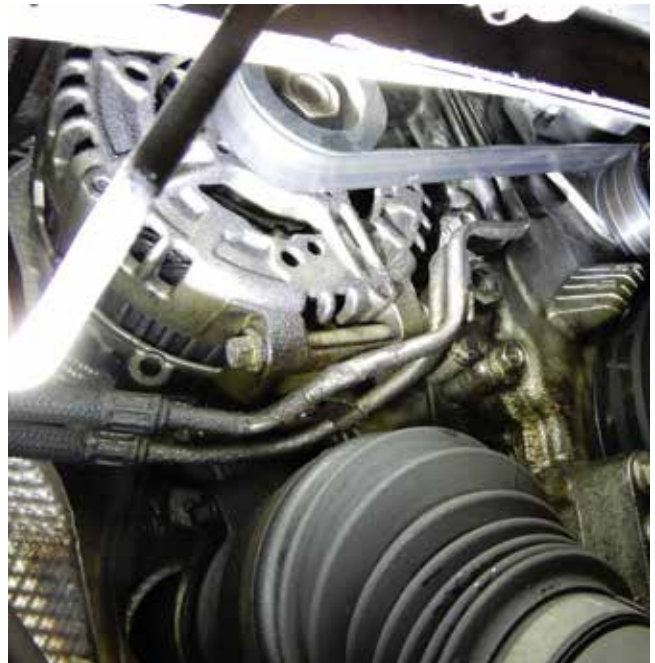
Alternator mounted on engine near firewall

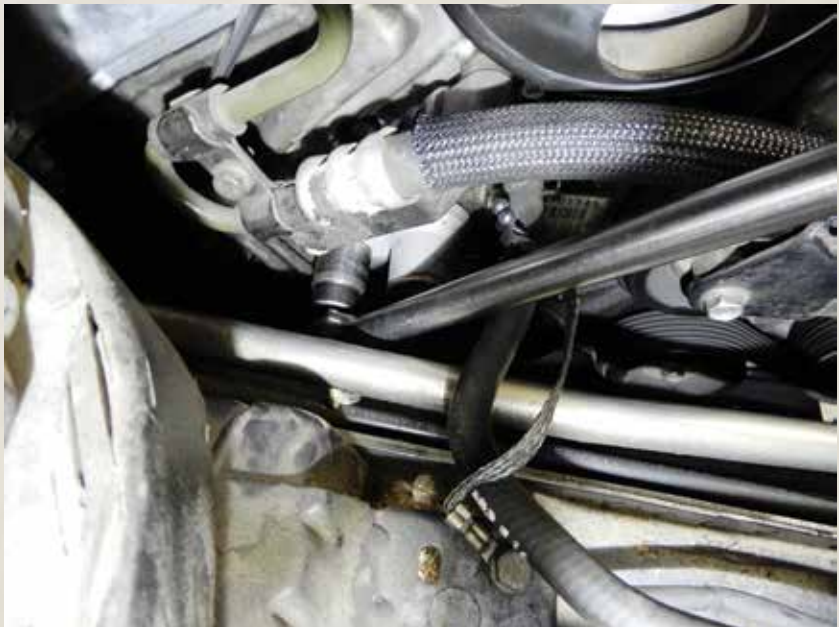
Tool installed to remove pressure on belt tensioner

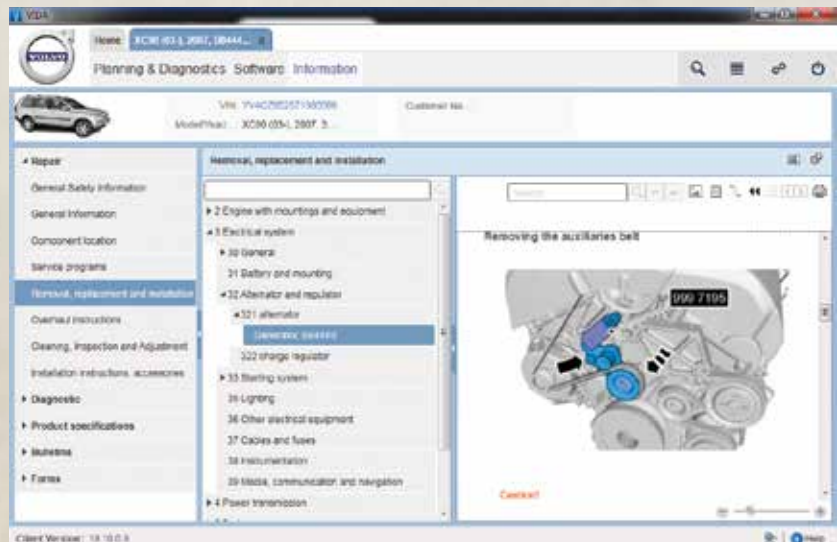
Auxiliary belt tensioner tool installed and belt path

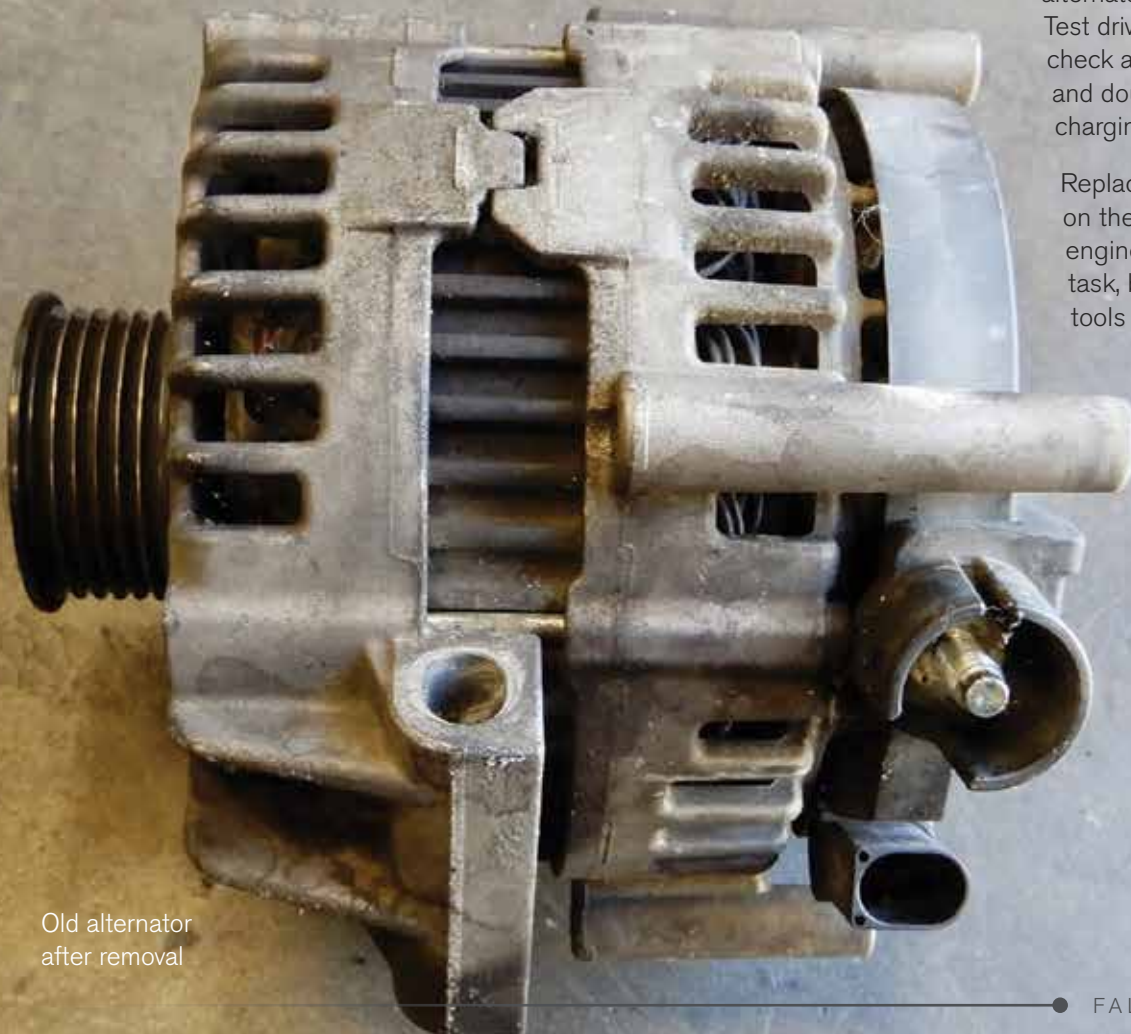
Old alternator after removal

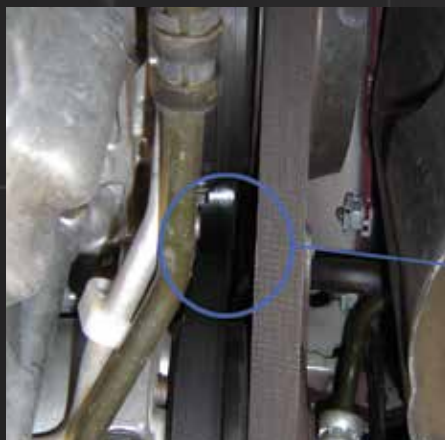
Inspect that the inner auxiliary belt is in center of the tensioner pulley. Illustration shows an incorrectly tracking belt.

- Place vehicle on a lift
- Remove protection plate under the engine
- With the engine running, check the alignment of the inner auxiliary belt to the idler pulley. This is best viewed with a flashlight while standing just behind the RF wheel (see illustration)
- The belt should be centered on the pulley

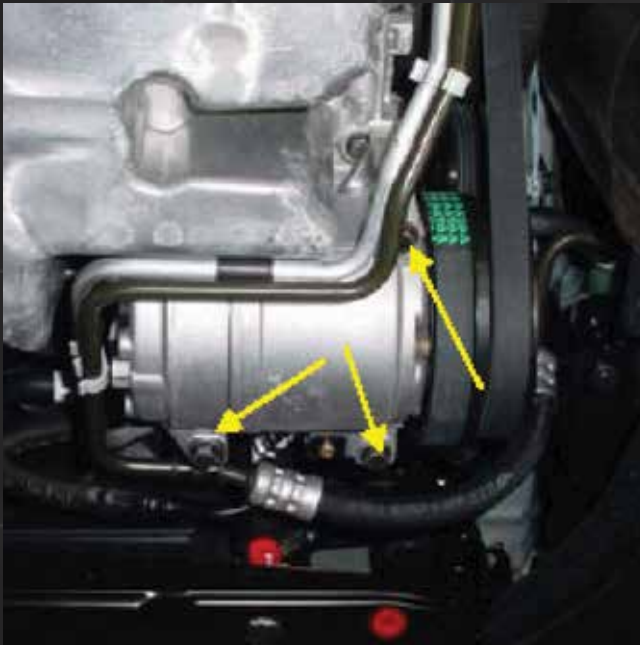
Loosen the 3 bolts on the A/C compressor, 12 mm socket.

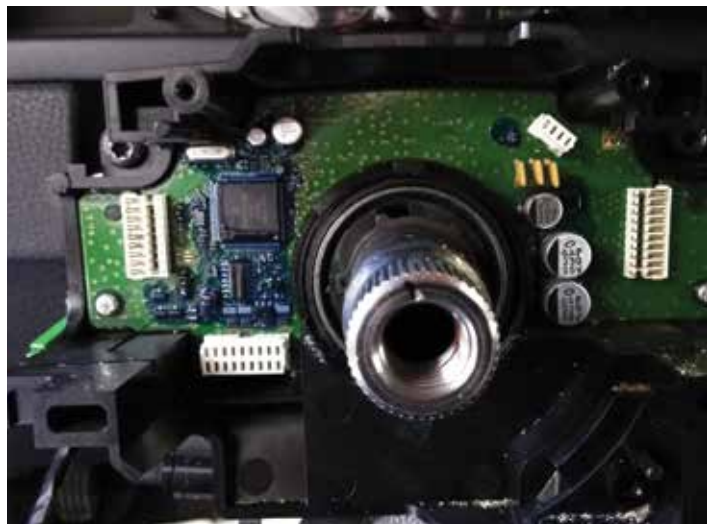
The steering wheel angle sensor module (SAS) is powered via the steering wheel module (SWM).

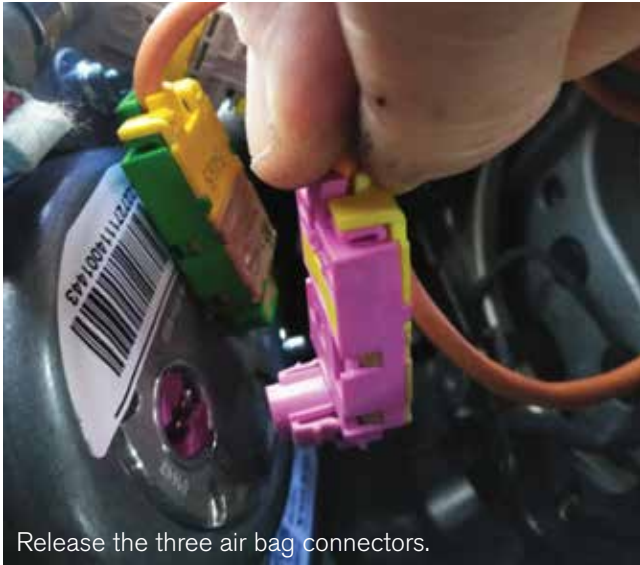
Release the three air bag connectors.

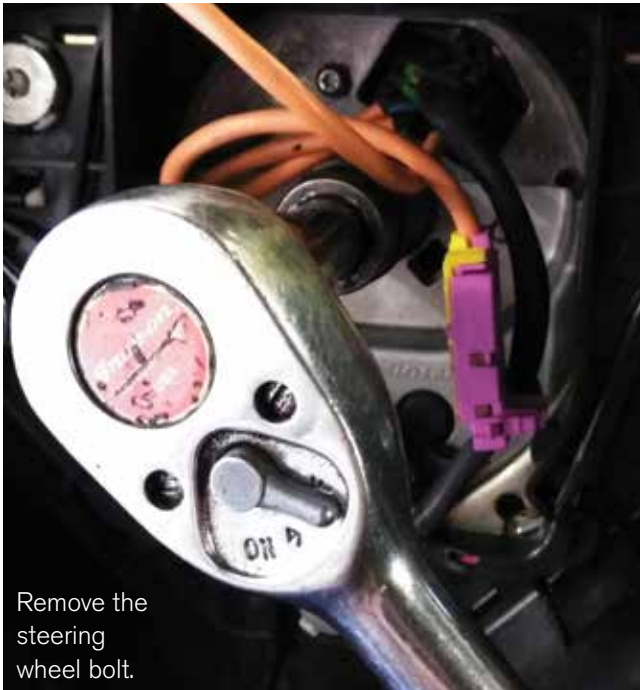
Remove the steering wheel bolt.

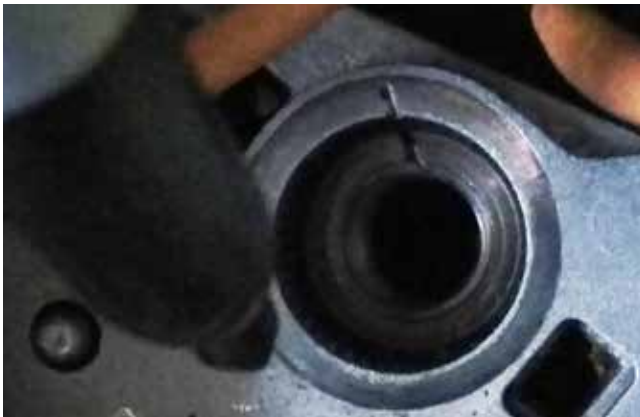
Mark the position of the spline shaft and the wheel center so you can put the wheel back on in the exact same position.

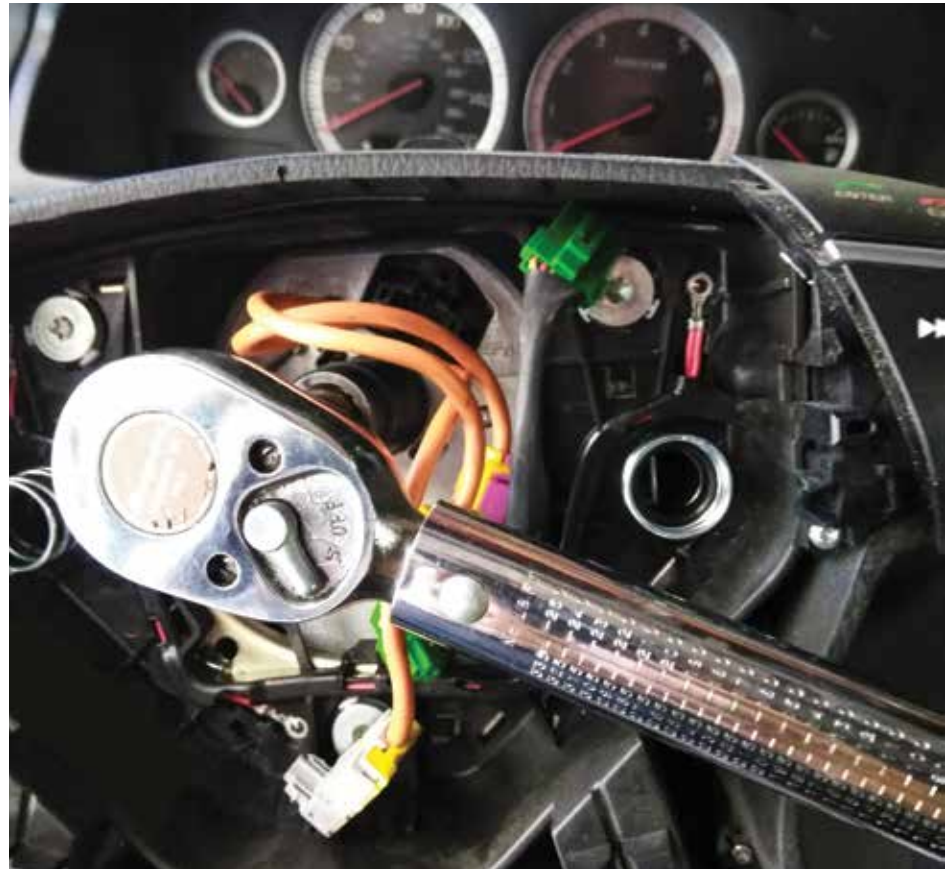
Torque the steering wheel center bolt in two stages: first stage 30 Nm and second stage 30 degree angle torque.

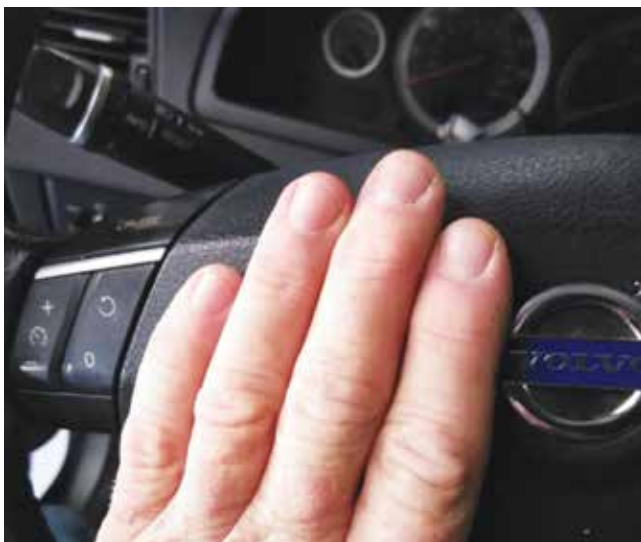
Remove the new SAS sensor's holding screw and install the air bag connectors and press on the air bag.
