Spring 2017

v2 | n1

VOLVO TECHTIPS

Information for the Independent Volvo Specialist

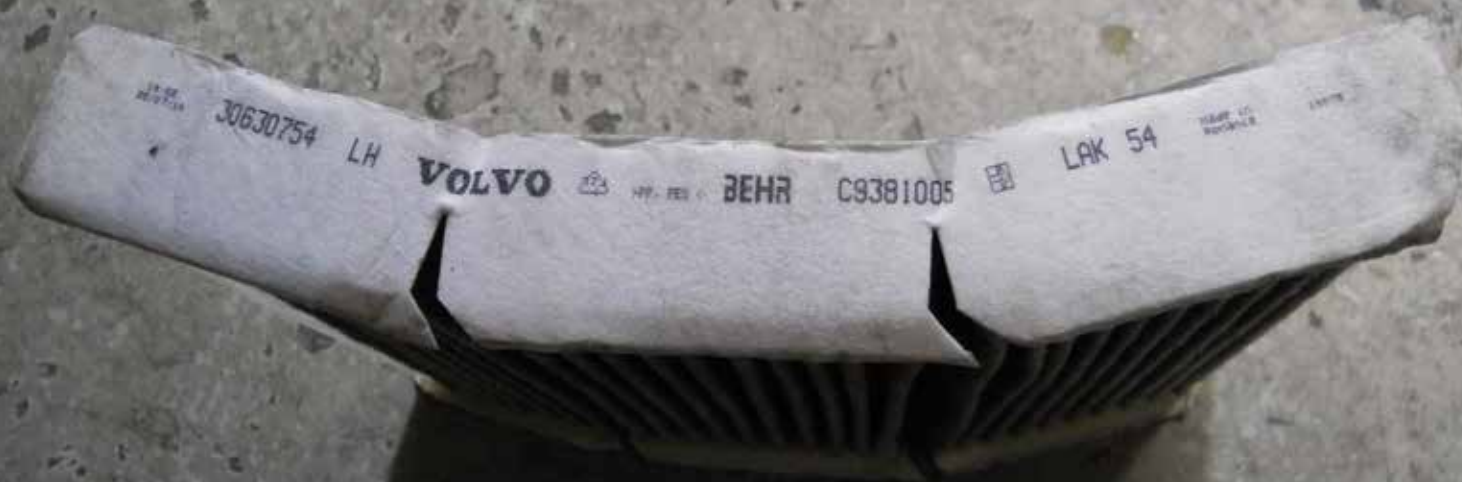
WHEN REPLACING THE CABIN FILTER
ON A VOLVO, USING AN OE VOLVO FILTER
WILL NOT ONLY MAKE INSTALLATION
MUCH EASIER BUT WILL MAKE YOUR
CUSTOMER'S HVAC SYSTEM PERFORM
THE WAY IT WAS DESIGNED TO.

Volvo HVAC systems work best when you install an OE Volvo replacement cabin filter. These high quality filters not only fit better, but they are designed specifically for Volvo climate control systems.

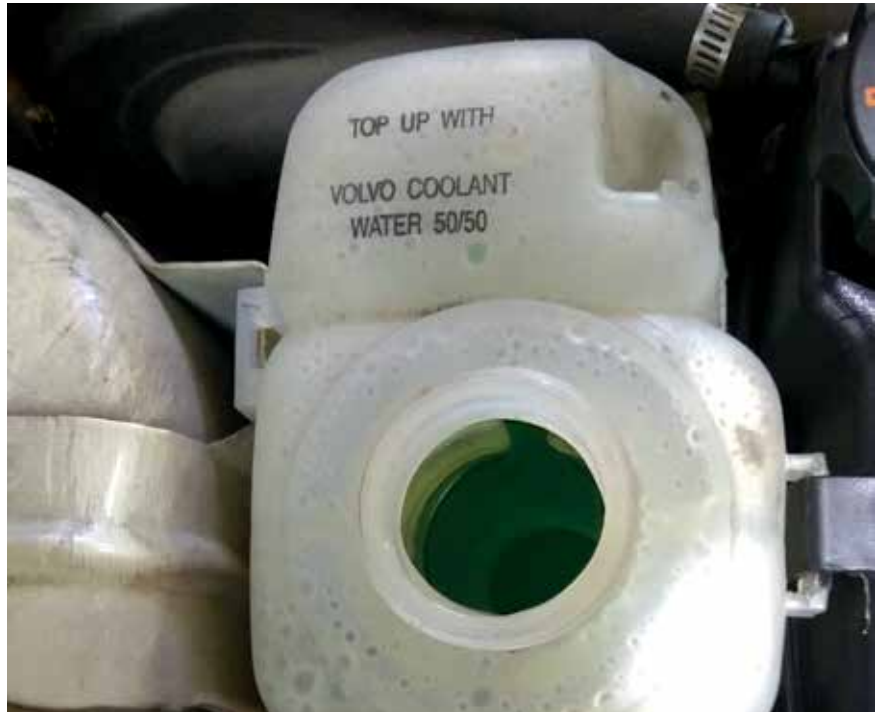
It's a good idea to check your customer's coolant during your regular service inspection. The easiest way to determine the coolant's condition is with disposable test strips. These strips not only check freeze level but also check pH level. If the coolant pH is 9.0 or less it is time to change the coolant.

The easiest way to check the condition of your customer's coolant is to use disposable coolant test strips. These can reliably test engine coolant for glycol level (freeze protection level) and pH level.

Volvo does not specify a recommended coolant pH level, but a pH level between 9.8 and 10.5 is about where you want it to be.

A good rule of thumb is, if your customer's coolant pH is below 9.0 you should recommend a coolant system flush and change.

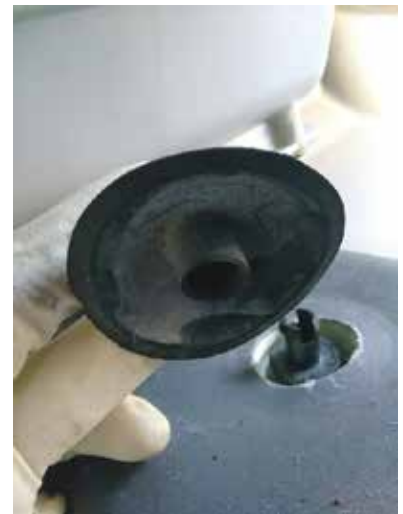
If organic debris is allowed to build up and clog the evaporator drain tube, the condensation and moisture will not only leak into the car but can start to grow mold and bacteria that can be difficult to completely remove.

EVAPORATOR DRAINS

and accumulate in the evaporator drain tube. It is important to make sure this drain is clear, especially in areas where there is high humidity or if your customers use the A/C

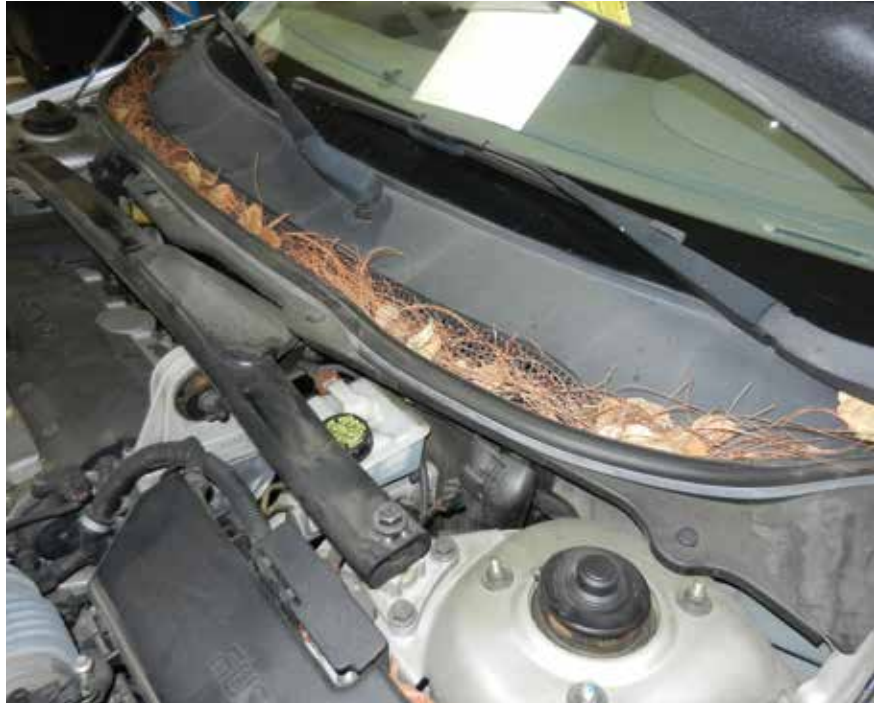
You should make vacuuming the leaves and debris that collect under the hood part of your regular service. This will help prevent organic material from breaking down and clogging the evaporator drain.

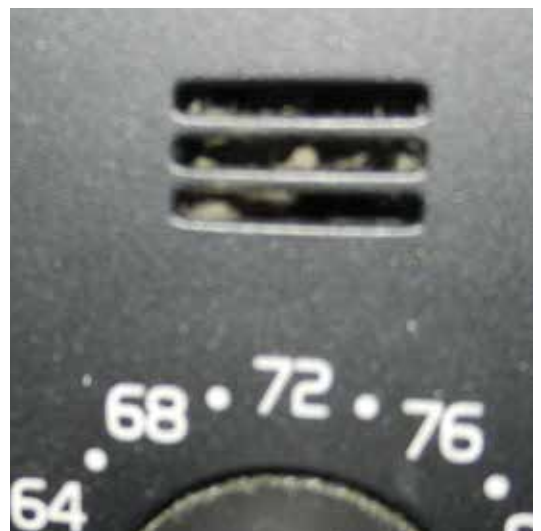
Later Volvo climate control systems use an interior temperature sensor mounted in the dash. These sensors rarely fail but because they use a miniature fan to constantly sample the cabin air temp., they also pull in dust and debris that can cause the sensor readings to become fuzzy (no pun intended). It's always good to clean these sensors with low pressure air when the car is in for service or HVAC repairs.

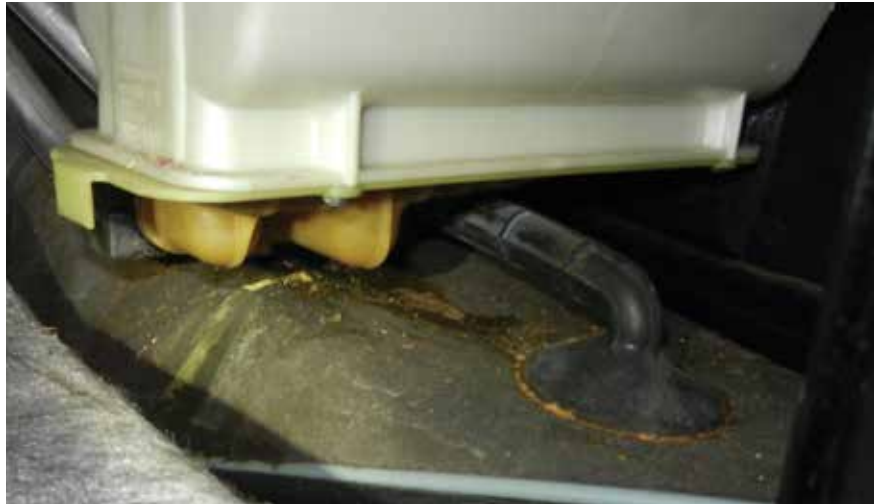
The most common heater core leaks seen at independent shops are those from the 1993-2000 Volvo 850/70 series cars.

If you work on a lot of older Volvos, you will have to make checking the heater core for seepage or leaks part of your regular inspection procedure, especially on cars that have coolant loss problems. The most common heater core leaks are seen on 1993-2000 850/S-V 70 Volvos.

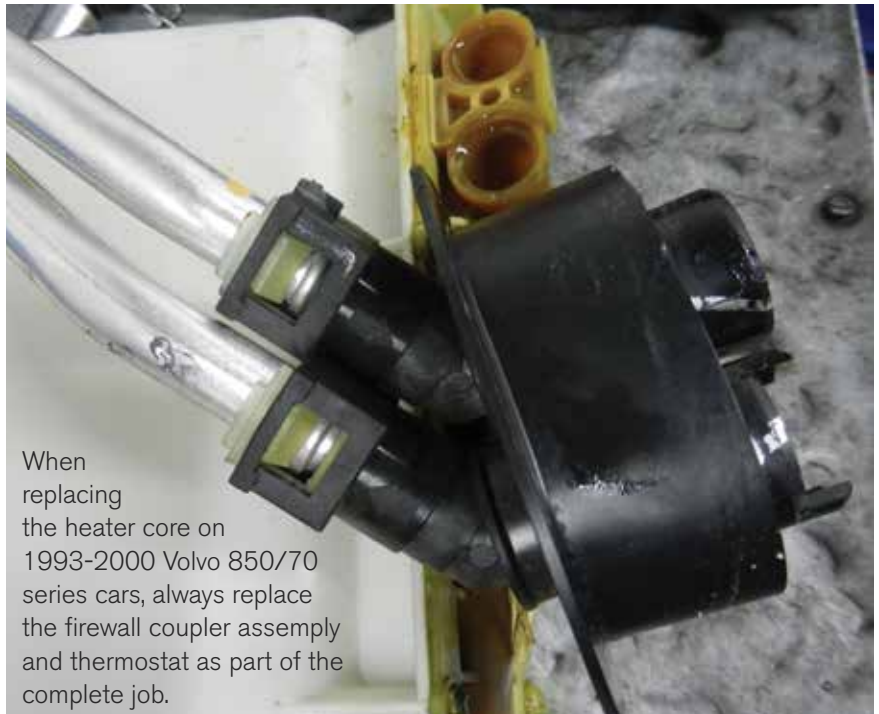
When replacing the heater core on 1993-2000 Volvo 850/70 series cars, always replace the firewall coupler assembly and thermostat as part of the complete job.

Many shops have replaced heater cores on these early Volvos only to have the car come back with hot coolant gushing into the interior. The couplers get brittle over time and when the core is replaced, the pipes connected to the coupler get moved around. So do yourself and the customer a big favor and include this in every core replacement on these early Volvos. ●

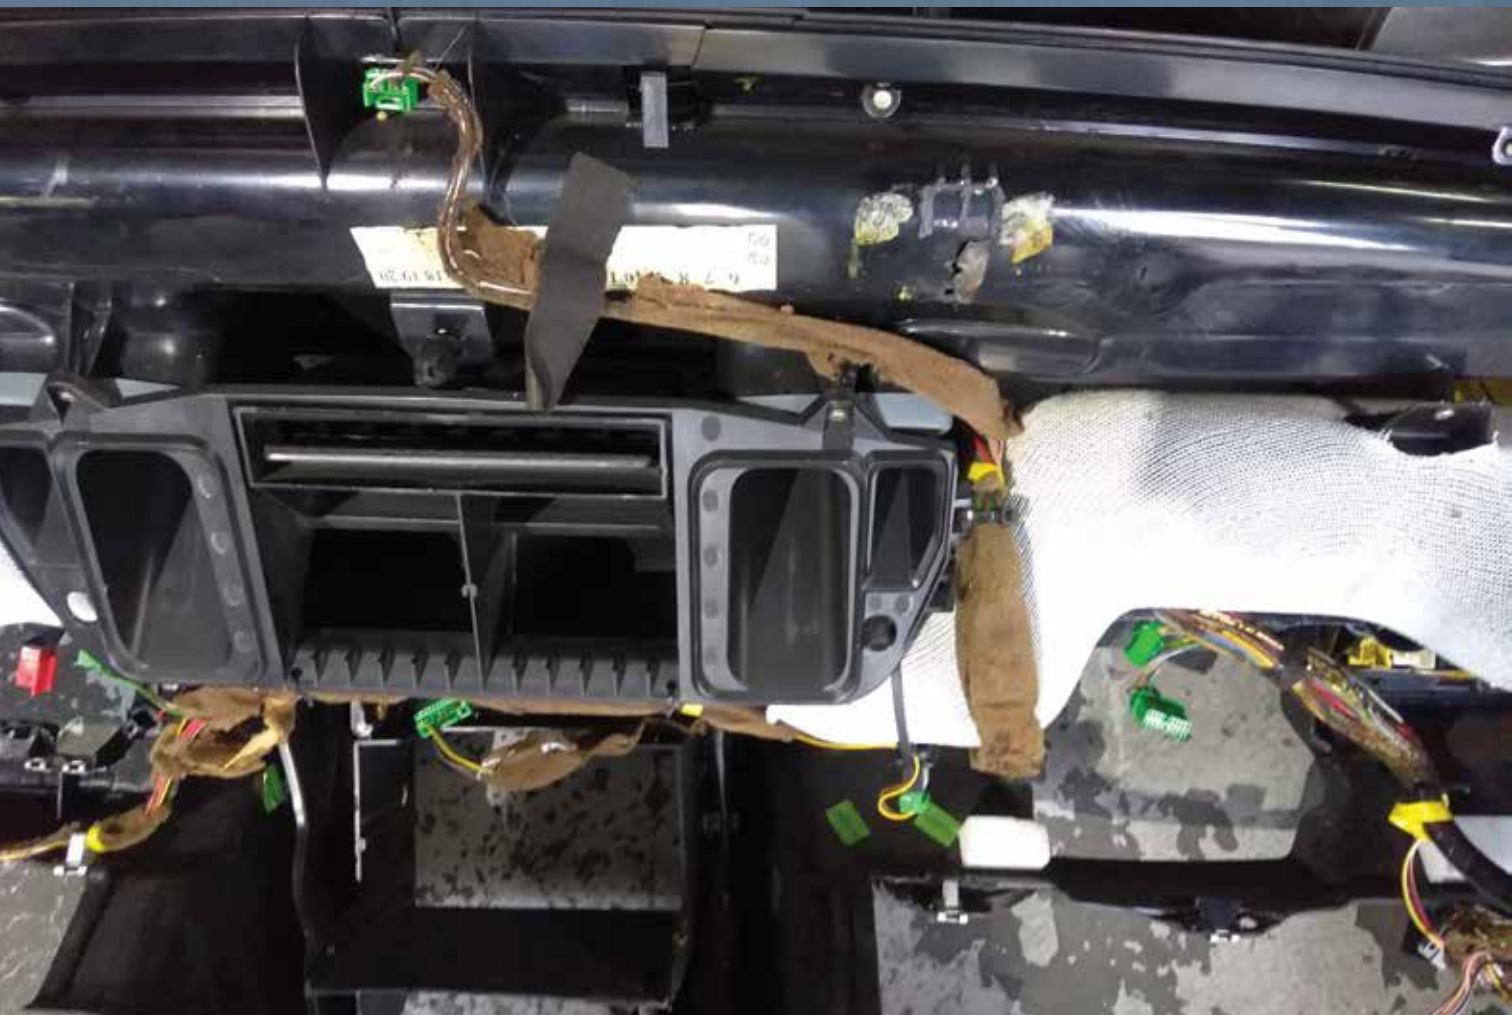
Opposite page: If you have an 850 that makes a loud crack or pop noise from the front of the dash board when the car hits a large bump, you may have a broken dash assembly mount on your hands.

LOUD "POP" OR "CRACK" NOISE OVER LARGE BUMPS OR POT HOLES (1993-1997 850 SERIES CARS)

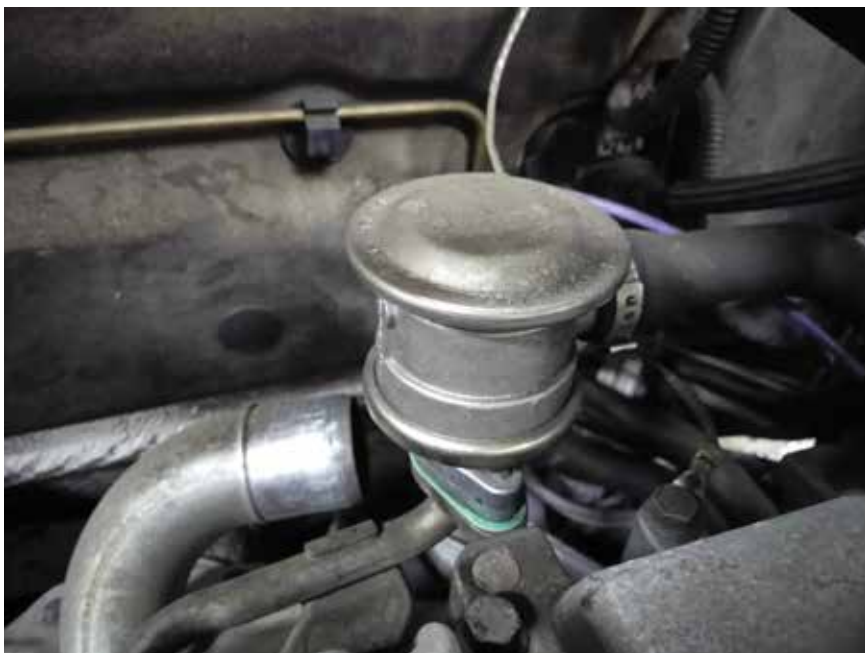
The rust residue inside the air cleaner housing is a sure sign that the SAS valve is leaking.

When the SAS check valve fails it usually damages the air pump by allowing exhaust gases and moisture to be sucked directly into it.

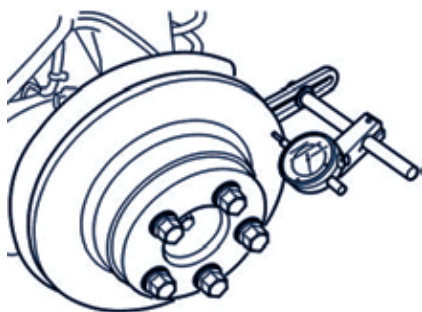
When you measure runout with a dial indicator on a Volvo, you should make sure the rotor sits flush against the hub. You can do this with washers and lug bolts or Volvo has a nice kit for this (Part #999-5418-2).

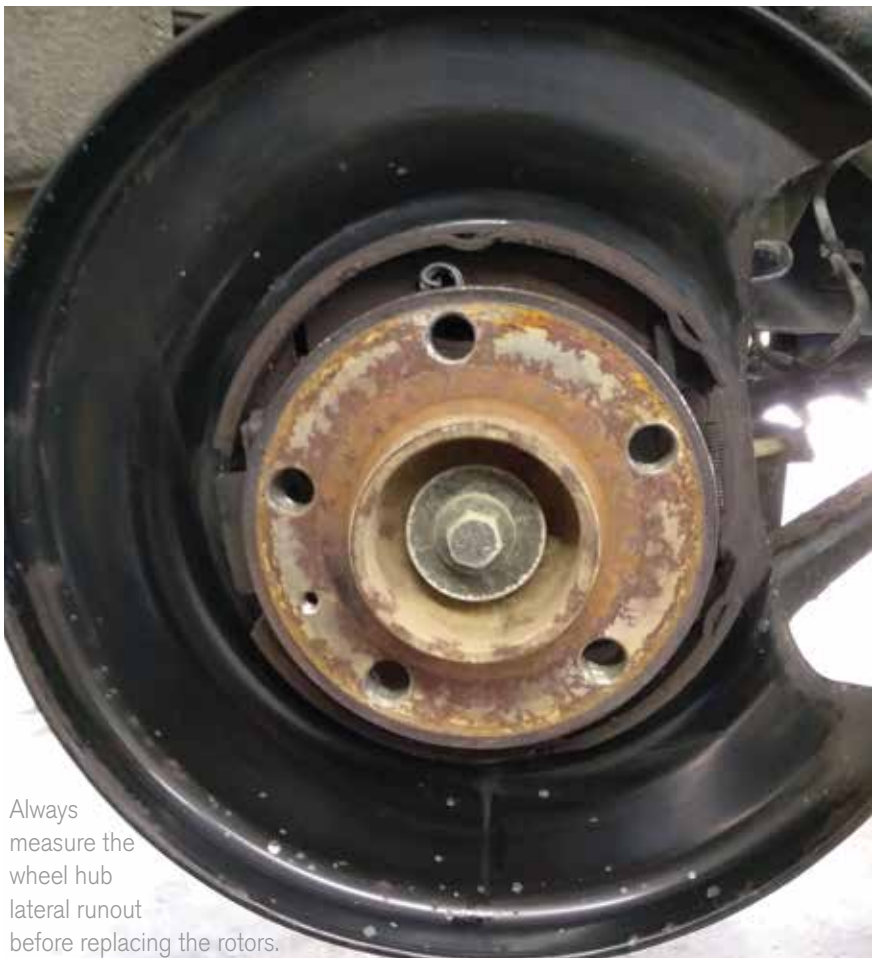
Always measure the wheel hub lateral runout before replacing the rotors.

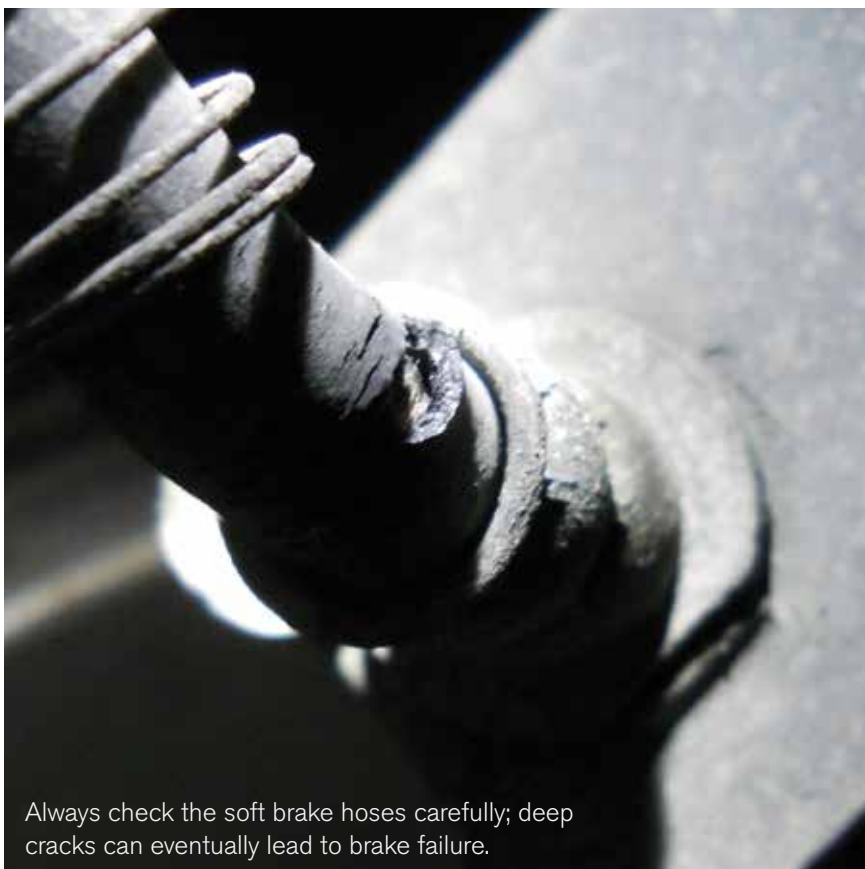
Always check the soft brake hoses carefully; deep cracks can eventually lead to brake failure.

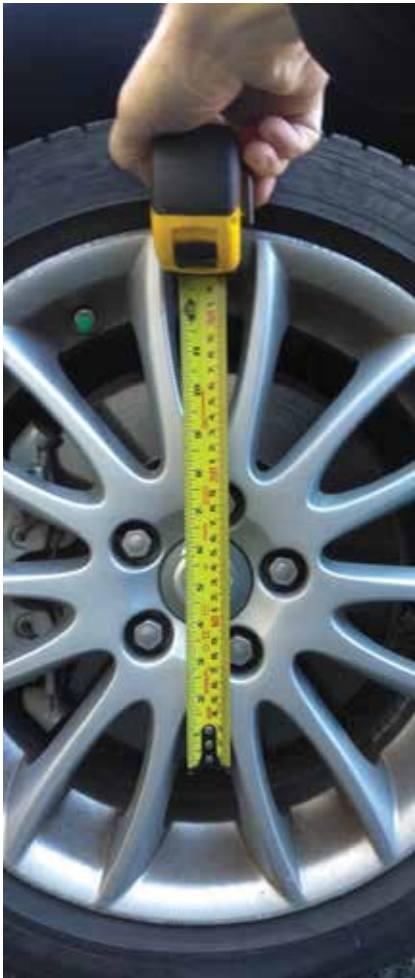
Volvos have a tendency to wear down the rotors along with the pads, so if the rotor is close to the minimum thickness, it's better to just replace the rotors rather than turn them.

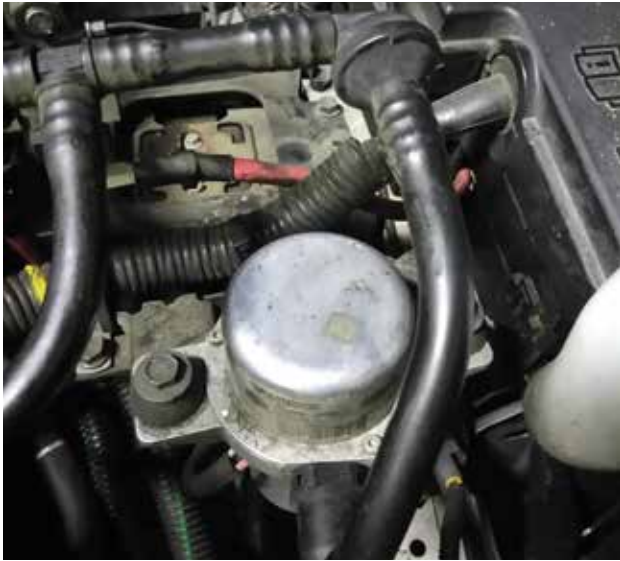
If you have a Volvo come in with symptoms that feel like a bad brake booster, make sure you check to see if the car is equipped with an auxiliary vacuum pump. When these pumps fail their symptoms can feel like a bad booster.

When the vacuum pumps malfunction, the symptom is felt more after a cold start. Also if the vacuum pump has failed on a P1 Volvo, there is an updated overload relay and wire harness that needs to be installed with the new pump (this is covered in Volvo TJ 20293).

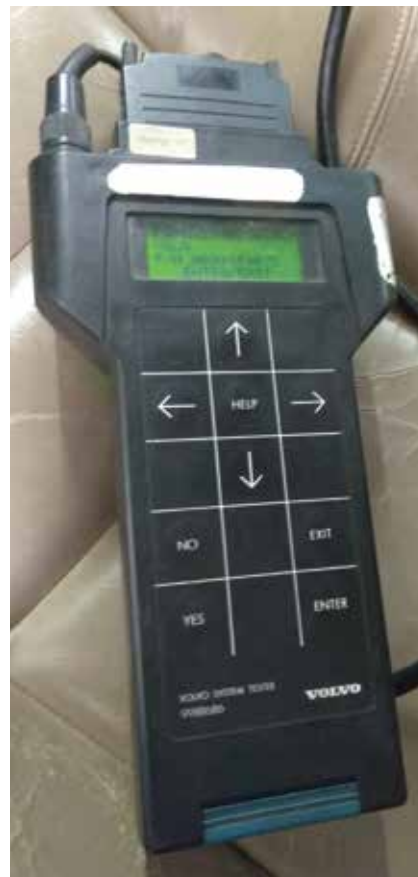
To program the remote for a 1998 Volvo you will need a four digit key code from Volvo and the use of a Volvo system tester tool.

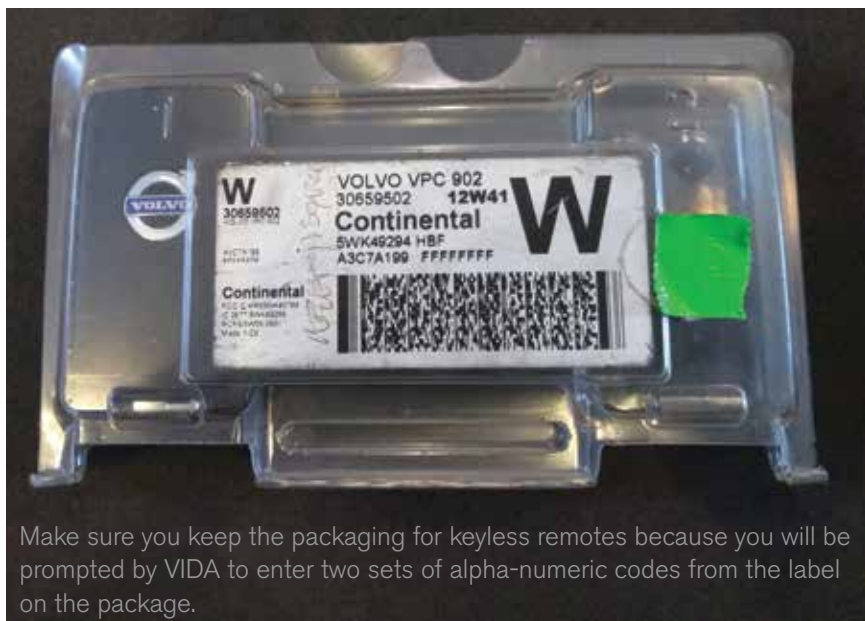
Make sure you keep the packaging for keyless remotes because you will be prompted by VIDA to enter two sets of alpha-numeric codes from the label on the package.

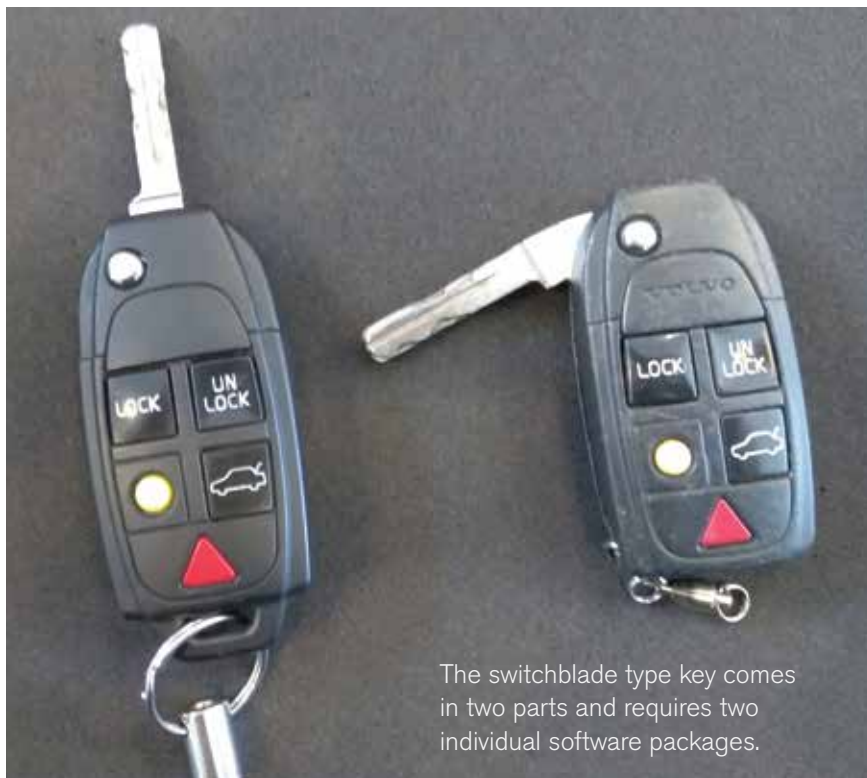
The switchblade type key comes in two parts and requires two individual software packages.

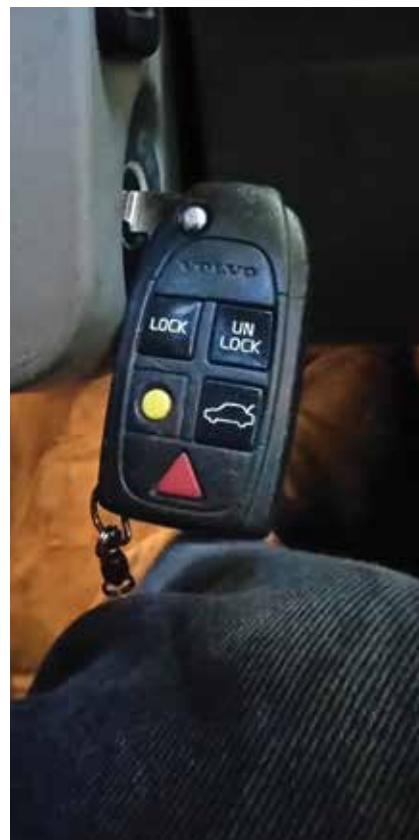
A floppy key can be a safety issue, because it can hang down, close to the driver's knee, which could cause them to inadvertently switch off the engine while driving.

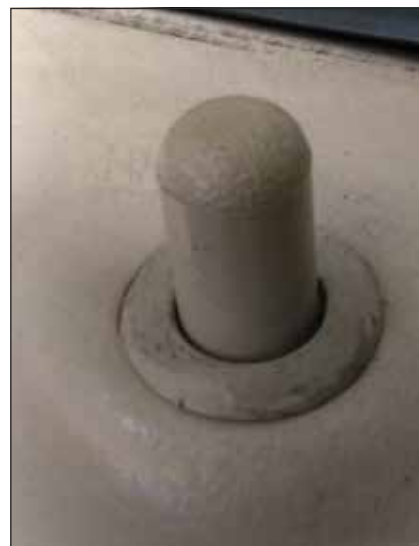
Early Volvo C70 series cars have lock pin bezels that are made from soft plastic. Over the years, the plastic starts to get sticky and soft. This can be caused by sunlight and cleaning products.

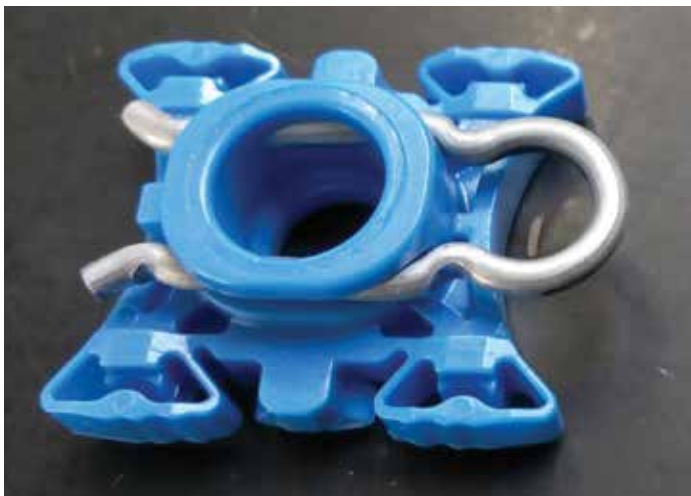
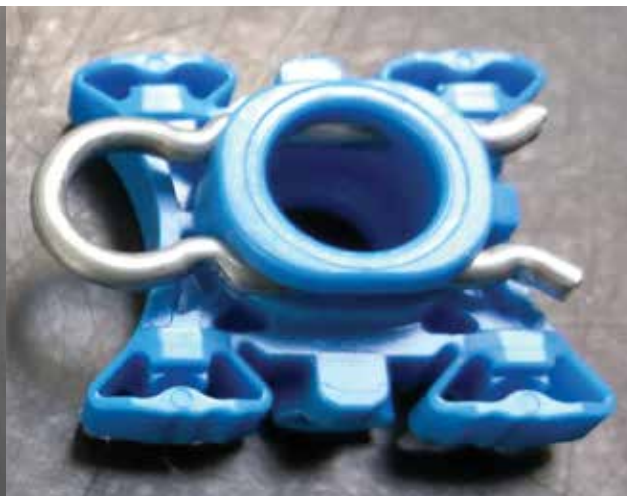
If you have a 1999 - 2016 S60, V70, XC70, or XC90 in the shop with a window that's off the tracks, jamming and sticking, the window regulator sliding pivot may be broken or worn.
