Mastering the Gen 2 Prius Engine Cooling System

The Prius hybrid includes two separate cooling systems. Their roles are very different, as are servicing procedures.

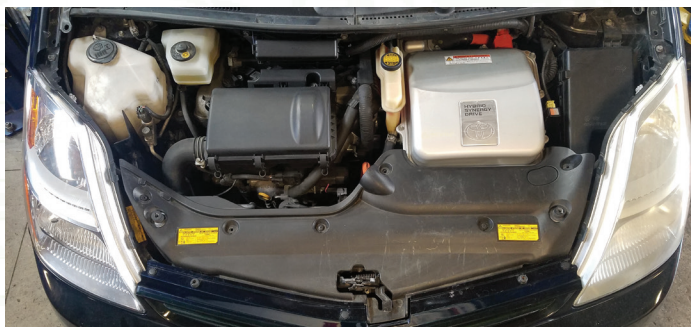
Engine as viewed from above. Note that the inverter reservoir is central and prominent while the engine access point and reservoir are hidden by the plastic cover.

Locate the inverter cooling system beginning with the inverter coolant reservoir directly center in the engine compartment.

The cap and the overflow reservoir are mostly obscured by a plastic cover; the lazy observer sees only the inverter reservoir and assumes the systems are the same.

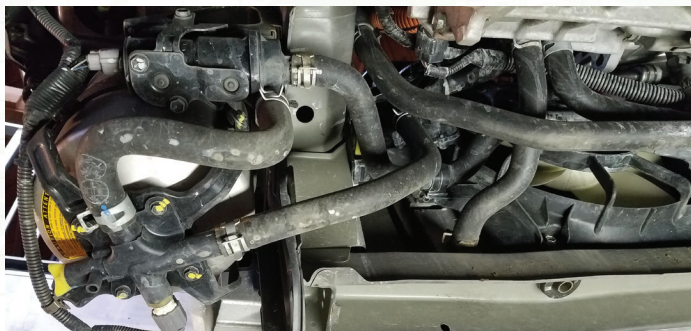
Inverter and engine cooling system hoses share the LF corner of the undercarriage. Because they all look the same it is easy to misroute them during reassembly, or to assume the systems are interconnected.

The hoses that connect these components are the same size and share vicinity with the engine cooling system hoses, with the potential for misrouting, kinking, or cross-connection. Also note, while the inverter radiator is the same physical assembly as the engine radiator, the tanks/tubes are isolated and no liquid is shared.

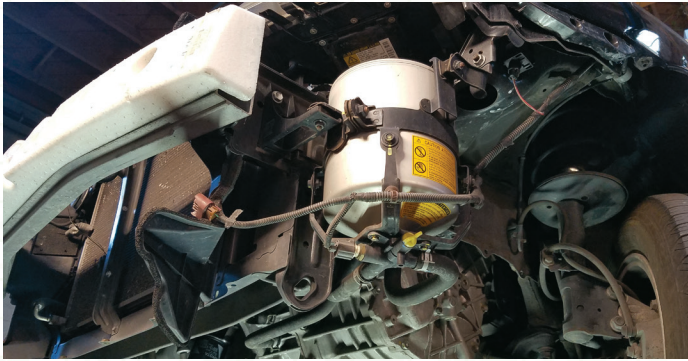
The Prius has a coolant thermos, or “Coolant Heat Storage” (CHS) tank located behind the front bumper.

Keeping the cabin warm is not the only exceptional feature of a Prius. As part of its PZEV emissions rating, the system includes a thermos (called the “Coolant Heat Storage” or CHS tank) that can store coolant at 180 degrees F for up to 3 days.

When readied on, the driver may hear a faint whine while a third electric pump (at the thermos) runs for several seconds (prior to engine crank) to push hot coolant to the block, heating it to reduce fuel condensation, therefore lowering hydrocarbon emissions during startup.

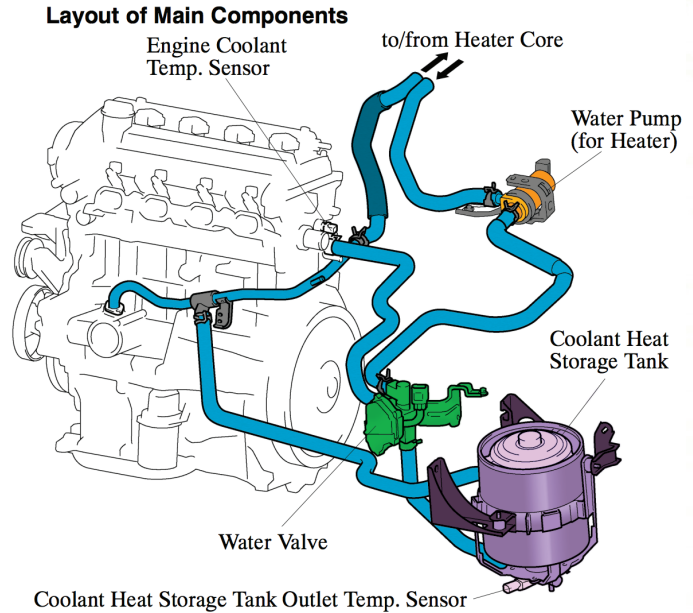
View of system components and routes. Pump at bottom of thermos not shown. (Colored for illustrative purposes only.)

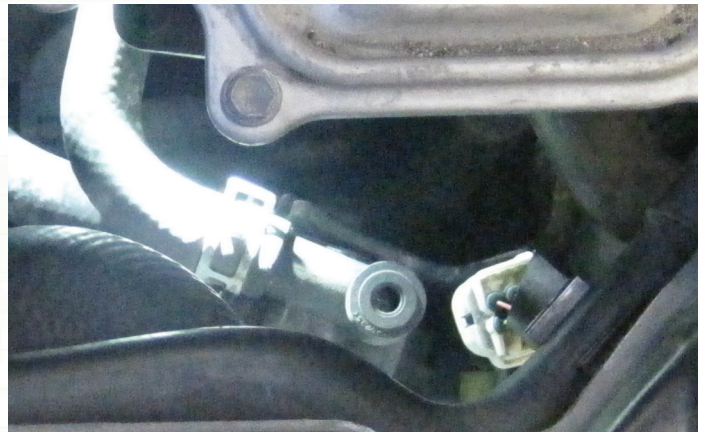
The three way valve is located in front of the inverter

To manage both exceptional cases — cabin heating and engine warm up — the Gen 2 has yet another exceptional component: the so-called “water valve” (a.k.a. “three way valve”). This valve determines when hot coolant is circulated to the heater core, the thermos, or both. The three way valve is the gatekeeper to make sure heat isn’t wasted, but its existence in the system adds yet another layer of complexity regarding diagnosis and bleeding.

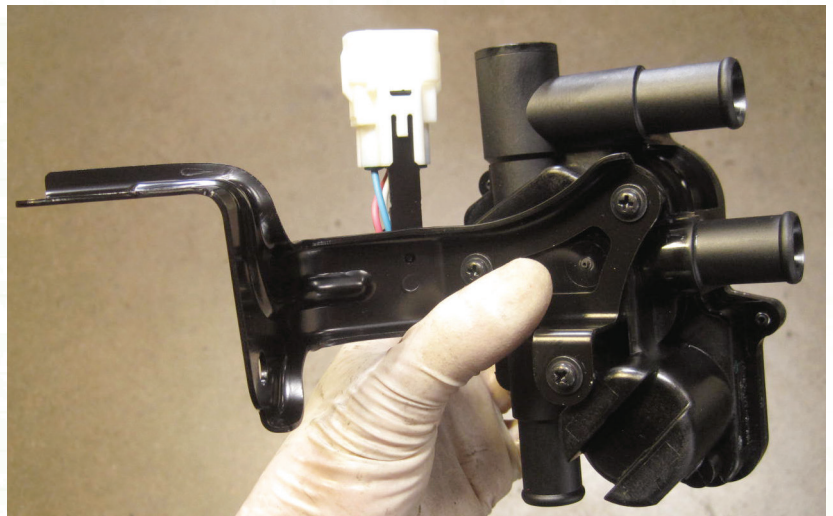
Appearance of the three way valve removed from the vehicle

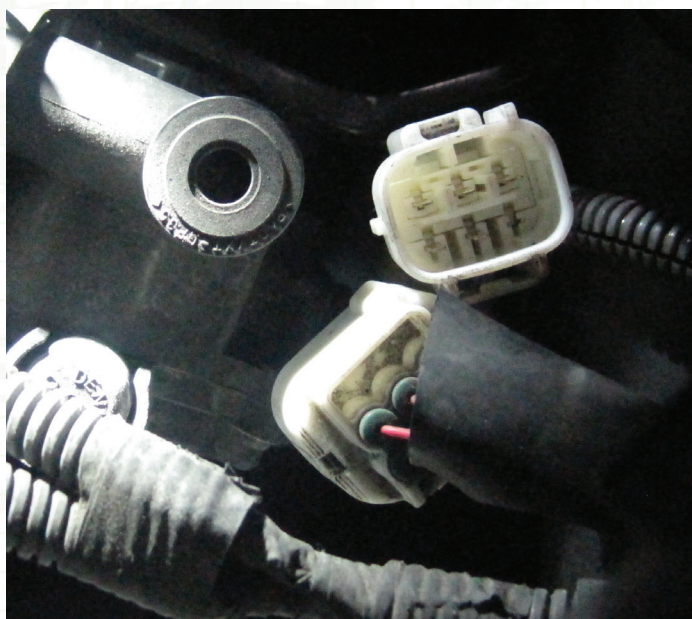
The three way valve has five circuits occupying a six pin connector.

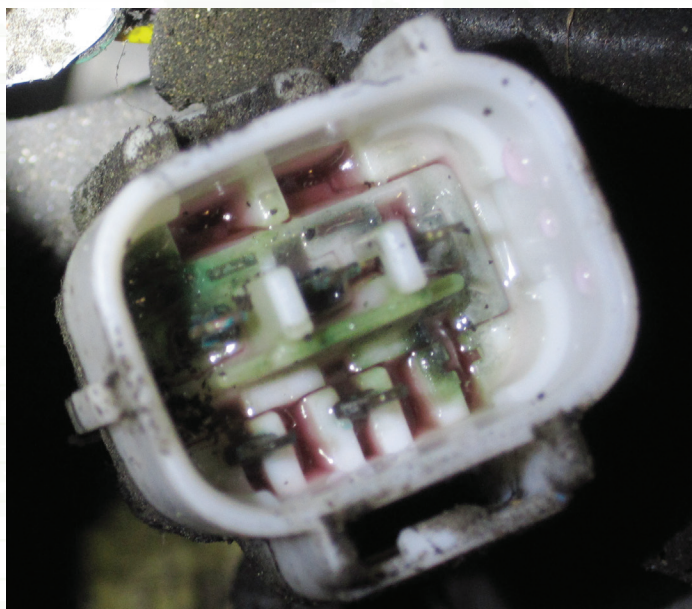
When the valve leaks internally, it will push coolant into the connector, eventually shorting the reference voltage circuit VC. This creates all sorts of system havoc.

Left alone a faulty three way valve may develop an internal leak. Best case you will find evidence of coolant inside the connector (at the part itself) but the circuits through the connector are still functional. Worse is when the connector floods and shorts the reference voltage signal VC, shutting down the car and setting various DTCs for the myriad components that share the VC circuit. (Got a weird one on your hands? Check here!)

Some problems get so serious that pressurized coolant in the connector pushes into the wiring harness, corroding pins at the

engine ECU all the way inside the dash. In that case the fix is the valve, the engine wiring harness, and a replacement ECU.

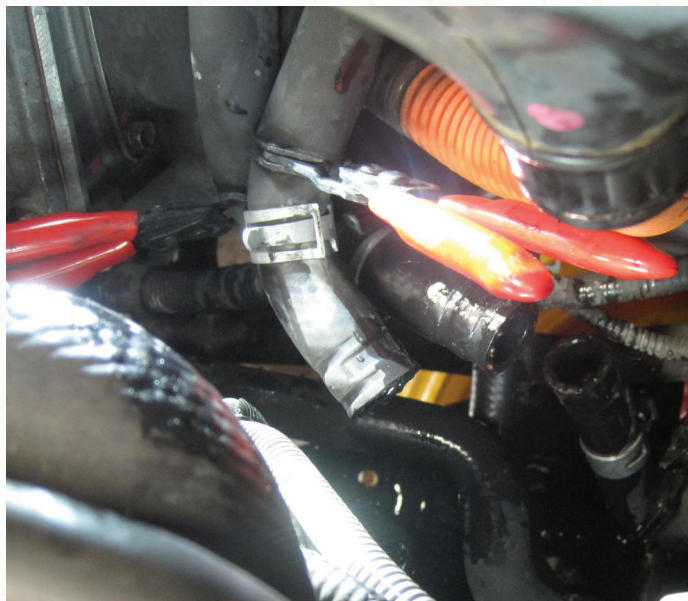
Preferences vary, but this view shows the valve removed from above with the inverter propped up. Coolant loss can be minimized with the use of small hose clamps.

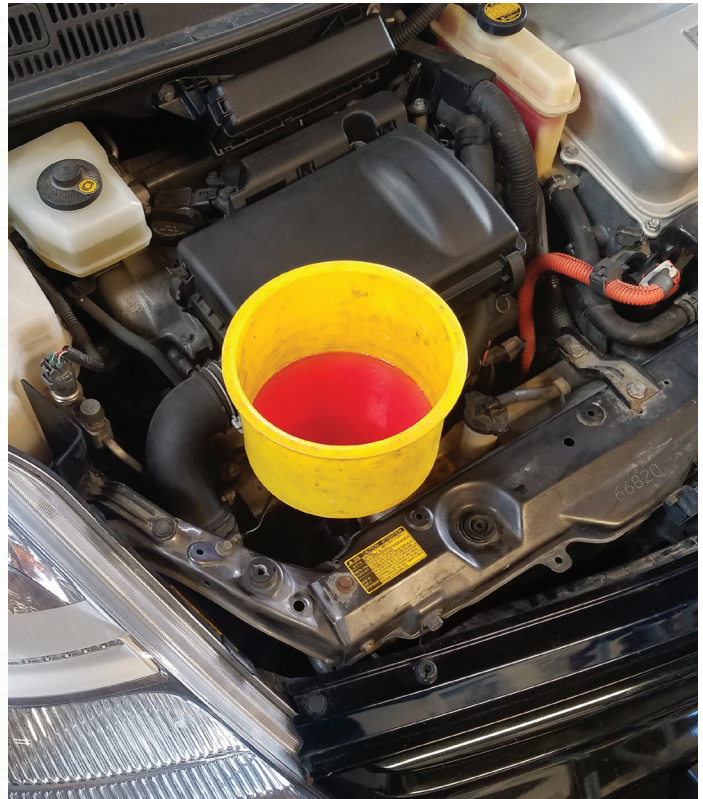
Fill and bleed the system with a bucket atop the radiator neck.

1. Remove the radiator cap and attach a filling bucket. Add Toyota Super Long Life Antifreeze until there's a resting fluid level in the container.
2. Turn the vehicle key on (not ready on).
