Technical Knowledge for Volkswagen[®],
Audi[®] and Porsche[®] Service Professionals

Audi 4.0T Turbo

January 2021

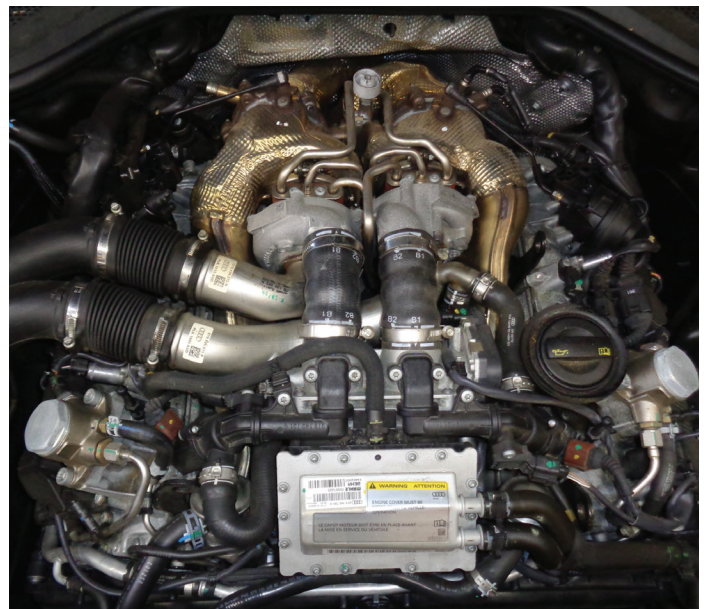
Previous Page: If you must remove this oil separator module, it's wise to replace it.

air intake assembly and must be slid out and up during removal. This is one large piece when removed. Be careful not to damage or drop any of these expensive components during removal. If removing the oil separator, it's wise to replace it along with any associated gaskets. This includes air pipe gaskets and exposed coolant or oil gaskets.

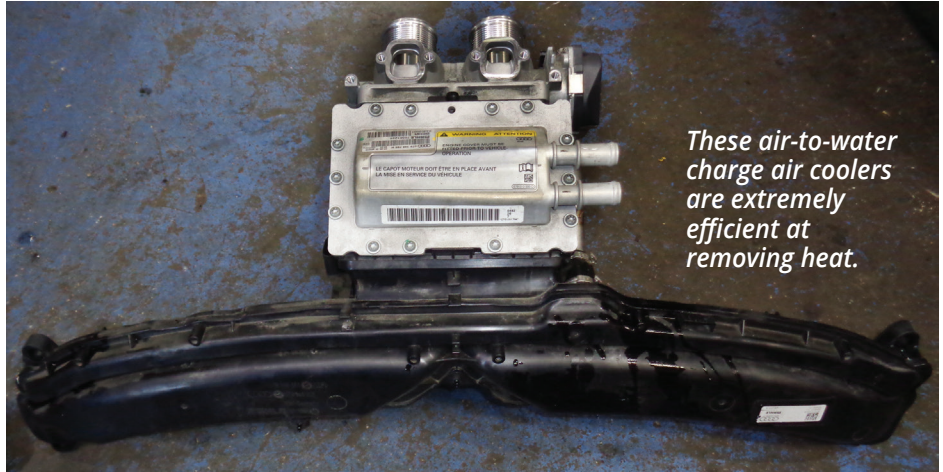
These air-to-water charge air coolers are extremely efficient at removing heat.

As with every other modern forced induction engine, charge air cooling is necessary to lower boost temperature. Audi uses an air-to-water intercooler design on the 4.0T engine. By using a separate heat exchanger circuit with an electric coolant pump, charge air temperatures can be kept much more consistent than with an air-to-air cooler.

The air-to-water cooler utilizes a small coolant radiator at the front of the car to further lower intake temperatures. These are mounted very low at the front of the car, often sustaining damage from parking and other low speed maneuvers. Watch for coolant leaks here. Air-to-water coolers also reduce the length of the necessary intake runners, reducing perceived boost lag. The charge air cooler on the 4.0T engine is mounted directly on the top front of the engine and must be removed during turbo replacement.

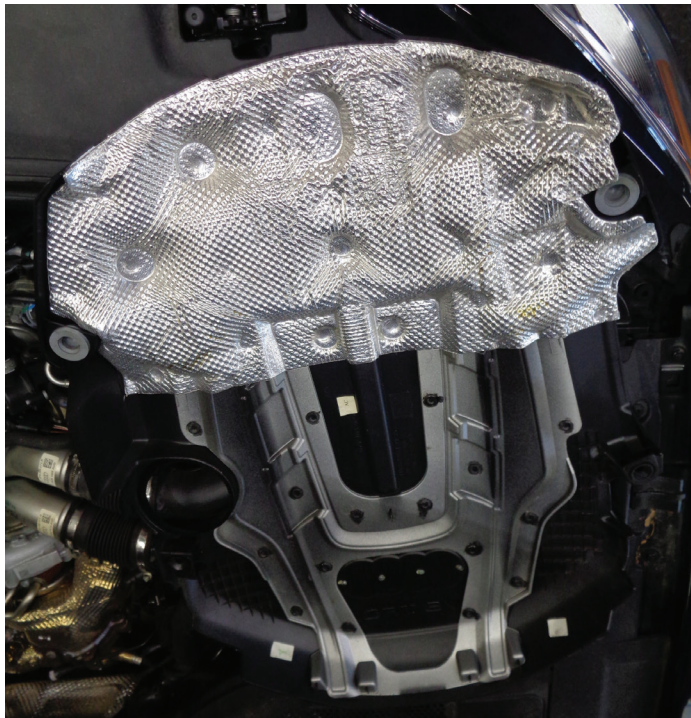
Damage to under-hood components and even the paint and body work will occur if covers are not installed.

It is critical to never run the engine without proper engine covers. Shielding is installed on the lower half of the engine cover to divert heat away from the hood and bulkhead of the vehicle.

Audi also utilizes an under-hood temperature sensor mounted near the turbochargers in the valley. If excessive under-hood temperatures are found, this system activates the cooling fans to lower engine bay temperatures. The engine cover is

used to divert under-hood air flow as well. Again, do not run the engine without covers properly installed!

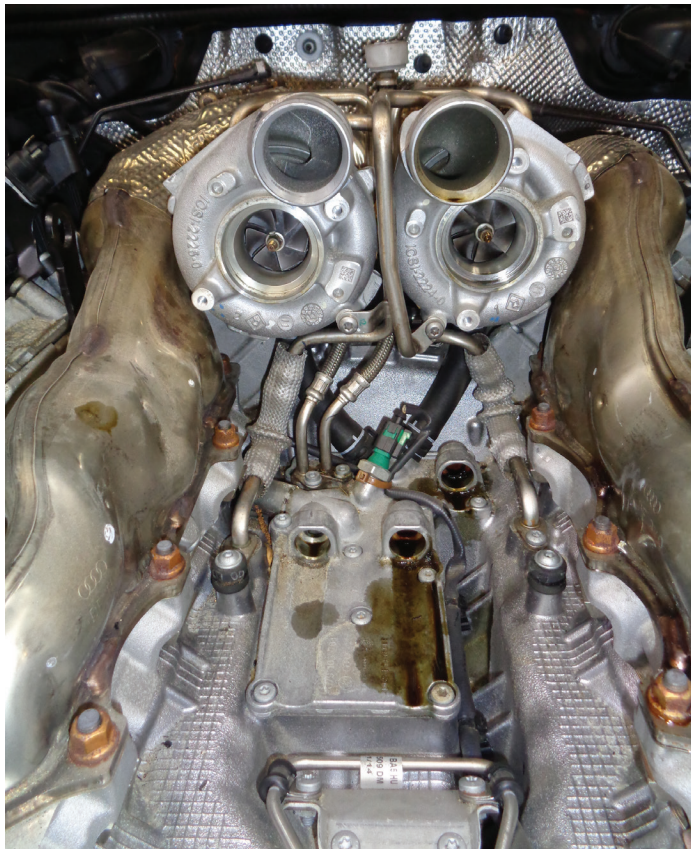
With the charge cooler/intake removed, great access to the oil module and turbochargers is granted.

Because the engine turbochargers are mounted in the valley, oil supply and return must also be secured in the valley. Audi refers to this as the oil module. This module is mounted directly below the turbochargers in the center rear of the valley. In addition to oil supply and return for the turbos, the crankcase ventilation oil returns also pass through this module. Because they are located directly below two turbochargers, this module and engine oil can get quite hot. This extreme heat can be detrimental to the engine oil, causing coking and oil breakdown.

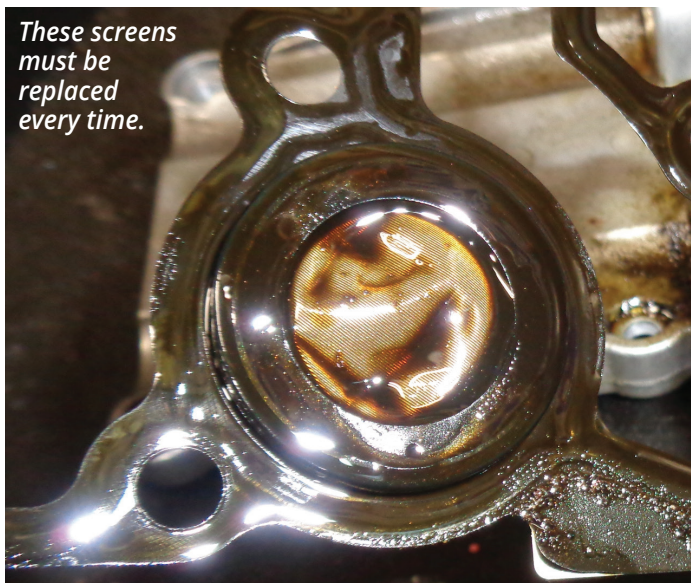
These screens must be replaced every time.

With direct access to the oil module in the valley, now is the time to remove the cover and inspect the oil supply screen. These are usually partially to fully blocked. Always check and replace this screen during turbocharger replacement. Failure to do so will result in an expensive comeback repair. Audi also recommends replacing the oil control check valve located in the oil module during turbo replacement.

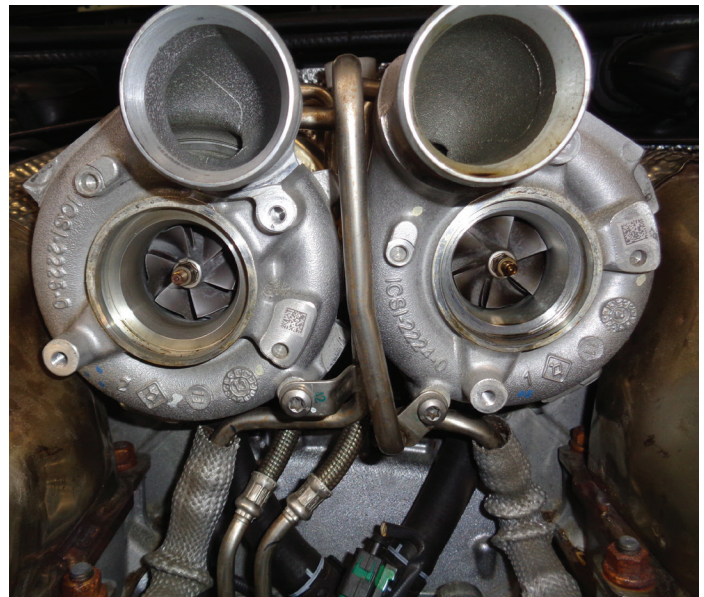
The oil supply to the passenger bank turbo was blocked on this vehicle. This caused turbine damage and a distinct lack of residual oil on that bank.

Audi has installed a screen in the oil module to protect the turbocharger oil supply from contaminating the oil. This oil supply screen can become blocked with sludge, effectively cutting off oil supply to one or both turbochargers. Oil supply blockage is the number one killer of turbochargers on this engine and is, unfortunately, not uncommon. This is why it is important to stress proper oil change intervals to customers. These engines do not do well with longer intervals between oil services. Oil contamination and

In many cases, oil blockage kills one turbocharger before the other. This can be more difficult to diagnose as the vehicle will probably run but be low on power. This is where visual examination of the turbine is necessary to determine failure. A borescope is an absolute necessity here to examine the turbochargers without disassembling half the engine. By removing the upper air inlet pipes toward the air box, the borescope may be inserted toward the turbocharger cold/inlet side turbine. Turbine damage is what you are looking for here.

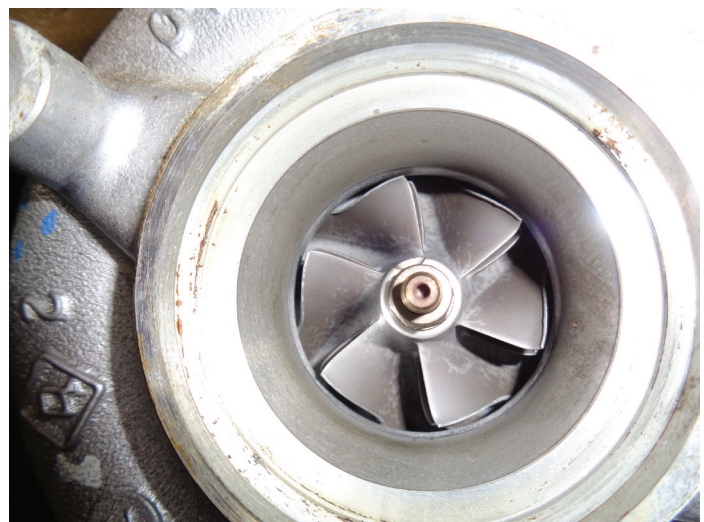
This turbine and housing are destroyed from lack of lubrication.

If oil supply to the turbocharger journal bearing is obstructed, the turbine will quickly fail. Without lubrication, and if the turbine contacts the turbocharger housing, important clearances are destroyed, and the turbine will destroy itself in short order. Customers may complain of a screeching sound coming from the engine when this is the case. If turbine damage is discovered, the damage has been done. Both turbo assemblies must be replaced and the oil supply system flushed thoroughly.

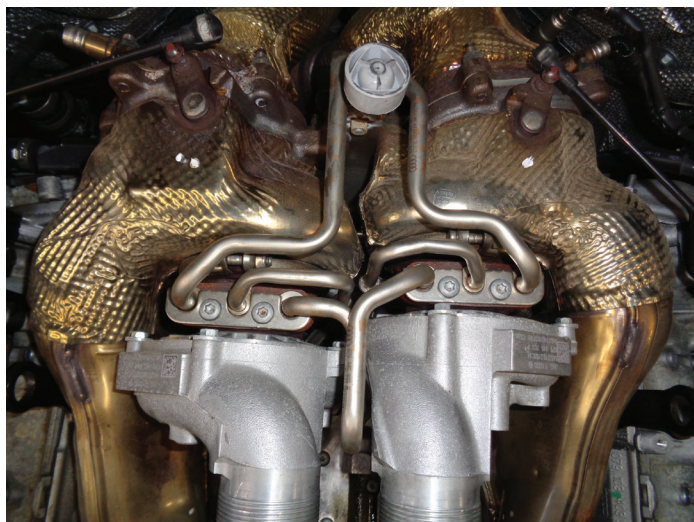
Always replace the o-rings on these coolant and oil lines when removed. No comebacks here.

The oil and coolant supply lines come in from the top of the turbochargers. Carefully remove these from the turbochargers, being sure not to kink or bend them in any way. The oil supply lines should be thoroughly inspected and cleaned before reusing. If they appear to be blocked or damaged,
