The new N52 series includes the N52B25. Also included is the N52B30 engine which has 6 cylinders and is totally different from previous versions of the M54B30. It is equipped with popular Double-VANOS camshaft and light-weight aluminum-magnesium engine block along with lighter connecting rods and pistons.

The N52 engine uses three aluminum bolts securing the cylinder head to the timing cover. This is where our problem starts for this oil leak. These aluminum bolts tend to break; the one you can see with a quick glance is the bolt located behind the oil filter housing.

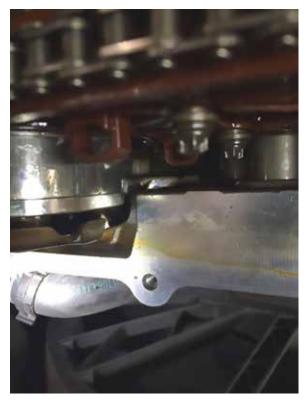
There are two more bolts located under the timing

gears. These are also aluminum and should be checked. If either of these is found to be broken or loose, you will have to pull the front timing gears off to change the bolts. BMW instructions can be found in 1131505.

If you find the broken bolt head, pull it out. However if you have gotten unlucky and the bolt head cannot be found the fun is only beginning. At this point you should remove the oil pan to retrieve it. The bolt head can easily jam in the timing chain and cause jumped timing or worse. Once the pan is pulled down and you have retrieved the bolt, it's time for reassembly.
