STARTUNED<sup>®</sup>

MARCH 2021

VOLUME 21 | NUMBER 1

#### Information for Independent Mercedes-Benz Service Professionals

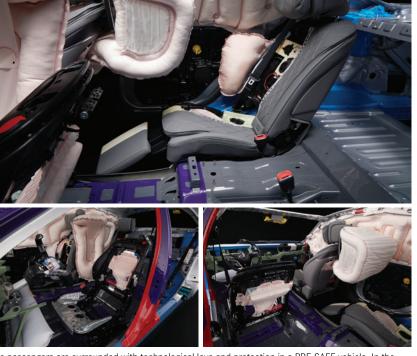
The passengers are surrounded with technological love and protection in a PRE-SAFE vehicle. In the case of an accident, the vehicle seemingly transforms into a version of the Stay-Puft Marshmallow Man.

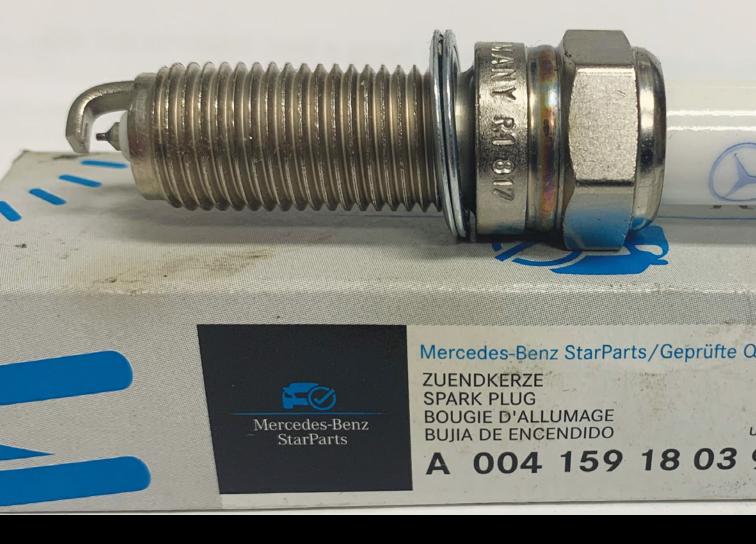
### **Spark Plug Procedures & Precautions**

This essential component was invented about 160 years ago, but is still evolving in terms of design, materials, and service.

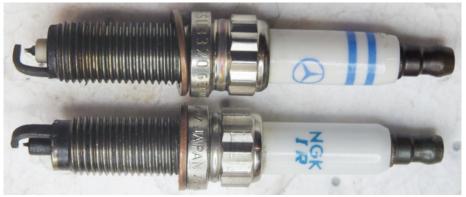
In this photo, an NGK spark plug is compared to a Mercedes-Benz spark plug. The Mercedes-Benz spark plug has the correct thread length for proper indexing and meets the correct heat range criteria.

The Mercedes-Benz approved spark plug at the left has its electrode gap facing a correct 45 degrees from the injector nozzle. The aftermarket plug on the right, torqued the same as the Genuine Mercedes-Benz plug, is facing the wrong way. This caused a melted piston and required complete engine replacement, at the independent workshop's expense. Definitely not covered by warranty!

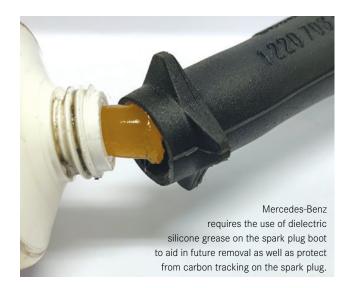
Proper torque is critical to spark plug seating! It only takes a few extra seconds and is the only way to do the job correctly.

Proper torque is absolutely critical to seating the spark plug to ensure good contact with the seat and to ensure it doesn't back out over time due to expansion and contraction. Too tight can also be a problem as this can lead to cracking of the porcelain, not to mention not being able to remove it later. In the old days we could just install the spark plugs what we called "gootentight," but today you really must observe the torque specs for the application.

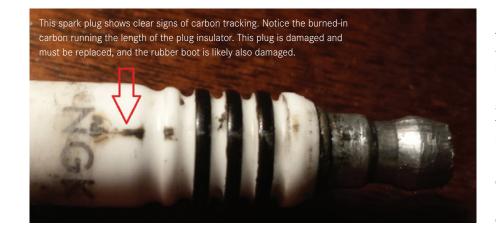
According to NGK (and others echo the same thing), their spark plugs feature tri-valent plating. This silver or chrome-colored finish on the threads is designed to provide corrosion resistance against moisture and chemicals. The coating also acts as a release agent during spark plug removal. NGK spark plugs are installed at the factory dry,

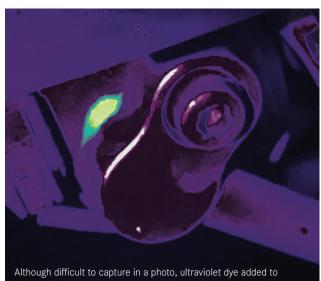
Although difficult to capture in a photo, ultraviolet dye added to the A/C system will help you find even the smallest leak with your eyes, here seen in green at the compressor connection.

If you suspect a leak in the refrigerant circuit, the first task should be to sniff as much of the system as can be accessed using a refrigerant detector. It may be necessary
