# Classics: Model 210 A/C Diagnosis

## Accessing Self-Diagnosis and What the Numbers Mean

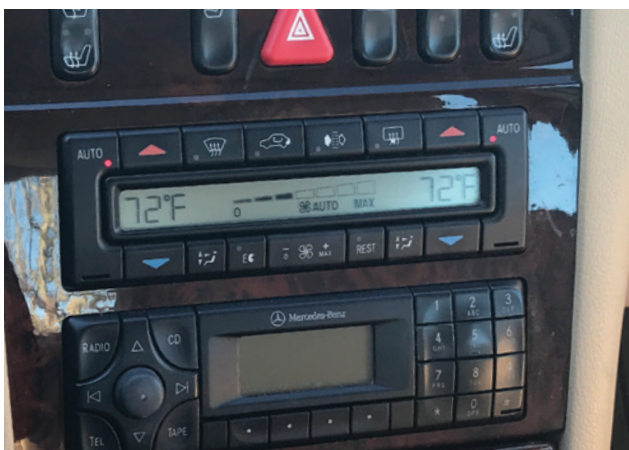
The climate control controller (N22) is located just above the radio in the center stack. Use the standard radio-removal tools to remove N22 from the dash.

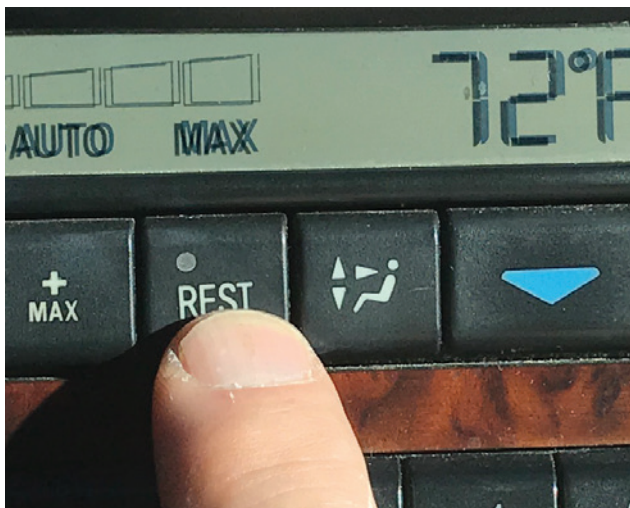
Pressing and holding the REST button on the climate control controller (N22) starts the diagnostic display mode. Diagnostics are best performed with the engine running.

In the self-diagnosis mode, the parameter number appears on the left side of the display, and the actual value is displayed on the right side. You scroll forward through the parameters using the left 'auto' button, and backwards using the right 'auto' button. After reaching the last parameter, the display moves back to the first one again. To exit self-diagnosis mode, press REST again or switch off the ignition.

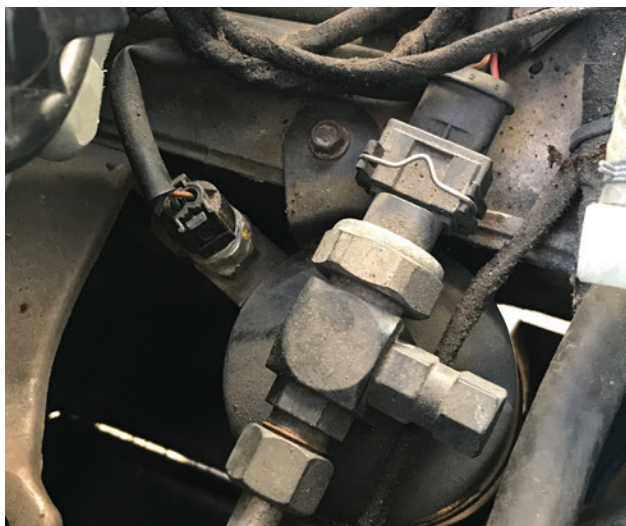
The refrigerant pressure (B12, top) and temperature (B12/1, left) sensors are both located on the receiver-drier, found behind the driver's headlamp. They are at system pressure, so be sure to evacuate and recover the refrigerant before loosening them.

Display code 7 is the value reported by the refrigerant pressure sensor (B12) located on the receiver-drier just behind the left headlamp. The values are reported in Bar (1 Bar = 14.7 PSI). The pressure sensor needs to have a 5-volt (± 0.25 V) power supply to return a reading. If this sensor has failed, you'll need to evacuate the refrigerant to replace it. This sensor value may be the most useful reading you can get, since it can confirm an over- or under-charge of refrigerant. We'll get into the details in a moment in the Diagnosis section.

Display code 8 is the refrigerant temperature sensor (B12/1) also located on the receiver-drier. Measure the sensor resistance and estimate the temperature of the refrigerant it is reading. At 20°C (68°F) the sensor should read less than about 13kΩ, at 40°C less than about 5.5kΩ and at 70°C less than about 1.8kΩ. If the measured values seem reasonable, check the wiring before condemning the sensor.

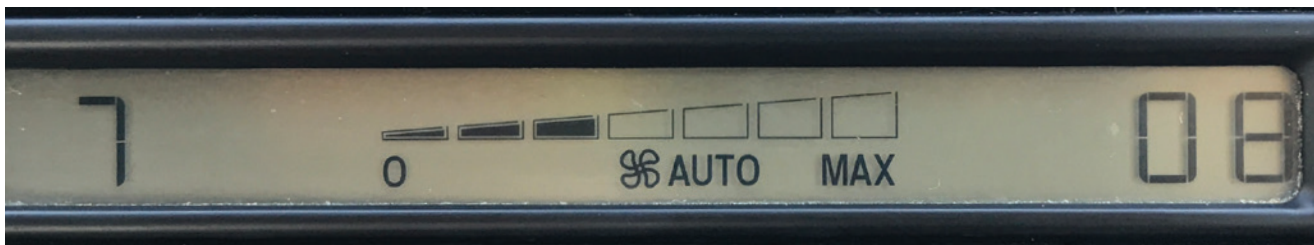
Here we see the diagnosis mode display code 7 showing a system high-side pressure of 8 bar. Since the engine is running and A/C is on, a low reading such as this indicates a low refrigerant charge, confirmed by noting the passenger-side vent is delivering cooler air than the driver-side vent.

Looking at display code 7 (refrigerant pressure) we can expect to see a high-side value of about 5 bar with the system and vehicle at ambient temperature. In operation,

values typically range from about 9 bar to 15 bar, with higher pressures seen when cooling demands are high. Really low system pressure will cause the EC light in the control unit to light, and the compressor cannot be engaged. If you find that the passenger side vents have cooler air than the driver side vents, it indicates the refrigerant is just a bit low, likely from a slow leak.

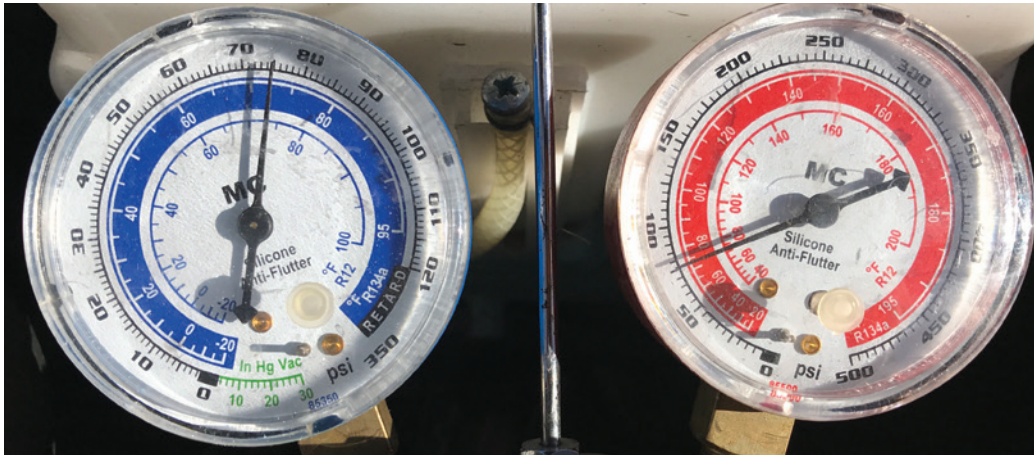
Old-school manifold gauges can be used to understand the problem. With the engine off, both gauges read the correct pressure corresponding to the system temperature (73°F, scale with white numbering for R134a), meaning the system is properly charged.

Two gauges are usually used for system diagnosis, one on the low-pressure side and one on the high-pressure side. These are connected to the ports at the driver's inner fender (low-side) and at the condenser (high-side). At rest, both gauges should read the same, with the pressure roughly corresponding to the system temperature (gauges have 'temperature' markings along with pressure). If these are both low, it is an indication of low charge, while if these are high, the system could be overcharged. In both cases, use your A/C machine to evacuate the system and measure the quantity recovered.

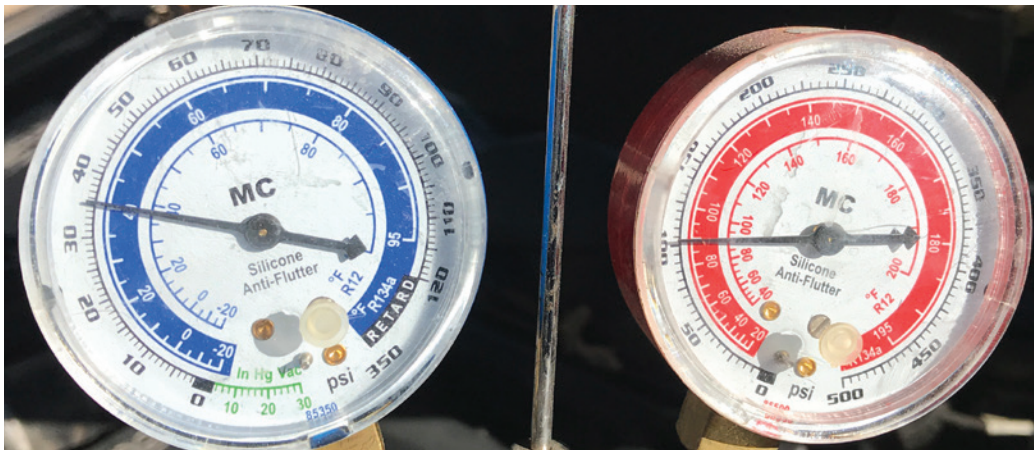
In the same car as the previous gauge photo, but with the engine running and A/C engaged, these gauges, with the high-side low and the low-side high, indicate a faulty A/C compressor.

With the compressor engaged, low refrigerant is indicated by low readings on both gauges, with the low-side approaching vacuum. If the high-side reading is low while the low-side is not, the compressor might be faulty.
