Back to the 2006 Accord

Import Service June 2021 2

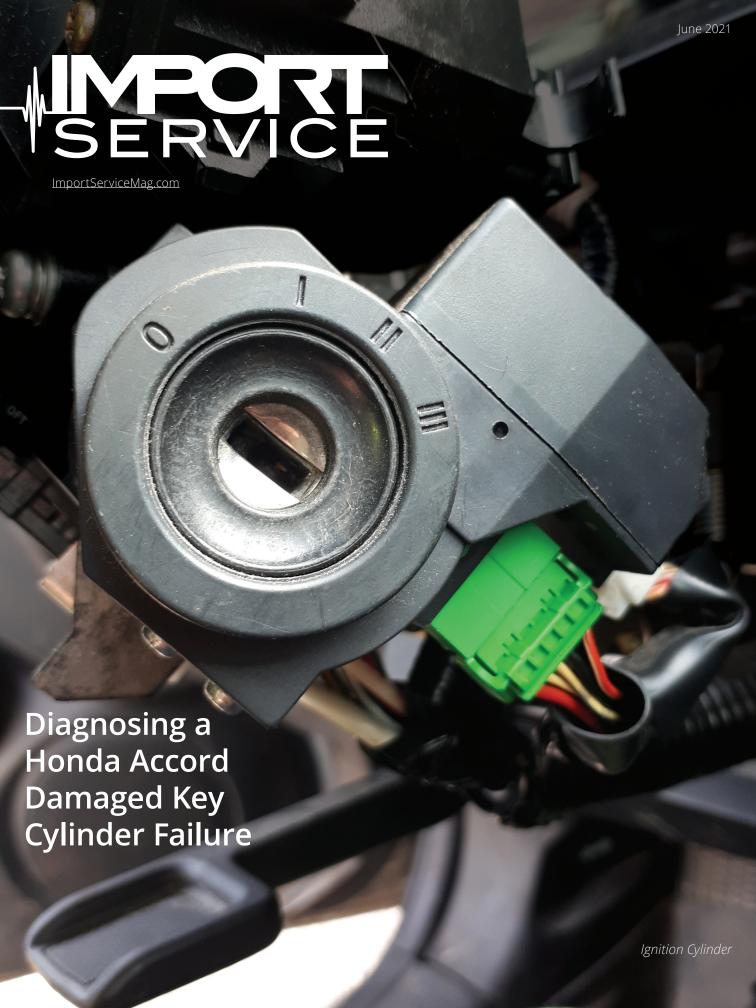
A co-worker had an ignition key problem and soon thereafter the entire key cylinder failed, disintegrating to the point of a total failure.

The co-worker searched and found an entire lock set at the local scrap yard. The ignition assembly was removed and installed into the 2006 Honda Accord. He tried to start it and adapt the used parts with a Snap-On scan tool until the lock set failed the adaptation procedure.

Both keys were opened and we decided to exchange the transponders.

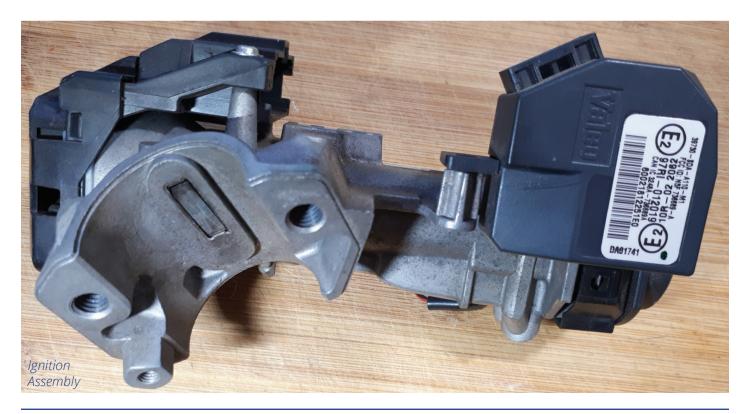
This lock set (ignition assembly) is the original that was removed from the Accord.

The original damaged lock set was, thankfully, saved and not damaged. The young lad did take the time to "carve open" the tamper proof screws at the scrap yard, slotting the sheared heads for a slotted screwdriver. All of those screws were saved to reinstall into the replacement lock set.

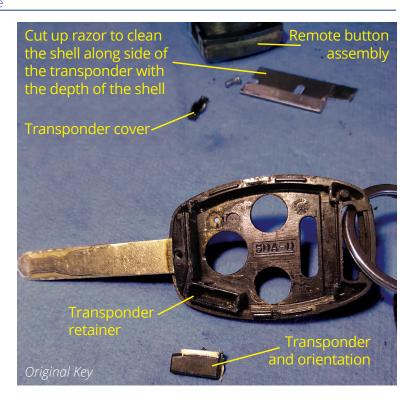
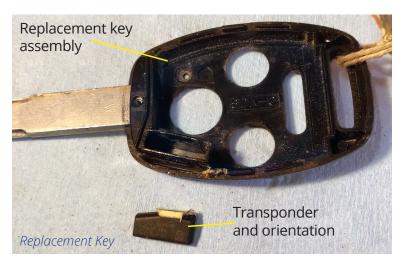
It is best to take images and notice the white glue or silicone material. If held, it would appear to stretch like white silicone. No glue was used and we only pushed the transponder in place. The cover over the transponder was also pushed into place.

We removed the screw and split open the key fob assembly. There is a very small cover that holds the transponder in place. The cover was gently lifted off.

With a magnifying glass, the transponder was viewed, but we noticed a white glue or paste holding the transponder in place. A razor blade was cut up and, with some brake parts cleaner, we slid the razor between the retainer of the transponder and physical transponder to scrape and pull out this glue.

The goal was to not damage the plastic key body or retainer. Gentle pulses of brake cleaner with light air pressure allowed the transponder to dislodge from the retainer.

Light air pressure also allowed the transponder to lift out of the retainer with a finger in place so the transponder would remain in place and not be lost. Both keys were worked on and we separated the transponders. The original transponder was placed inside the replacement key after it was cleaned and dried. The transponder orientation was noted with photos. The cover and orientation for the transponder were also noted and installed. The remote was now

assembled with the original RF remote buttons into the key shell.

Now the original transponder was swapped into the replacement key.

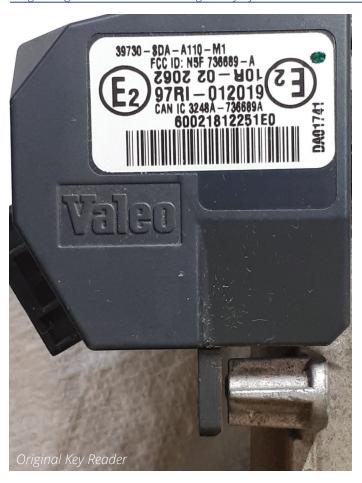
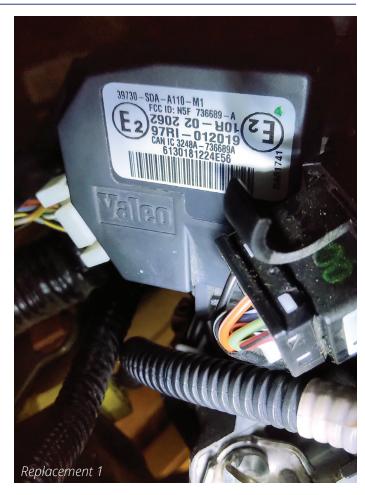
Notice in image "Replacement 1," the slotted screw heads that retain the ignition lock assembly. Hint: Keep the old cut off wheels for the die grinder.

Another photo from the top of the steering wheel assembly offers another view if the part numbers require a match. The camera is another tool in the tool box.

There were numbers on the key reader that looked identical, but we had a thought about the original key reader being "attached or married" to the Immobilizer system.

The part and ID numbers were not identical, and we began the swap while the entire assembly was attached to the Accord.

The young lad swapped the original key reader back to the replacement ignition assembly; the process was simple and quick, especially when the steering wheel covers were still not installed.

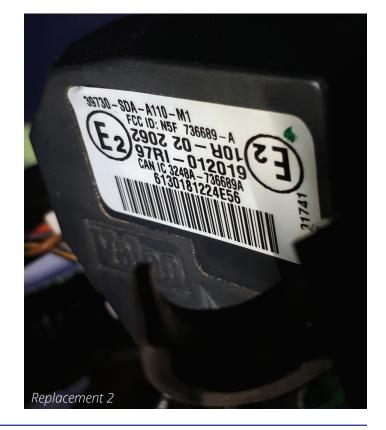
The Honda now starts and runs

The Honda HDS is the best "go-to tool," but at times quick and convenient with a tablet while using EasyDiag does save a lot of time. All that was required at the moment was; no faults recorded.

With the final test, we installed the covers and scanned one more time. The replacement was a success and a learning moment.
