TechNews

Nissan Evaporative Emissions

By Jordan Hill

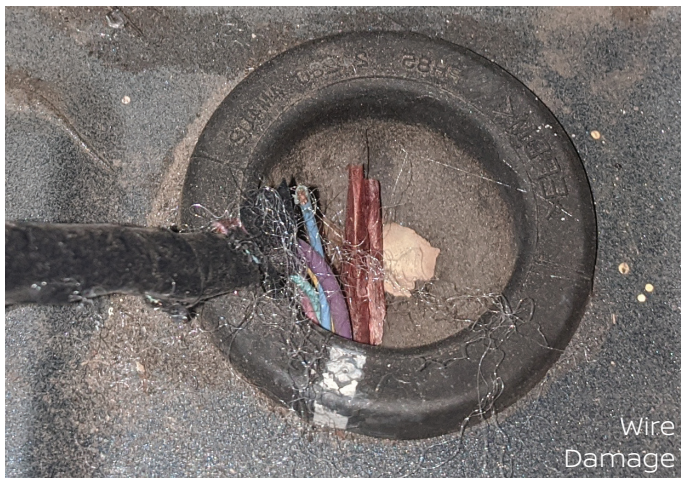
harness section under the vehicle. After removing all the contents of the trunk (including a vintage Buffy the Vampire Slayer board game) and inspecting the rest of the harness, the problem was visible. There was a small rodent nest right where the wires passed through the body, and the wires had been chewed apart.

The wires were repaired, and the rodent nest removed. The vent control valve fault was cleared and did not return. After reprogramming the ECM for the Mass Air Flow fault, this Sentra was sent on its way home.
