Technical Knowledge for Volkswagen®, Audi®
and Porsche® Service Professionals

SERVICING THE AUDI Q3

PART 3: DIAGNOSING PARK ASSIST AND STEER ASSIST

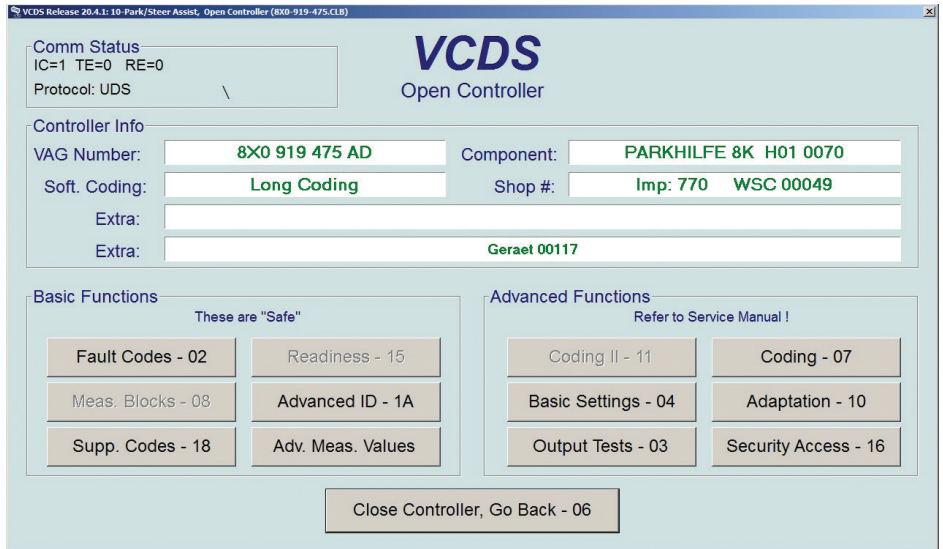
Park/Steer Assist identification

1. View Park/Steer Assist Identification and request for any faults and save.
2. At address 10 Park/Steer Assist, choose Adv. Meas. Values.

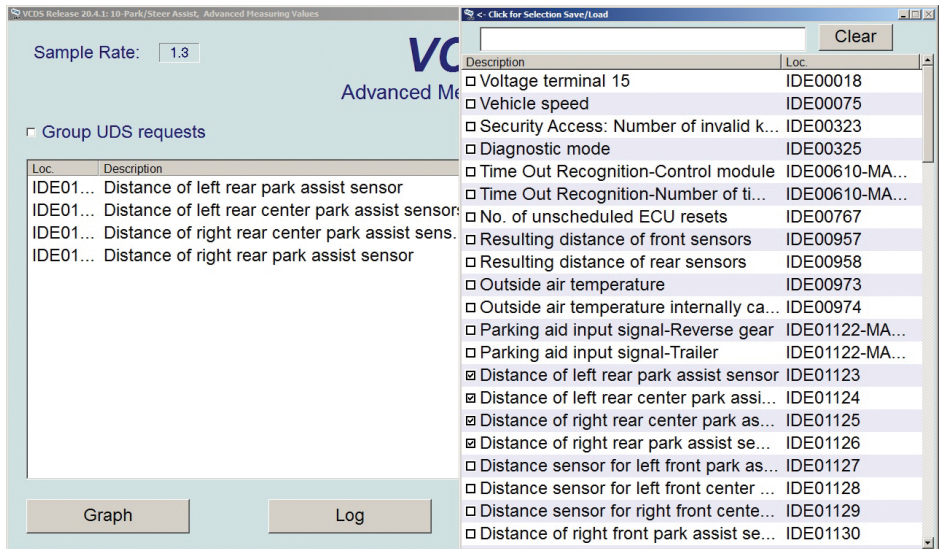
Park/Steer Assist value check

Within that option, scroll the screen until the four sensors are in view and click the boxes on the left to access the set of choices.

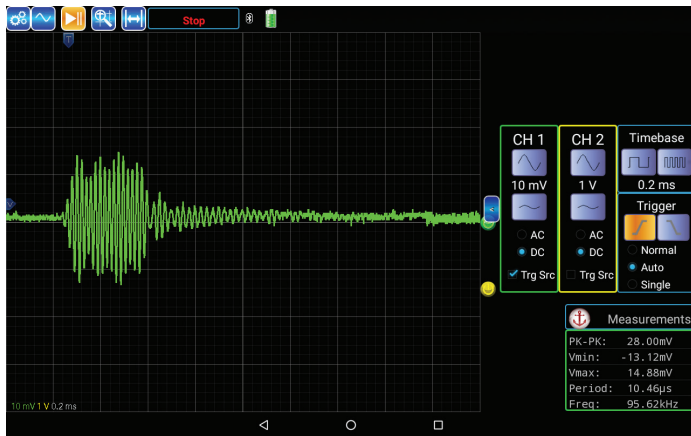
Tablet test 02 was approximately 15 cm or 6 inches (95.62 kHz).

Review the "Tablet test" images, 01 through 03. These are real time values with the oscilloscope while the Q3 is in the Reverse position, blocked, and measured with a ruler.

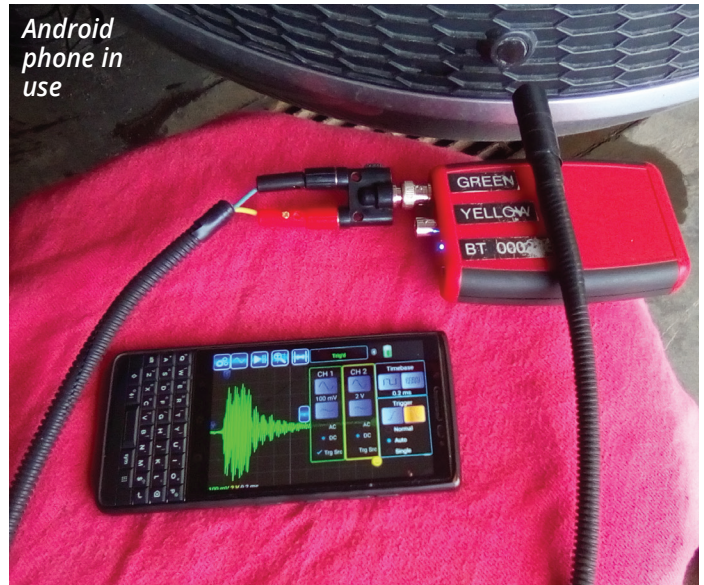
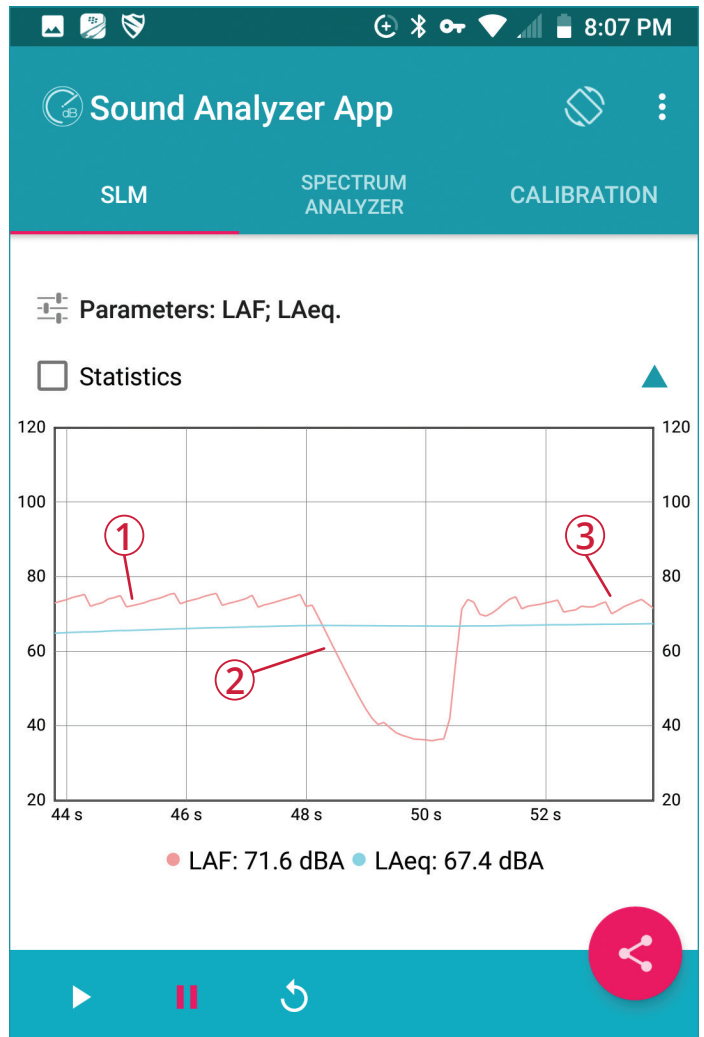
Sound Analyzer App 1: 1. Microphone pointed towards the bumper sensor, 2. Microphone pointed away from the bumper sensor, 3. Microphone pointed towards the bumper sensor.

Match tests 01 to 03 with the Android tablet and Bluetooth oscilloscope attachment, "Sound Analyzer App" images.

The Android applications (Sound Analyzer App 1-3) were a curiosity.

The beginning rise and wave of this image is with the microphone pointed at the bumper sensor; the drop in sound is moving the cell device up and away, a few inches from the sensor. Moving the cell device in front of the sensor raised the image and wave with the SLM feature.

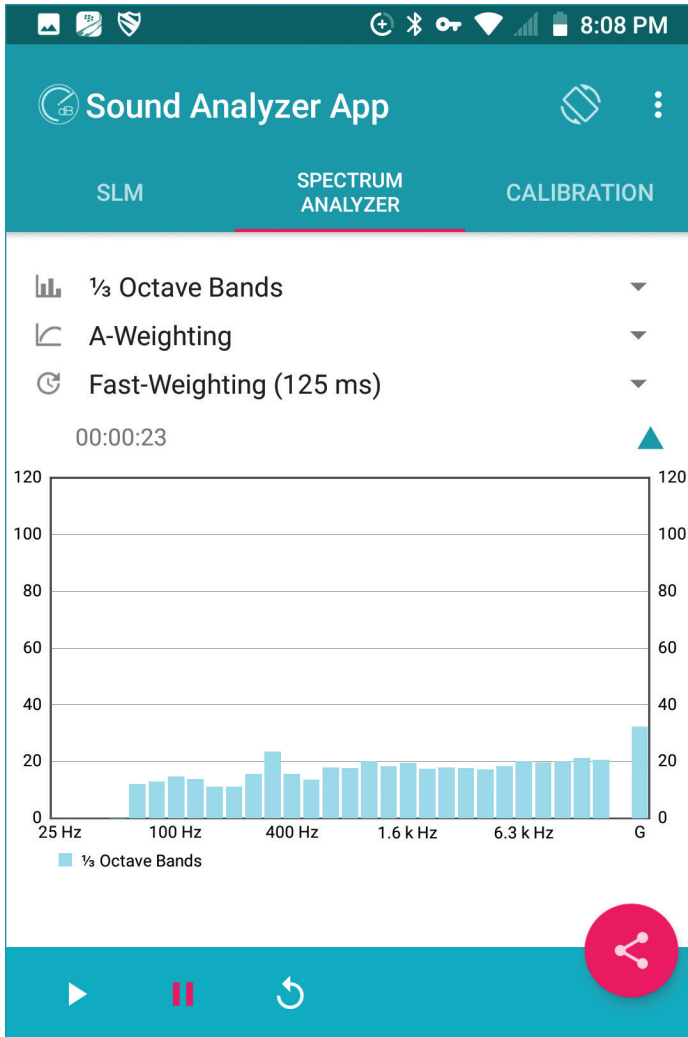
Sound Analyzer App 2: Microphone pointed away from the bumper sensor
