TechNews

Information for the Independent Nissan Specialist

Infiniti Cold Case File #FX35

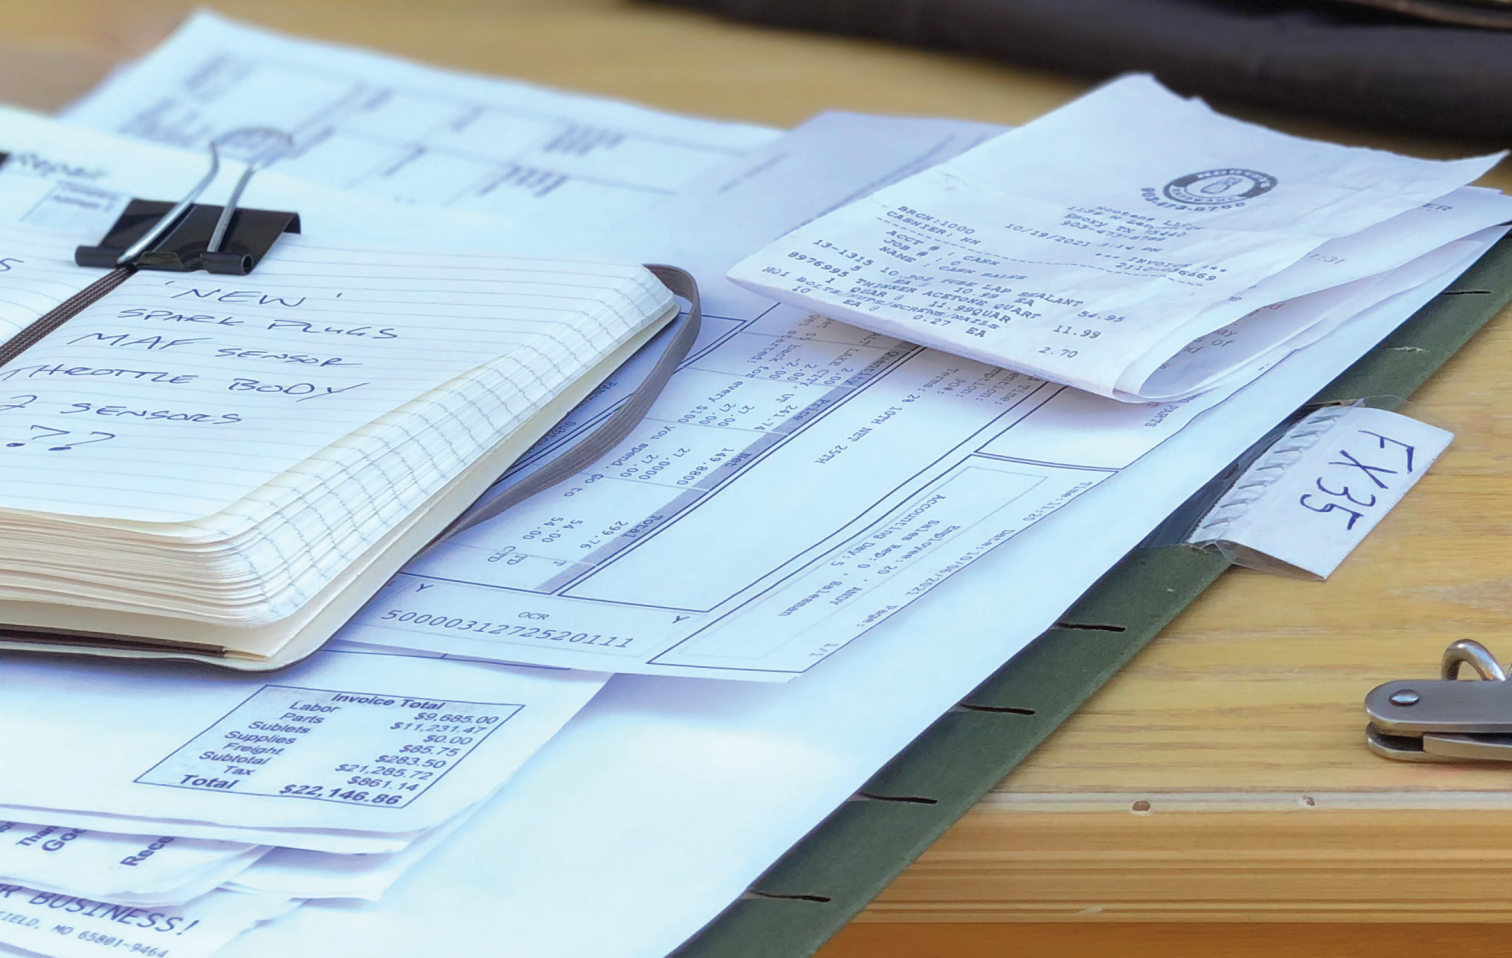
Handwritten notes in a notebook:

- 'NEW'
- SPARK PLUGS
- MAF sensor
- HEATLE BODY
- 2 sensors
- ??

Receipt from a shop:

10/18/2021 11:14 AM
 9976945 10.00
 13-1313 10.00
 10.00
 11.99
 2.70

Invoice Total	\$22,146.86
Labor	\$5,685.00
Parts	\$11,231.47
Sublets	\$0.00
Supplies	\$85.75
Frugal	\$283.50
Subtotal	\$21,285.72
Tax	\$861.14
Total	\$22,146.86

Handwritten label: FX35

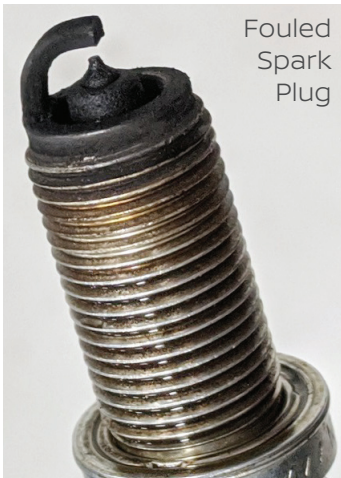
to crank the engine over while running a few basic checks. Using a handheld COP ignition system tester, he quickly determined that the ignition coils were indeed firing.

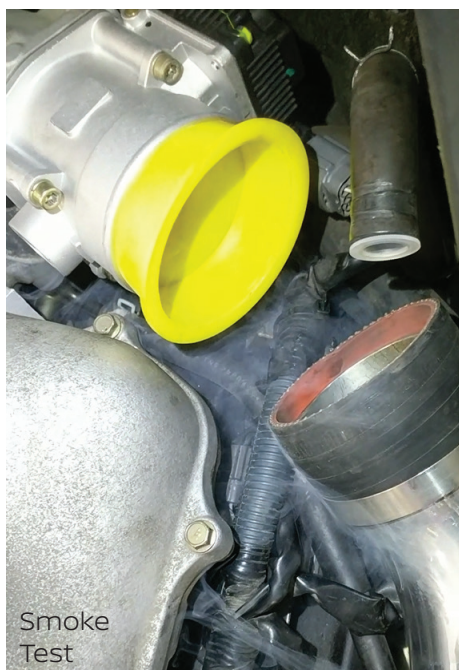
Despite the contradictory data, Harry went with his gut and hooked a smoke machine up to the air intake system to check for leaks. With the throttle body blocked off and the smoke machine connected into the brake booster hose, it didn't take long for Harry to find a large air leak at the upper intake plenum.

The smoke appeared to be coming out from between the lower intake manifold and the upper plenum, right where the gasket should be. The plenum was going to need to come off for the investigation to continue any further.

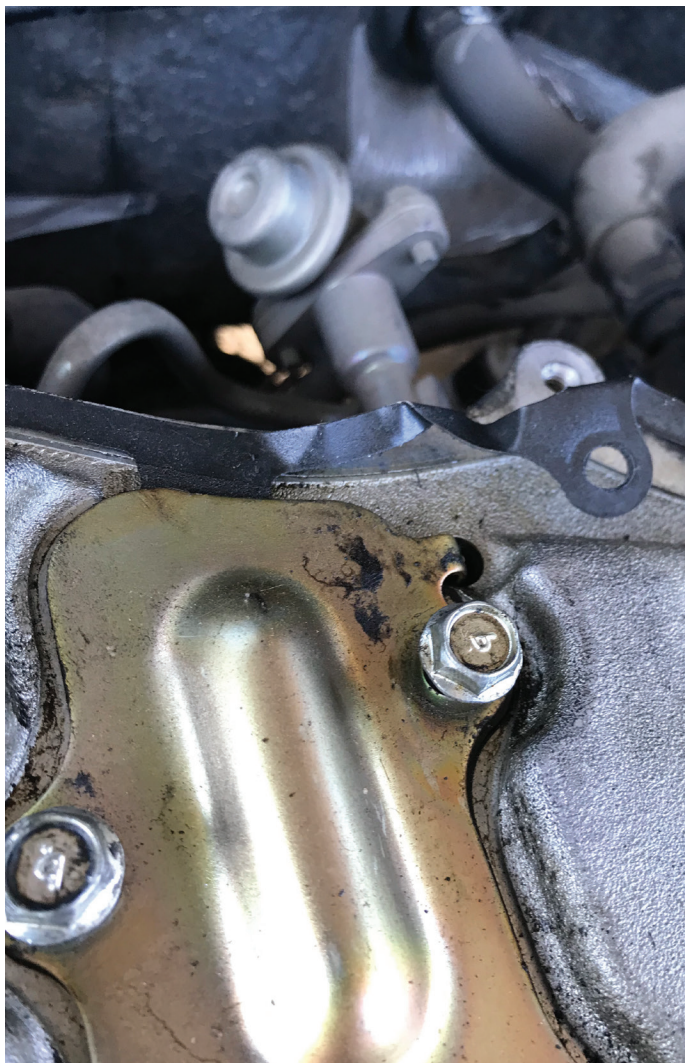
Plenum Gasket

After all the bolts were removed, he lifted the plenum off to inspect further. Harry found the gasket was bent over onto itself and not sealing the upper plenum. He also found the lower intake bolts were loose and not properly torqued.

Harry was confident he knew how the gasket got so badly brutalized. A follow-up interview with the witness confirmed that he had removed the upper intake plenum to replace the spark plugs; another vigilante repair gone wrong.

The next step on this vehicle would be to replace the plenum gasket and properly torque the lower intake manifold. That would have to wait until the next day though. Harry was beat. He dropped off the parts requisition forms with the dispatch officer and headed home for the night.

The next morning, the new plenum gasket was waiting for Harry when he arrived at the station. The gasket was installed and all the bolts were torqued to factory specification. A second smoke test showed that no further air leaks were present. Harry started the SUV, and the idle had dropped from 1200 to 900. This was still too high, but was a large improvement from what Harry had started with.

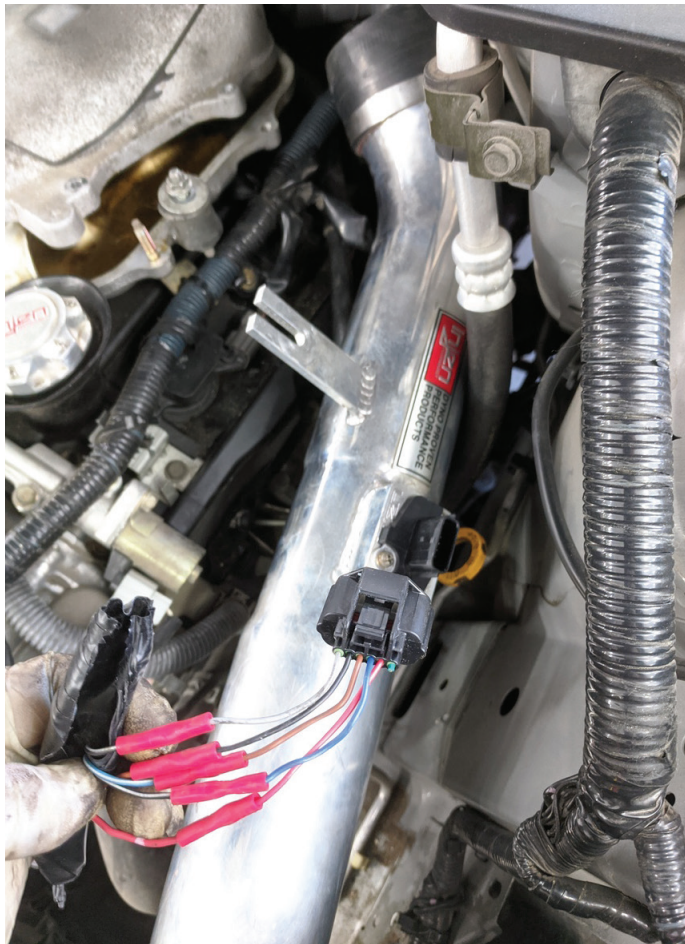
MAF Sensor and Connector

Closer inspection of the mass air flow sensor revealed it was an aftermarket part with no brand name marking of any kind. Harry knew the MAF sensor reading was a critically important input for the engine management system, since all of the lookup tables in the engine control module were based on the air volume being measured correctly. The only choice for this important of a sensor was an OE part from the Infiniti dealer.

The MAF sensor connector (next page) was also new and had been spliced into the harness. Harry

pulled up a wiring schematic to confirm that the new pigtail connector had been wired to the correct pins. Thankfully the wiring was OK and all the pins were in their correct positions. The clues all pointed to a faulty mass air flow sensor that would need to be replaced. Harry also really wanted to get rid of the aftermarket air intake tube, but that wasn't his call to make.

The new OE mass air flow sensor was ordered from the dealership and was delivered later that day. He installed the sensor and cleared the fuel trim memory before starting the engine again. This time the fuel trims were completely normal, fluctuating between -5% and +5%.
