Tackling Pesky Oil Leaks

Tips and tricks for getting it right the first time

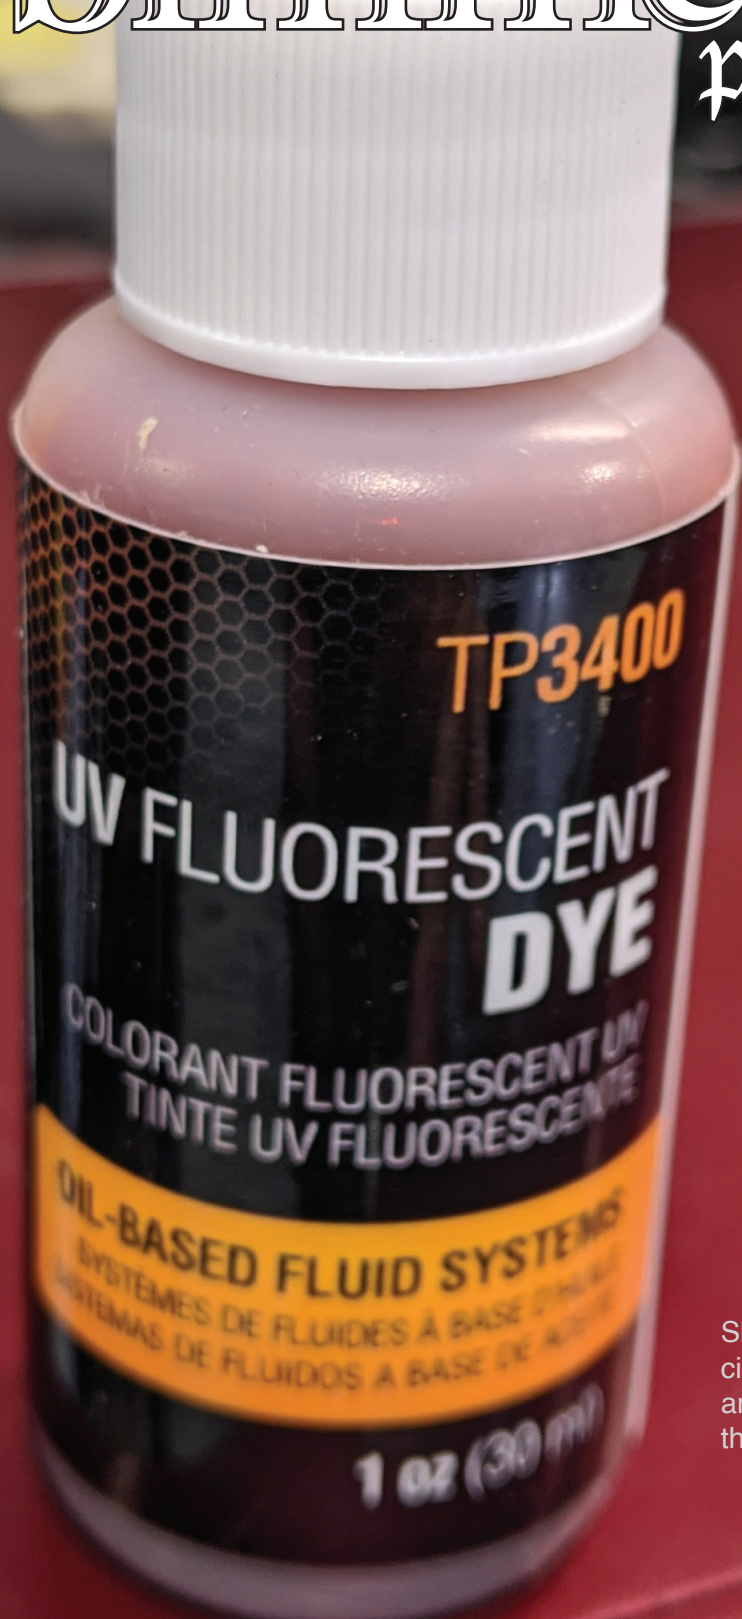
Shown here: UV dyes added to the oil will circulate internally through the system and can identify the source of the leak with a UV light.

We prefer a UV leak detection dye that is engineered for use in engine oil. When added to the oil for a test drive, the dye will disperse and show up at the leak site. Often a leak will only show up after the car is actually driven. The oil needs to get good and hot and the pressures need to be elevated. Otherwise you may not find any leaks.

A UV lamp will aid in the detection of the leak. These are jam packed engines so it can sometimes be quite difficult to locate the leak. You may have to begin removing parts in order to see more clearly the offending components, so be sure to allow for plenty of diagnostic time to locate the leaks. On some models, BMW recommend the use of a borescope to look into tight spots.

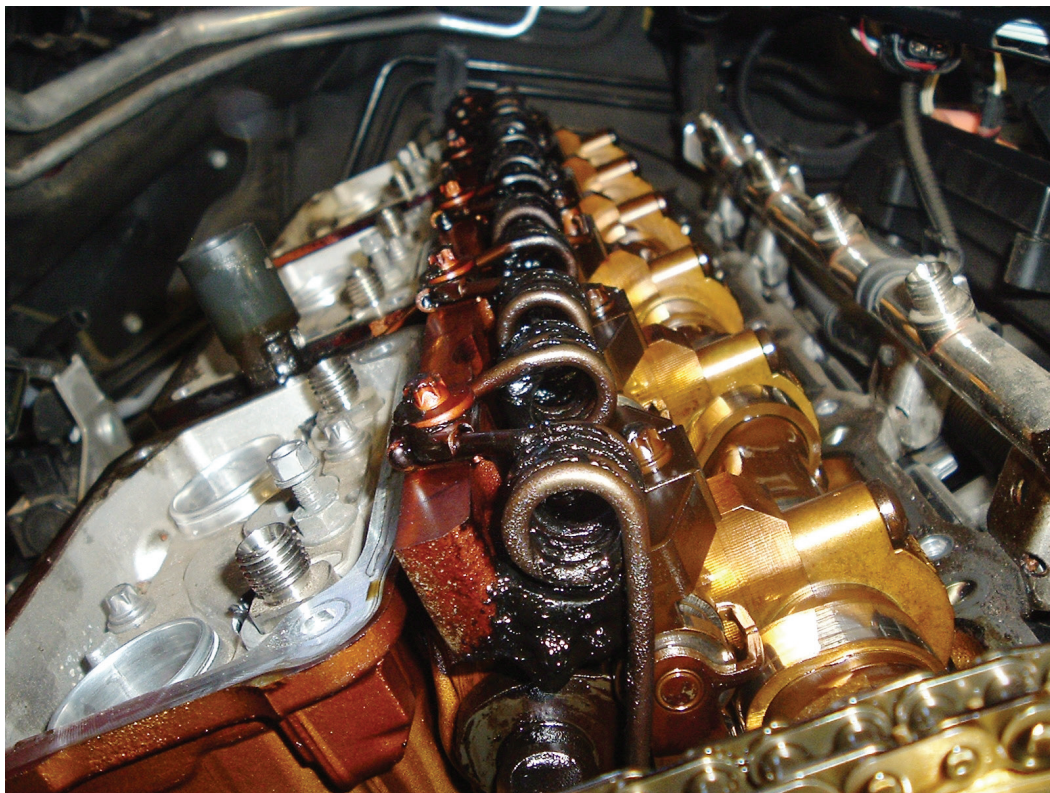
This valve cover was removed from an N55 engine with only 55k miles. Note the sludge buildup already. The customer had the oil changed at the dealer at the recommended intervals of 15k miles. Not often enough!

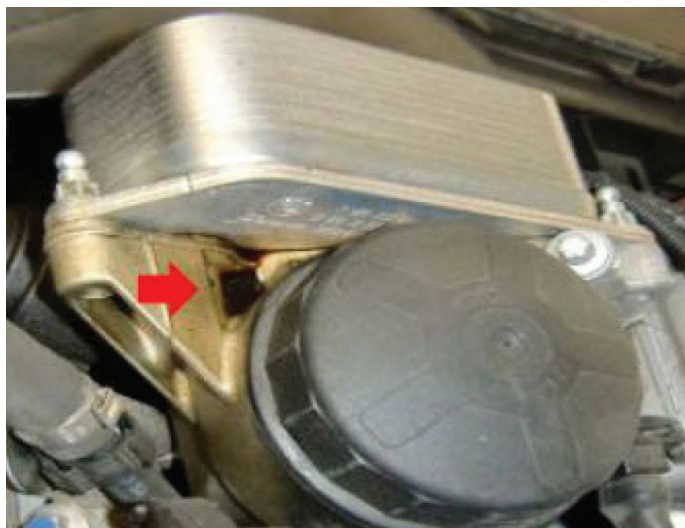
Note that the TSB states a repair is necessary for the condition shown in this photo. Careful! This may be sloppy workmanship from an oil filter change.

Oil spillage – This is usually a customer related issue, but some sloppy shops have been guilty of simply spilling the oil when filling or topping up. In this case, the oil may also run onto the oil pan and be mistaken for a leak at this location. You can usually identify this by the stain of oil running down the filler opening. It is also recommended, when removing the oil filler cap, do not put the cap down with the sealing surface facing up. Otherwise, the oil that is in the cap may get behind the seal and, once the cap is refitted, may be mistaken for an oil leak. Also, you may note in one of the photos some oil accumulated in what looks to be the oil stand area below the filter cover. This too may be sloppy workmanship or the result of not cleaning up after changing the filter.

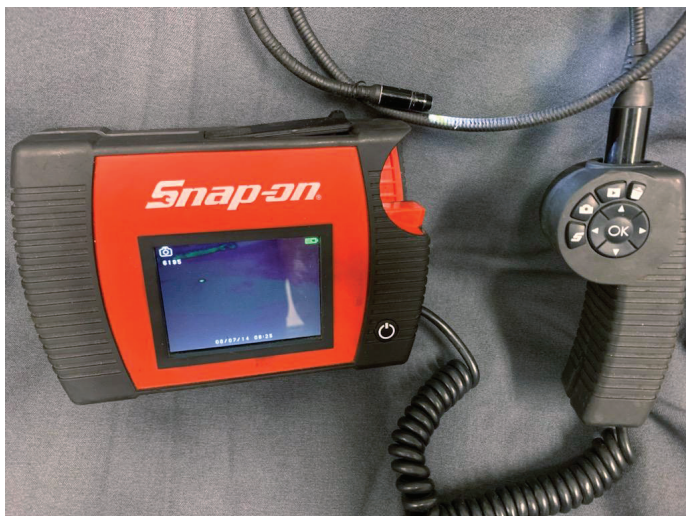
The use of a good borescope can help you see into tight spaces.

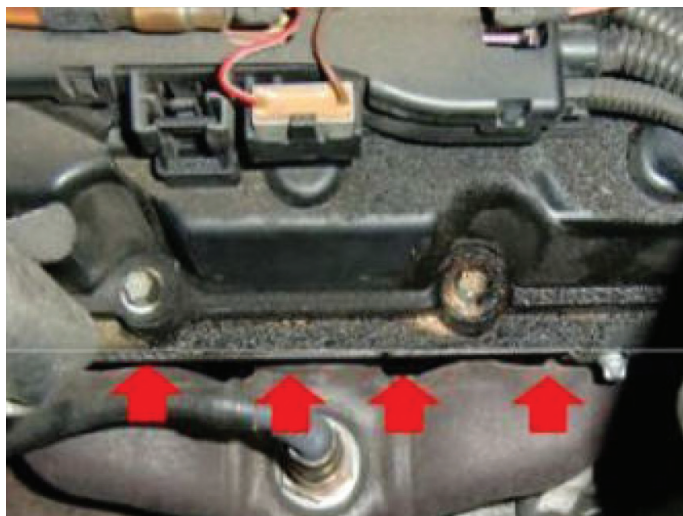
Note the oil accumulation where the valve cover meets the cylinder head.

Valve Cover Gaskets – This may be found on most models, certainly those with N54 and N52 engines. Telltale signs are wet areas around the hold down bolts, the front of the engine, and along the cover's joint with the cylinder head. Some models have plastic valve covers that develop hairline cracks over time from the heat involved in the engine compartment, expansion and contraction, etc. These often have to be replaced along with the gaskets.

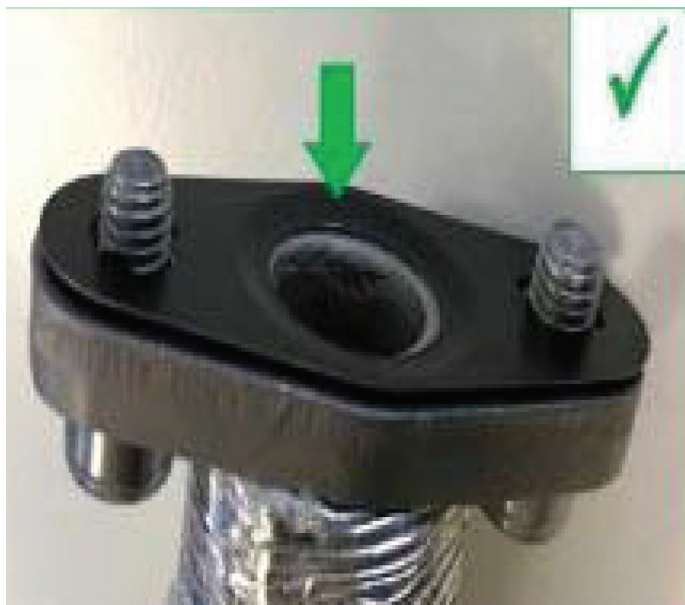
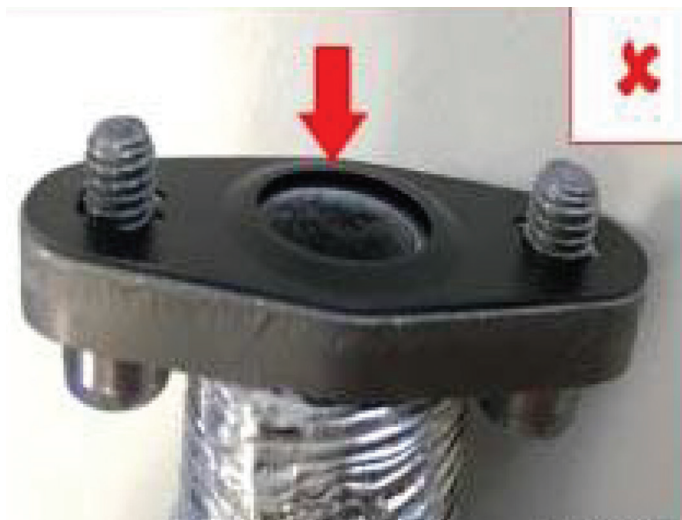
Note in the two photos the correct and incorrect installation of the return line gasket.

B46/48 Engines in F30 models – You may encounter an oil return line leaking at the connection to the turbocharger. There is actually a service bulletin SI B11 15 17 addressing this issue. It is possible that the gasket has been installed improperly.

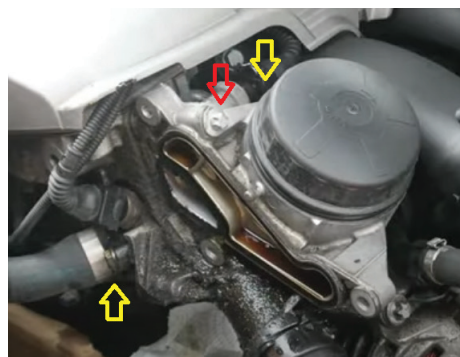
Here is the oil filter housing on an N52 engine with the oil cooler removed. The yellow arrows point to the two hidden bolts. The red top one is easy.

The housing itself is now accessible. It also has three bolts holding it on. First, you'll need to unplug the oil pressure switch connector. Underneath, in the front, is a difficult one to reach without removing the nearby coolant hose. The one in back is somewhat hidden by the intake manifold. A combination of a ¼ inch drive extension with a universal T10 Torx socket will reach it however. The top one is the easy one.

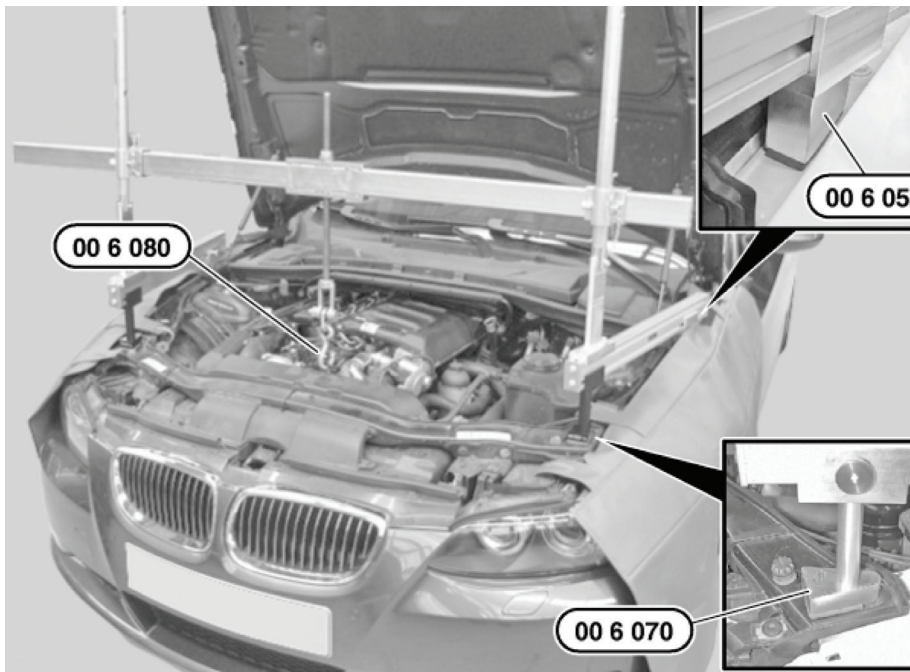
The engine needs to be supported in order to remove the subframe for clearing the oil pan.

- Remove the lower engine cover.
- Secure the engine in installation position. This means supporting the engine with a fixture from above. This step requires removal of several components to facilitate installation. Use the vehicle's tow hook for the front support connection. Remove the upper motor mount bolts. Here again the factory workshop manual suggests lifting the engine with the support fixture about 10 mm. Most techs find that simply supporting the engine is enough.
- Lower the front axle support or subframe. Interestingly, the repair manual lists this a simple step. This is easier said than done! It can be accomplished, however, with a universal transmission jack or floor jack if you're
