Four Common High Mileage Repairs

Different terrain, temperatures, and road conditions affect vehicles differently. Here are some common problems found in high mileage Volvo vehicles.

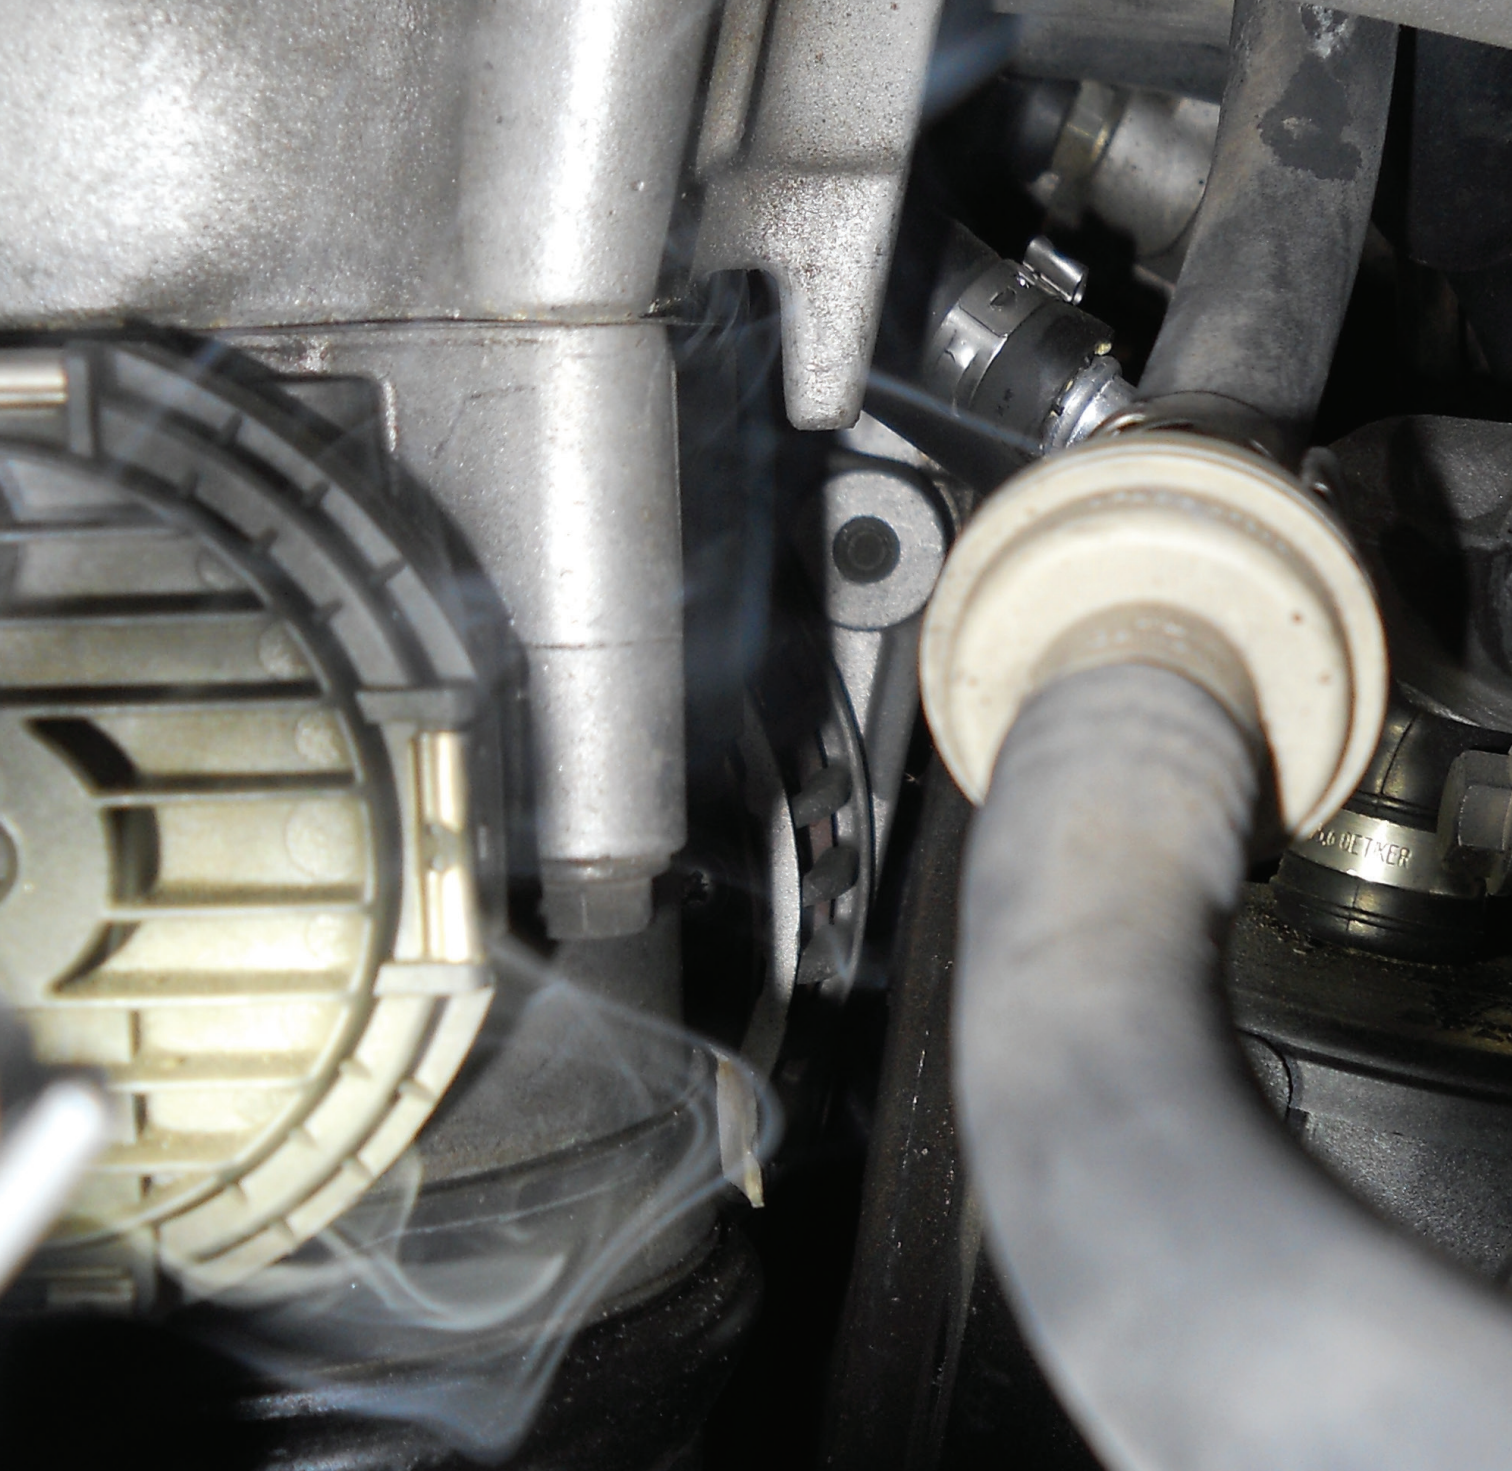
Shown here: Leaking smoke from throttle body pipe flange

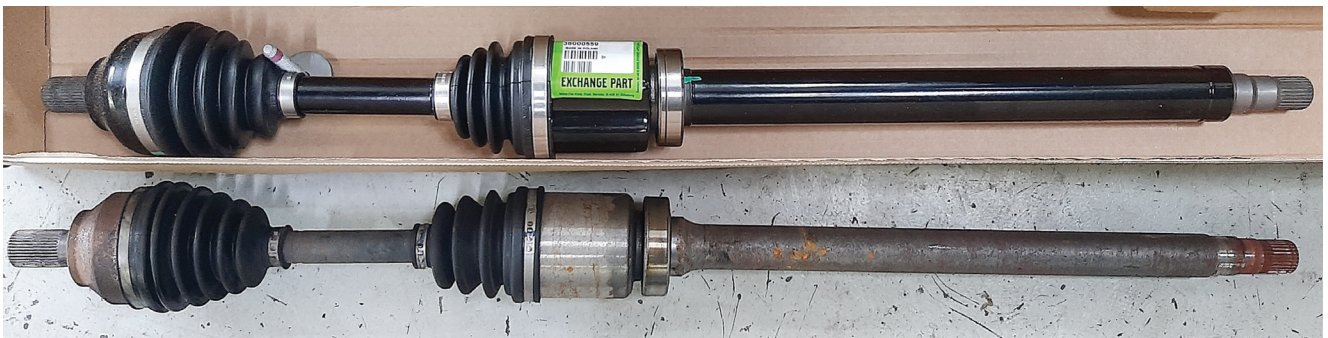
If you are going to replace a front C-V axle on a P1 Volvo, you better use an OE Volvo replacement part from your local retailer because P1 Volvos don't get along well with aftermarket axles.

Including the front C-V axles, these axles are not unique among other C-V axles but, for some reason, the P1 chassis Volvos are very picky when it comes to the brand of replacement axles that are used.

The aftermarket parts manufacturers do make axles for these cars, but if you don't want the car to come back, you better use only Volvo OE axles from your local retailer.

Yes, aftermarket axles may be cheaper, and some may be well-made parts, but if you use any of these, you may be in for a disappointment, because the fact is that nine out of ten times, the use of anything but an OE Volvo axle will cause problems such as high speed vibrations. It may not happen right away, but there's a good chance that it won't last a year without a problem.

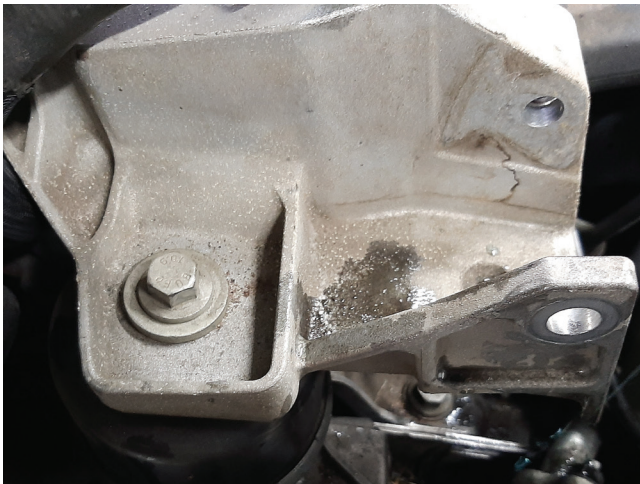
Top view of right mount bracket with torque mount removed.

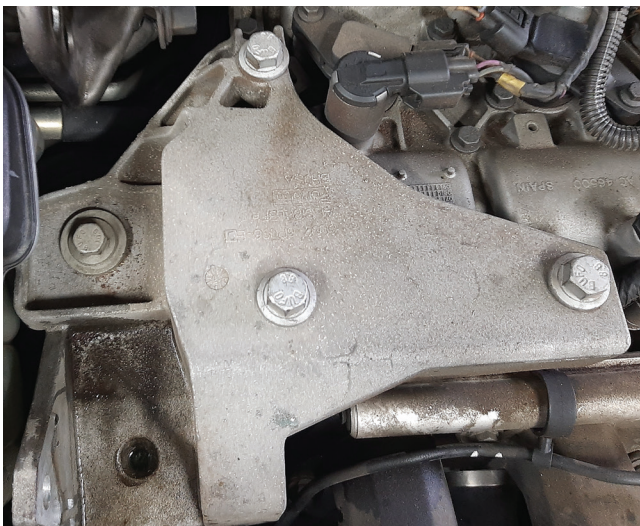
Top view of mount bracket with torque mount removed. This motor mount is hard to inspect without removing the upper engine torque rod and moving the coolant expansion tank out of the way.

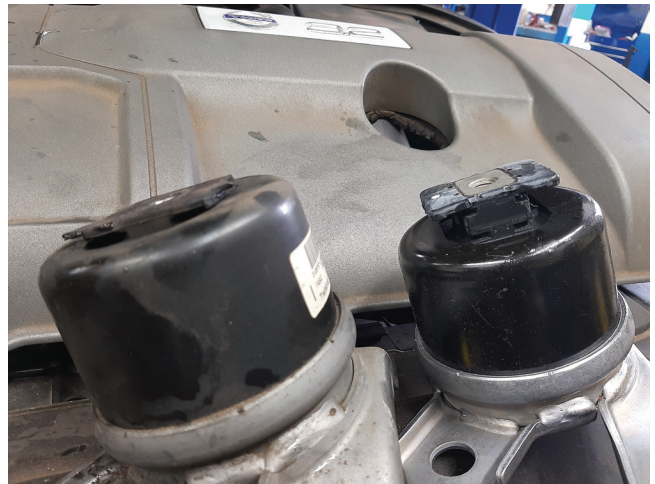
It's easy to see that the engine mount shown on the left is worn out when compared side by side with a new one, but this may be hard to see when the mount is still installed.

When you compare a new factory Volvo mount to the old worn out one side by side, the problem is obvious.

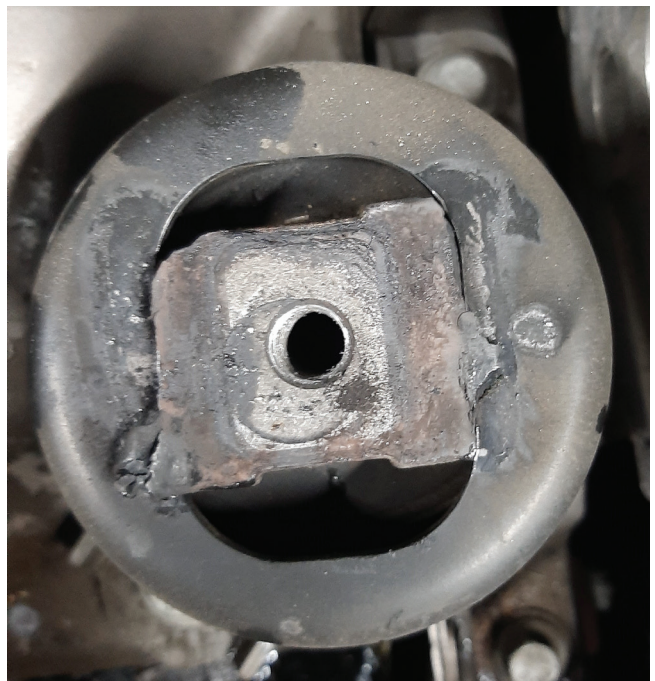
To confirm that the right hydraulic motor mount is worn out you may need to remove the upper mount bracket from the engine.

If you suspect one of these right hydraulic mounts is bad, you may have to remove the upper bracket that holds it to the engine to confirm it.

Once you get the upper mounting bracket removed, you will see that the center of a worn mount has collapsed into the mount's housing.

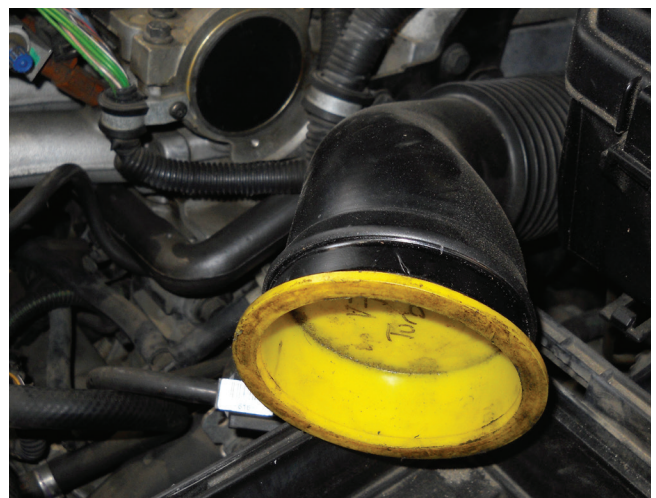
Air box pipe plugged for smoke testing

In most cases, the best way to start is to disconnect the intake pipe from the air filter box and plug it with a tight-fitting cap or even a rubber glove.

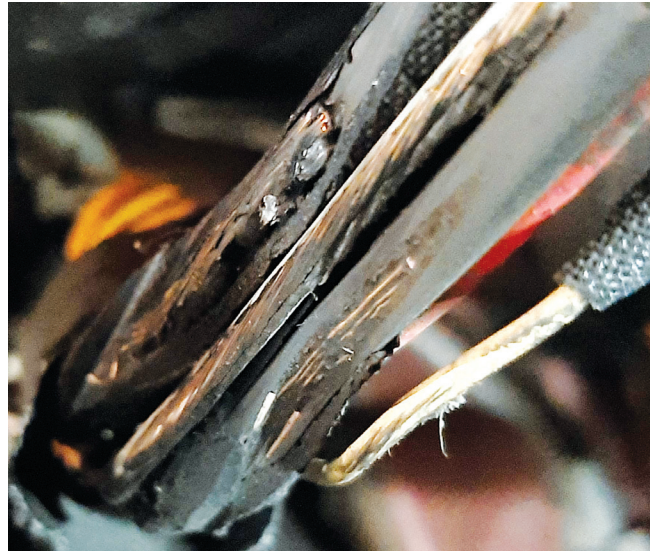
Belt rub damage to wire harness.

Over time, the loose wire harness tends to gravitate towards the pulley and belt on the power steering pump. Then the power steering pump pulley will make short work of the wire harness's insulation and then start to work on the wires themselves.

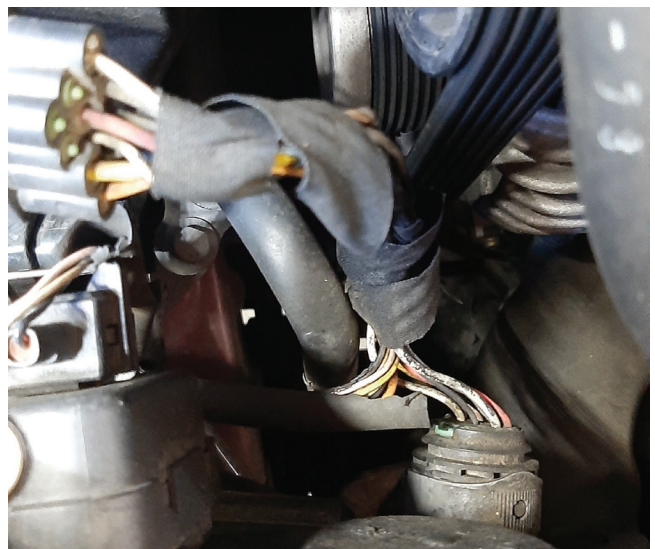
If the wire harness behind the right headlamp assembly on an early XC70 or V70 (2005–2007) breaks its tie down, it can start to rub against the power steering pump pulley and cause damage to the harness.

What happens is, part of the wire harness on the right side of the engine compartment behind the right headlight can come loose because the plastic tie downs that hold it in place deteriorate.

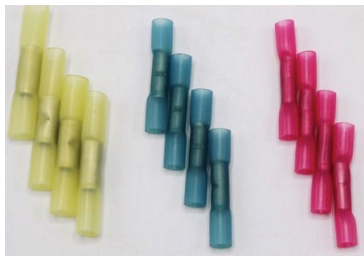
If you find yourself splicing two wires together on a Volvo, you should use one of these all-in-one heat shrink connectors. When done right, the fix can be watertight.

One of the best new options for effective splicing of wires is sort of an all-in-one connector. These repair connectors, commonly known as butt connectors, have an outer sleeve that is made out of a high-strength heat shrink material that, when properly installed, can be completely water tight.
