Volvo TechTips

Information for the Independent Volvo Specialist

Spring 2022

MIL Codes and Faults

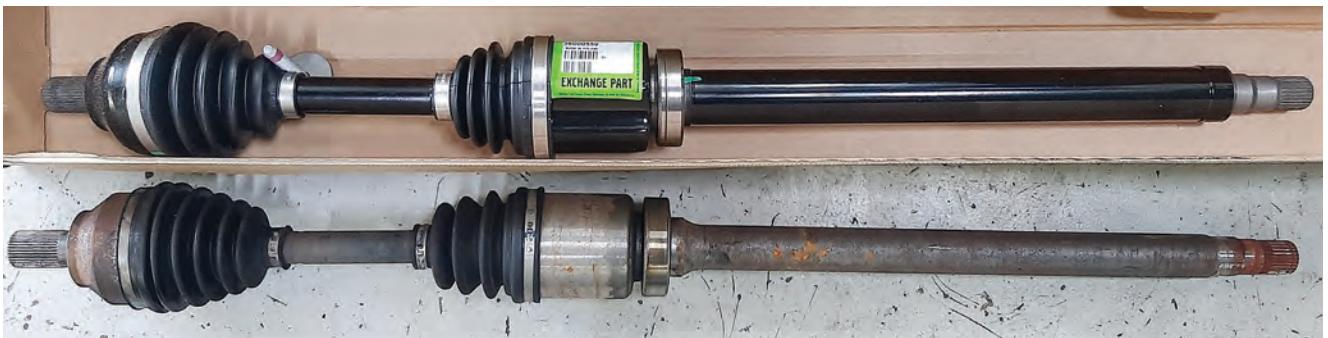
If you are going to replace a front C-V axle on a P1 Volvo, you better use an OE Volvo replacement part from your local retailer because P1 Volvos don't get along well with aftermarket axles.

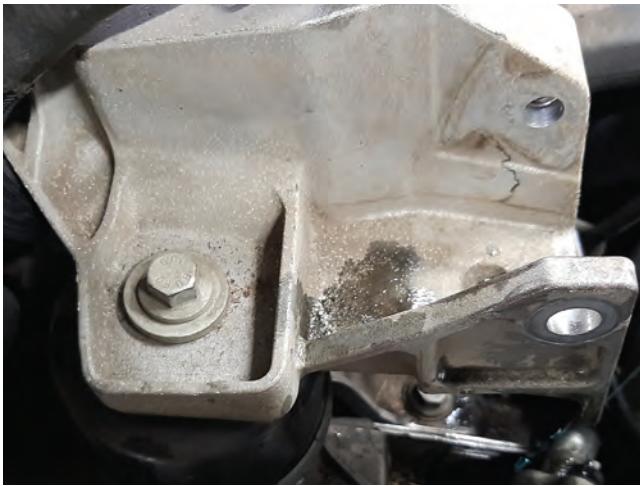
Top view of right mount bracket with torque mount removed.

Once you get the upper mounting bracket removed, you will see that the center of a worn mount has collapsed into the mount's housing.

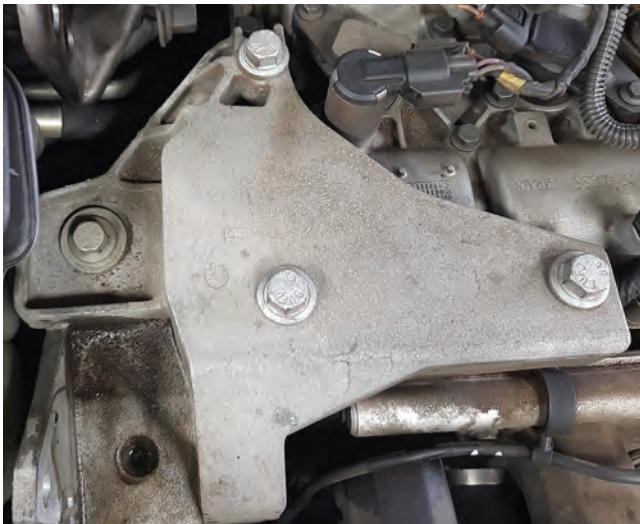
Top view of mount bracket with torque mount removed. This motor mount is hard to inspect without removing the upper engine torque rod and moving the coolant expansion tank out of the way.

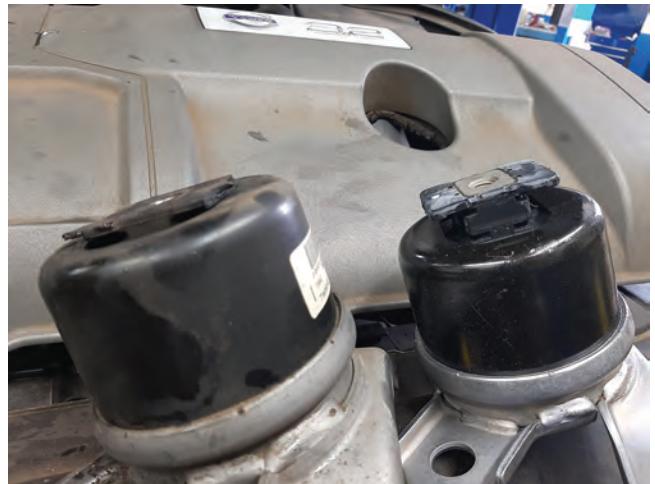
It's easy to see that the engine mount shown on the left is worn out when compared side by side with a new one, but this may be hard to see when the mount is still installed.

When you compare a new factory Volvo mount to the old worn out one side by side, the problem is obvious.

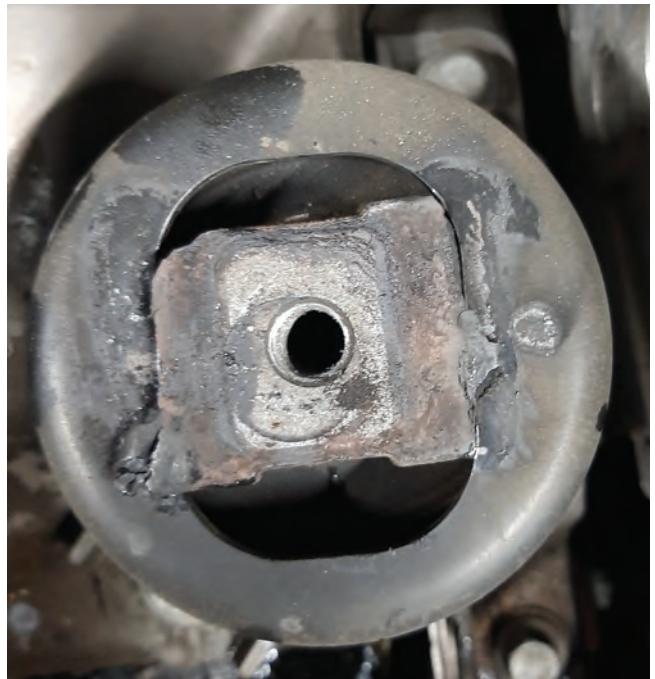
To confirm that the right hydraulic motor mount is worn out you may need to remove the upper mount bracket from the engine.

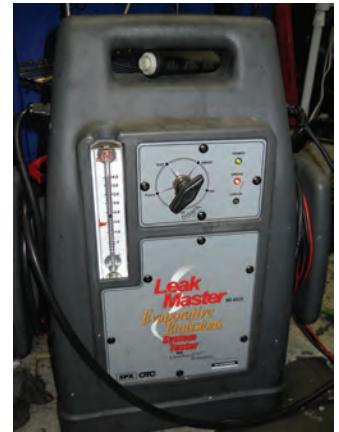
Smoke Machine

When trying to isolate an intake air leak on a Volvo or any car, the best tool is still a good diagnostic smoke machine. The newer models are very effective, and you can even get smoke oil for your machine that has an ultraviolet dye in it that can leave a trace residue at the site of the leakage that can be seen with a UV inspection light.

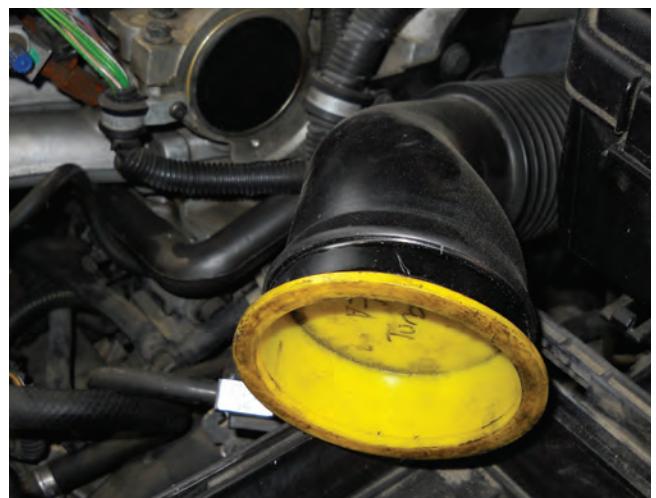
Air box pipe plugged for smoke testing

The best way to find an intake leak on a Volvo is to try to isolate the intake system that you want to test as much as possible before applying smoke to the intake.

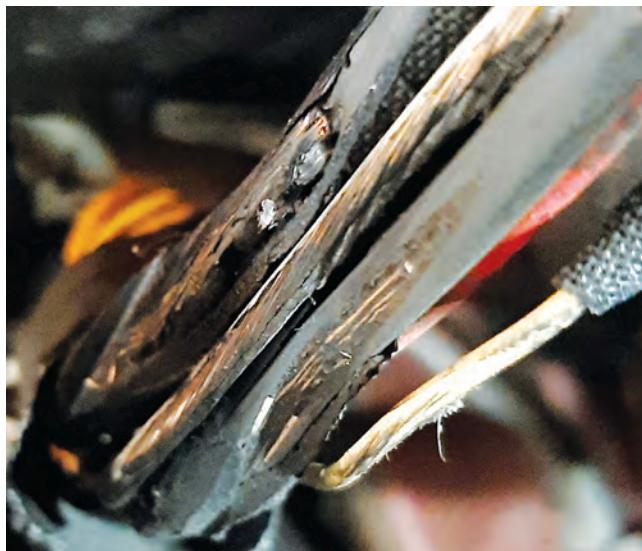
Belt rub damage to wire harness.

Over time, the loose wire harness tends to gravitate towards the pulley and belt on the power steering pump. Then the power steering pump pulley will make short work of the wire harness's insulation and then start to work on the wires themselves.

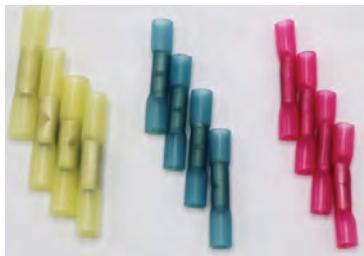
If you find yourself splicing two wires together on a Volvo, you should use one of these all-in-one heat shrink connectors. When done right, the fix can be watertight.

One of the best new options for effective splicing of wires is sort of an all-in-one connector. These repair connectors, commonly known as butt connectors, have an outer sleeve that is made out of a high-strength heat shrink material that, when properly installed, can be completely water tight.

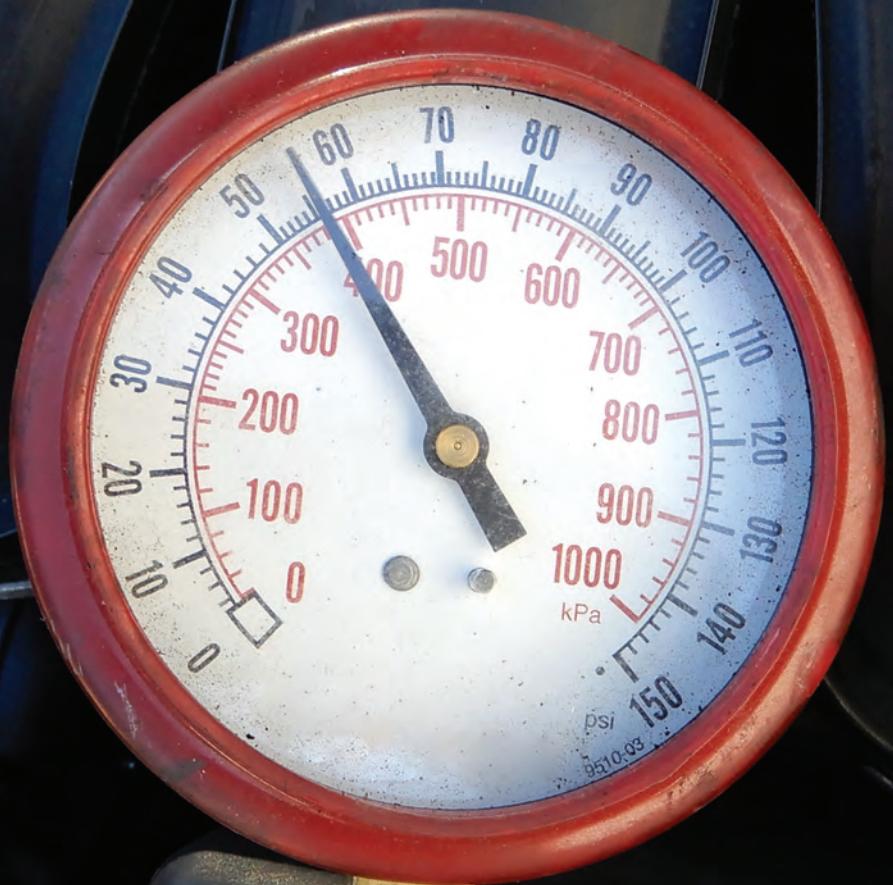
Fuel gauge attached to fuel rail at Schrader valve

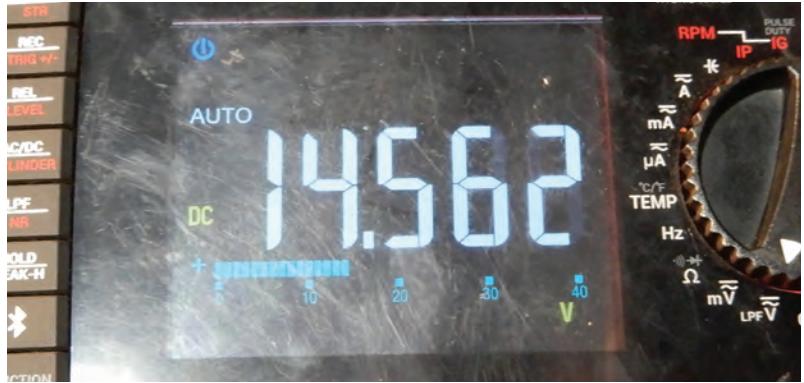
Correct alternator voltage using a volt meter

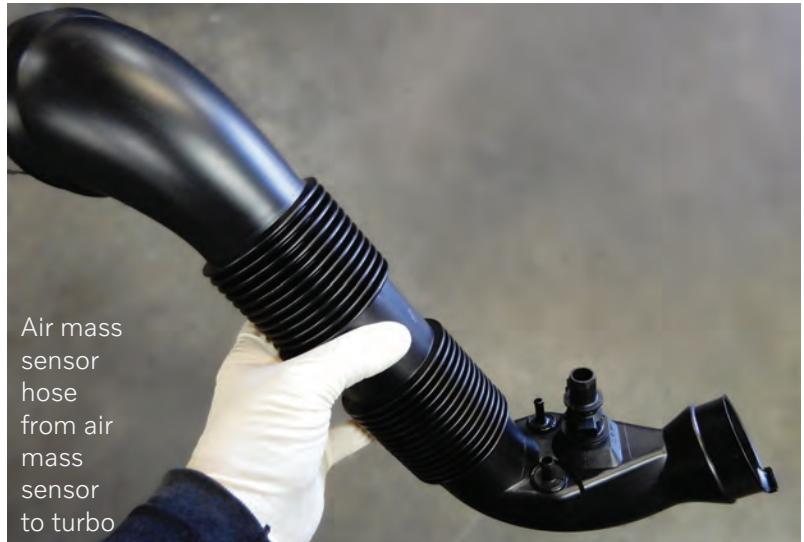
Air mass sensor hose from air mass sensor to turbo

On the Volvo five-cylinder engine, the plastic hose from the air mass sensor to the turbo can set this code. Smoke testing the vehicle can find the leak

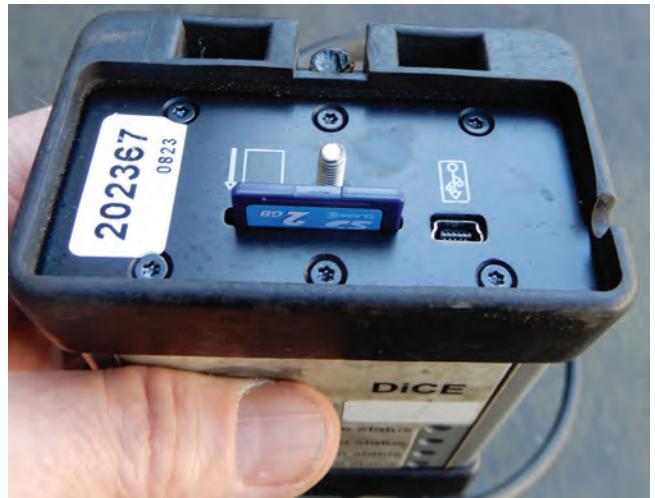
Memory card inserted into DICE

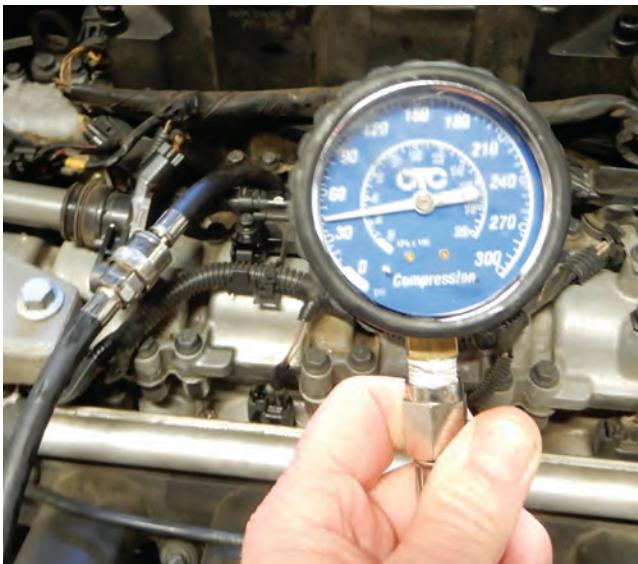
Taking a compression test on each cylinder to measure compression

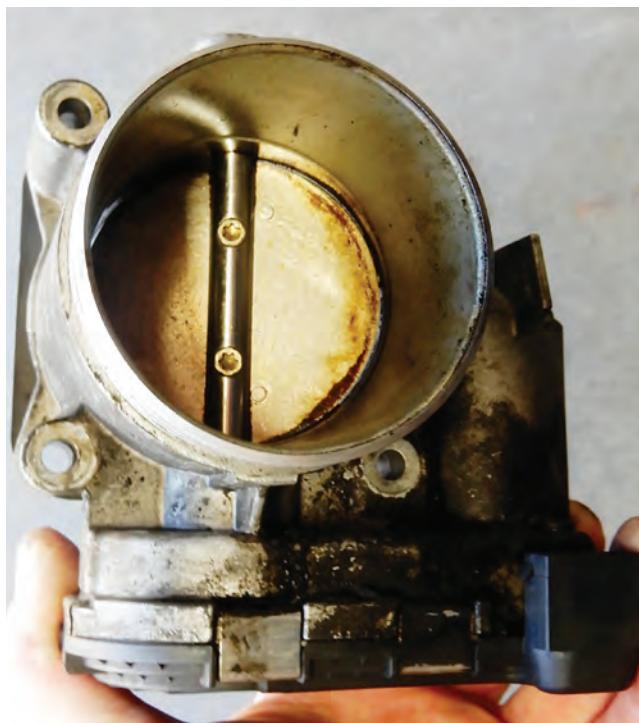
Electronic Throttle Module (ETM) that has been removed from vehicle, and throttle plate build up has caused the throttle plate to have resistance.

Electronic throttle modules can make a vehicle run poorly, might cause an uneven idle, or the vehicle might die coming to a stop and never set a diagnostic trouble code. You will want to hook up VIDA and, in Vehicle Communications, go to ECM and monitor the

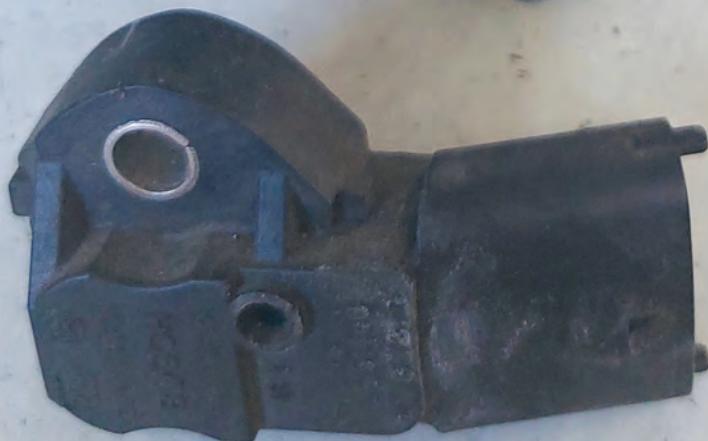
If you end up replacing the fuel pressure sensor on one of these Volvos, make sure that you use the part number of the old one and pay attention to the color—different ones will fit but can cause driveability issues.

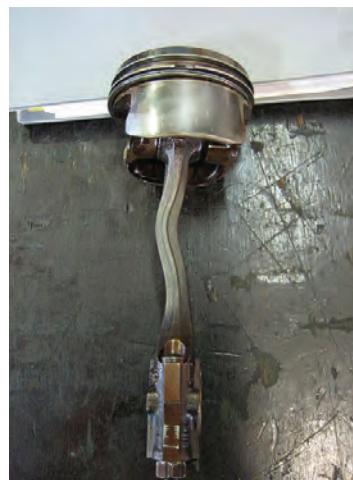
If a car that you are working on comes into your shop dripping raw fuel out of the tailpipe, do not try to crank over the engine to clear the flooded spark plugs because one or more of the cylinders may be filled with fuel. It is very possible that you could cause permanent damage when the pistons try to compress all that fuel.

If you continue to crank over the engine that is filling with raw fuel, hydrolock can be a real possibility, so don't do it; you may end up bending some connecting rods.

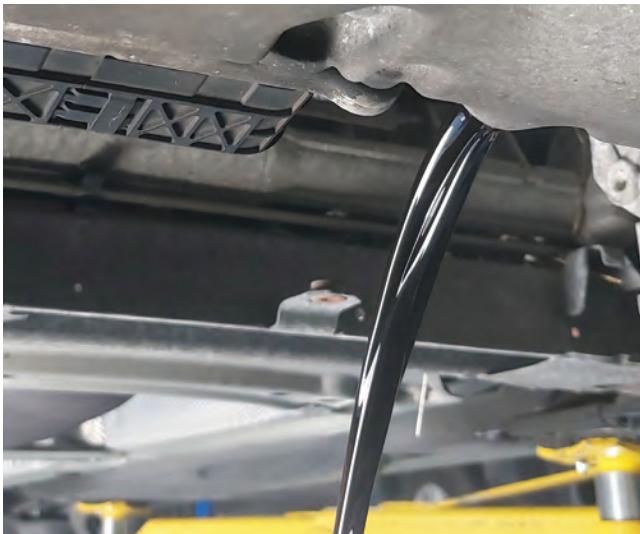
If you are repairing a car that has been dumping raw gas into the combustion chamber and washing down the pistons, you should always recommend that your customer have the spark plugs, engine oil and oil filter replaced after the problem is solved because in most cases the engine oil will be saturated with fuel.

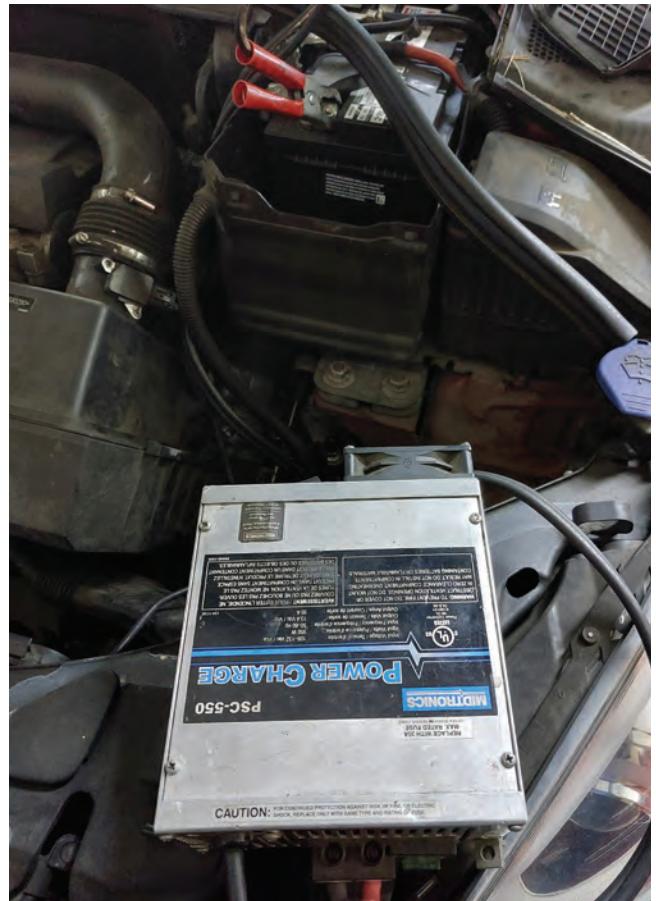
When you are performing diagnosis and testing on a Volvo's fuel injection system, you should always hook up a battery voltage maintainer such as the Midtronics psc-550 or similar. This will ensure that your readings and testing won't be affected by low battery voltage.

The tech also hooked up a Midtronics battery support unit to make sure that the system voltage was maintained so the test data would be accurate.

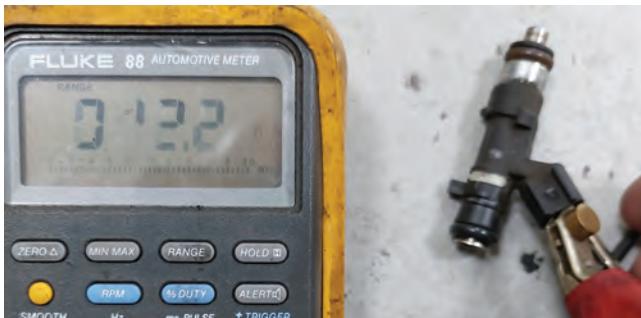
Old injector Ohm reading

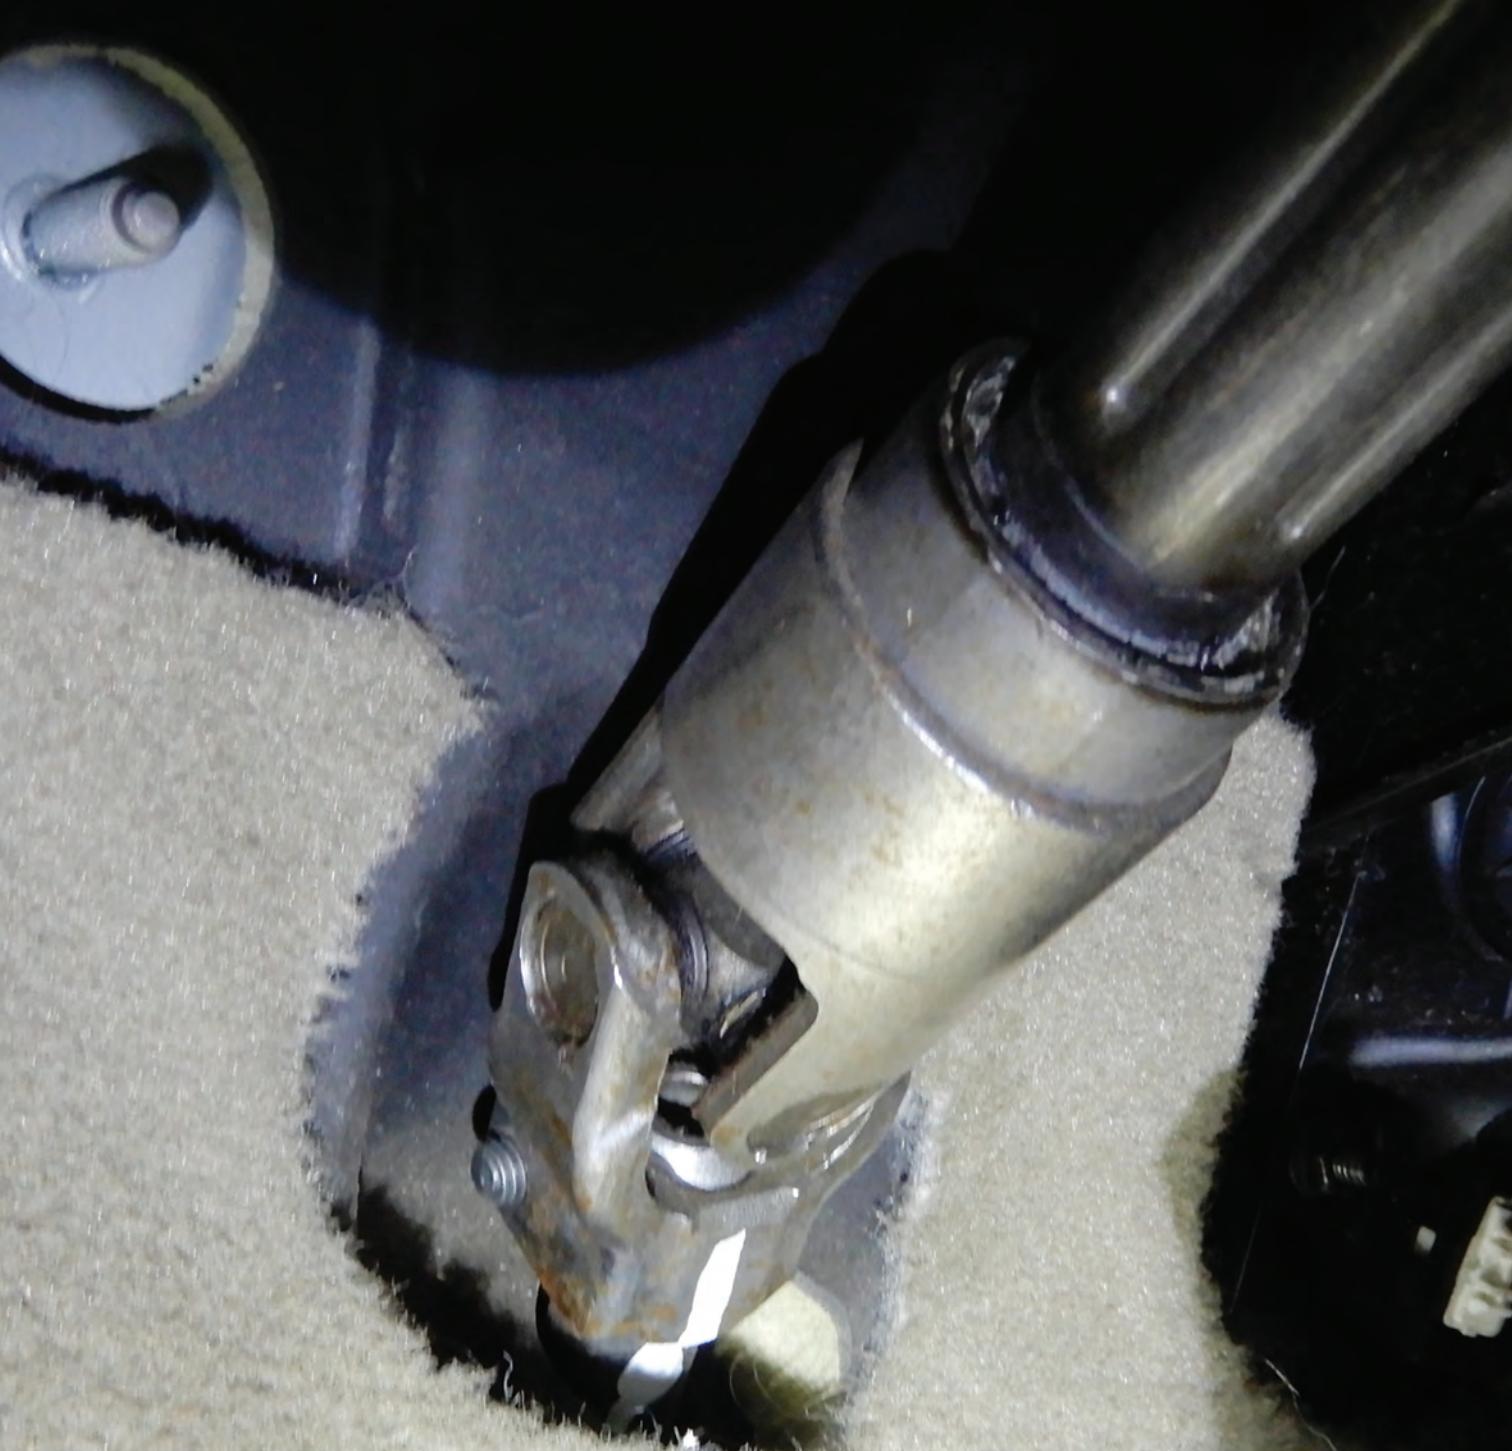
Steering Column Lock (SCL)

Shown here: Bottom of steering column, removing bolt and lift up steering shaft joint so that it releases from the steering gear

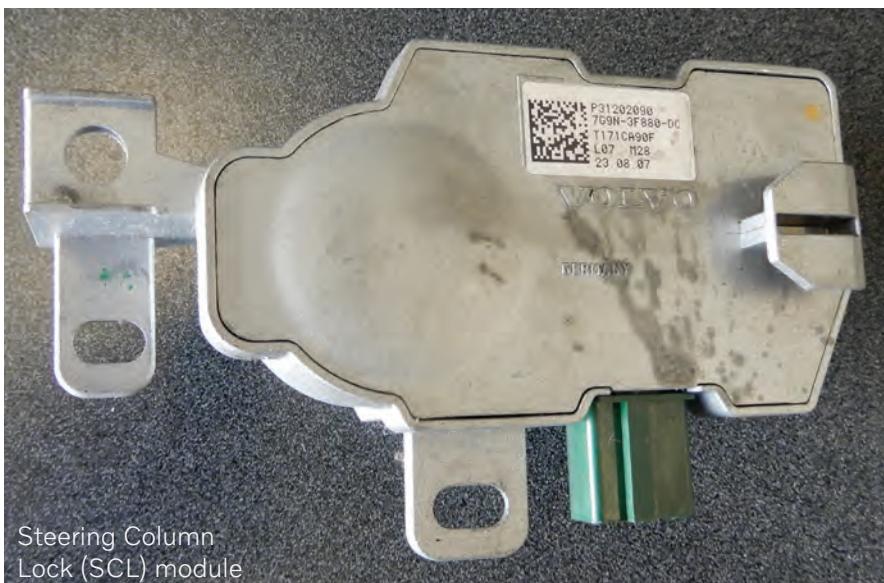
Steering Column Lock (SCL) module

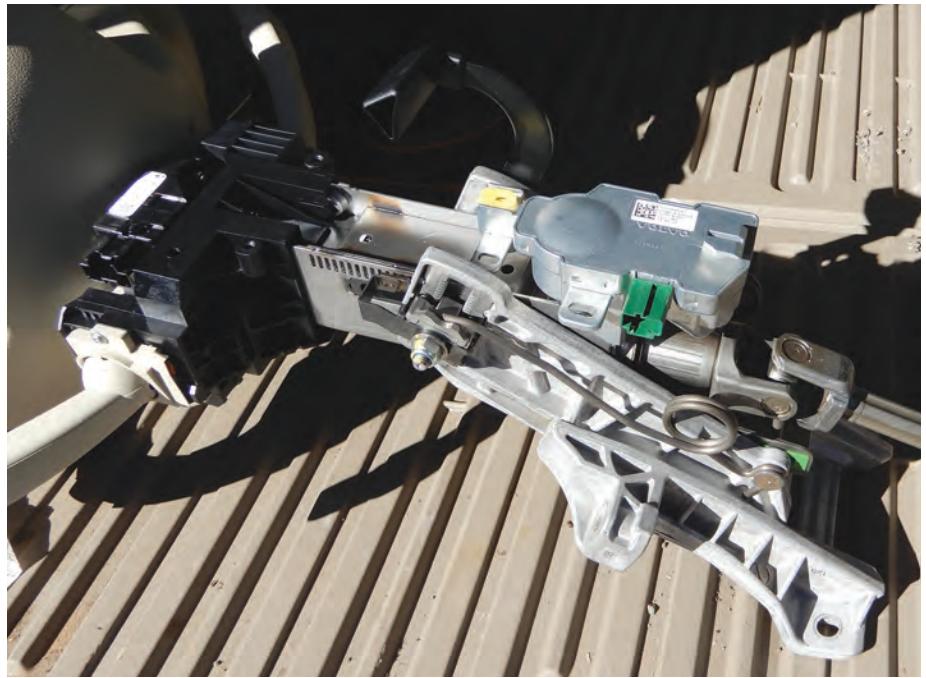
Steering column removed from vehicle

Now you will be able to remove the steering column from the vehicle.

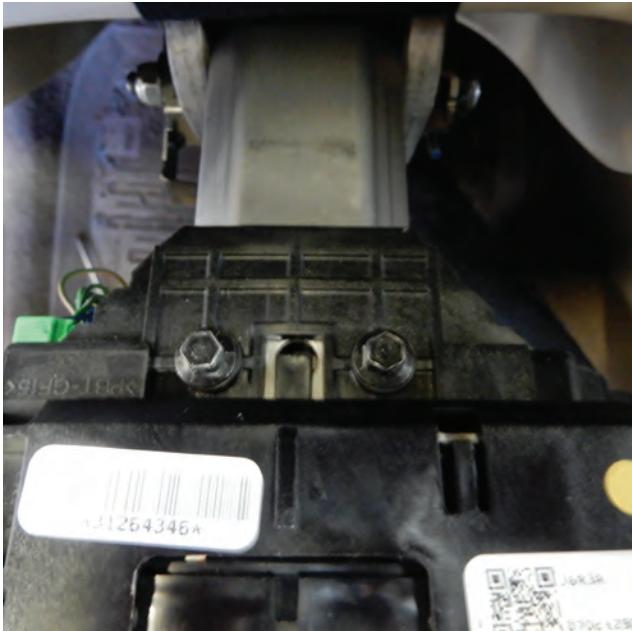
Steering Wheel Module (SWM) installed on steering column, the two bolts that hold it to column

Set the electrical harness in place and attach the electrical connector at the steering column lock. Install the steering wheel module onto the steering column and tighten down the two 7 mm bolts at the top of the module.

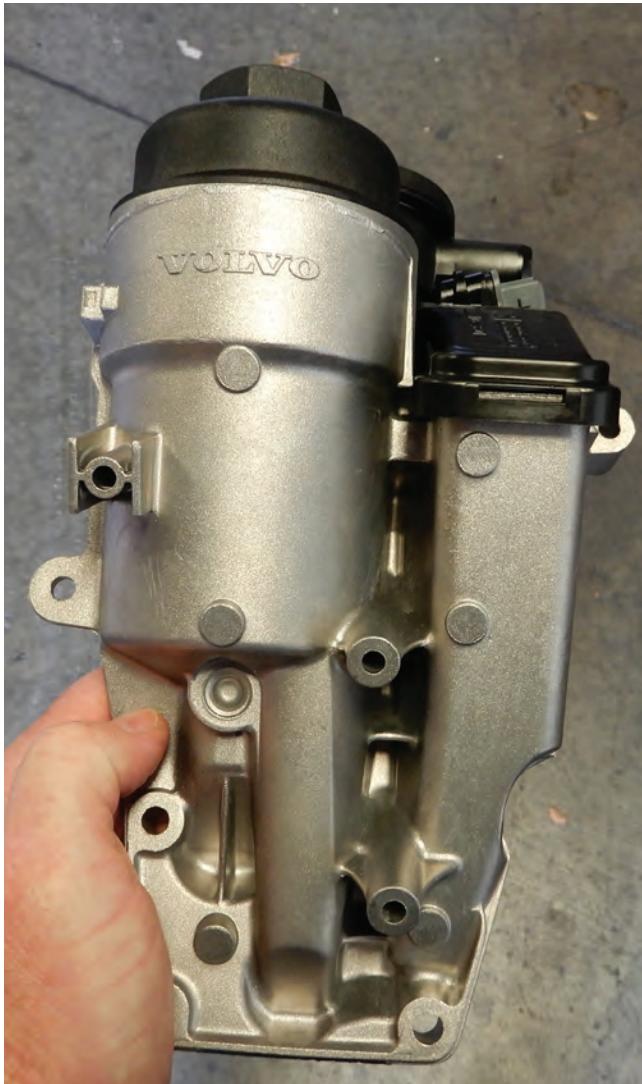
Oil separator

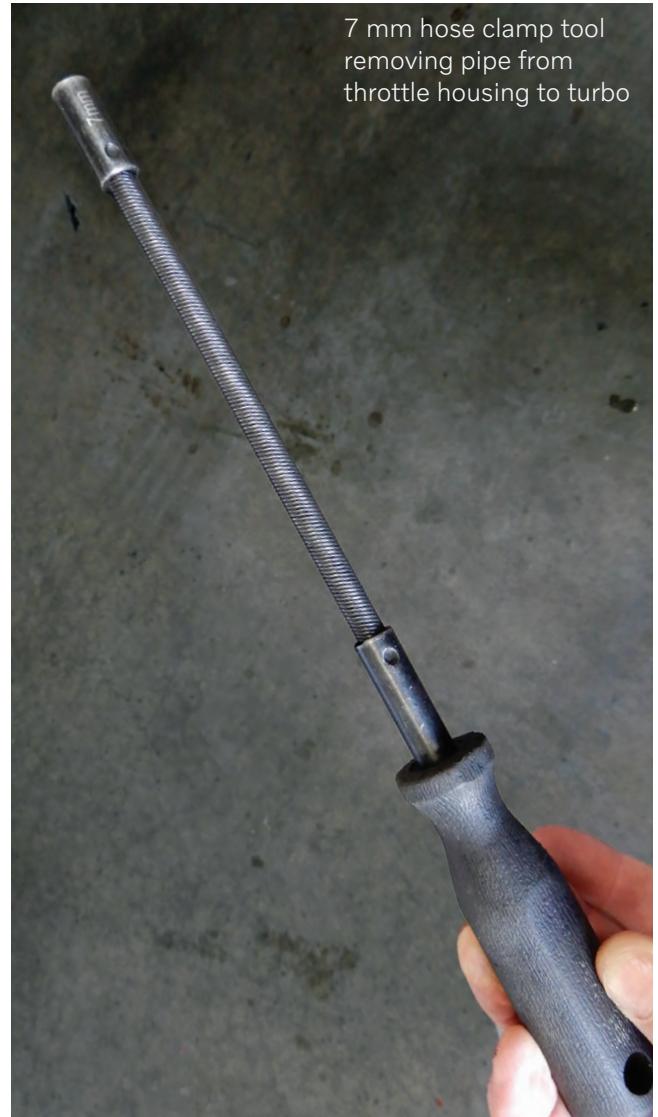
7 mm hose clamp tool
removing pipe from
throttle housing to turbo

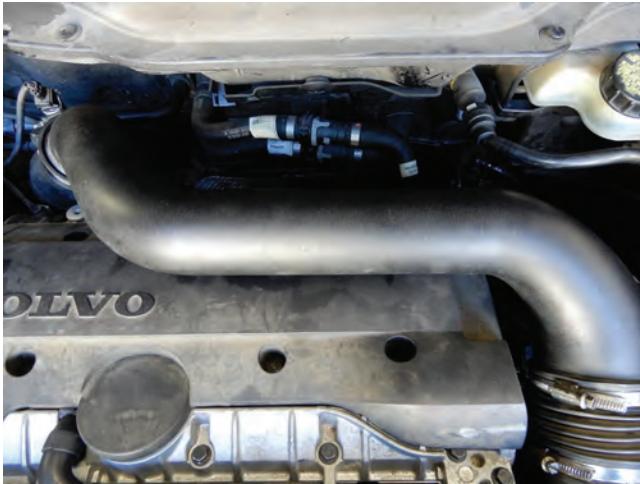
Hard pipe from air mass meter to turbo

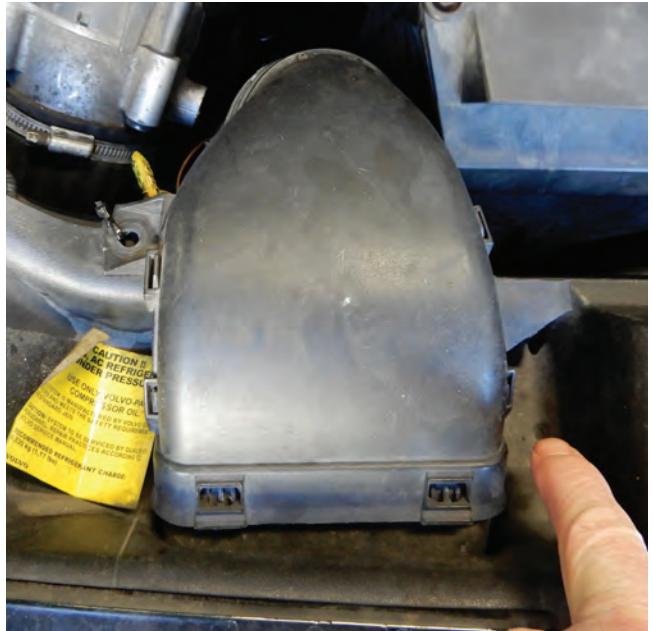
The two bolts that secure fresh air intake

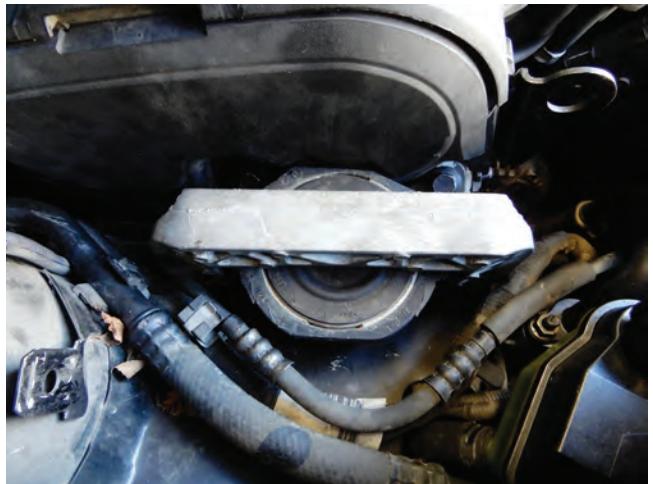
Front engine mount that needs to be removed

With a 15 mm socket, pull out the two bolts that hold the top part of the mount. You will need to remove the plastic rock shield cover from underneath the vehicle. Support the engine under the front of the oil pan. Use a piece of wood and jack to support the engine, being careful not to damage the oil pan. Now remove the rest of the engine mount, two 15 mm bolts at front of the engine. Disconnect hose clamp at hose for the throttle housing. With the mount out of the way, you can now jack up the engine about four inches; this will help to remove the air filter housing.

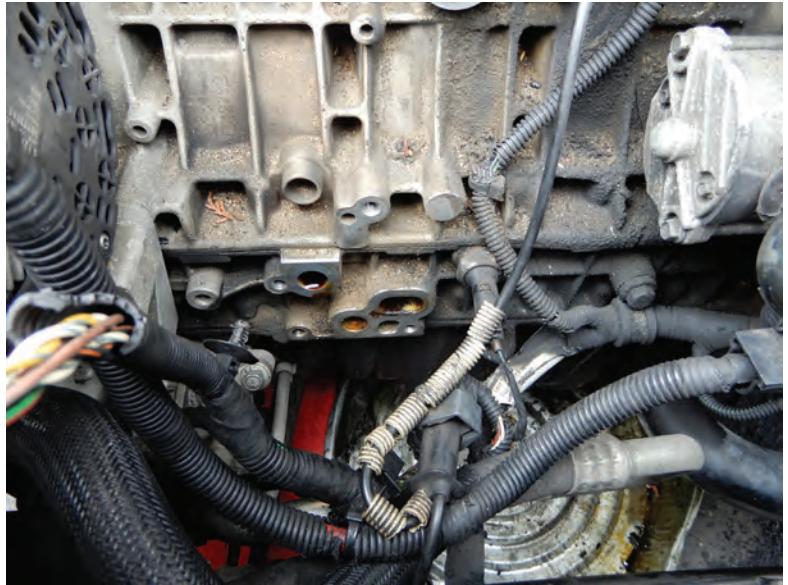
Oil filter housing removed from engine block and cleaned for new filter housing

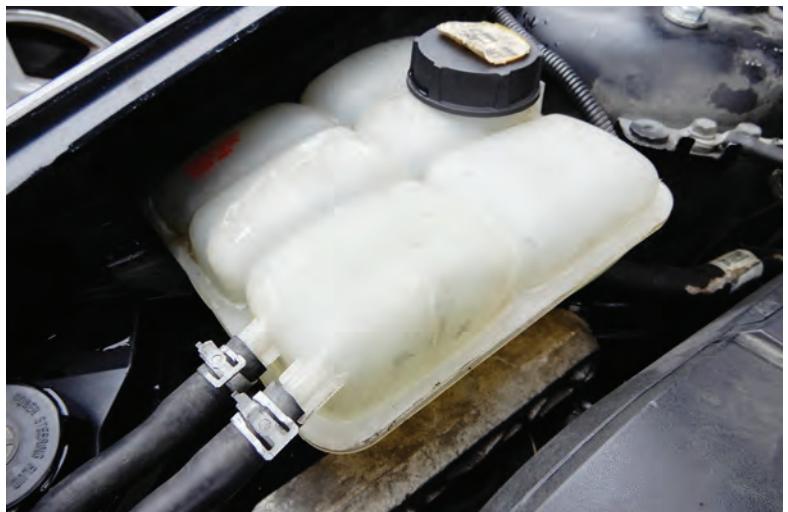
Coolant expansion tank back into place
