A Study in Pink: Understanding Toyota's Pink Super Long Life Coolant (SLLC) and Cooling System Components

By Jordan Hill

A study in Toyota's pink coolant and some of the cooling system components that utilize this coolant including electric coolant pumps, EGR coolers and heat exchangers.

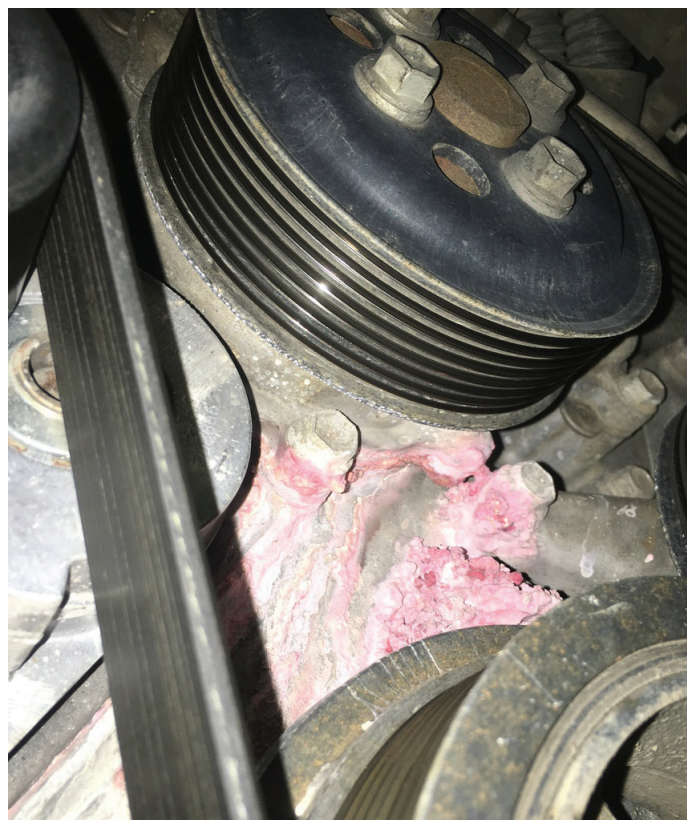
A second generation 2007 Toyota Tundra has been dropped off at the shop for a 5K service and inspection. While performing the service the technician notes dried coolant stains by the water pump pulley shown in the photo below.

2007 Tundra Water Pump

The technician finished the inspection and submitted his findings to the service writer. The service writer made an estimate for the pump along with a few other minor service items. After a phone call to discuss recommendations and pricing, our customer asks a question we've all heard before – "Do I really have to replace it now, or can it wait for a while?" The book time on the water pump is just under five hours, so it's not an inexpensive repair and our customer's question is reasonable.

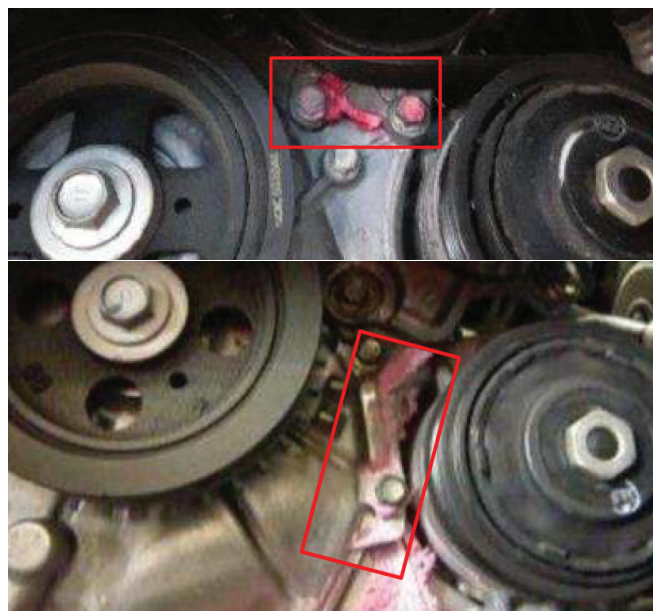
- As the water pump assembly rotates, a small amount of engine coolant is discharged to cool and lubricate the sliding surface of the mechanical seal and evaporates.

Temporary Leak - Dry Coolant Residue (Do Not Replace the Water Pump)

Water pump replacement is NOT necessary for a temporary leak condition. The water pump should be replaced for an active leak condition. Examples of both conditions are shown below:

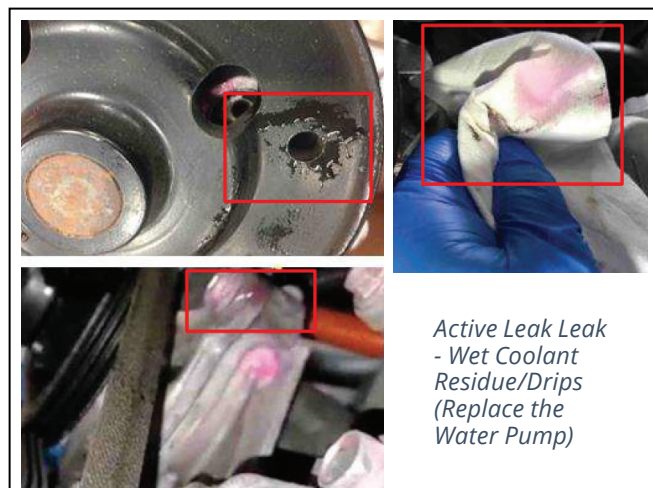
Active Leak Leak - Wet Coolant Residue/Drips (Replace the Water Pump)

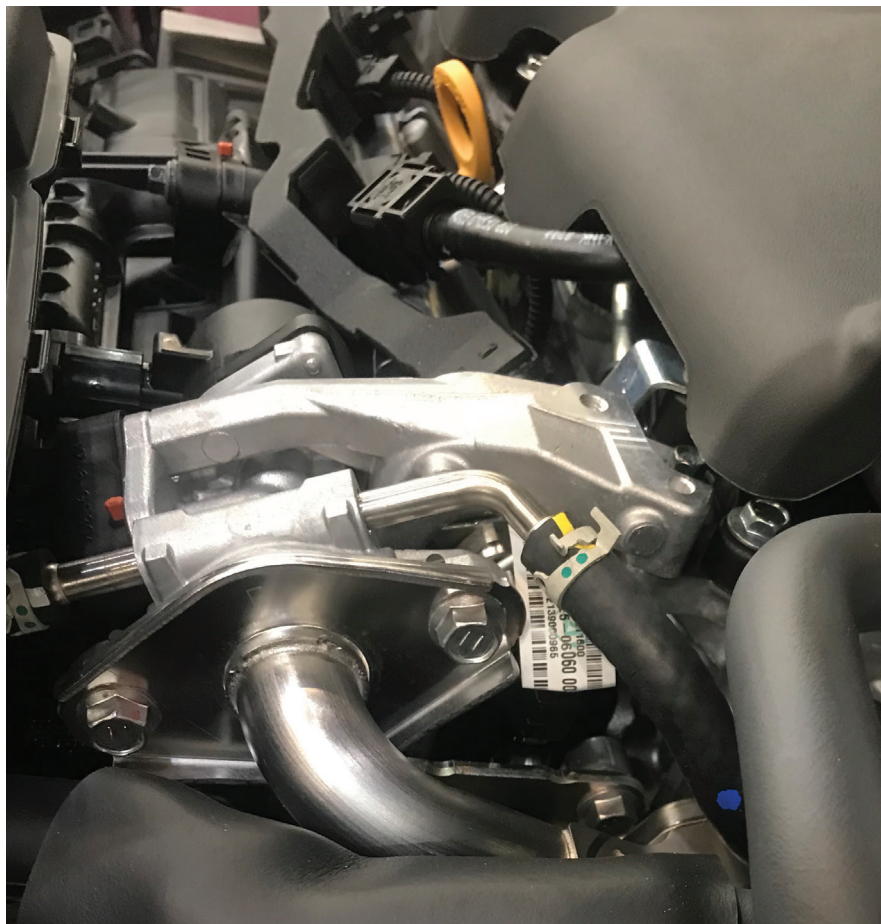
EGR Cooler - A25A-FXS engine (partial view)

cooler is an air to coolant heat exchanger that cools the recirculated exhaust gasses before they are re-introduced to the air intake.

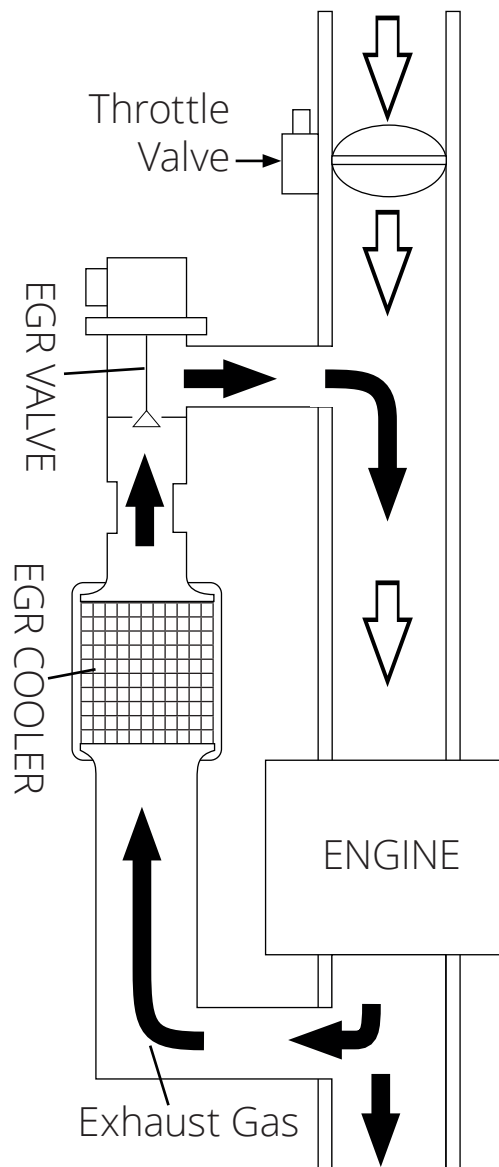
The main purpose of EGR systems is to lower in-cylinder temperatures and thereby lowering the production of Nitrogen Oxides (NOx) which are a negative byproduct of internal combustion. The EGR cooler aids in this process by further cooling the exhaust gasses before they are recirculated and improving the overall efficiency of the system. The cooler sits inline of the exhaust gas flow just before the EGR valve (see EGR System Diagram).

EGR System Diagram

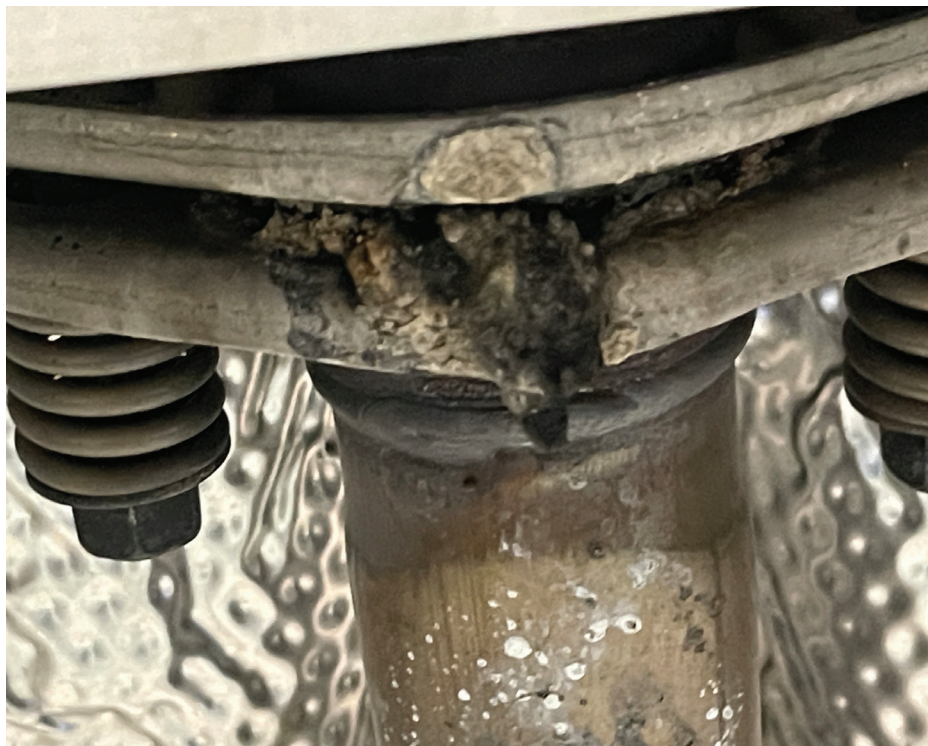
Coolant Stains from Heat Exchanger

heat exchanger leak is suspected the exhaust pipe should be examined for stains and the pipe may need to be disconnected to inspect inside. The TSB lists an updated front exhaust pipe assembly to address the failure point of the heat exchanger. This assembly is rather expensive, so care needs to be taken when diagnosing a faulty exchanger.

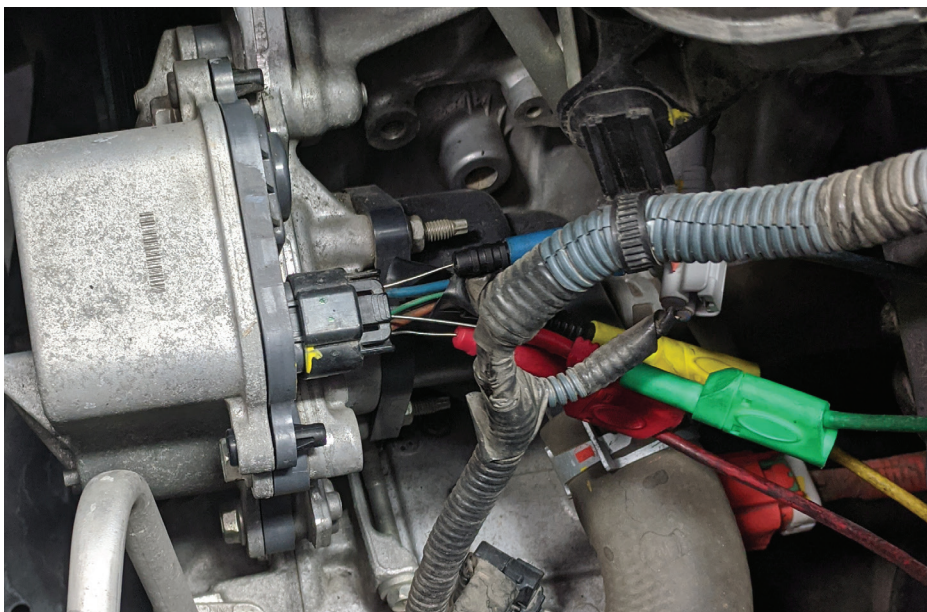
After reviewing the code set criteria and testing information, we connected a lab scope to the four wires at the coolant pump connector to capture waveforms while we were performing the Toyota's test procedures for P148F.

Electric Coolant Pump Testing

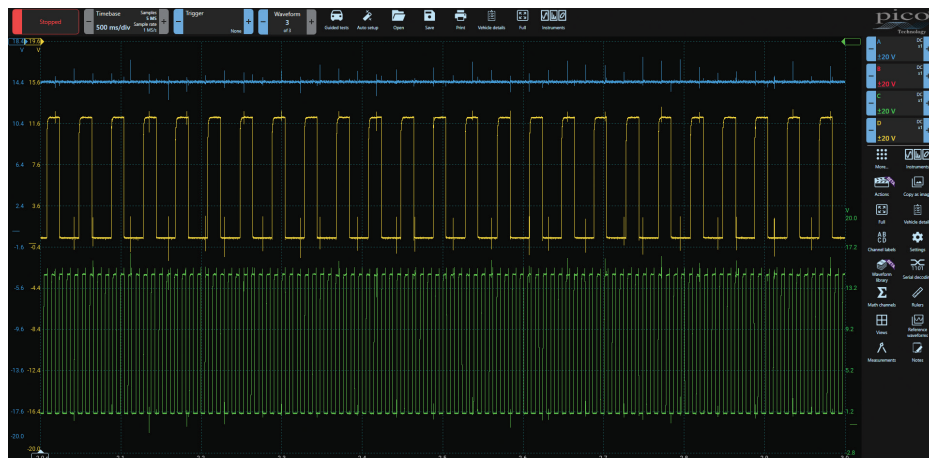
Channel A in blue is connected across the power and ground wires to the pump. Channel C in green and channel D in yellow are the command and feedback signals to and from the coolant pump. Despite all signals looking OK, the water pump was rotating faster than the ECM was commanding, possibly due to the impeller slipping on the shaft.

Coolant Pump Command & Feedback Signals

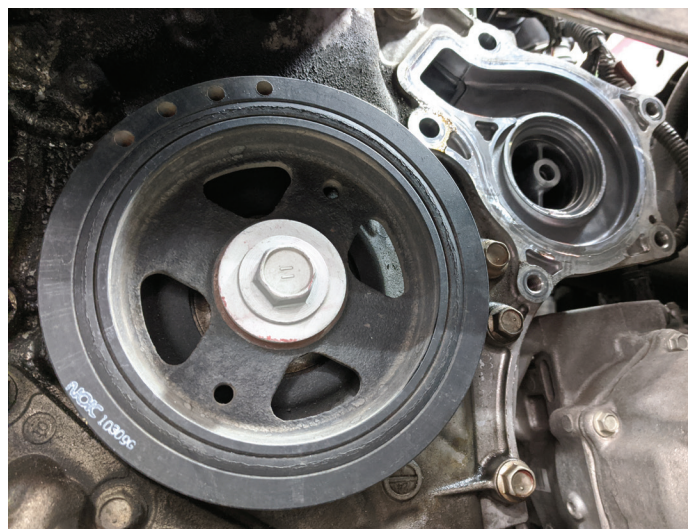
Electric Coolant Pump Replacement

The location on the electric coolant pump and the replacement procedure are very similar to the previous belt drive pump. Make note that two of the five bolts are longer than the others and require a different tightening torque.

Once the new pump is installed, the engine needs to be put into Maintenance Mode to keep the internal combustion engine running and properly bleed the cooling system. This procedure is outlined in service information and if executed correctly will result in the multi-information display reading "Maintenance Mode." After the coolant pump was replaced and the cooling system bled, an extended road test was carried out with no issues or faults present.
