Volvo TechTips

Fall/Winter 2022

Understanding and Diagnosing the Volvo TF-80SC Automatic Transmission in FWD and AWD Vehicles

The design and function of this transmission, what goes wrong, and how to diagnose problems

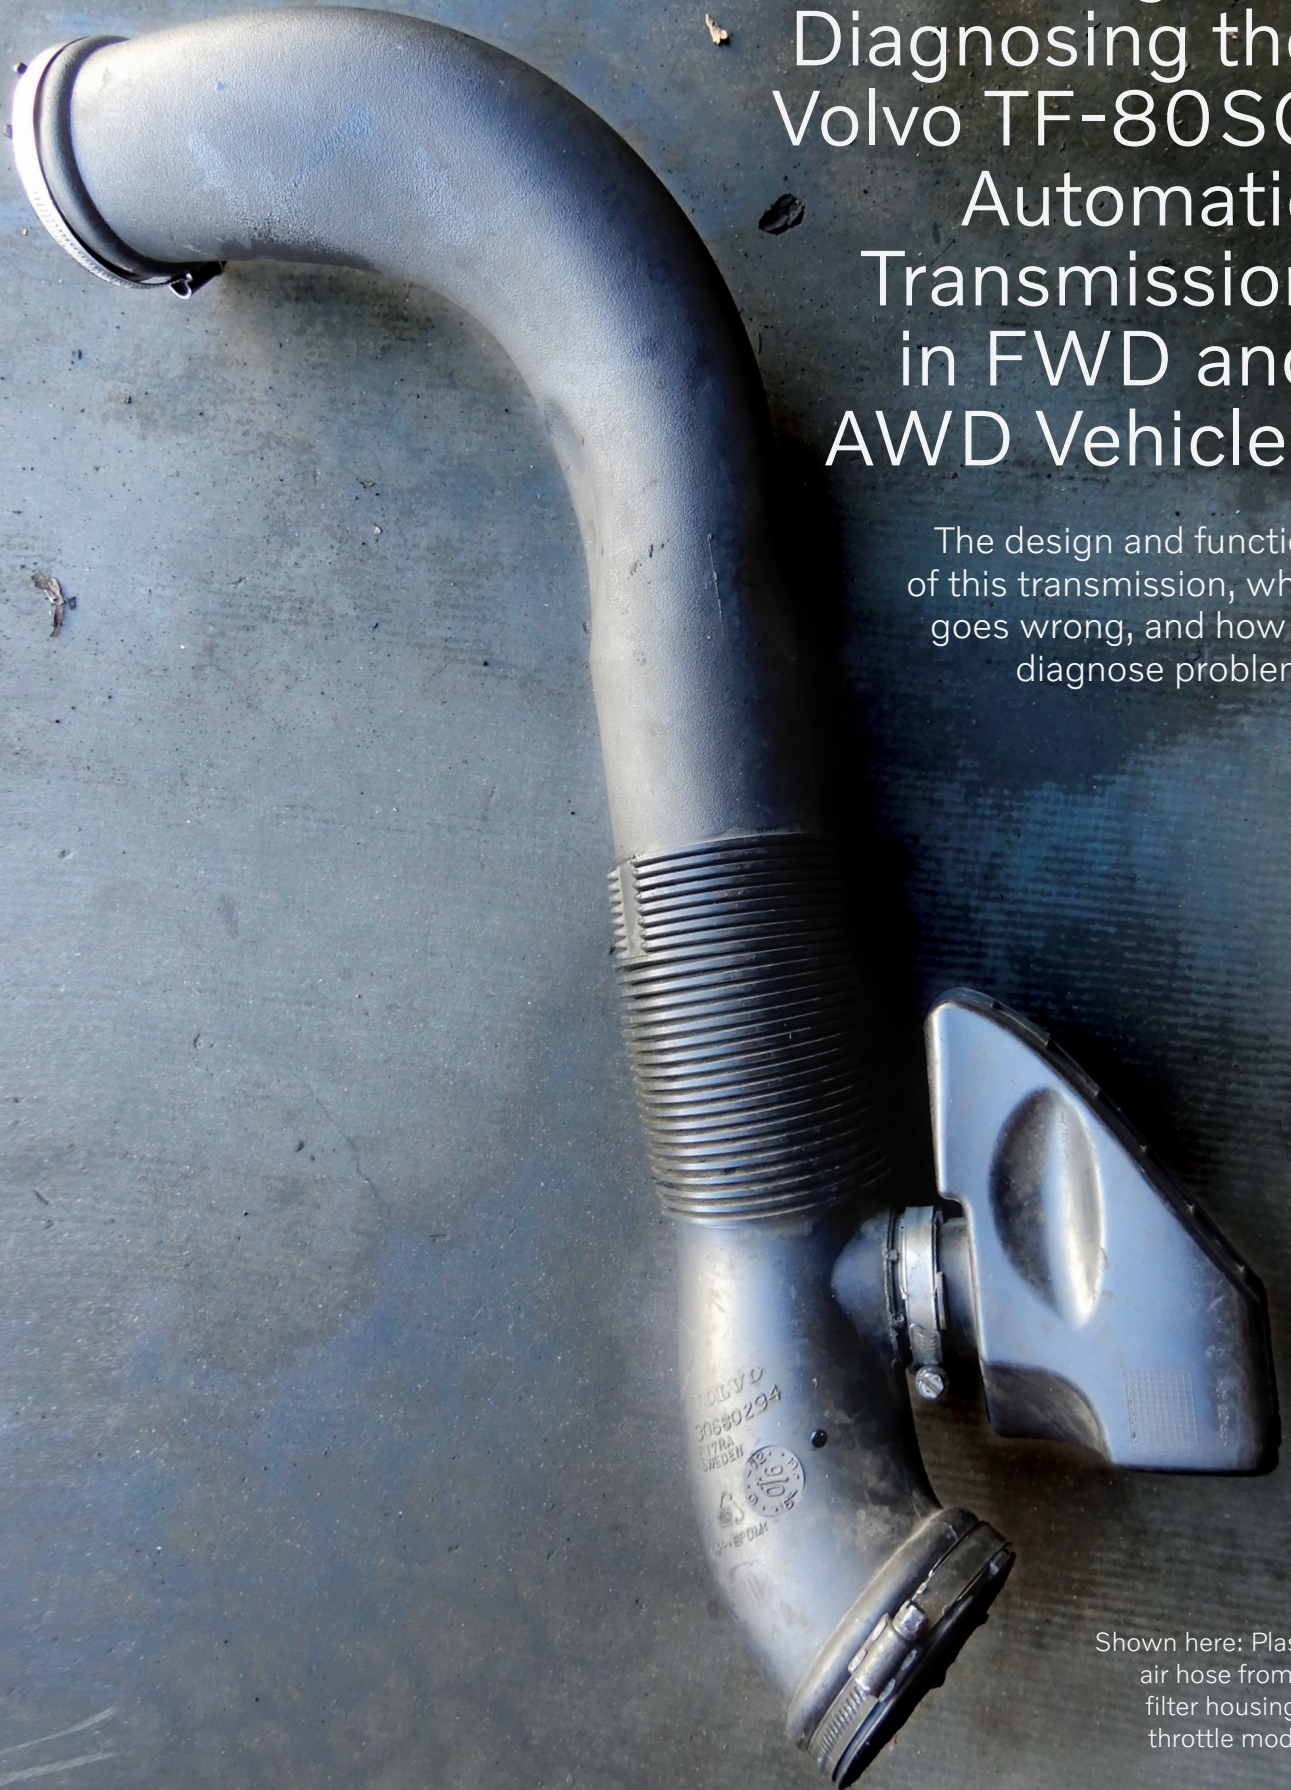
Shown here: Plastic air hose from air filter housing to throttle module

Disconnect the air mass sensor and remove the air hose from the air filter housing and at the throttle module and set aside.

Install the plastic hose from the throttle housing, install the air filter housing in place and connect the hose from the throttle body and tighten. Connect the air mass meter. Set the power steering reservoir in place and connect the hoses. If needed, set the ECM in place on the air filter housing and connect.

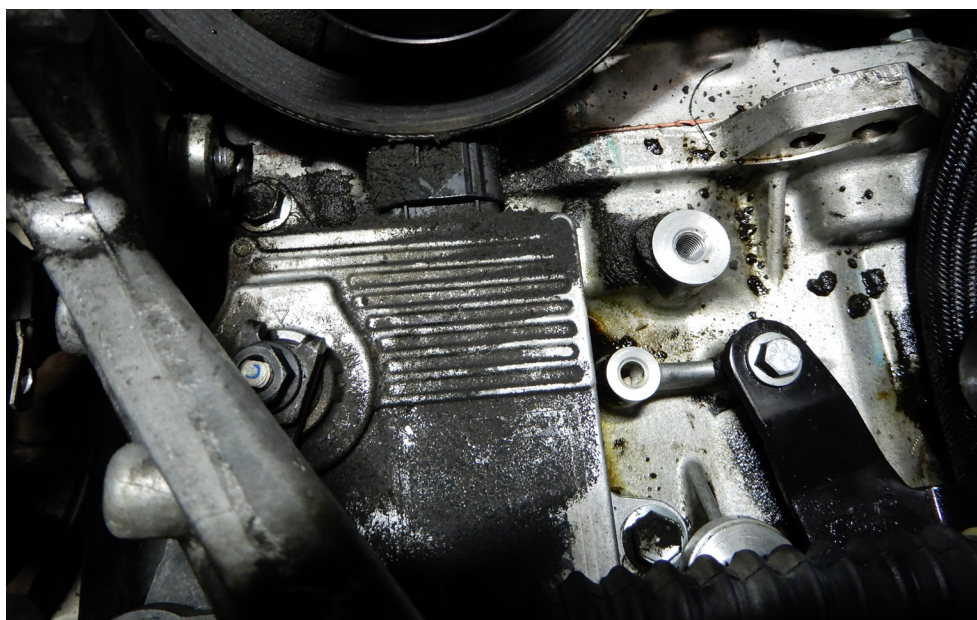
Automatic transmission with control module on top

The Transmission Control Module (TCM) is located on the transmission itself. The advantage of this is the elimination of external wires. Gear changing happens when one clutch engages the instant the previous gear disengages.

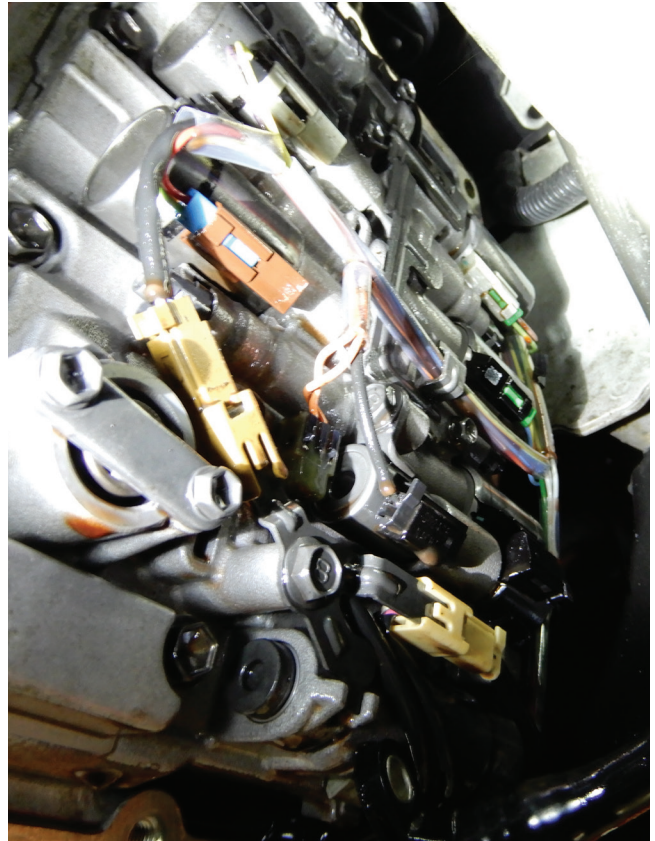
Valve body and solenoids inside transmission

Inside the transmission pan is the valve body. The valve body contains solenoids and hydraulic valves. The solenoids are activated by the Transmission Control Module (TCM). Hydraulic pressure builds up inside the transmission, and the hydraulic valves, which are controlled by their solenoids, send hydraulic pressure to the relevant clutch.

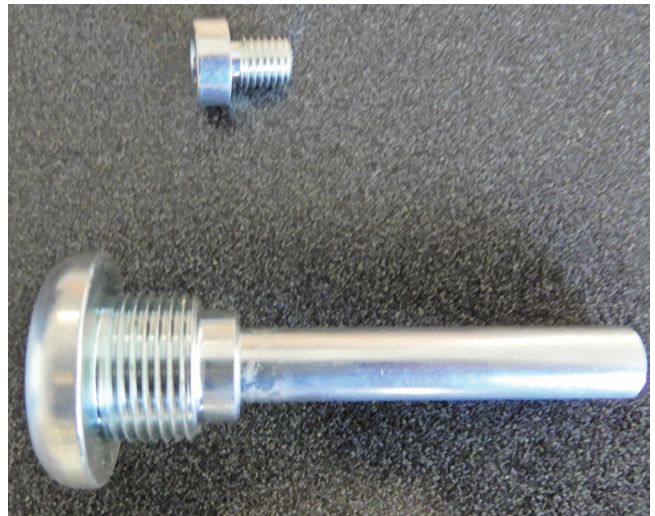
Level indicating pipe 30713218 and plug 30713219

After the transmission is drained, with a new washer, install the first plug with the long tube, the level indicating pipe. Adding fluid can be done at the bottom of this plug by injecting transmission fluid into the plug until fluid starts to escape. Insert the smaller plug and start the vehicle up and monitor it on VIDA; go to Vehicle Communication > TCM Transmission Control Module > Monitor Temperature Of Fluid. The fluid should be between 50 and 60 degrees C and just dripping out in small drops.

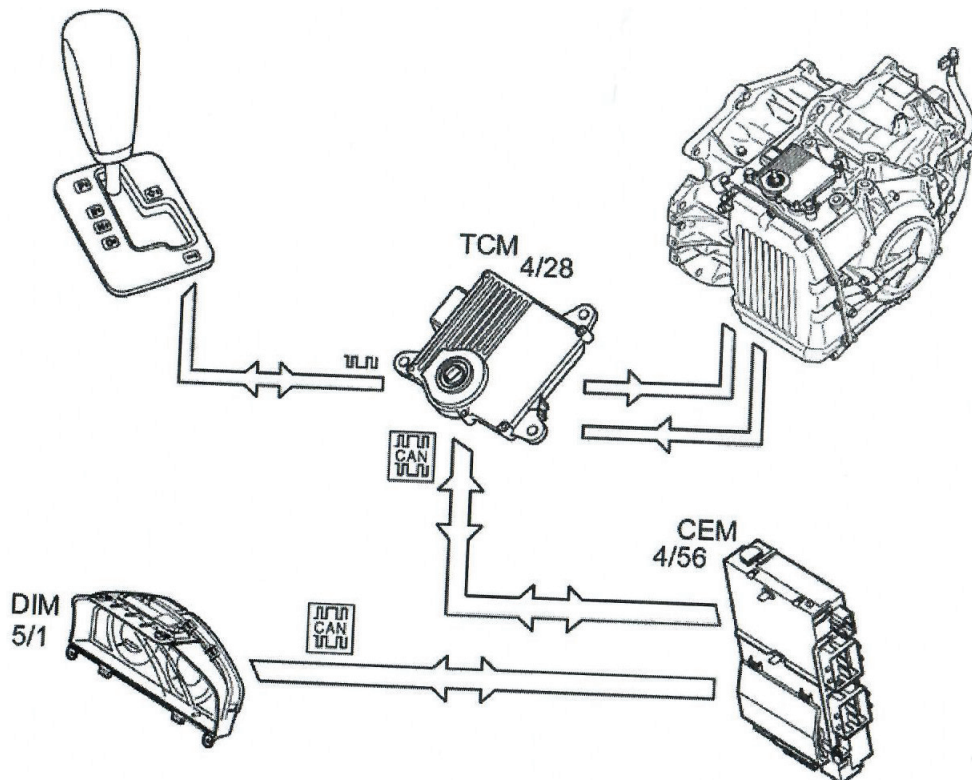
Electronic Controlled Transmission with component wire diagram numbers

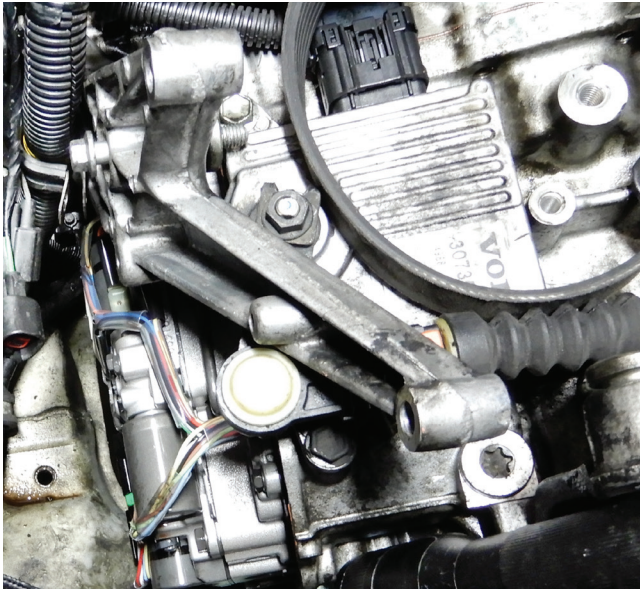
Transmission fill plug at top of transmission

Fluid can also be added at the top of the transmission. Remove the air filter housing to expose the fill plug.

Doing it this way, you will need to add three to four liters. Set the filter housing back in place, start the vehicle and check at the bottom plug. (See "transmission fill plug" image on next page.)

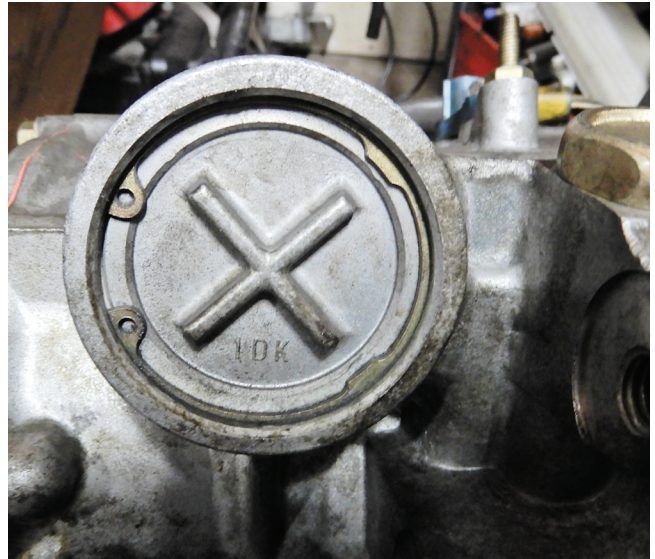
The B1 servo cover will need to be replaced due to transmission oil leak.

Transmission oil leaks can be spotted pretty easily most of the time. The most common are at the pan that covers the valve body controls, the B1 servo. The other common leak is actually motor oil from the rear main seal between the engine and transmission.

The complete transmission will have to come out to replace this seal. The B1 servo cover can be replaced and is now available separately from Volvo. There are two kits for repairing this job, for low torque and high torque engines. The low torque engine is XC70 (08-) engine B6324S, and the high torque version is found in other engines. The low torque part number is 31259740 and high torque 31259757; you will also need transmission oil. Use fluid part number 1161540 and 1161640 for the generation 1 TF80. Later transmissions take 31256775 or 31256774 depending on bottle size.

Drain the transmission fluid. Clean the area around the servo so not to contaminate inside the transmission. Remove the lock ring and remove the servo piston. If the piston is damaged, the transmission will need to be replaced.

Clean the components and make sure there are no burrs on the piston ring groove. If there are burrs, use a fine emery cloth to remove them. Install the piston with new O-rings into the transmission and push down and install the lock ring.

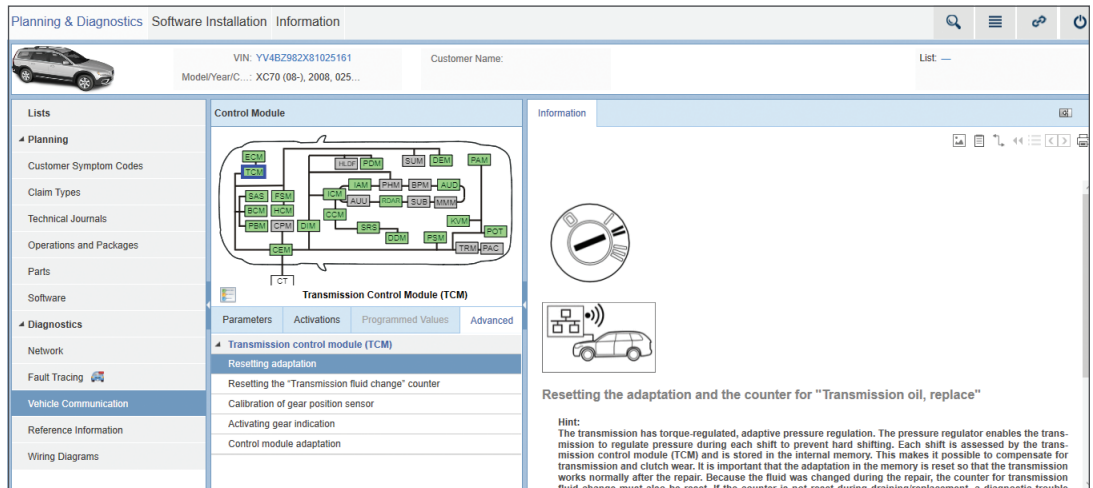
Use VIDA to reset transmission adaptations.

Connect VIDA to the vehicle; go to Vehicle Communications > TCM Transmission Control Module. Click on the Advanced tab > Control Module Adaption and reset the adaption.

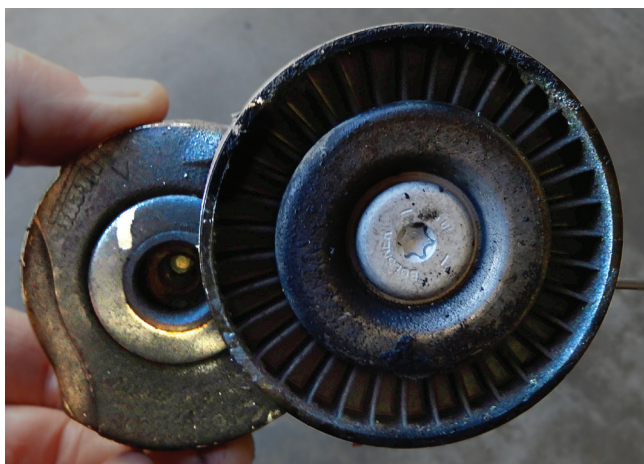
Belt tensioner with 3 mm pin in place

Once the refrigerant is removed, disconnect both A/C lines from the compressor and tuck them out of the way. Remove the power steering hose bracket that sits on top of the A/C compressor if equipped. Using a 19 mm wrench, release the pressure at the drive belt

tensioner and insert a 3 mm pin to lock the tensioner in place so the belt is loose. (See image next page.)

Once the A/C compressor is in place remove 3 mm pin using a 19 mm wrench to release the pressure. Install the A/C low and high pressure lines with new O-rings and tighten. Add the brackets at the compressor and the power steering hose and bracket if so equipped.

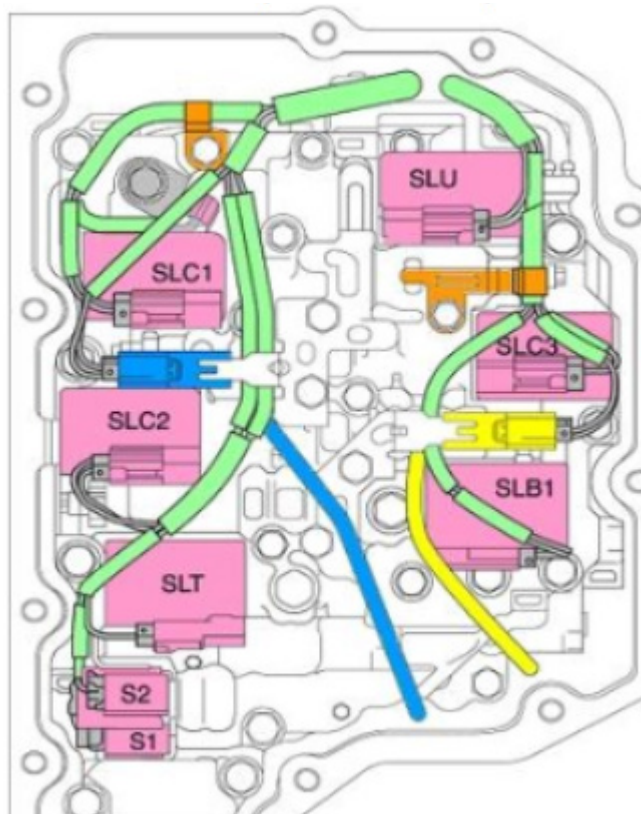
Valve body with solenoids

Now remove the 12 bolts that hold the pan in place and remove the pan from the transmission. Depending on what you're doing, resealing the pan or replacing solenoids or even replacing the valve body may be necessary. On certain vehicles it might be necessary to lower the subframe to remove the pan.

After repair and replacing parts, make sure to clean the surface and the oil pan. If you're replacing solenoids, make sure that any electrical connectors are secured and clipped into place so they don't disconnect.
