# STARTUNED<sup>®</sup>

INFORMATION FOR THE INDEPENDENT MERCEDES-BENZ SERVICE PROFESSIONAL

Winter 2022  
V22 | N4

# Crankcase Ventilation in the Modern Mercedes-Benz Engine

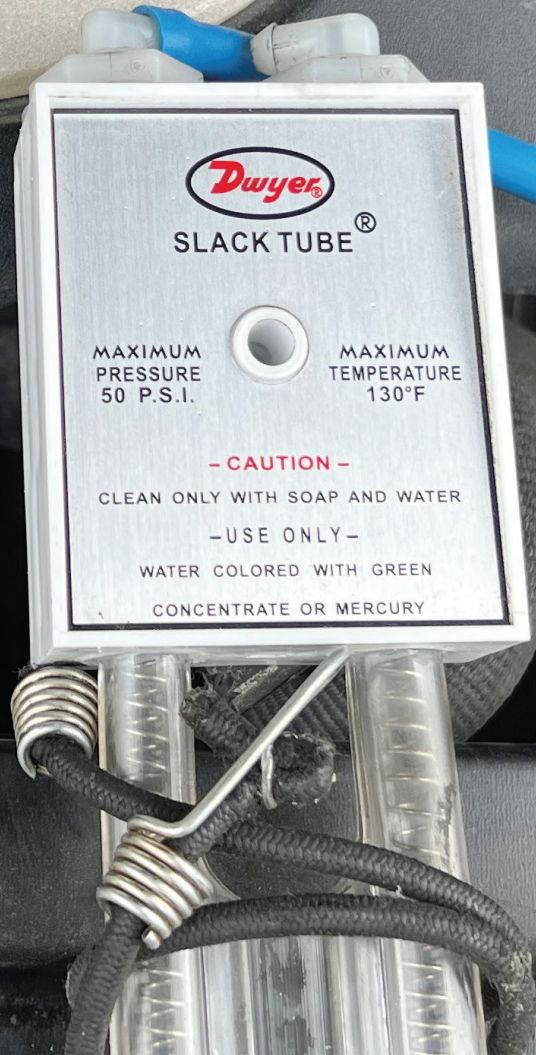
Shown here: A manometer is an indispensable tool for accurately measuring crankcase pressure/vacuum.

About manometers: The U tube manometer is an extremely accurate way of measuring crankcase pressure/vacuum. Since crankcase pressure/vacuum is so slight, your normal vacuum gauge is not precise enough. Many years ago, our shop purchased one and it has been a life saver in diagnosing crankcase pressure issues properly.

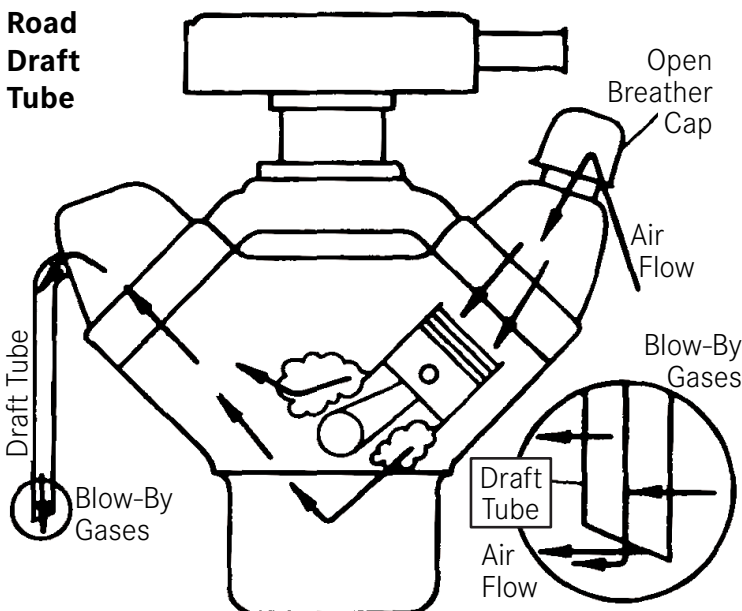
This early design of crankcase ventilation was functional but neither highly efficient nor environmentally friendly.

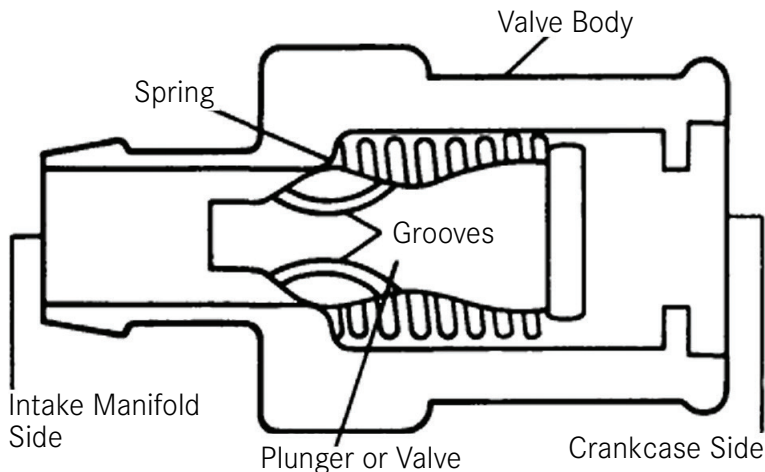
Here we see the early design one-way PCV valve with a tapered pintle with grooves to regulate the flow of crankcase vapors into the engine.

The simplest and earliest designs of a PCV used engine intake manifold vacuum to extract the crankcase vapors and introduce them into the combustion process. This idea, however, needs some sort of regulation in order to not affect the engine performance. The PCV valve was designed as a simple spring-loaded valve with a sliding pintle inside. The pintle is tapered so it will increase or decrease airflow depending on its position inside the valve housing. The movement of the pintle up and down changes the orifice opening to regulate the volume of air passing through the PCV valve. It is also a one-way valve, so that any engine backfiring won't be directed back into the crankcase. These early designs were open systems, meaning the fresh air was introduced into the crankcase through a mesh filter in the oil filler cap or the valve cover. In 1968, closed systems were designed to further reduce emissions by placing the fresh air intake portion within the air filter housing so that any backed up gases would be sucked into the engine.

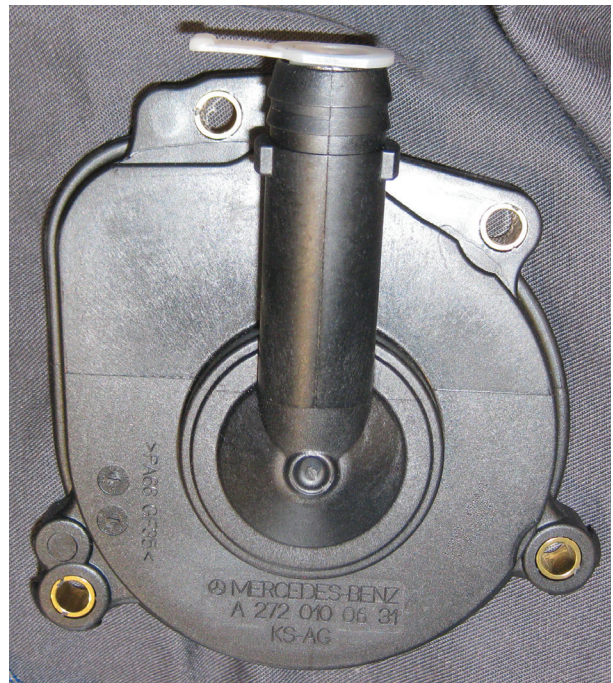
These earlier style oil separators are fairly easy to change and should be checked regularly starting at around 60k to 100k.

Replacement of this earlier style is fairly straightforward. After removing the engine covers and air filter, reach behind the RH cylinder head and remove the valve. There are four E10 Torx bolts holding it in place. If you find access difficult, you can actually use a twelve-point 5/16" wrench, which fits on the bolts nicely.

The new part number from Mercedes-Benz for an M272 engine is A272 010 06 31 (but please verify the correct part for your vehicle!), and it comes with the gasket and new bolts. If you are replacing this due to leakage, there are also three plastic plugs that are advisable to replace, also available from your Mercedes-Benz parts dealer. Also advisable is replacing the hoses and oil separator mounted on the valve cover. All in all, about 45 minutes to replace.

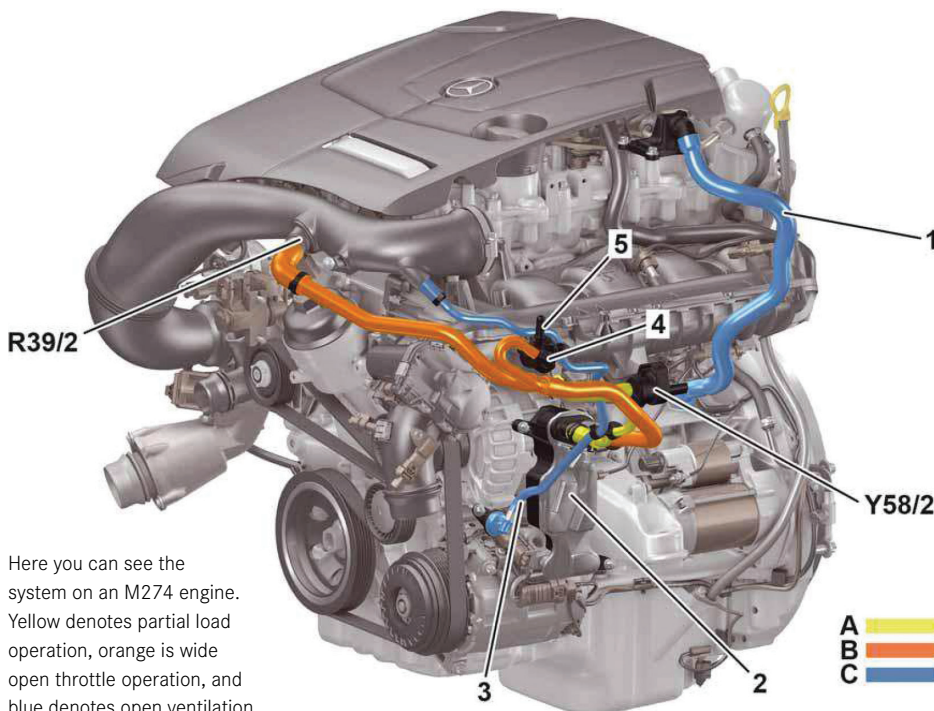
Here you can see the system on an M274 engine. Yellow denotes partial load operation, orange is wide open throttle operation, and blue denotes open ventilation.

In partial load operation, bleeding is performed starting from the oil separator to the charge air distributor. To do so, the partial load operation crankcase ventilation system valve (Y58/2) is placed in the partial load vent line. The valve is actuated in

deceleration mode by the engine control unit and closes the partial load vent line from the crankcase to the charge air distributor. This results in the inflow of exhaust from the crankcase during the mixture adaptation and disruptive background noise being avoided. If there is no actuation by the engine control unit the valve stays open.

In wide open throttle operation, ventilation is performed starting from the oil separator

to the air intake pipe. The wide-open throttle operation vent line heater element (R39/2) is located in the full load vent line and prevents freezing of the system. The heating element is actuated by the engine control unit when outside temperatures of under 7°C are measured.

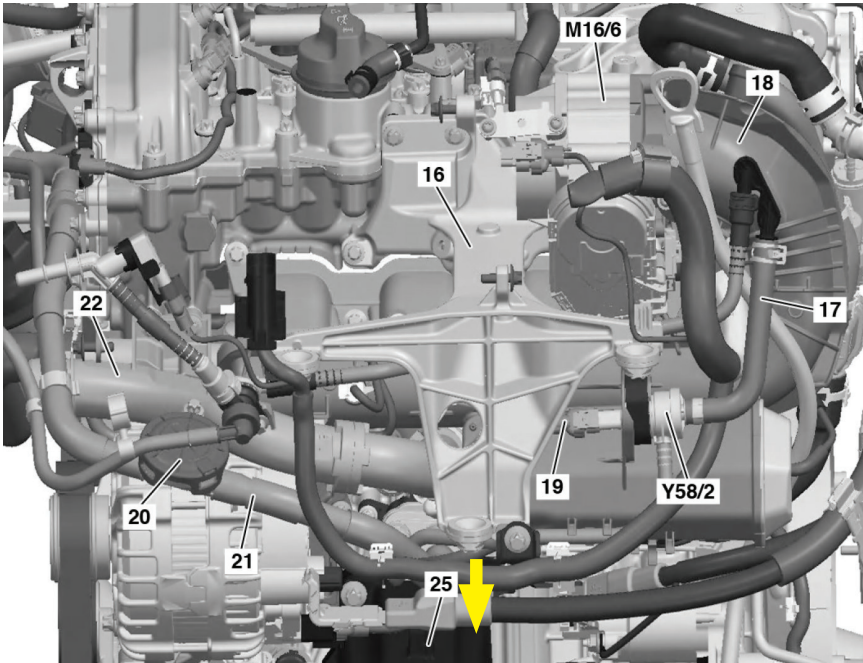
This side view of the assembly is deceiving, as the oil separator is buried under the engine mounting bracket. Several other components have also been removed for access.

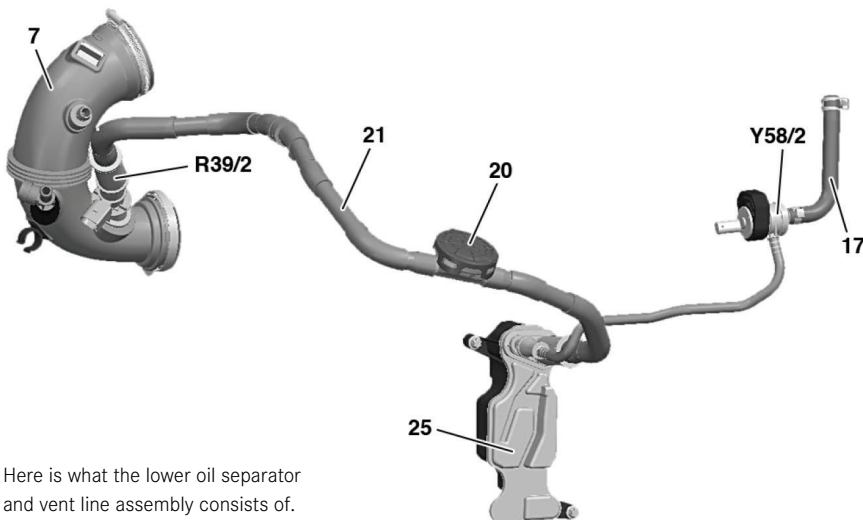
Here is what the lower oil separator and vent line assembly consists of.
