Volvo TechTips

Diagnosing and Repairing Manifold Exhaust Leaks, Part 1

On a Second
Generation Volvo XC90
(2016—Present) T6
2.0L B6324S Engine,
With Supercharger and
Turbocharger

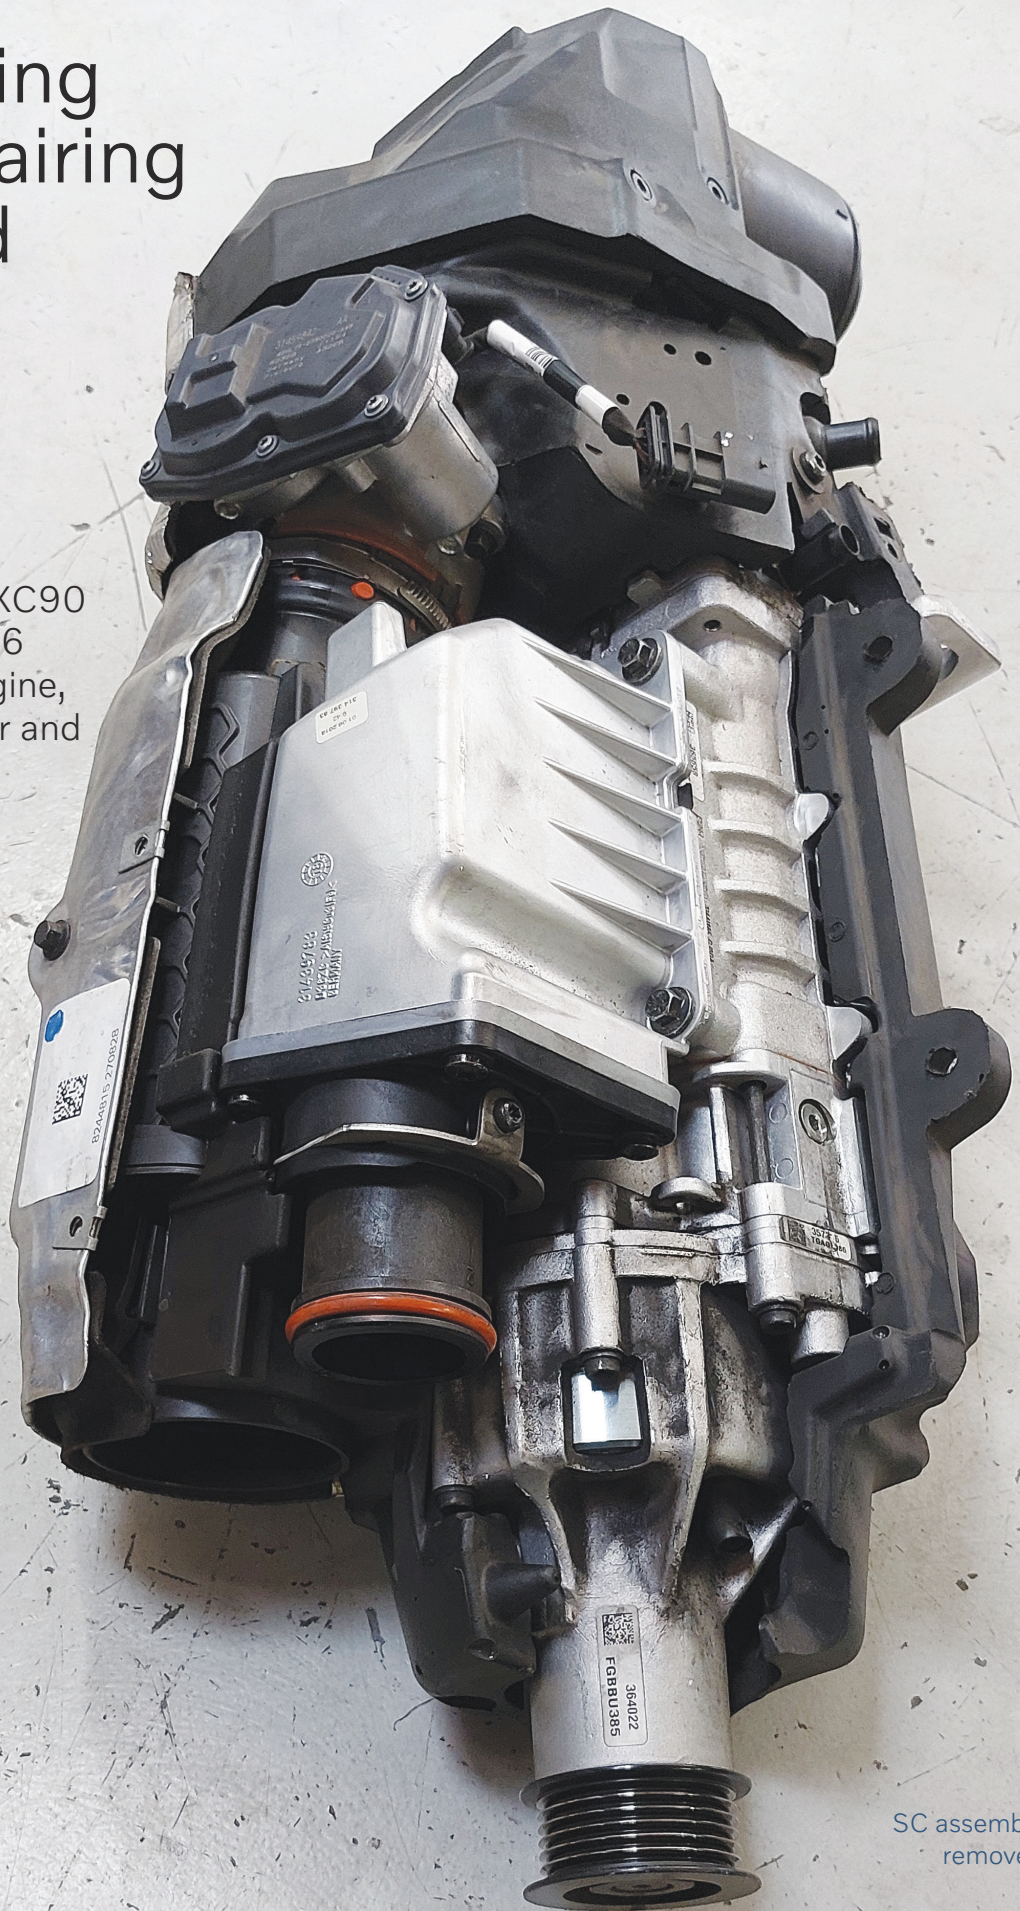
SC assembly
removed

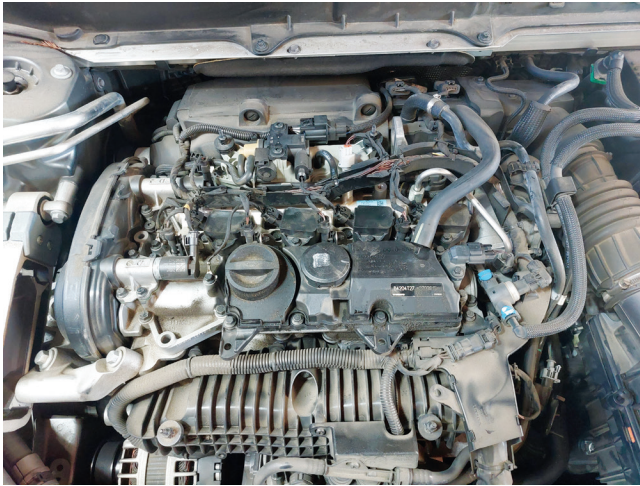
Volvo 2.0L T6 B6324S engine

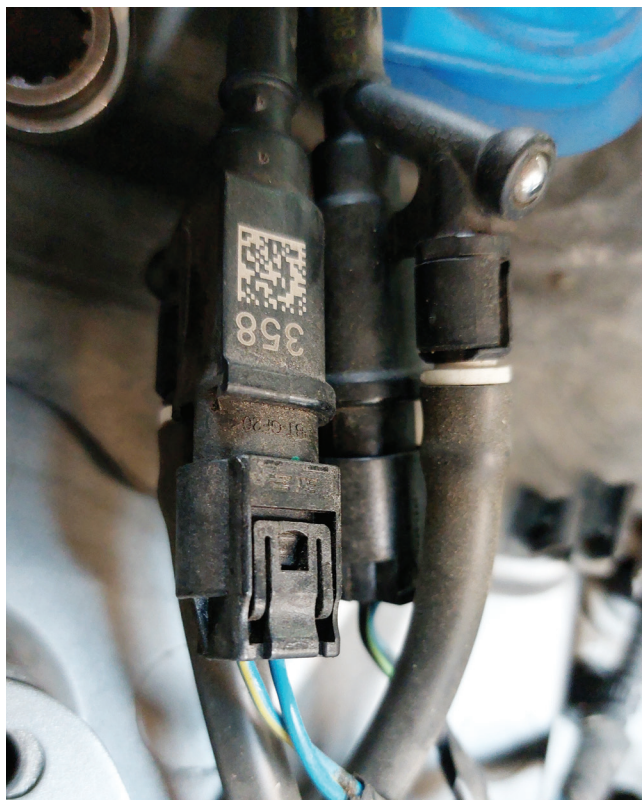
Wiper washer connectors

The connectors for the washer/heaters are under the cover on the left side of the engine bay.

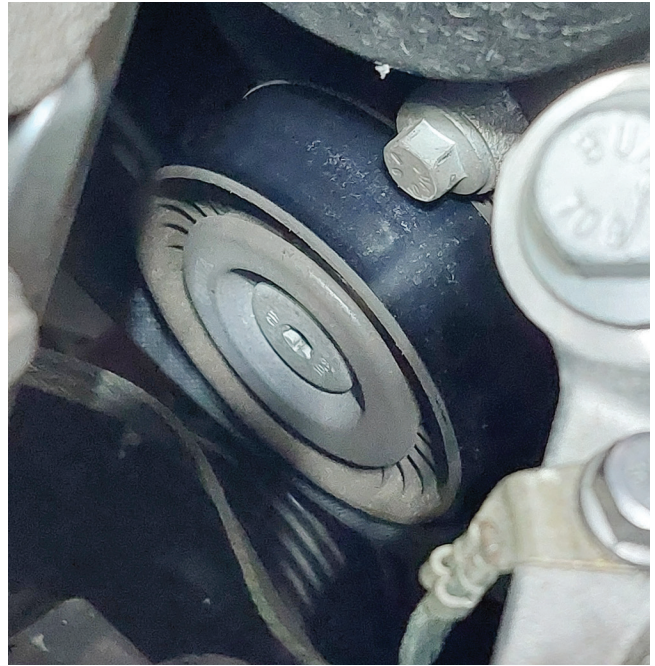
Remove auxiliary belt idler bearing after right motor mount is removed.

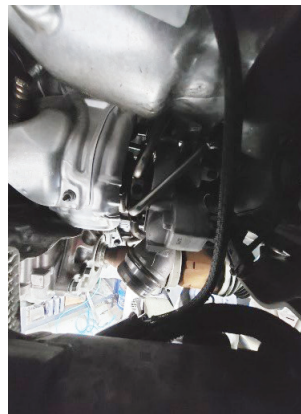
With the right inner fender covers removed, you will gain more access to the area.

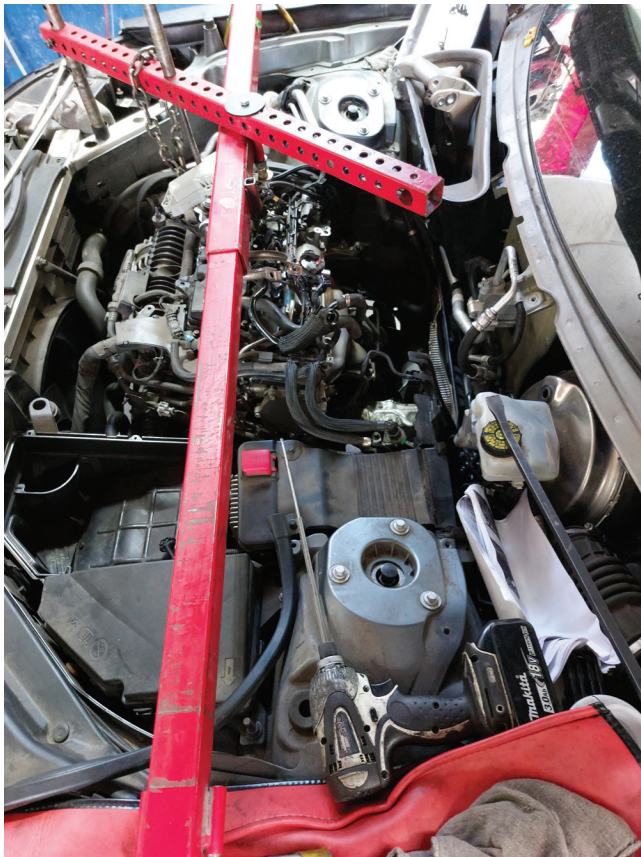
Using an engine support will allow you to remove the right engine mount. This will give you a lot more access to the supercharger's belt and bolts.

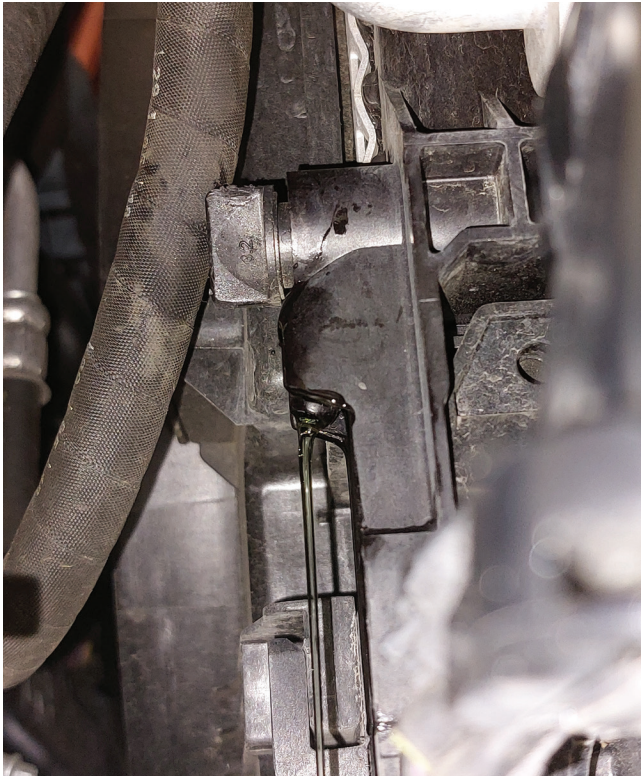
After removing the splash shields under the bumper and engine, drain the engine coolant by loosening the radiator petcock at the bottom of the radiator.

Radiator drain cock

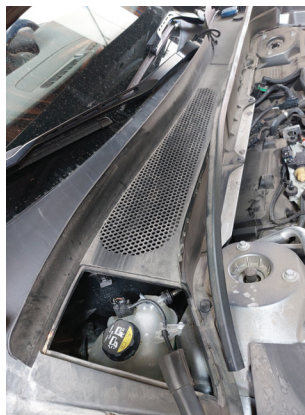
Remove cowl to expose the crossbar and wiper motor assembly.

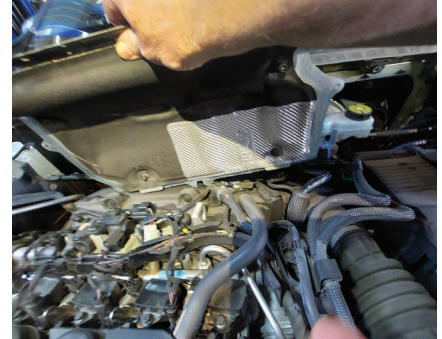
Lift out firewall plate.

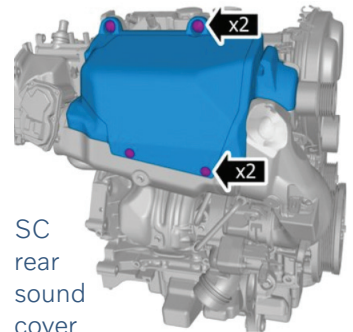
Remove the soft plastic sound deadening cover on the back of the supercharger by removing the four fasteners from the top and the bottom.

SC rear sound cover

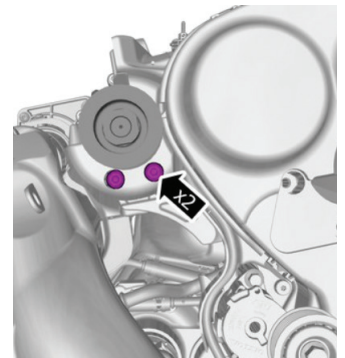
SC pulley bolts

Remove the two 6 mm Allen bolts under the supercharger pulley.

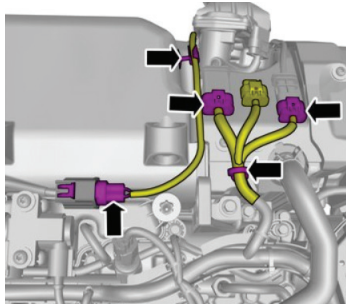
Oxygen sensor connections on top of the SC

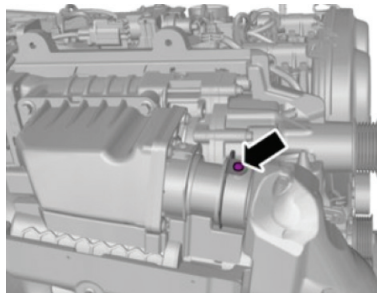
The lower connection of the pipe has a clip that can be a real challenge to keep in the open position while you try to pull the pipe off.

The air pipe that comes out of the supercharger is secured with wire clips that sit in a groove. The lower retainer clip can be a pain to keep in the open position while trying to pull the pipe free.

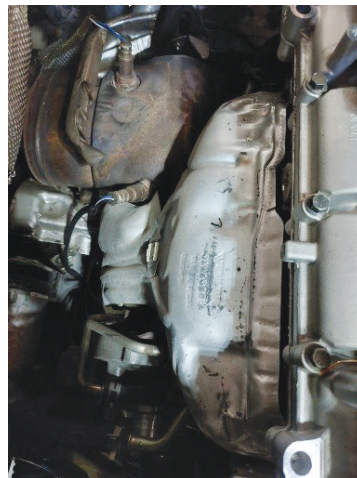
You will get full access to the turbo and exhaust manifold with the SC removed.

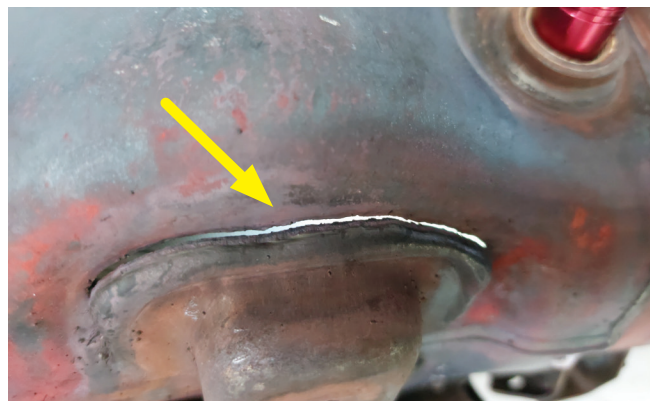
The cause of this customer's exhaust leak turned out to be a large crack in the side of the catalytic converter.

Using a flashlight, you can see evidence of this large crack that was causing the leak.

The shop decided to advise the customer to replace all the other exhaust manifold gaskets while the supercharger and catalytic converter were removed. ●
