Volvo TechTips

Spring 2023

Supercharger Service

Also Inside:
3.2L Engine Timing
Chain Replacement

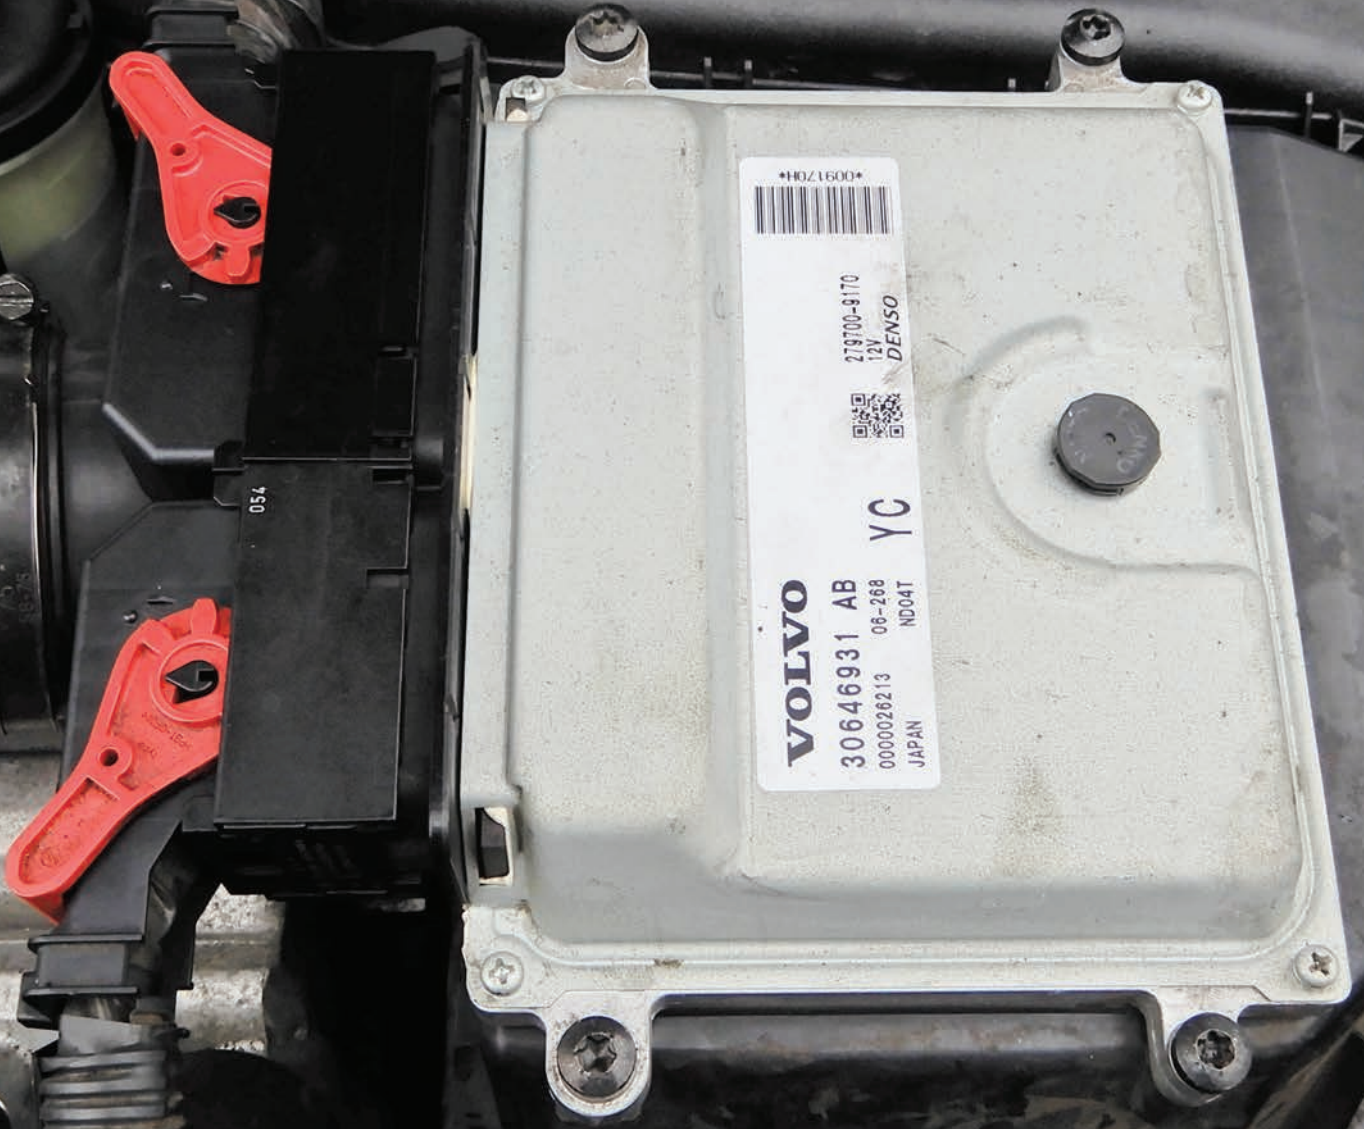
Shown here:
ECM on top of
air filter housing

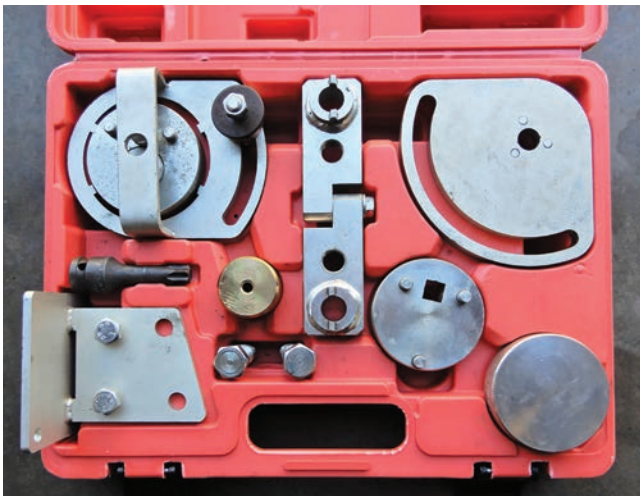
Special tools needed to replace the timing chain on the 3.2L engine

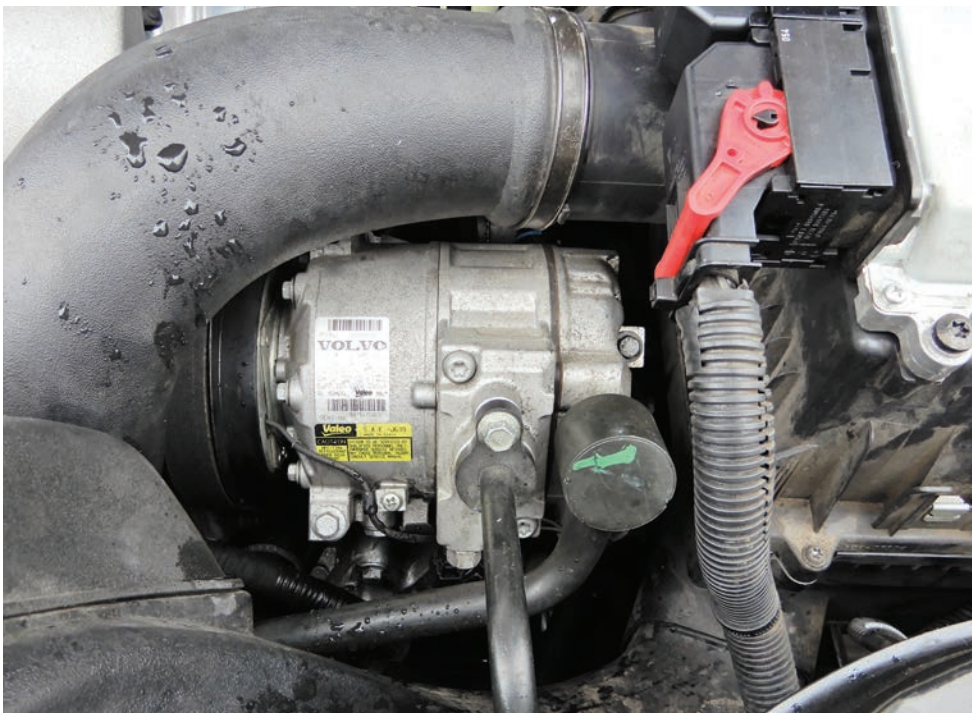
A/C compressor that will need to be removed

both A/C hoses, plug the hoses and compressor so moisture and debris cannot contaminate the A/C system. This will make it easier to remove the hose to the throttle housing. Once the hose to the throttle housing is removed, we can then remove the A/C compressor. Disconnect the two electrical connectors at the compressor.

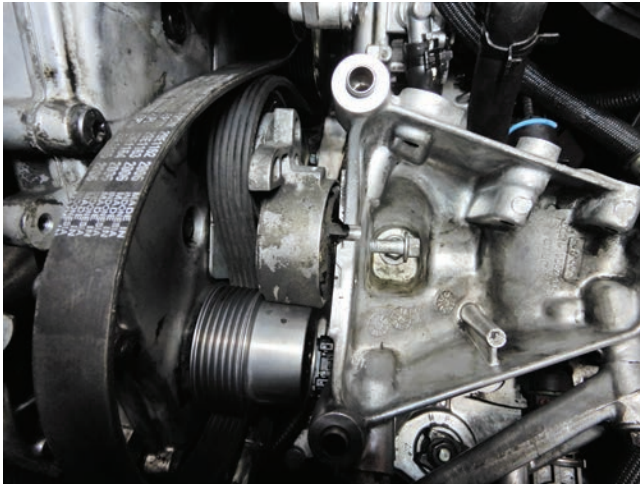
Drive belt tensioner that needs to be removed

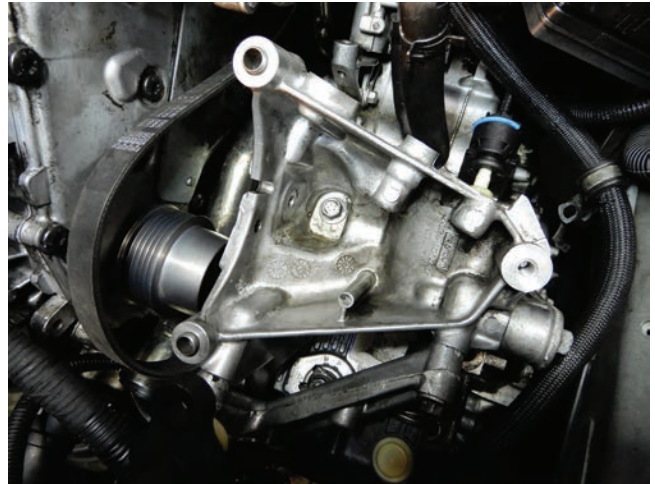
Air conditioning bracket at top of transmission with tool installed

Now set the air conditioning bracket into place on top of the transmission, and start the bolt in the center of the bracket to the transmission finger tight. Use tool number 9997262 to align the A/C bracket. Set the tool into place and start the bolts, but just finger tight at this time. Make sure that the tool is in place correctly and that the coupler pulley turns counterclockwise.

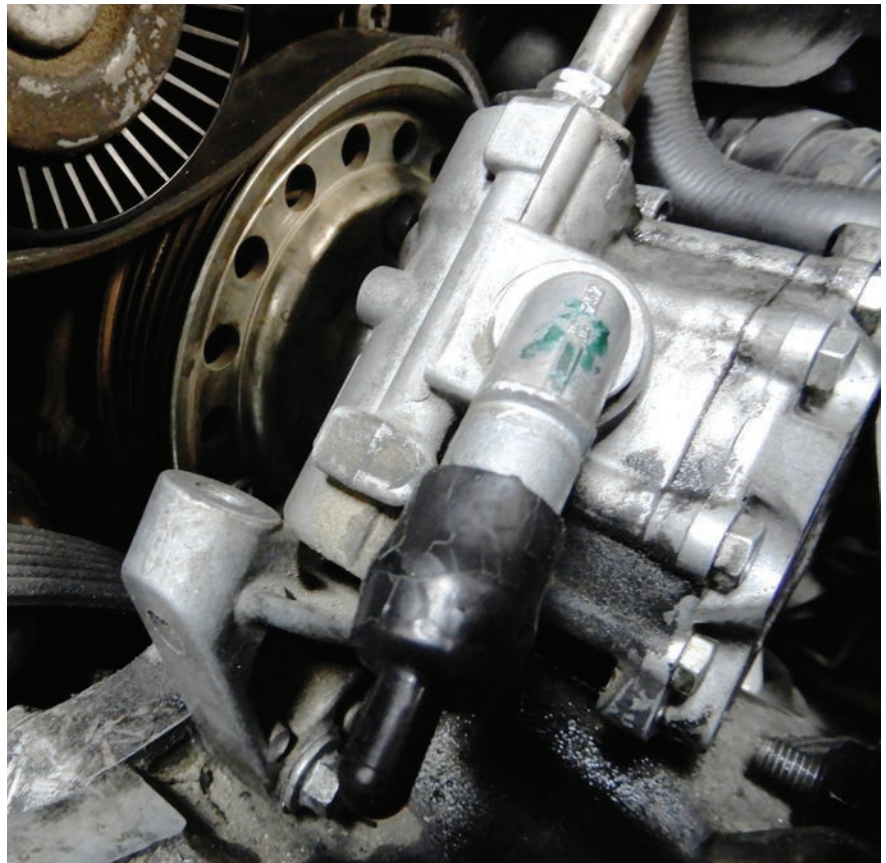
Power steering pump connected to water pump

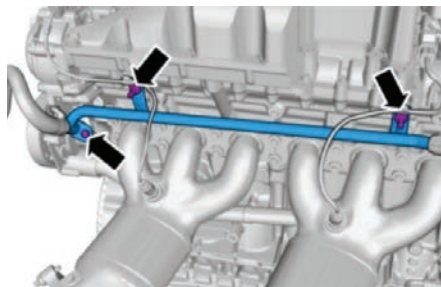
Water pipe at back of engine that connects to water pump

On the back side of the engine, on the exhaust side, there is a coolant pipe that is connected to the water pump. This pipe needs to be disconnected; there are two bolts above the exhaust manifold on each side that need to come out. There is also a bolt right at the water pump that needs to be removed, and then pulled loose from the water pump.

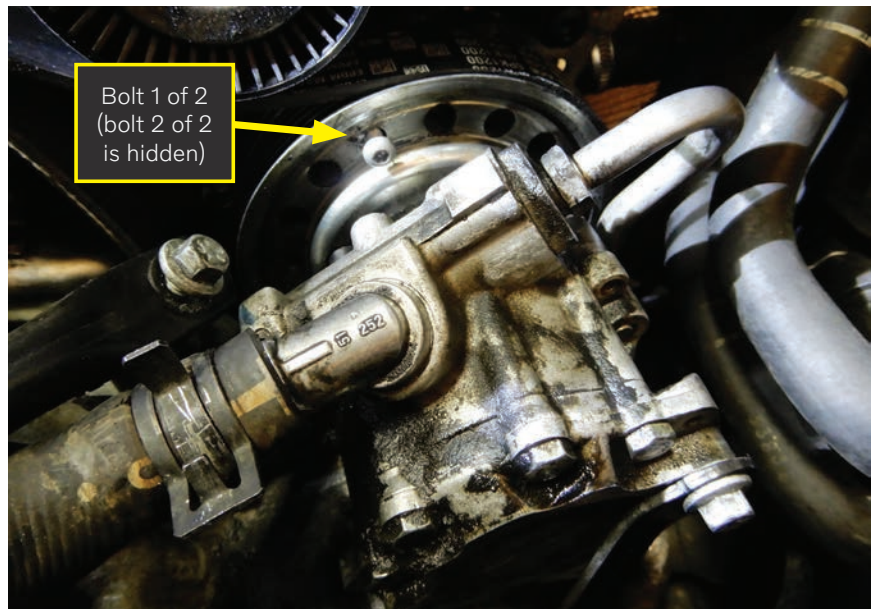
Two bolts at power steering pump pulley to water pump that need to be removed

Disconnect the high pressure hose at the pump. Remove the bracket at the back of the pump. With a long stem T25 torx bit, remove the two bolts at the power steering pump pulley to water pump.

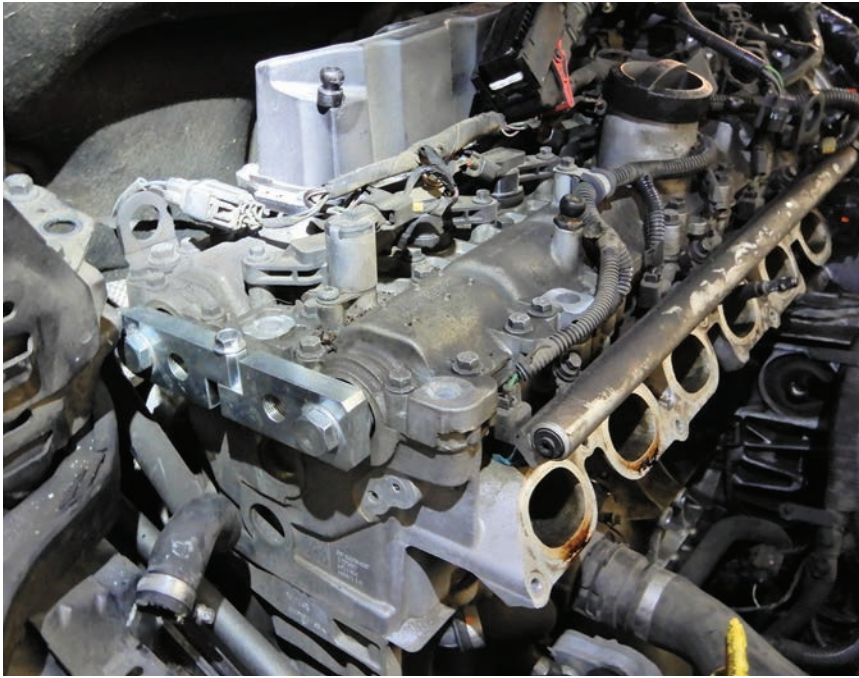
Special tools installed at camshaft gears

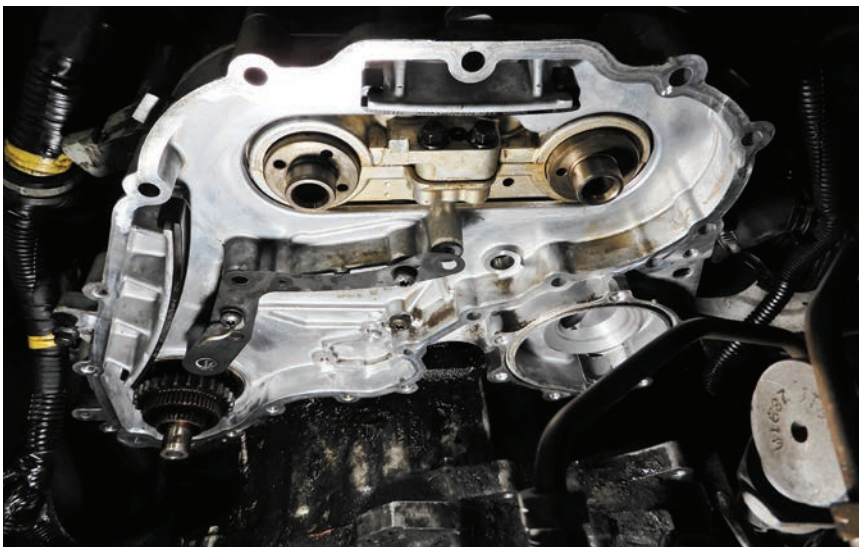
Inner timing cover that needs to come off and replace inner gasket

This will be a good time to replace the gasket at the inner timing cover. Remove the two bolts at the tensioner guide and remove the inner cover with the water pump assembly. Clean the area really well and

install a new gasket. There is also a rubber seal at the READ assembly that should be replaced at the same time, and replace the O-ring at the water pump pipe.

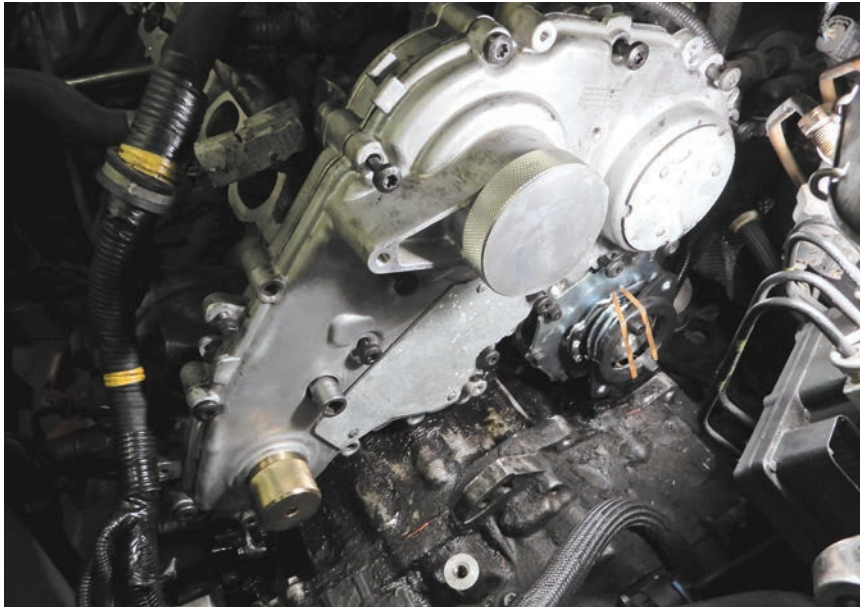
Special Volvo tool to align front timing chain cover tool numbers 9997267 and 9997266

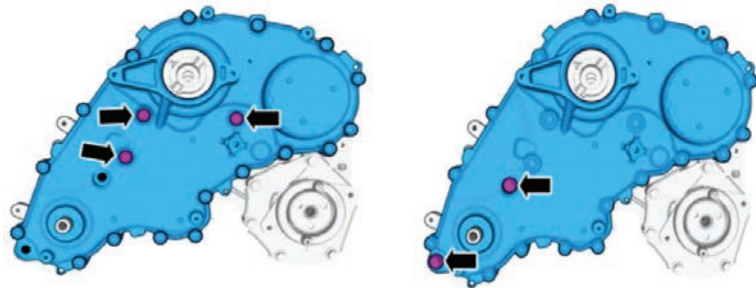
The three center bolts that need to be tightened first; then the twenty bolts that need to be tightened in order

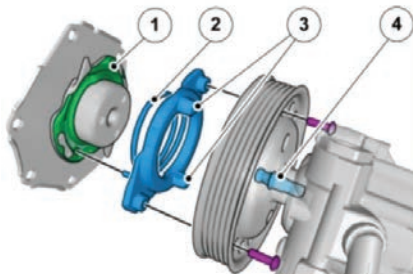
Correct way to install power steering pump onto water pump

Install the power steering pump onto the water pump coupling pulley, making sure to fit it into place properly. Install the drive belt first around the pulley before inserting the power steering pump to the water pump.

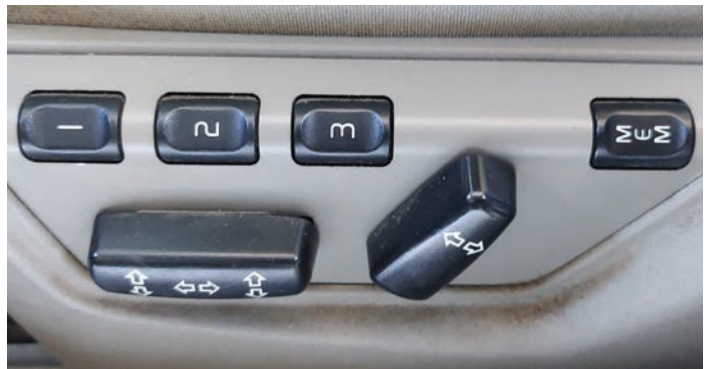
The best scan tool for performing testing on a Volvo is still a laptop with VIDA system. VIDA has all the features you need—codes, bi-directional control, software installation and a lot more.

VIDA is still the best tool out there when it comes to working with Volvos. It can help you get to the root cause of a problem quickly and is a great way to confirm a "fix." Fun fact: You can use VIDA software to set custom seat temperatures if your customer thinks they're too hot or not hot enough. (Although, you may or may not want to let your customers know about this because they may expect results that are beyond the available settings.)

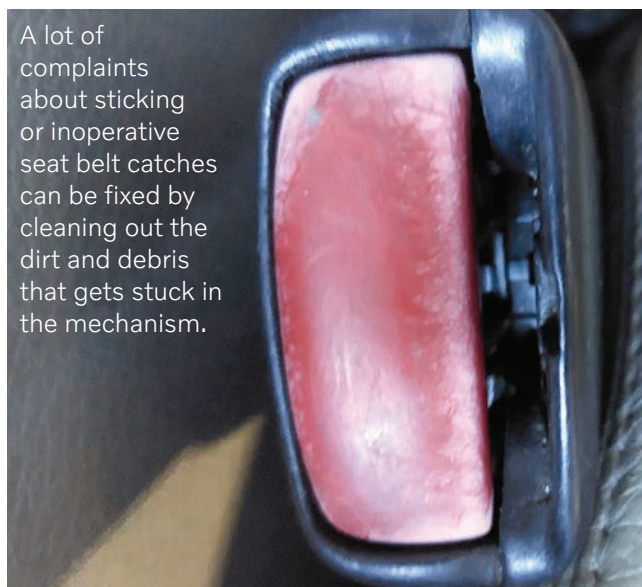
A lot of complaints about sticking or inoperative seat belt catches can be fixed by cleaning out the dirt and debris that gets stuck in the mechanism.

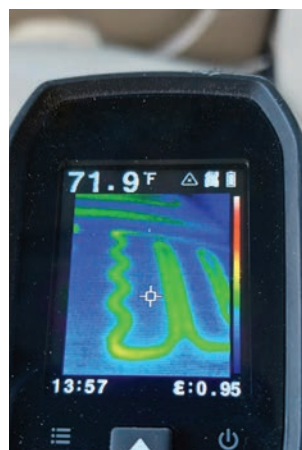
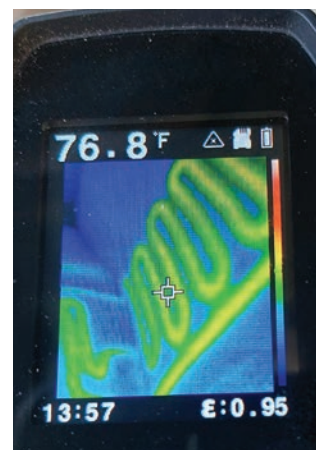
A cool way of checking out the heating grids in heated seats is to use a quality thermal imager. Just turn on the seat heater switch and you can "see" the grid through the upholstery and see breaks in the grids too.

One of the quickest ways to check if a seat's heating grid is fully working or is partially broken is to use a quality thermal imager.

If a seat heater grid is broken or open, you will be able to see what part of the heating grid is not heating up without removing the upholstery.

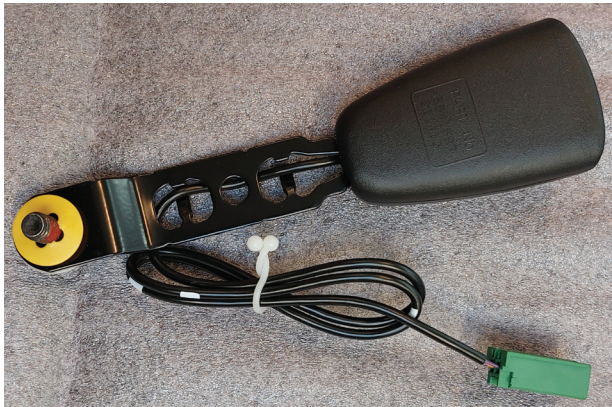
New Volvo seat belt catch

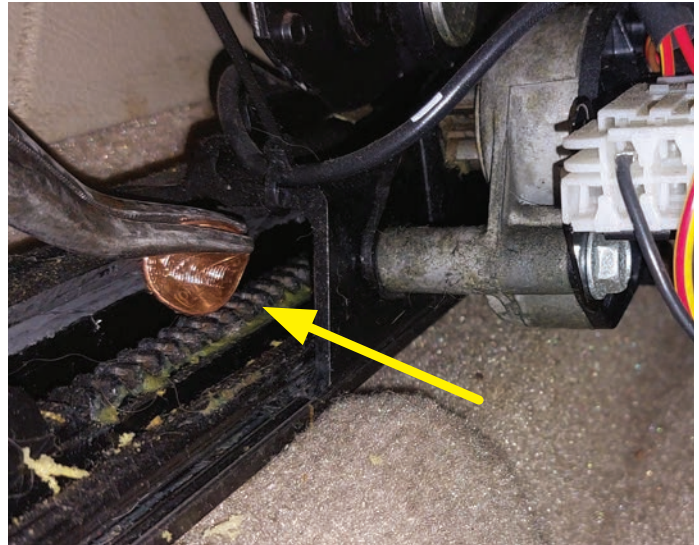
Sometimes the coins that fall out of pockets end up in the power seat's tracking system. And, when some one decides to adjust the seat forward or backward, the tracks try to "eat" the coin and jam.

One of the most common problems that your customers will have with their power seats is caused by coins and debris that fall under the seat cushions and jam into the track system when the seats are moved back and forth.

In most cases you can fix this problem by unbolting the seat and using some pliers to pry the bent coin or coins out. Make sure to clean and lube the tracks when you have the seat loose.

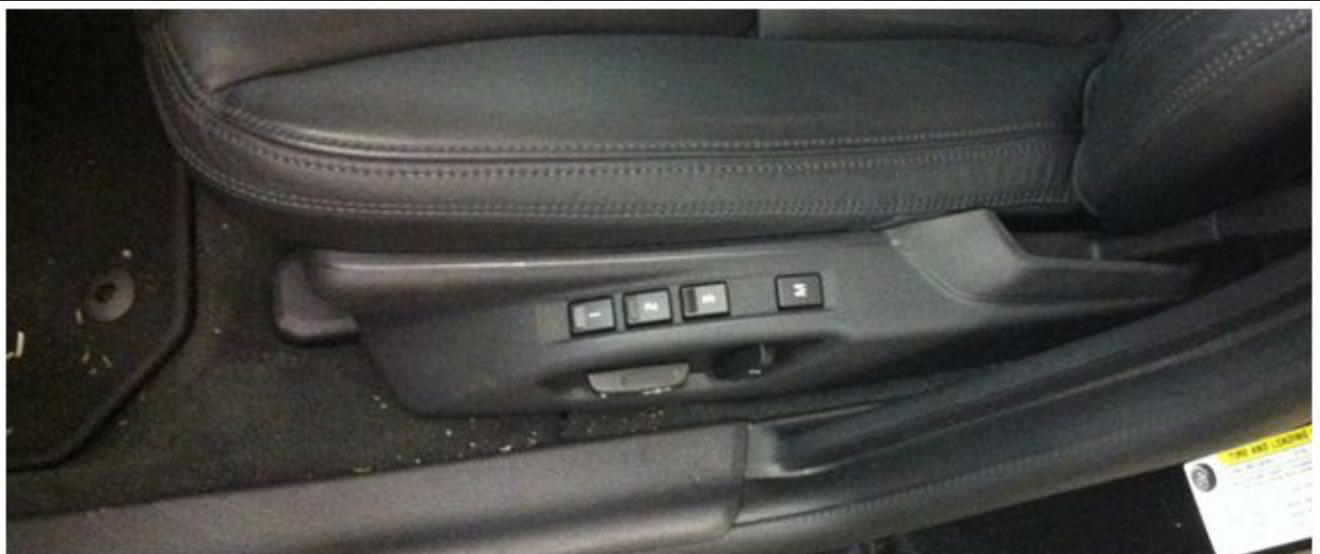
Select new delay time (in seconds) for the seat memory

Select setting for acknowledgement of seat memory

The following settings are recommended:
 Without acknowledgement: Delay time 1 second.
 With acknowledgement: Delay time 1.5 seconds.

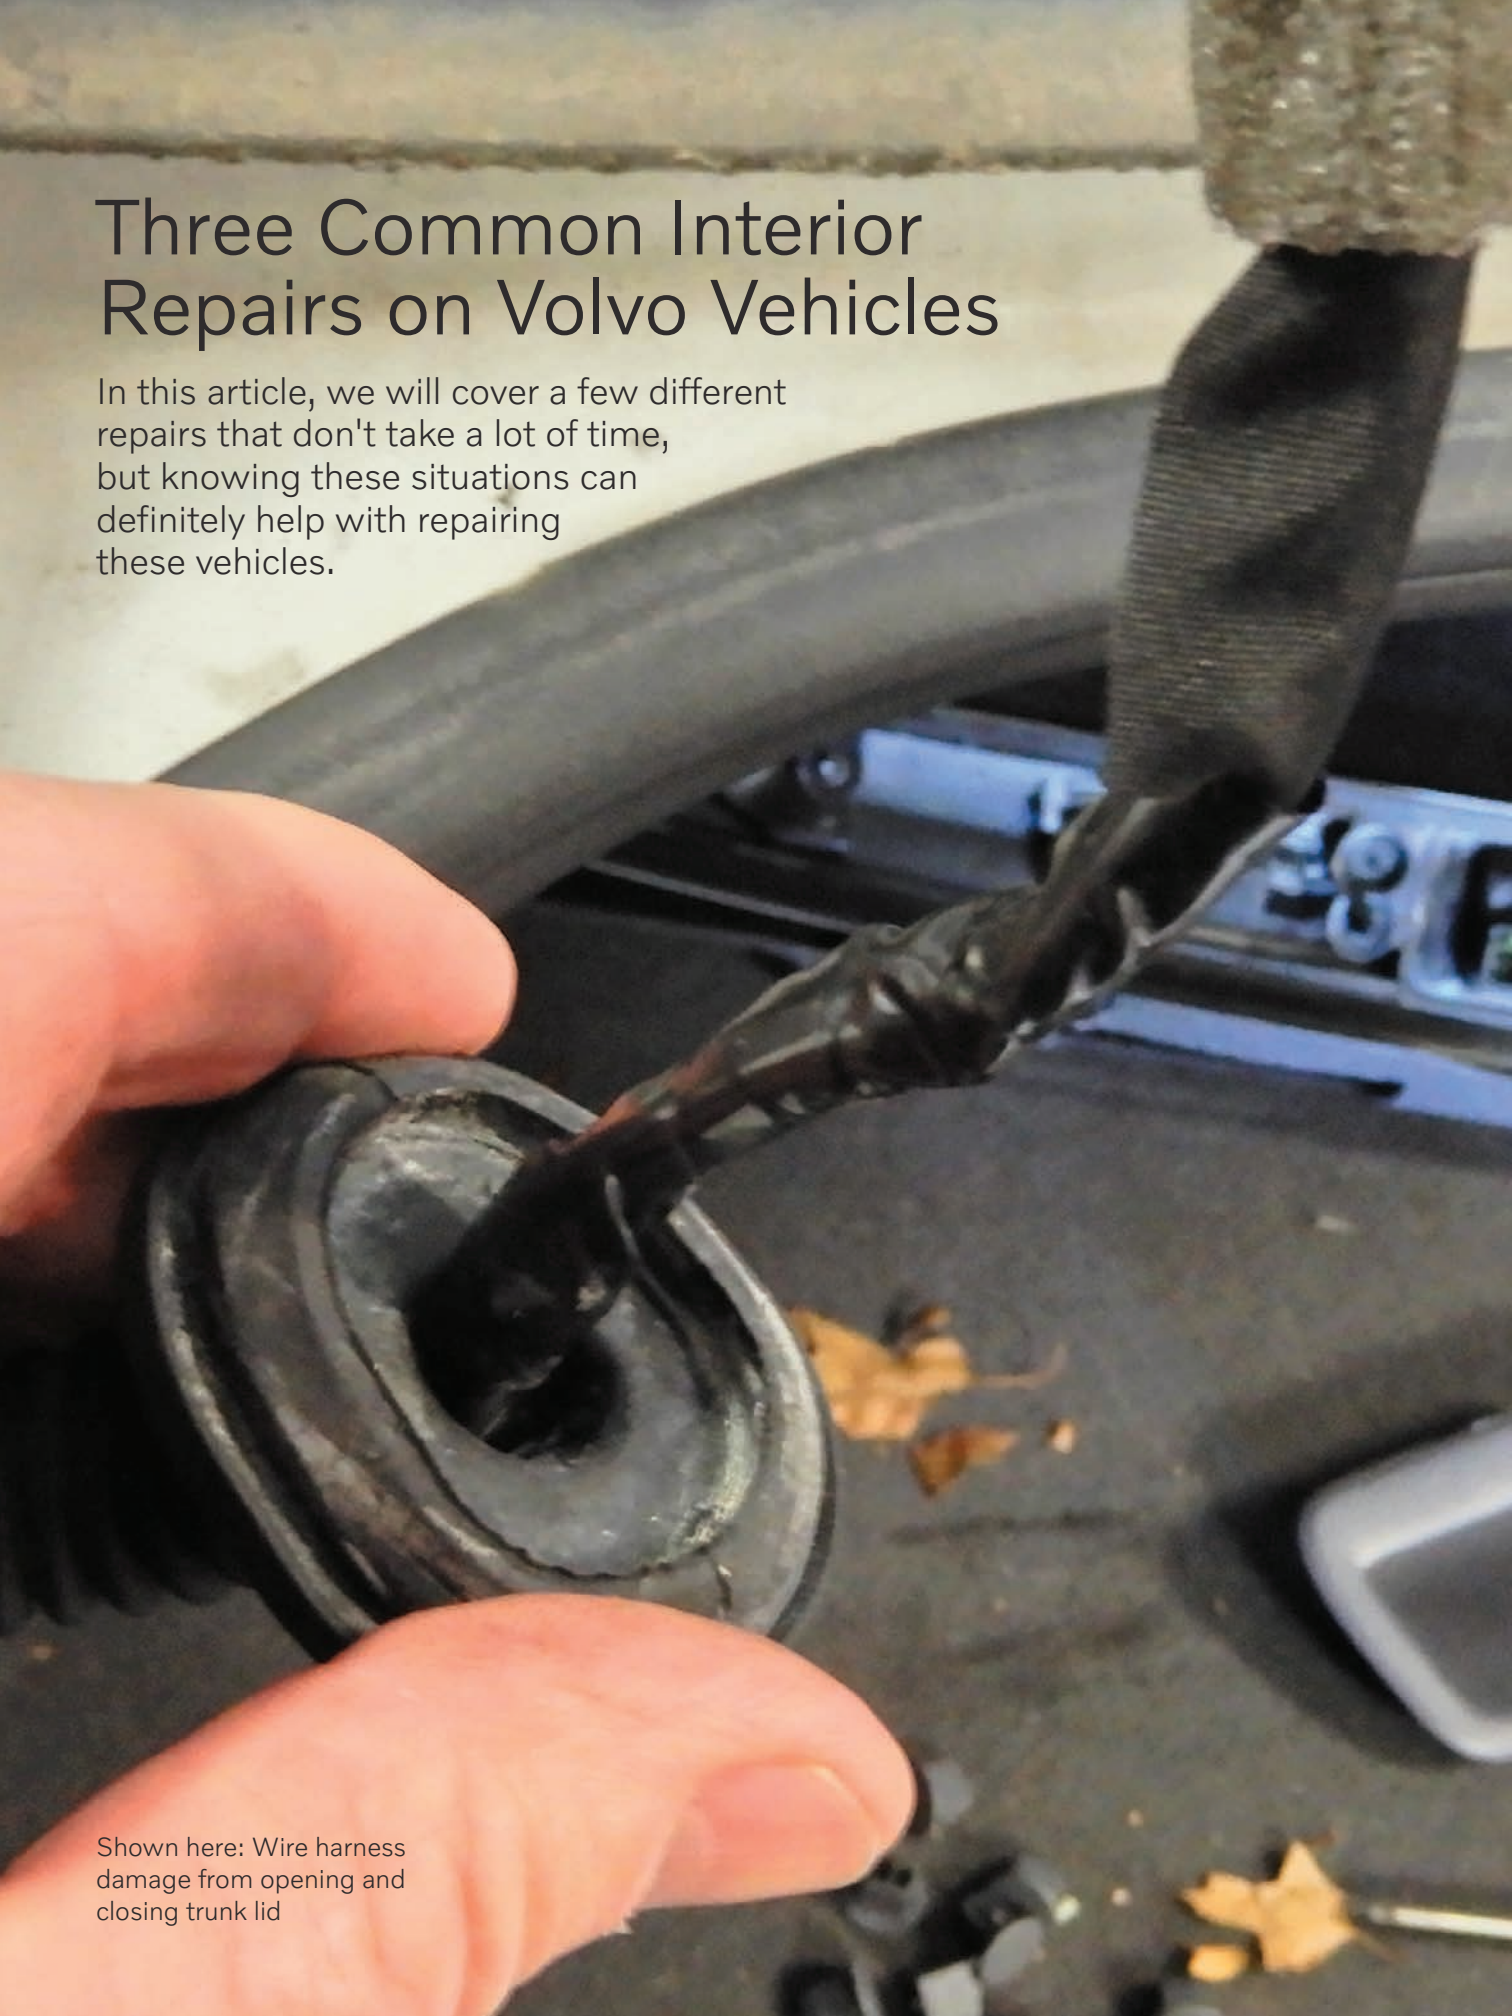
Shown here: Wire harness damage from opening and closing trunk lid

Many times on this model, the wire harness can wear out from repeated opening and closing the trunk lid, and the harness and the wires will become bare or even broken at times.

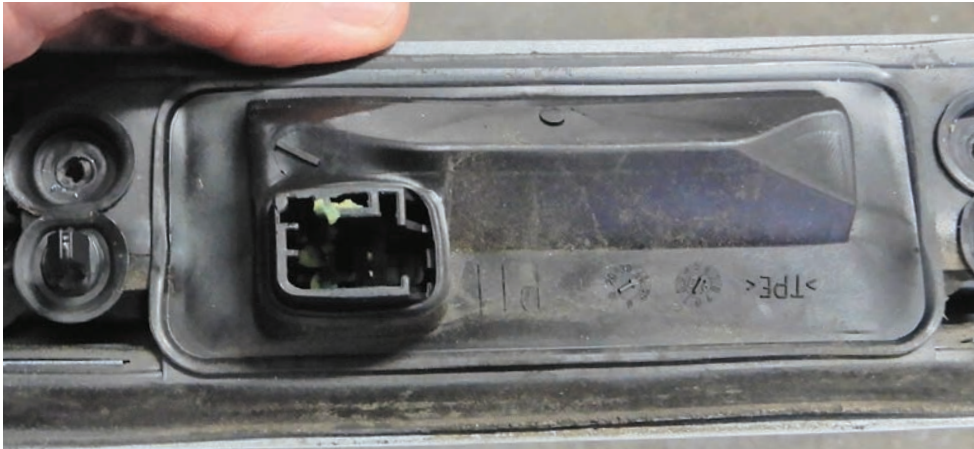
Trunk handle switch assembly removed from vehicle

There are four screws that hold the handle on; remove the screws and access the micro switch. With a test light, we can check for power and ground coming into the switch. If power and ground are present and the tailgate is still not opening correctly, its most likely the micro switch in the handle. Replace the handle.

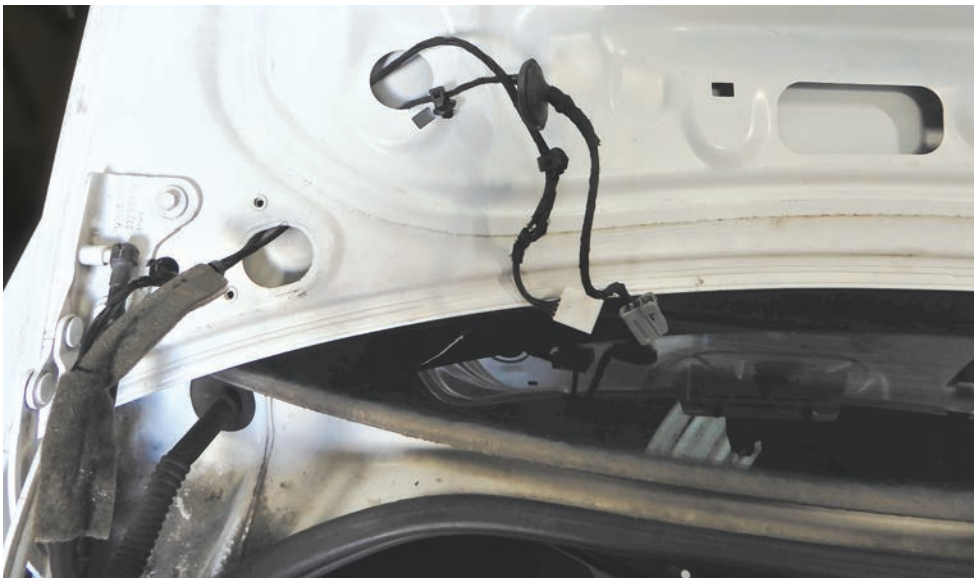
Trunk lid with inside trim removed and exposing wire harness

Remove the inner trim panel using a trim removal tool for the clips that hold it in place. This will expose the wire harness; now you can disconnect all the connectors at the lock mechanism, license plate lights, and so on. Disconnect all of the wire harness hold-down clips and tie downs that hold it in place.

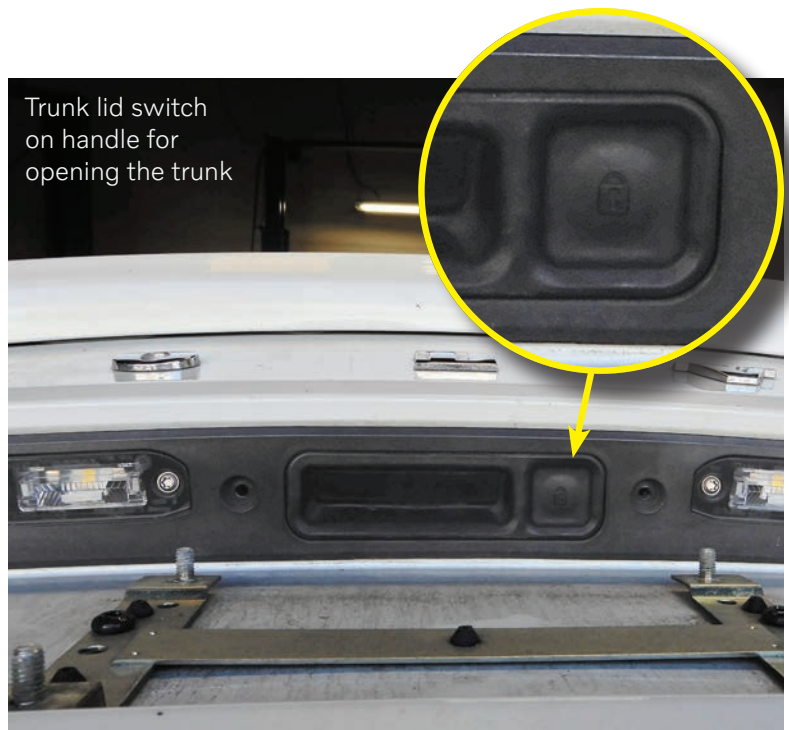
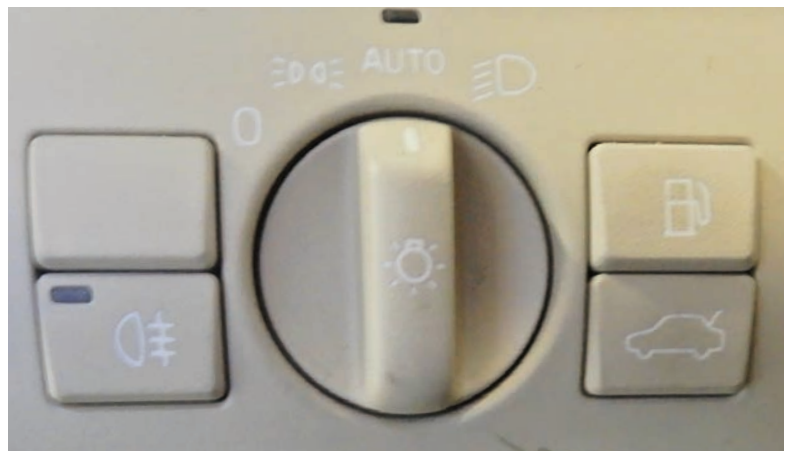
Switch for opening trunk on dash at light switch panel

Measure the voltage drop at the switch—not activated and then activated. Battery voltage should be present when not activated, and activated should be close to 0 voltage. If the switch has battery voltage, the switch is supplied correctly. If the switch voltage is not close to 0 voltage when activating, then the switch is bad and will need to be replaced.

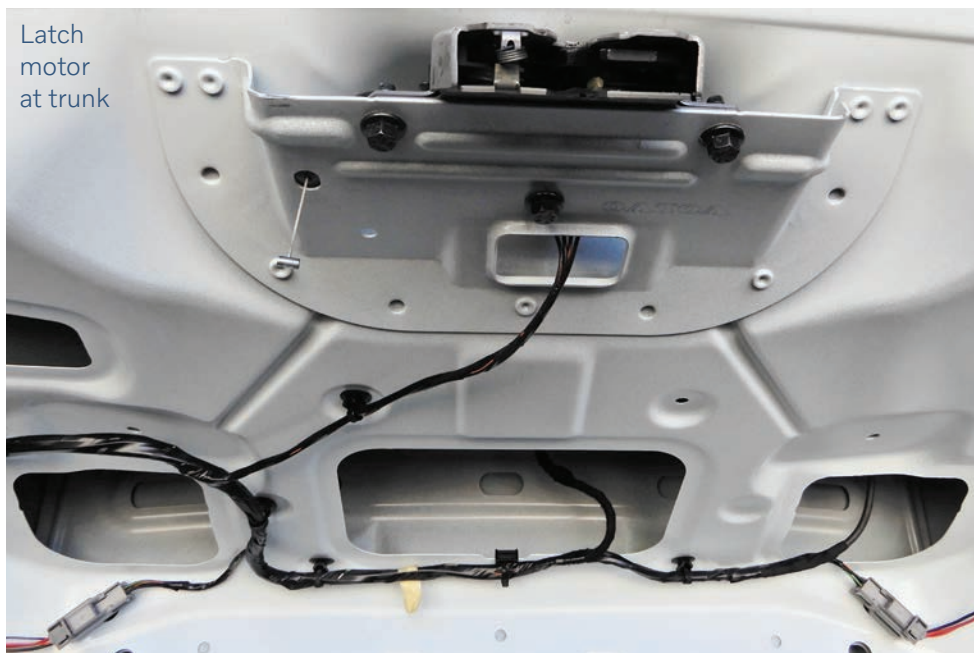
To check the latch motor, go into VIDA, CEM Activation; if the trunk does not unlock, measure the voltage drop at the latch motor. If the voltage drop is battery voltage, it's most likely a problem with the latch motor and it will need to be replaced. If the voltage drop is close to 0 volts, check the wire harness for a problem.

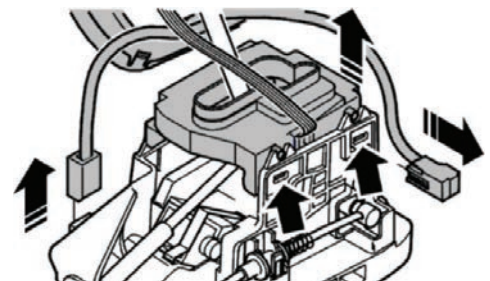
Gear selector knob that will have to come off on a Geartronic system

First off, you will have to remove the locking bracket at the bottom of the gear knob and the top of the boot.

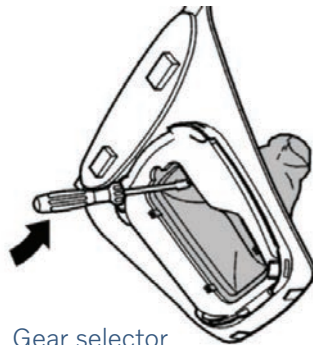
Gear selector boot panel that needs to be released using small screwdriver

After the panel is loose, be careful—there will be wires attached. At the bottom of the panel there are four clips that need to be released with a small screwdriver to separate the panel from the gear selector boot panel.

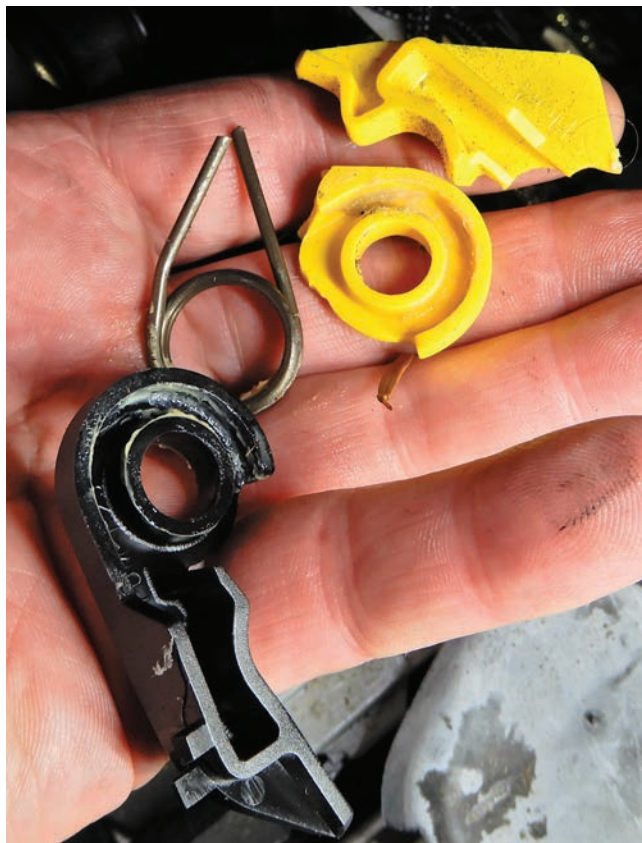
Broken shifter kit that will need to be replaced

On the top of the shifter assembly you will see a yellow and black component with two springs that will need to be replaced. Usually the yellow piece will be broken, so make sure to remove all of its parts from the shifter assembly. The automatic shifter repair kit is Volvo part number 9463559.

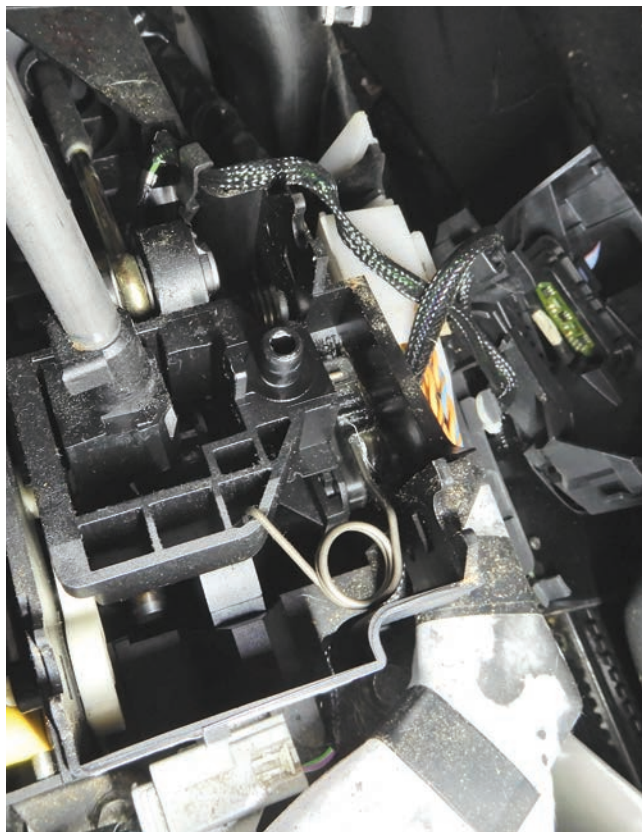
Shifter assembly with shifter kit removed

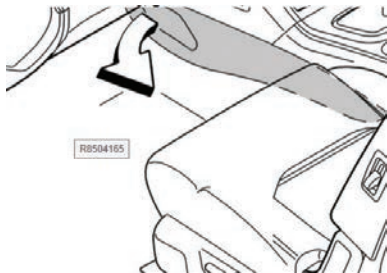
Side panels at sides of console that will need to come off and then back into place during reassembly.

Install the trim piece at the front of the shifter assembly, under the climate control. Put both side panels at the center console in place and secure.

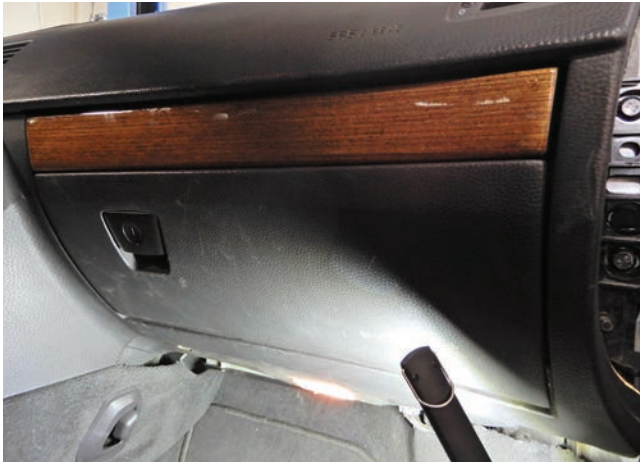
Glove compartment that needs to be removed

compartment; nine screws hold it in place and one electrical connector. Remove the cover at the end of the dash at the passenger side.

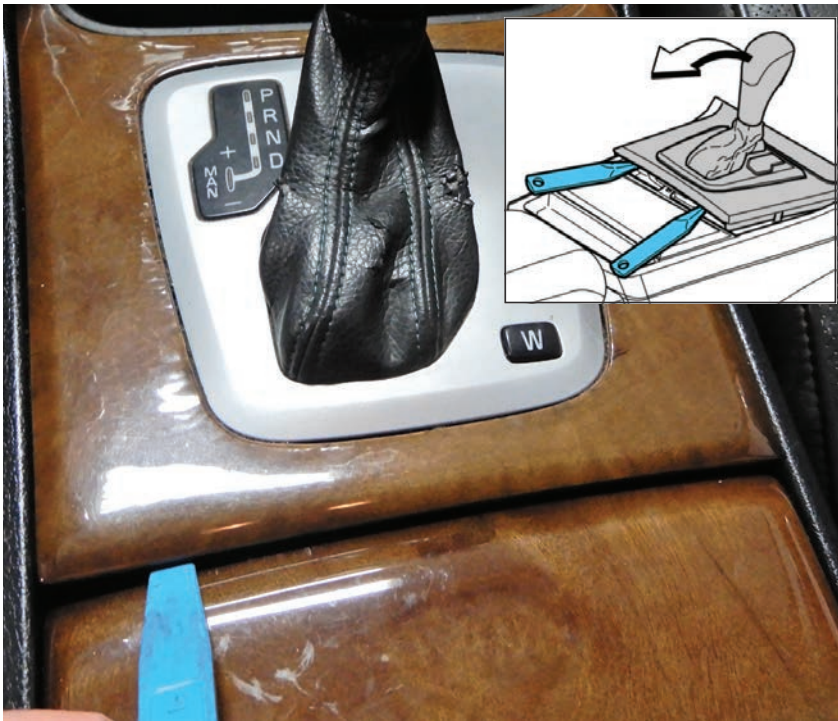
Trim tool used to remove trim at shifter shaft

With a plastic trim tool, pop up the trim around the shifter shaft and press the trim frame out of the gear shift selector panel.

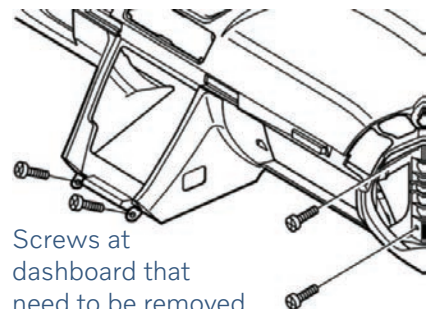
Screws at dashboard that need to be removed

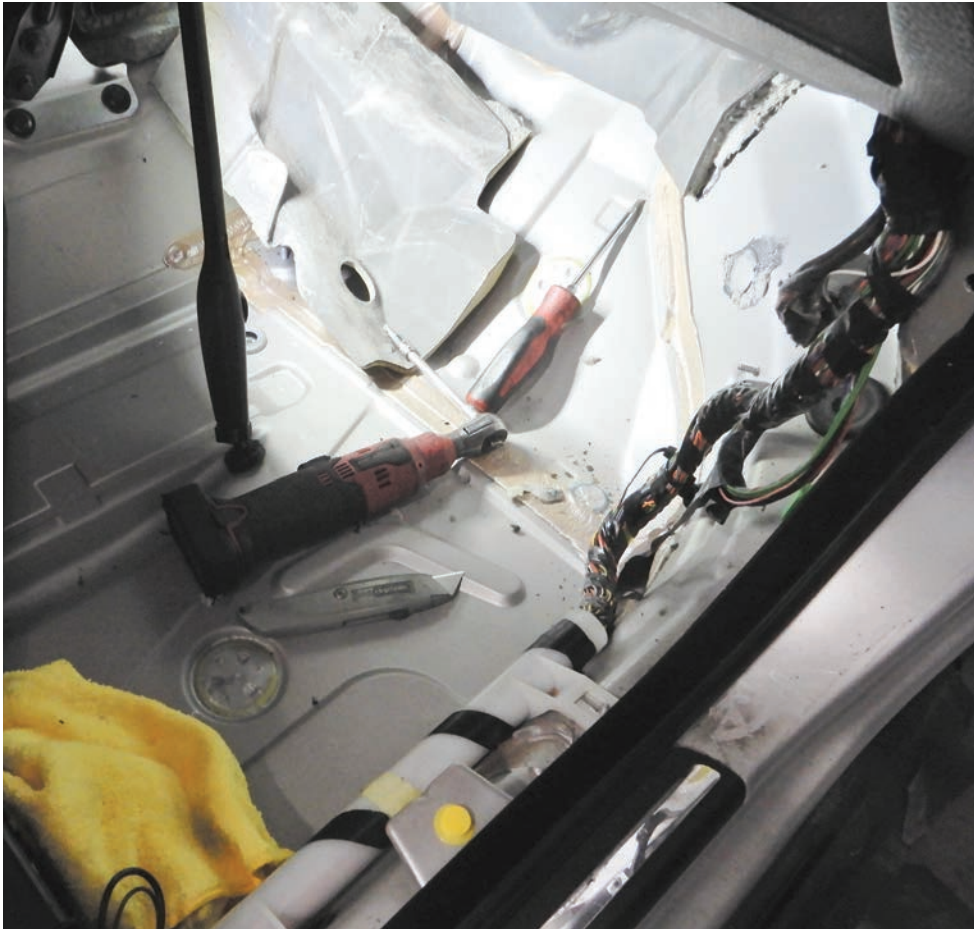
Cutting the soundproofing insulation around blower motor

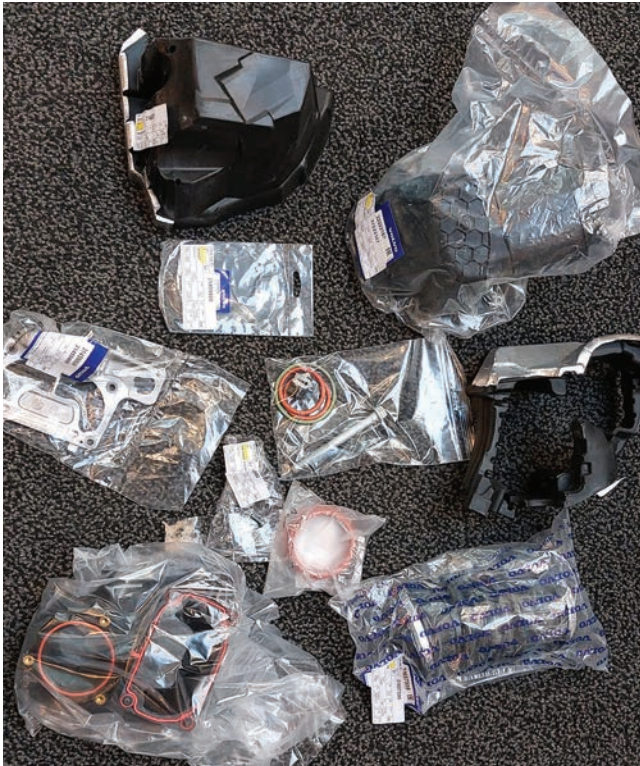
When you have to remove the supercharger on one of these XC90s to replace a leaking part, you should replace all the old seals and worn parts at the same time.

1. 32222165 Resonator
2. 32222167 Fresh air intake
3. 32252302 Sound insulation
4. 31492821 Sound insulation
5. 31657599 Bellows
6. 31459808 Gasket
7. 31459809 Bracket
8. 31657725 Plug
9. 31657726 O-Ring
10. 314744343 Sealing Ring
11. 32222126 O-Ring

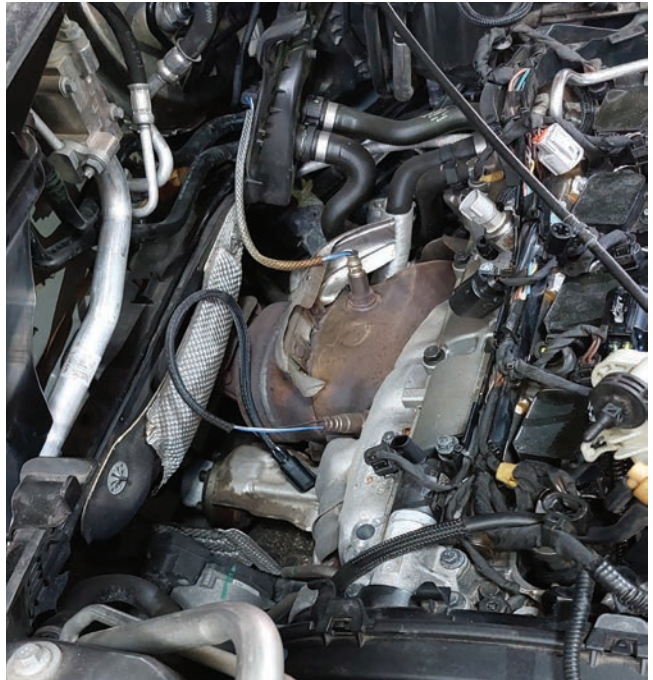
You should include a new upstream oxygen sensor in your estimate because of wear and the access to the sensor when the supercharger assembly is removed.

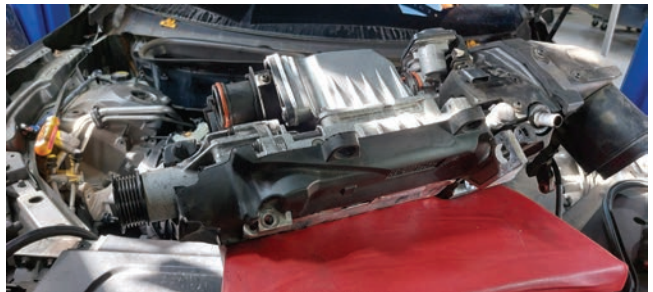
Supercharger removed

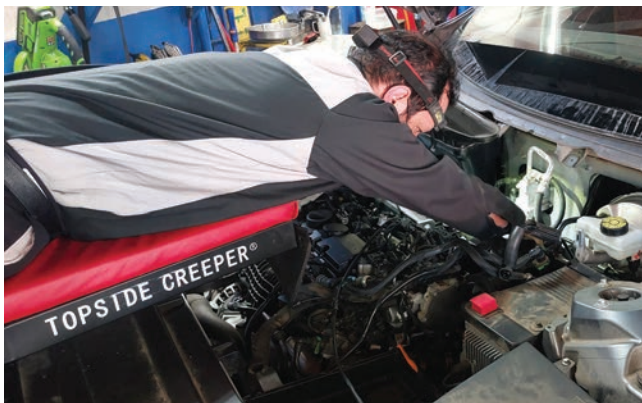
Using a top side creeper to access back of the engine compartment

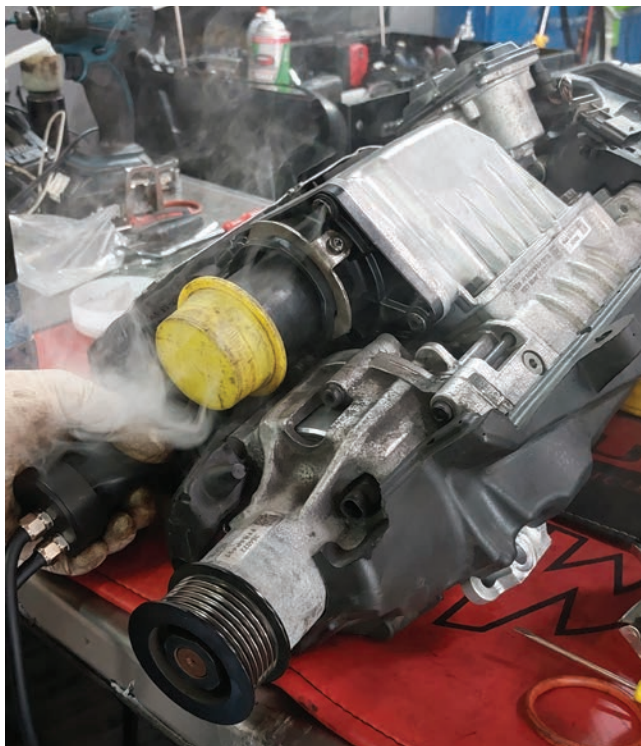
A smoke check of the supercharger assembly when it is first removed will show most of the leaks.

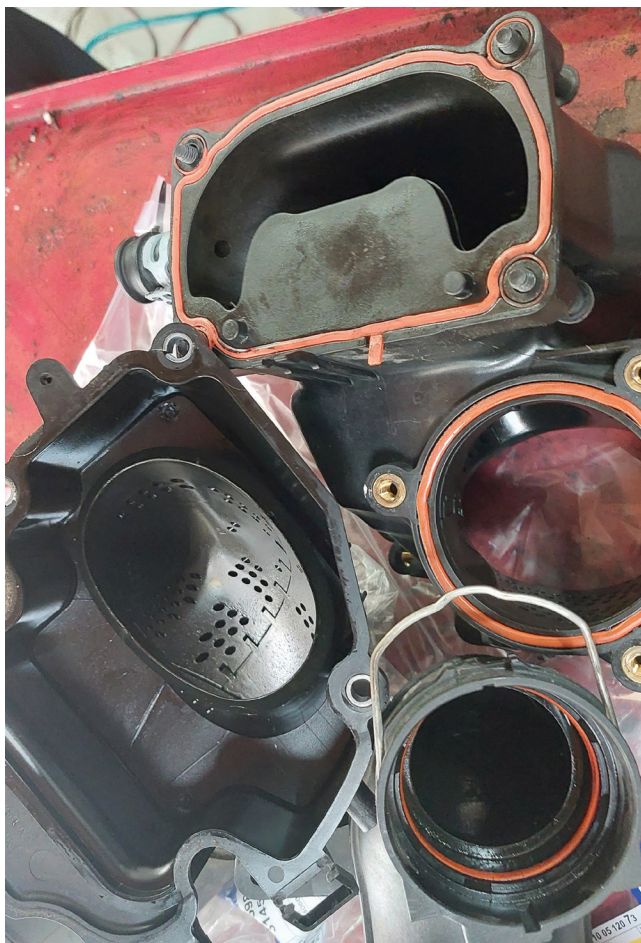
Worn supercharger parts
