Volvo TechTips

Summer 2023

Replacing the Air Conditioning Evaporator in the 2006 Volvo V70

More Volvo High Mileage Problems

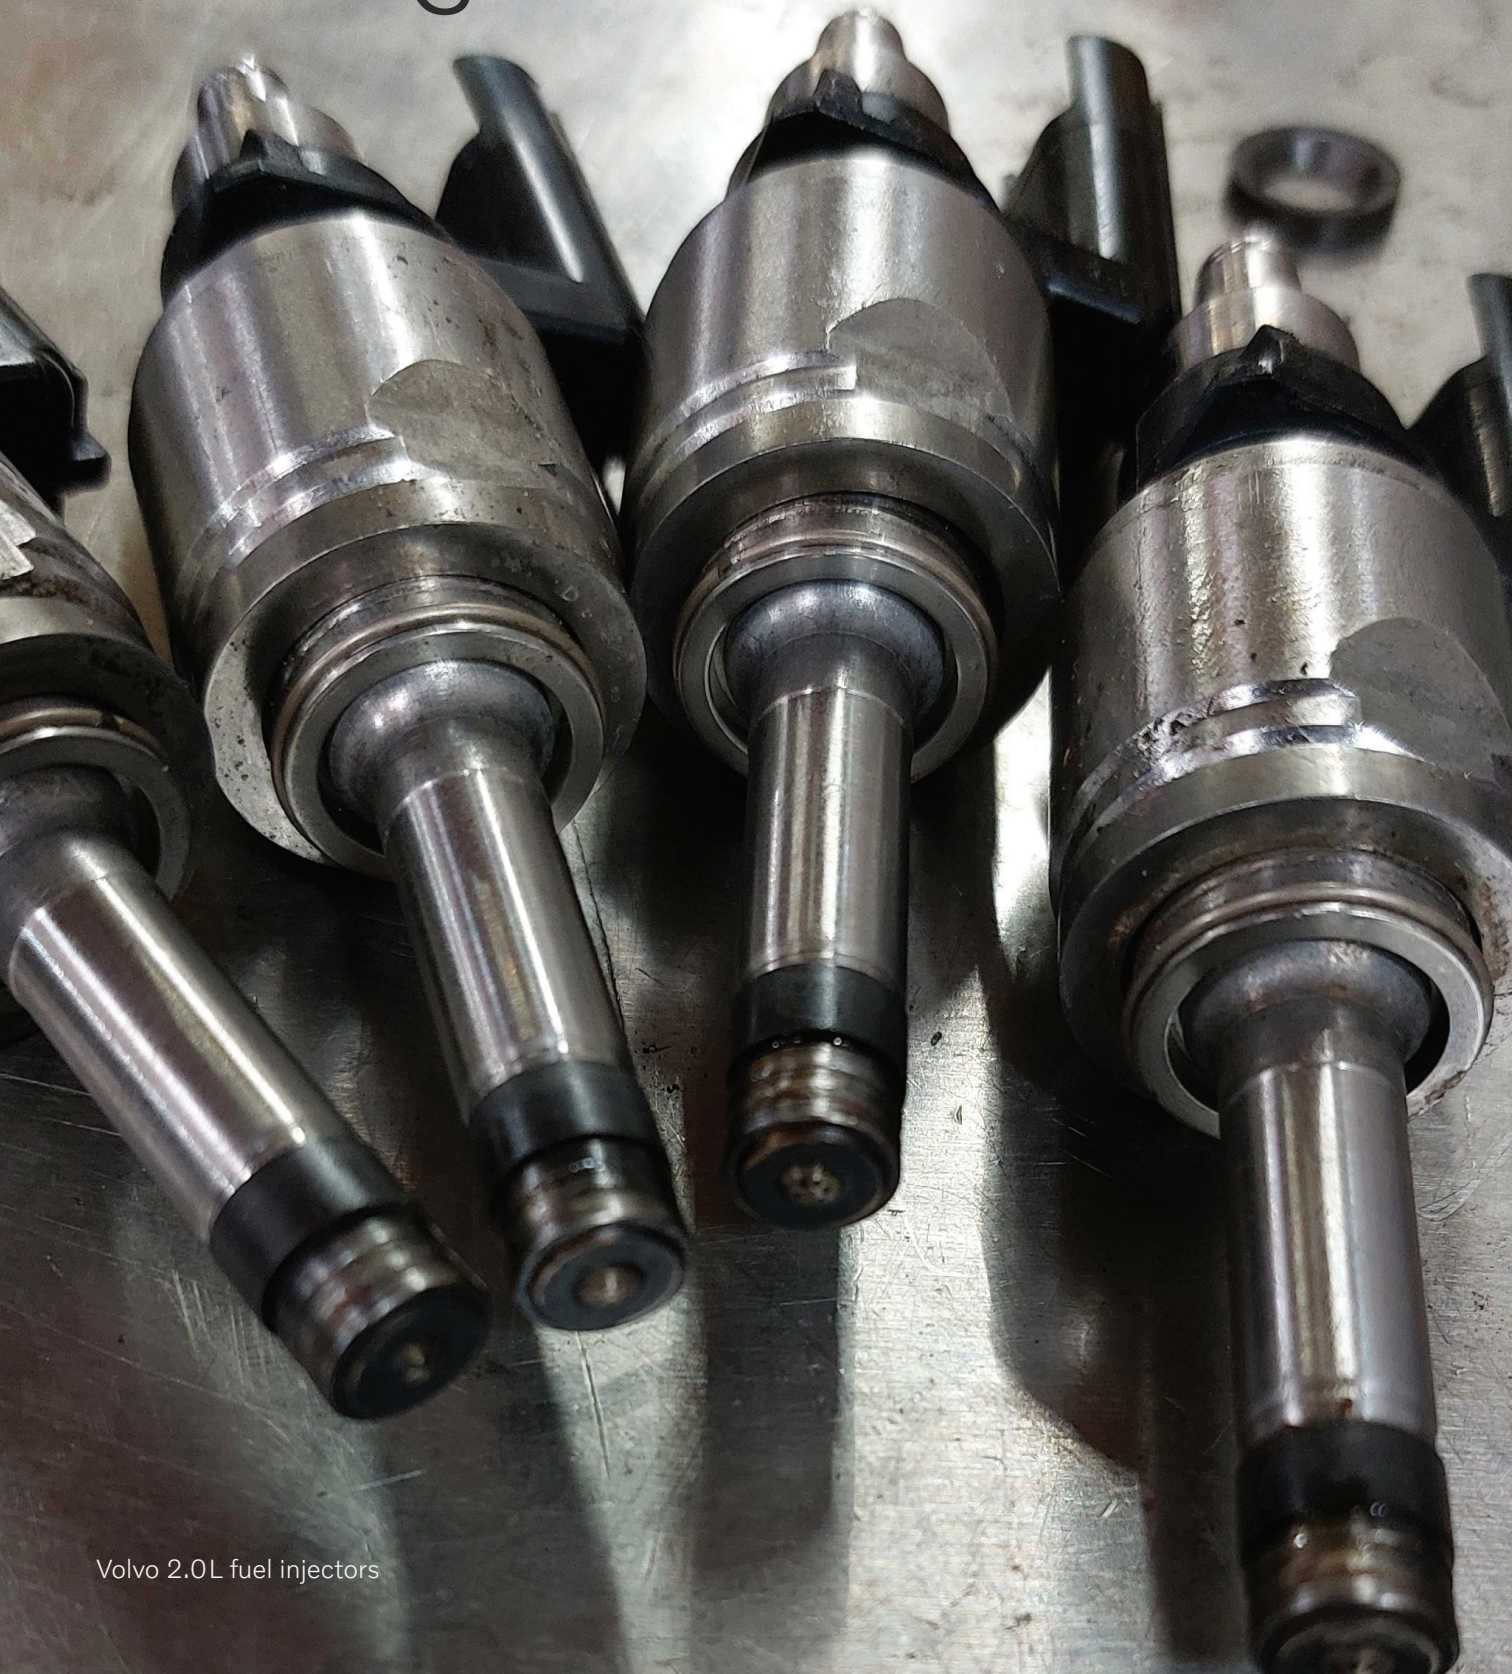
Volvo 2.0L fuel injectors

You may get a later Volvo in your shop that exhibits fuel injector problems. Most commonly if this type of fuel injector starts to leak, it will do so intermittently and may not be bad enough to set any trouble codes in the ECM.

Volvo recommends that you replace the high pressure fuel pipe that connects to the injection rail (part # 31669348) every time you replace the fuel injectors or the fuel injector seals.

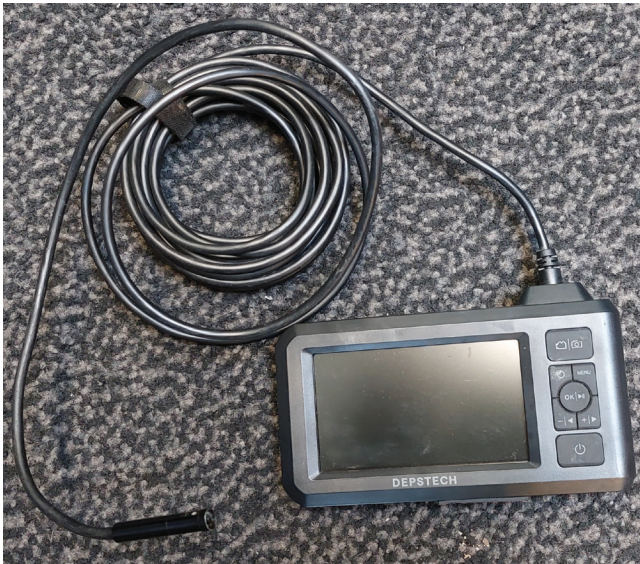
Your shop should have an endoscopic inspection camera to help diagnose internal engine issues like leaking fuel injectors.

If you have an endoscopic inspection camera you will be able to see a lot better.

In most cases, the injector that is leaking will start to drip after some time and leave a puddle of fuel on top of the corresponding piston.

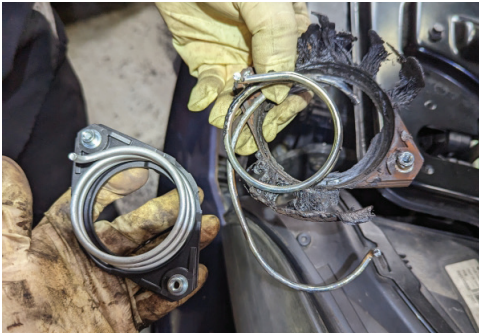
Damaged water pump coupler compared to a new one

The problem turned out to be caused by an incorrectly installed water pump drive coupler and spring assembly. The result was a water pump that was not being driven as fast as the engine needed to keep up with its cooling needs.

The incorrectly installed and damaged water pump coupler on this Volvo was causing the water pump to only turn at full speed intermittently, and when the engine got hot, the water pump was turning even less.

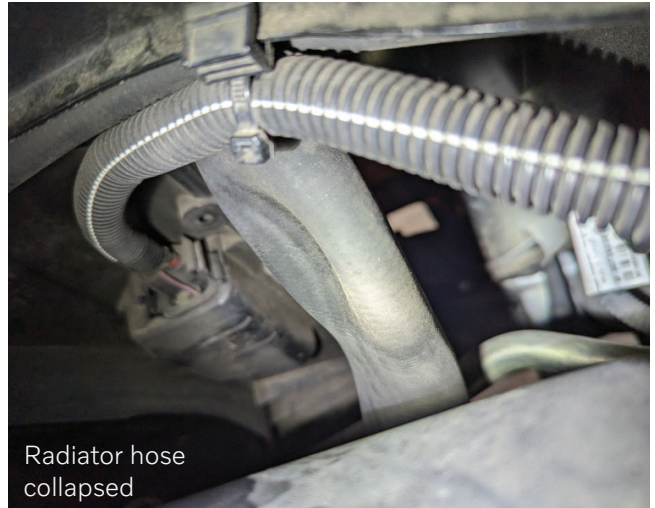
Radiator hose collapsed

In the case of this XC90, as the engine warmed up, the technician noticed that the radiator hose that is connected to the thermostat had collapsed, like it was under vacuum.

The technician's first thought was that the collapsing hose was due to a problem with the thermostat.

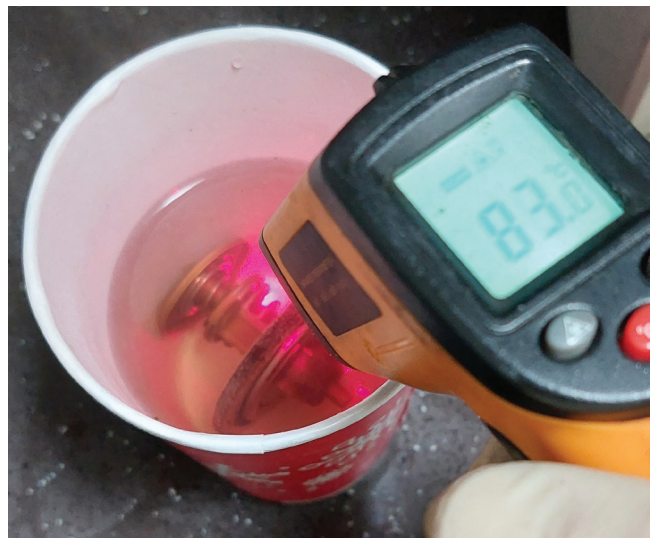
Testing the thermostat with hot water and a temperature gun

most shops, you will have to heat up some water in a microwave oven (DO NOT PUT THE THERMOSTAT INTO THE MICROWAVE). Use a microwave-safe dish to heat up enough water to submerge the thermostat assembly.

Use a thermometer to check the temperature of the water to make sure it is hot enough to open the thermostat fully.

You will need to drop the thermostat assembly into the hot water quickly because the water will start to cool down right away.

If the thermostat is working correctly, it should fully open within ten seconds or so.

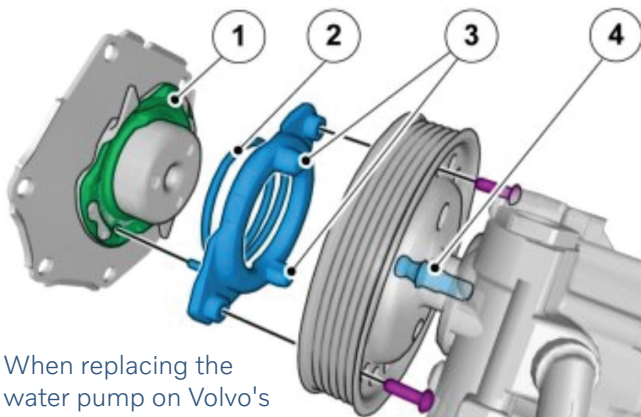
When replacing the water pump on Volvo's 3.2L and 3.0L SI6 engines you should always replace the coupler and spring with new OE Volvo parts at the same time.

There is a spring-loaded coupler that connects the two pulleys that can be tricky to install and should be replaced when replacing the main water pump on these engines.

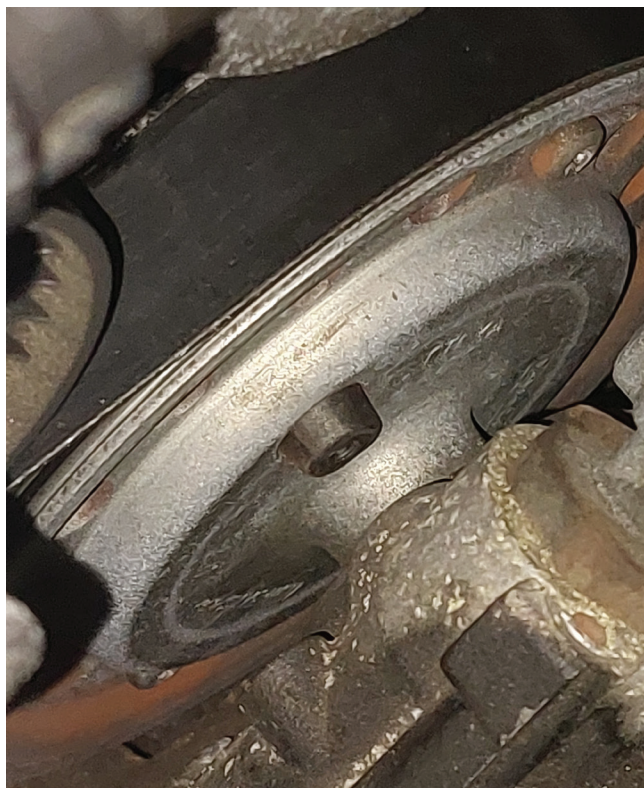
Water pump coupler pin showing through power steering pulley

So with this new information, the technician took a really close look at the new water pump. Upon close inspection, the technician saw that the water pump's drive pulley seemed to be wobbling slightly while the engine was idling.

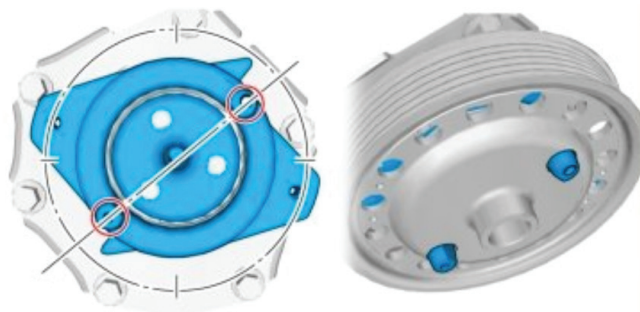
Water pump coupler pin location diagram

Remove the pins from the pulley. Rotate the power steering pump upward and rearward. When installing, to facilitate fitting of the water pump coupling to the power steering pump pulley, turn the coupling until the spikes are in the 8 o'clock and 2 o'clock positions, as illustrated. Make sure that the pins stick out through the holes in the pulley.

Make sure that the coupling's spring (2) clicks into position at the bonded part of the water pump (1), and that the pins (3) enter the holes of the pulley. Always use new centering pins (4).

There are plastic alignment pins that must be put in the right place when installing the coupler.

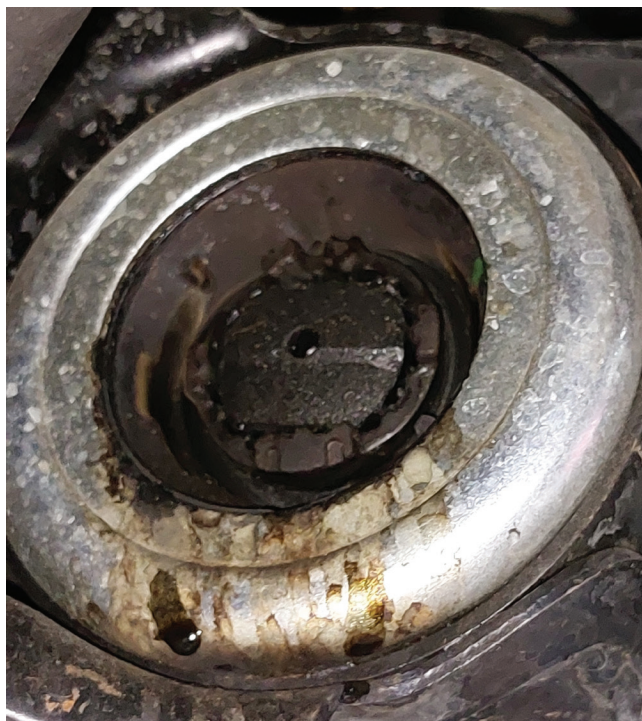
Leaking lower control arm bushing

That's, of course, if the bushings have not leaked out all or some of their hydraulic fluid.

The customer may have a complaint of loose steering, pulling to one side, or more commonly, a squeak noise from the front end when the car is driven over bumps.

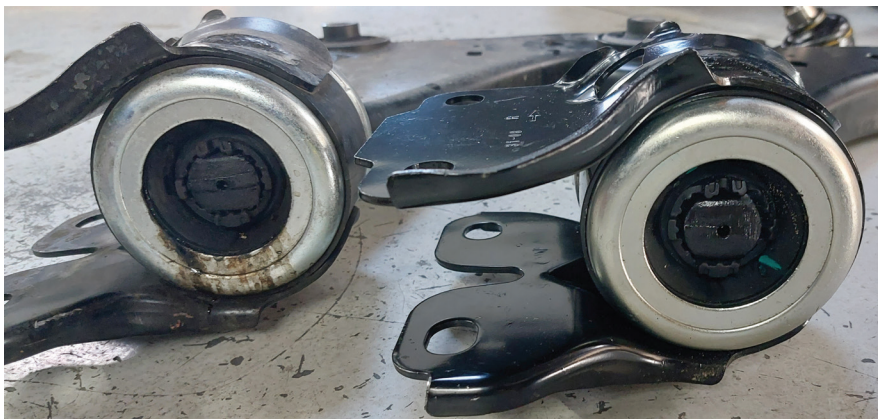
Here's an old leaking hydro control arm bushing compared to new bushing.

Volvo has designed a new updated version of this type of control arm bushing that reduces the movement of the control arm.

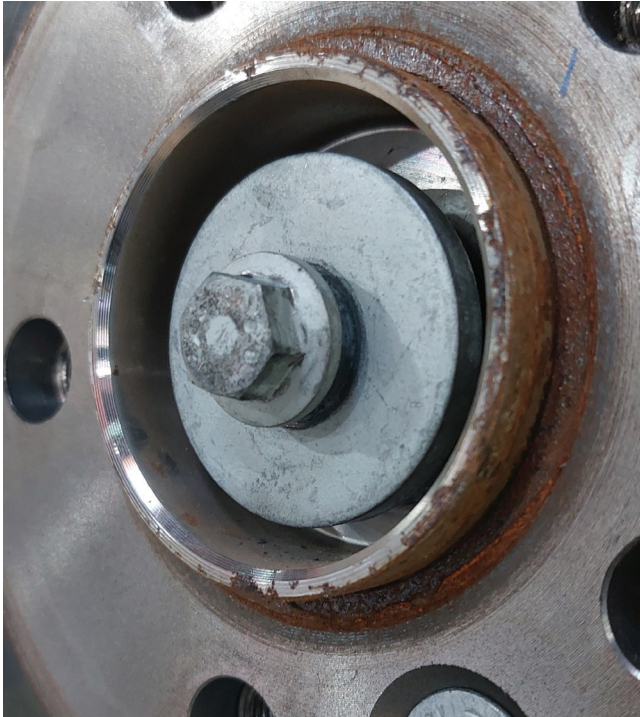
Loosen the axle bolt to make it easier to pop out the ball joint.

It will make it easier to pop out the ball joint if you loosen the axle bolt first.

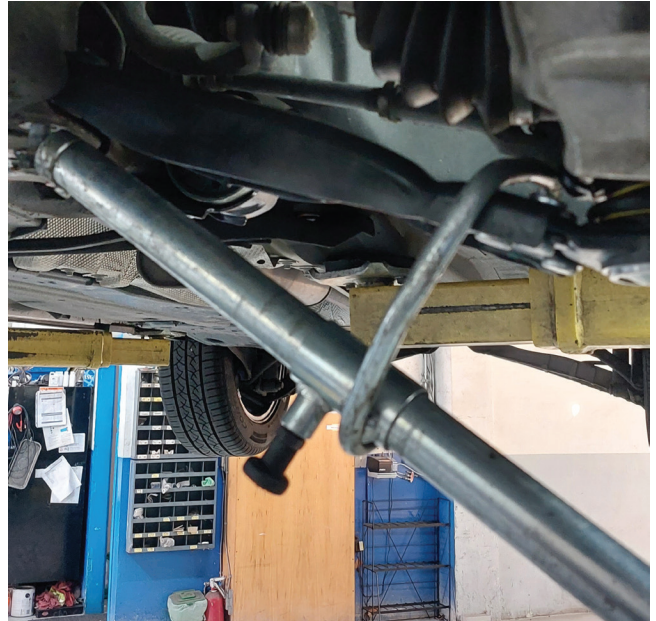
If you work on Volvo suspensions a lot, you should purchase one of these very handy special tools (Volvo part # 999 707 6c) from your local Volvo dealer or from volvotechinfo.com. Tools like this can make working on Volvos a lot easier.

Use Volvo special tool #999 707 6c or similar to pull the ball joint out of the lower part of the wheel knuckle.
