STARTUNED®

M274 Turbocharger Engine

Addressing Some Common Codes and Complaints With the M274 Turbocharger Engine

Today, we will spend our time looking specifically at the turbo units found on the GLC300, and similar models equipped with the M274 engine and turbocharger package.

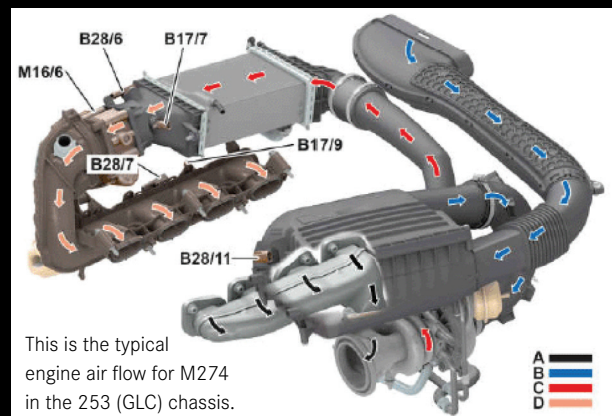
This is the typical engine air flow for M274 in the 253 (GLC) chassis.

Above: This turbocharged M274 engine produces 180 kW (241 hp; 245 PS) at 5,500 rpm. Learn your way around the turbo functions.

The flow and function are no different than most turbos with a charge air cooler. The ATL draws in fresh air via the air filter and the compressor

inlet, and directs this from the compressor outlet to the charge air pipe. This is accomplished using the flow energy of the exhaust gases to spin the turbine wheel at a very high rate of speed. The high rpm of the compressor impeller and the increased flow rate compresses the air in the charge air pipe, causing it to heat up. Finally, the compressed charge passes through the charge air cooler, which cools the intake air and directs it to the charge air distributor (manifold).

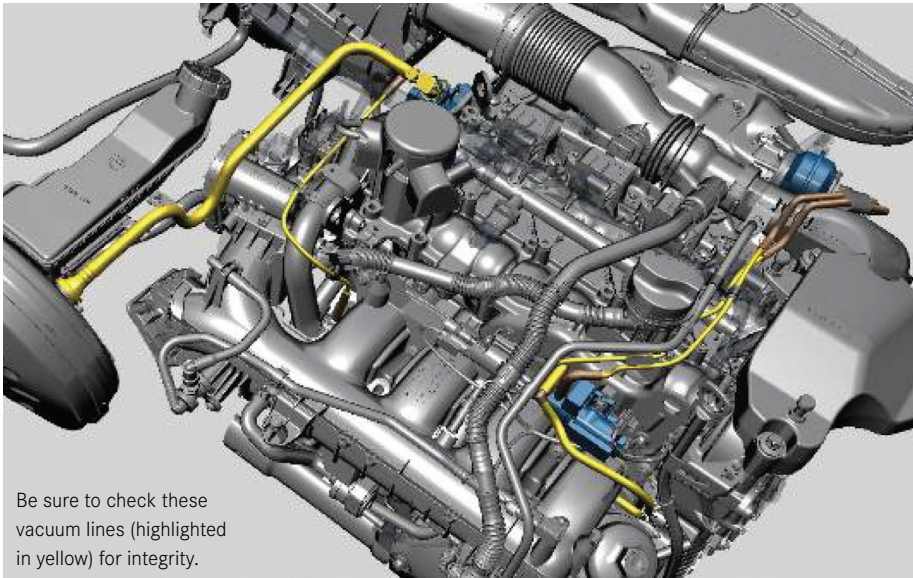
Be sure to check these vacuum lines (highlighted in yellow) for integrity.

lines associated with the turbo controls.

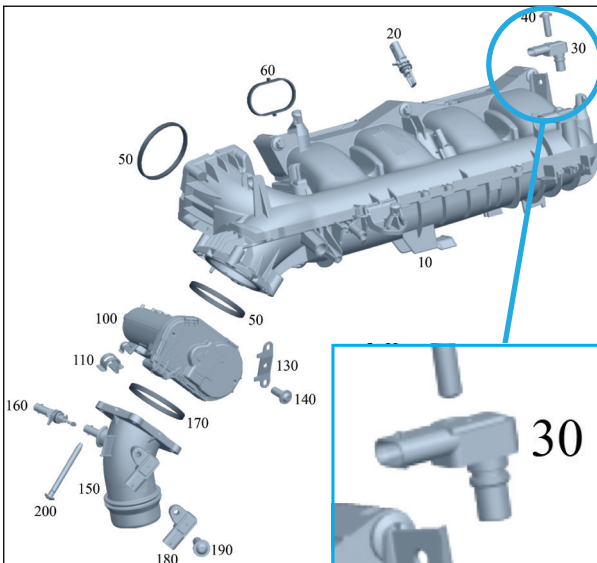
The boost pressure sensor (30) can fail due to oil contamination.

Using your scan tool, verify that the pressure sensors upstream and downstream of the throttle (B28/6 and B28/7) are reading atmospheric pressure with the key on and engine off (KOEO). Since there is no boost happening with the engine off, they should read nearly identical. If not, then one of them is

at fault and the engine control module just "thinks" it sees a boost problem. Pull and examine them for oil contamination, which can be a concern.

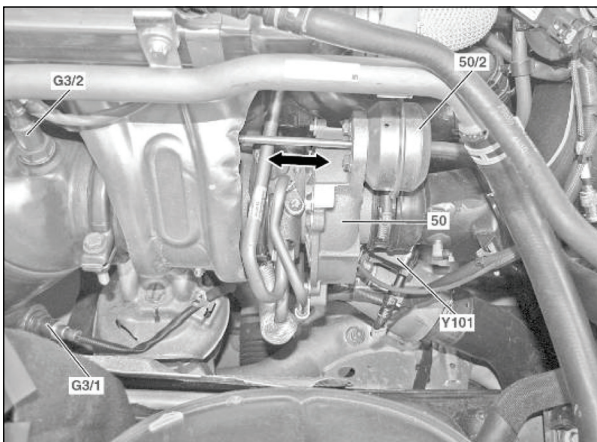
This control rod for the wastegate must move freely when performing activation of the Y31/5 transducer.

Hopefully, you have a scan tool that can activate the transducer. Using the actuation feature of the scan tool, you should be able to see the control rod move on the turbocharger wastegate diaphragm. Note: Do not force the rod by hand! If the rod doesn't move, verify that Y31/5 (the Boost Pressure Control Pressure Transducer) can mechanically pass vacuum while energizing it. Be sure to use a gauge and not just listen for a click, as sometimes these valves will energize without allowing vacuum to pass.

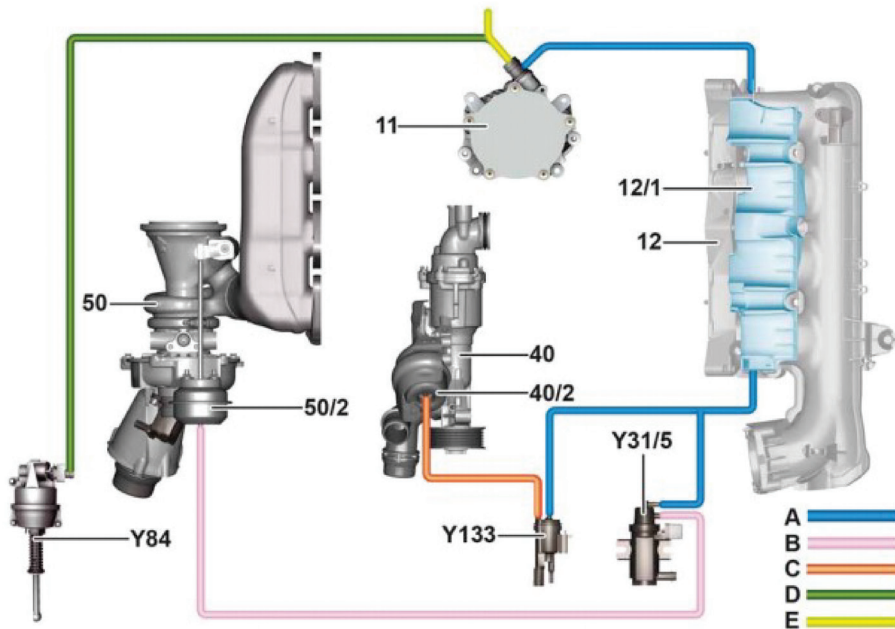
This diagram shows the boost pressure control transducer (Y31/5), which requires both a vacuum supply and the ability to pass vacuum when activated.

After you have verified proper vacuum being supplied by the pump, check for similar vacuum at the inlet of the Boost Pressure Control Pressure Transducer Y31/5, referring to the vacuum diagram to find the right spot. If that's low, then check for vacuum leaks along the vacuum circuit.

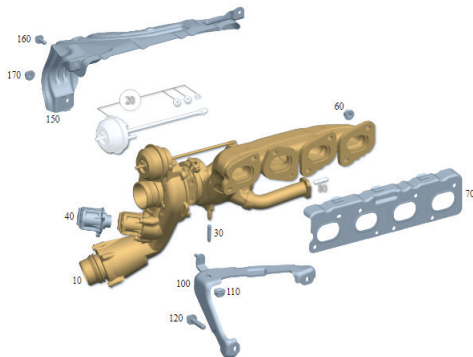
If you have a faulty wastegate actuator (20), you'll need to replace the entire turbo with manifold, as it isn't available separately.

Check the diaphragm on the turbo wastegate vacuum actuator and make sure it can hold vacuum, and that the wastegate rod moves with vacuum applied from a vacuum tester. The rod should move at about 620 mBar (9 psi) and it should hold vacuum for at least a minute or so. Field reports have shown that a failure of the wastegate diaphragm is one of the most common failures of the turbo setting codes and not working properly, aside from vacuum leaks and bad connections. The wastegate on this particular model with the M274 engine does not come separately, and the whole turbo with manifold must be replaced. Looking at the ISPPi portal (the Mercedes-Benz parts catalog), there are some models that show it separate, but none of the ones
