# TOYOTA SERVICE NEWS

Bulletin No. 2

November, 1981

**IASA/TOYOTA -  
"a Joint Effort  
to offer  
Quality Service"**

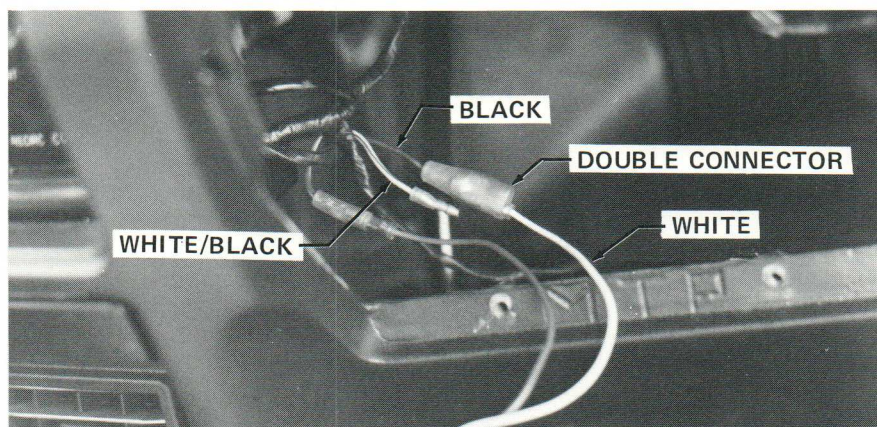
## TUNING FORK CLOCK

When the battery is disconnected, or the clock fuse is burned or removed, the clock will cease to operate and will not restart when the battery is reconnected or the fuse is replaced. To start the clock, the reset knob must be pulled out and then released. When the knob is released, the clock will continue to operate. This method of restart should
