# TOYOTA

# SERVICE NEWS

Bulletin No. 4

May 1982

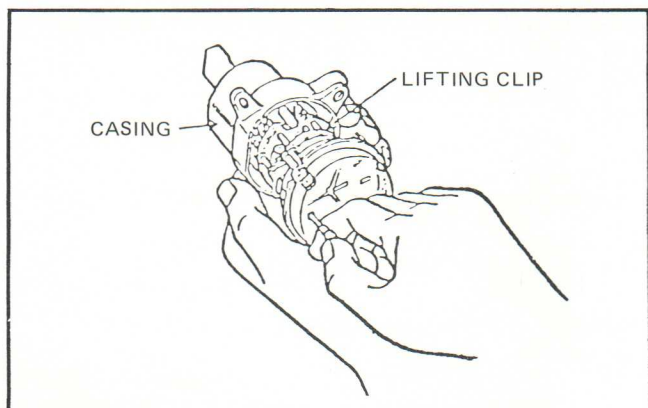
The Celica Quartz clock stopping or exhibiting intermittent operation symptoms has been traced to excessive spring plate pressure on the second hand drive gear. Installation of a "lifting clip" to remove this excessive spring plate pressure results in nearly a 100% successful repair.

- Pull the reset knob to slide the clock mechanism from the casing to expose the clock mechanism. Do not separate the clock as damage may occur to the internal electrical connections.

**CAUTION:** Take the mechanism out by tilting the clock downward so that plastic particles do not drop into the casing.

- Locate the spring plate.

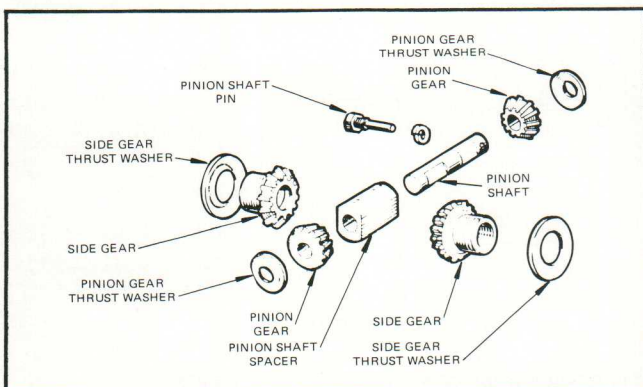
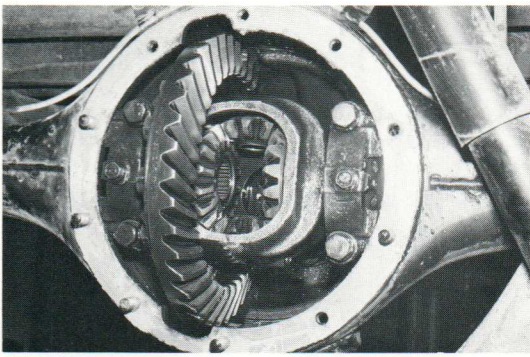
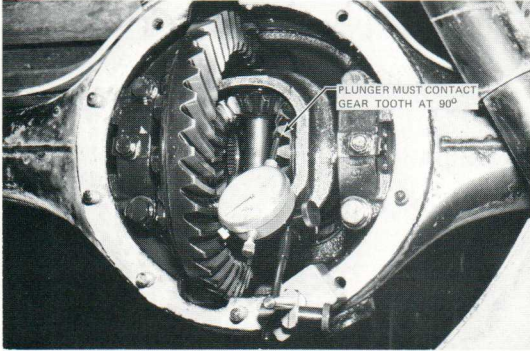
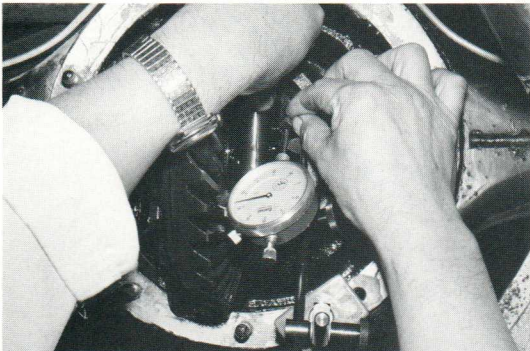
## MEASURING DIFFERENTIAL SIDE GEAR BACKLASH LAND CRUISER

This method is to be used:

- When excessive backlash has been diagnosed.
- When overhauling the differential assembly.

Hold the top pinion gear in place and rock the side gear back and forth to read the backlash on the indicator. Do not allow any of the other gears to move.

The specified backlash is 0.05-0.35mm (0.002-0.014 in.).

This adjustment is performed with the differential installed on the vehicle.

Remove the pinion shaft spacer and the rear axles.
