German Time Porsche 944 Timing Belts

Porsche 944

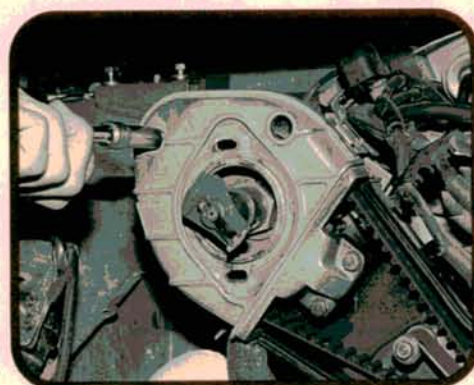
5

Remove the distributor cap and distributor housing. It isn't necessary to remove the rotor. Tilt the housing and "wobble" it past the rotor. There's no pickup inside the distributor, and there are no electrical connections. The primary ignition signal is supplied to the ECU by the crankshaft position sensor.

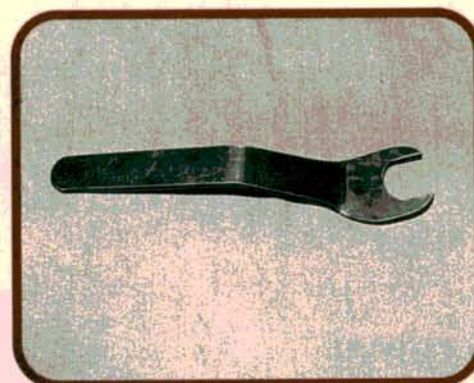
6

Porsche recommends several special tools for 944 timing belt service, some of which are essential. You can substitute standard hand tools for this tensonian adjustment wrench, but the job is more difficult without it. If you plan on doing this job more than once, the special tools are a worthwhile investment.

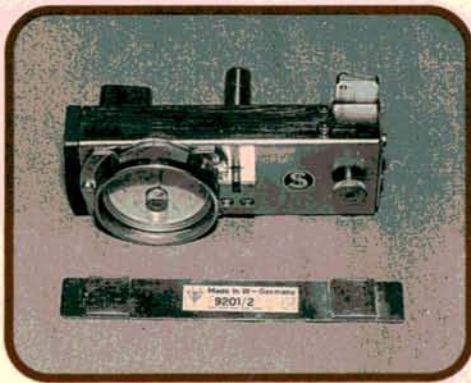
13

Proper belt tension is very important, Porsche techs tell us. You can't do this job properly without this belt tension gauge. Other belt tension gauges won't work because Porsche's tension specifications refer to the scale on this gauge. Use the metal calibration bar to test and recalibrate the gauge before each use.

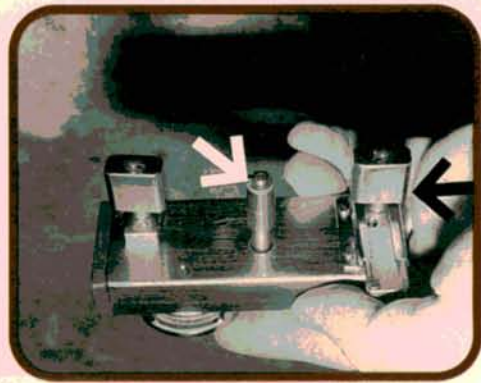
14

The gauge's flat shoes have a thin side to contact the balance shaft belt, and a thick side for the cam belt. Push the sliding shoe (right arrow) toward the outer edge of the tool, then set the lock. Slide the gauge over the belt with the shoes on the outer surface, and the pin (left arrow) in an inside belt notch.

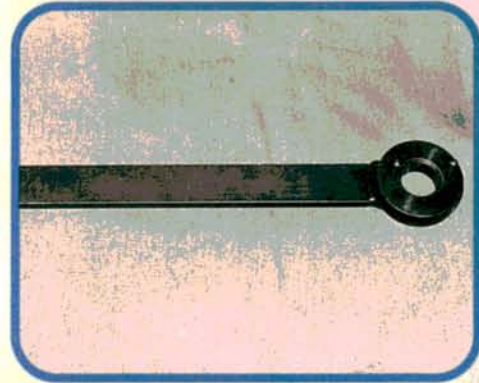
16

The spanner wrench is used to hold the balance shaft pulleys while removing the pulley retaining nuts. Pins in the spanner head match the pulley holes. The center hole allows access to the retaining nut. Balance shaft pulleys need to be removed only if you're replacing the balance shaft oil seals.
