# Little Star

## 190 Service

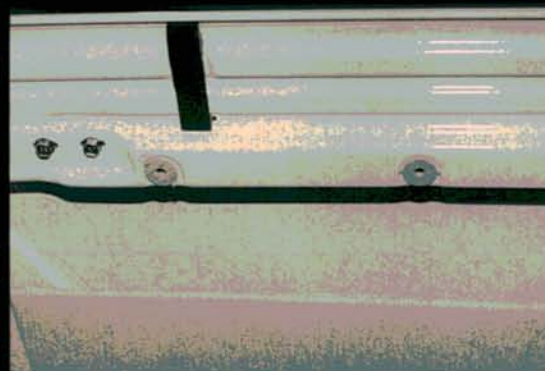
6

The sunroof headliner can be removed by partially opening the sunroof, then releasing the four headliner pressure clips at the front of the sunroof. Now pull the headliner through the sunroof opening. If the sunroof won't open, the headliner can be removed by bowing it downward after releasing the clips.
