Dual Citizenship

Service Tips

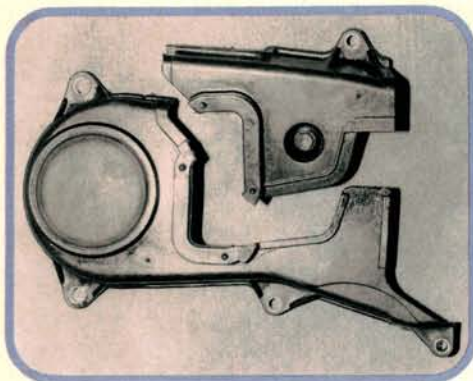
1

Removing and installing the timing belt covers on single overhead cam engines can be a test of your patience. The two upper covers interlock to surround the right motor mount. The motor mount must be removed to install a new timing belt. The lower cover protects the crankshaft pulley.

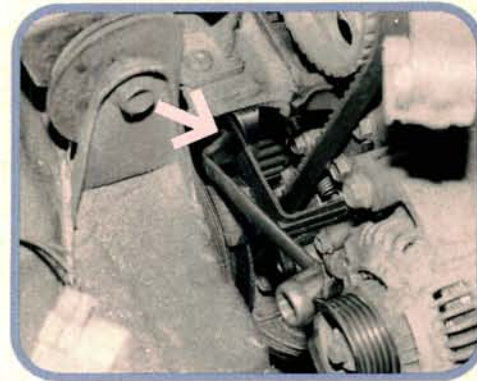
2

A properly tensioned timing belt is a happy timing belt. Routine belt tension adjustments during major services will prolong timing belt life to 60,000 miles or more. Loosen the tensioner bolt (arrow) near the motor mount. The spring loaded tensioner will automatically adjust for timing belt stretch.

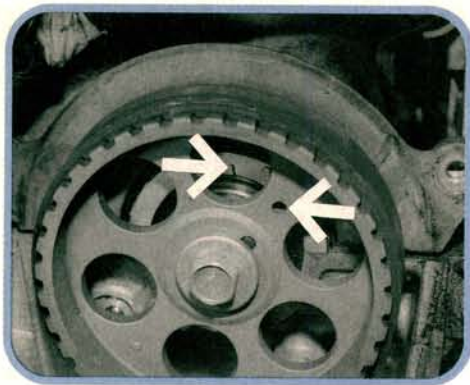
3

The single overhead cam timing belt alignment marks can be tricky to see. Align the hole in the cam pulley (right arrow) with the pointer on the cylinder head (left arrow). We rotated the cam slightly to show both marks. When the pulley is in position, use a mirror to sight the pointer.

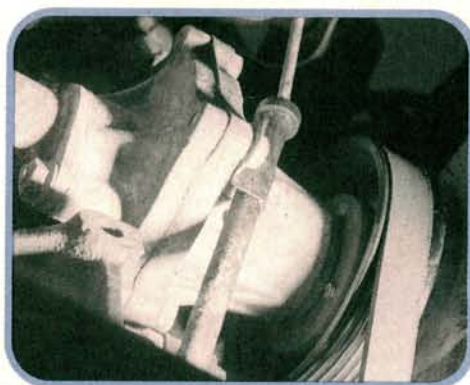
4

The water pump is driven by an accessory belt, not the timing belt. You might think this would make it easier to replace the pump, but it doesn't. The pump is mounted on an extension housing that's wedged into the back corner of the engine compartment. Working from underneath with a lift helps.

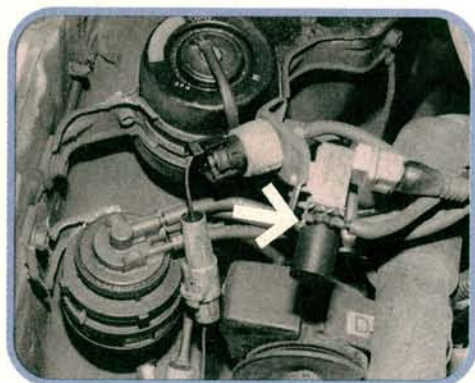
6

Rather than controlling the fuel to adjust the fuel mixture, the ECU adjusts an electronic bleed control valve (EBCV for short) to bleed air into the primary carburetor circuit. The mixture starts out slightly rich and is leaned out as air from the EBCV (arrow) is added during closed loop operation.

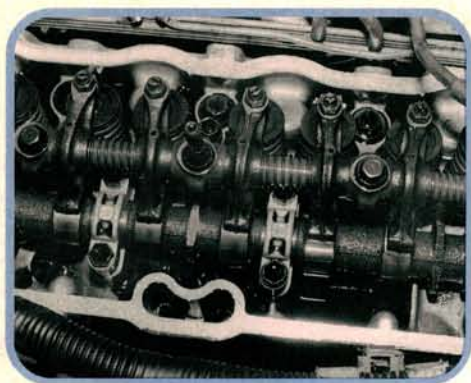
13

The valves should be adjusted hot. Rotate the cam until the lobe points away from the rocker arm, then adjust the valve. Mark the rocker arm with a colored grease pencil, then rotate the cam into position for the next valve. It may take longer, but there's less chance of a noisy valve when you're done.

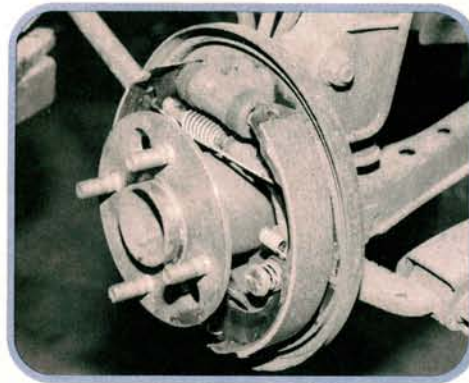
16

To remove a stuck rear brake drum, soak the hub and drum mating surfaces with penetrant, then thread two 10 X 1.0 mm bolts into the threaded brake drum holes until the drum breaks free. If the brake drum still won't come off, strike the drum with a soft hammer in the area between the wheel stud holes.

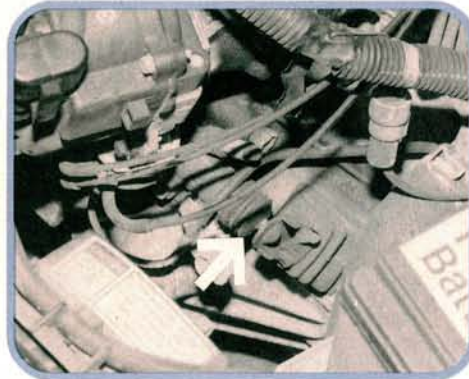
18

Hydraulic clutch actuation on manual transmission models means one less adjustment to check during a major service. Extend the service lives of the clutch slave and master cylinders by draining and bleeding the brake fluid during major services.

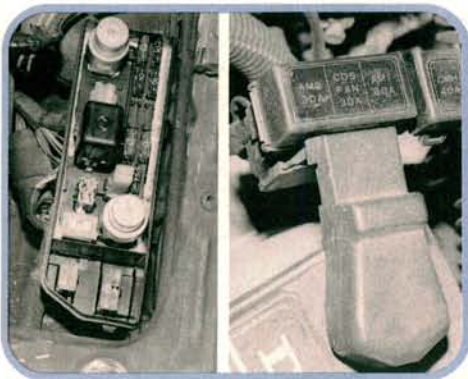
19

Common fuses and relays are located in the dash fuse box. Additional fuses and relays are housed in a panel next to the battery. The positive battery cable end contains the electrical system heavy hitters, the main fuses. These shouldn't blow unless the electrical problems are really large.
