Top to Bottom

Part Two

Welcome to the second half of our top to bottom look at a 1987 BMW 535 iS engine overhaul. We thought we had finished our top end coverage last month, but it turned out we were just getting started. This elevator is going to be stuck at the penthouse a little longer.

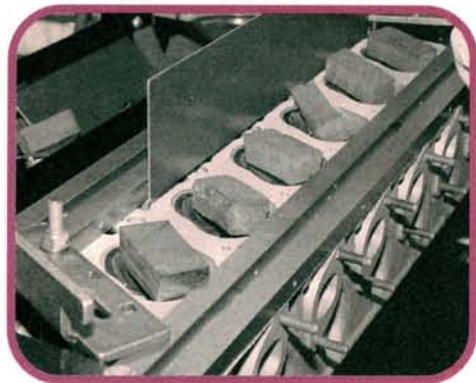
11

After giving the head a final pressure wash to remove the chips, we move to the head assembly bench. Foam rubber and sheet metal plates will hold the valves in position when we flip the head over. No more chasing the head all over the bench. Luxury like this can spoil you in a hurry.

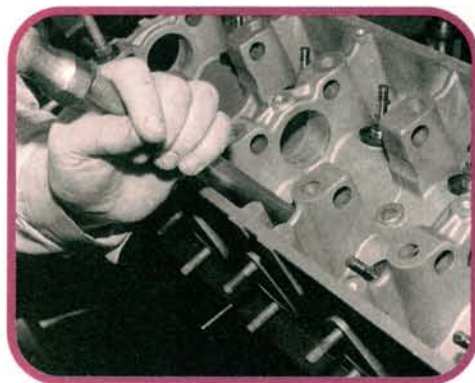
12

We've seen all sorts of inappropriate tools used to install valve seals. Valve seals are fragile, and can be easily torn or pushed out of shape with rough handling. This hollow punch pushes on the outside edge of the seal, assuring positive engagement on the guide shoulder.

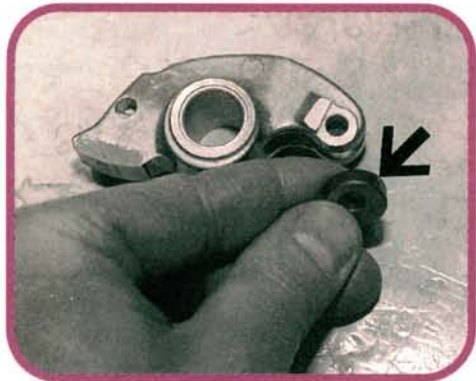
13

We're using all new rocker arms, eccentrics, and hardware. To properly install the eccentrics, place the rocker arm in front of you as shown. The eccentric's adjusting hole should be to the right of the mounting hole as shown. Turn the eccentric up for maximum clearance, then tighten the nut.

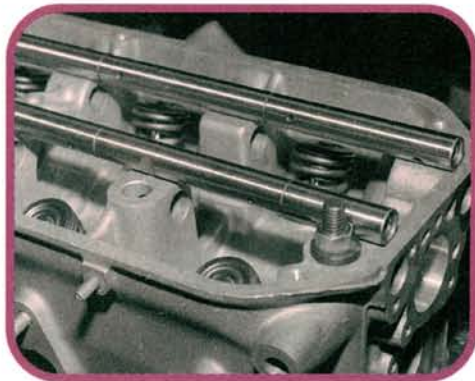
14

All four rocker shafts are different. The following tips will aid proper assembly. Longer shafts go toward the front of the head. The hex end plugs on all shafts must face out. Notches in the shafts line up with the head bolt holes. Lube holes in the rocker shafts line up with the rocker arms.

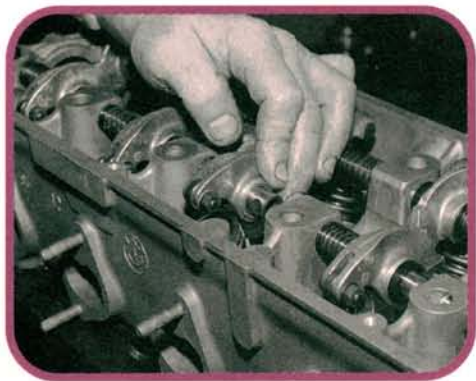
15

We're going to install the rocker arms and rocker shafts before the camshaft. Working from both ends of the head, slide the rocker shafts into position; adding rocker arms, spacer washers, springs, and thrust rings as you go. Hold the assembled shaft with a pin through a head bolt hole.

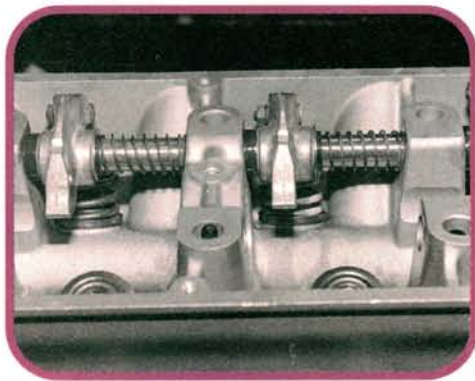
16

All intake valve rocker arm springs push the rockers toward the rear of the head. All exhaust valve rocker arm springs push from the rockers to the front of the head. A washer separates each spring and rocker arm. The thrust ring flanks the other side of the rocker arm. Its recessed side faces out.

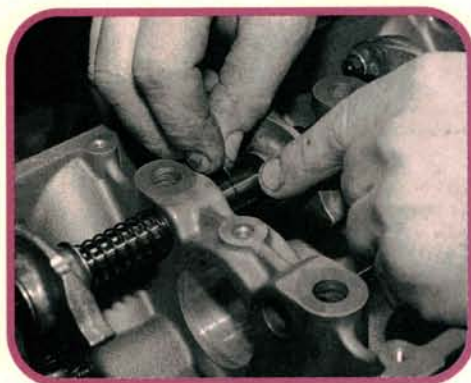
17

The pins keep the rocker shafts from rotating and also keep them from sliding back out of the head during the next step. Push the rocker arms and thrust rings aside, then install the rocker arm retaining ring. The rings wear on the thrust ring side and should be replaced during an overhaul.

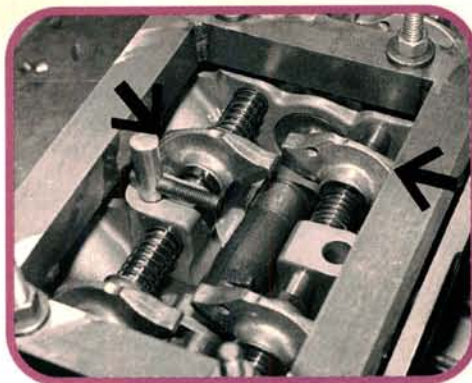
18

Not wanting to pay \$800 for the factory head fixture, Ray constructed his own. The fixture tabs index each of the rocker arms (arrows). By gradually tightening the fixture to the head, we can depress all of the valves, move the rocker arms out of the way, and reinstall the camshaft.

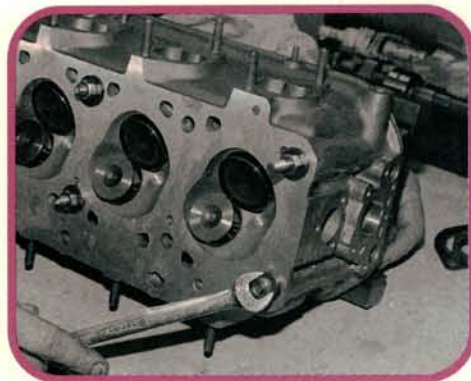
19

It's trickier than it sounds. Begin by gradually tightening the fixture bolts on the exhaust side of the fixture. After the exhaust valves have opened, begin tightening the fixture bolts on the intake side to open the intake valves. Watch for interference between the intake and exhaust valves.

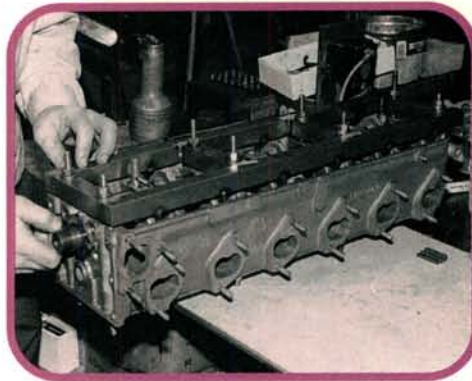
20

After tightening the fixture bolts, there is room to spare under the rocker arms. Slide the cam into position, then gradually loosen the fixture bolts to relieve the spring pressure. Keep your rocker arm locating pins in position until the fixture has been removed. This sure beats the hammer and punch method.

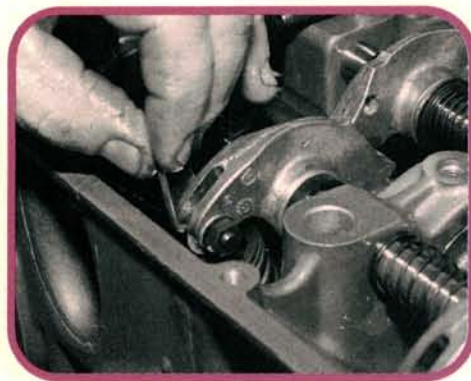
21

We'll give the valves a preliminary adjustment before we say goodbye to the head. Rotate the cam until both number 1 valves are lapping, then adjust the six valves that are closed to 0.30 mm (0.012 in). Rotate the cam until both number 6 valves are lapping, then adjust the remaining six valves.

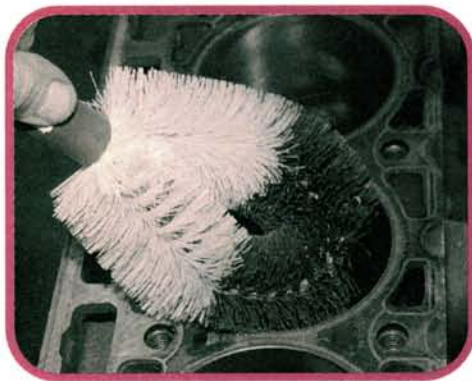
27

Overlooking this simple task can spell disaster for any aspiring engine builder. After we finished honing the cylinders, we carefully scrubbed the whole block with soap and water. All traces of the cylinder wall grit and hone material must be removed to assure proper ring performance.

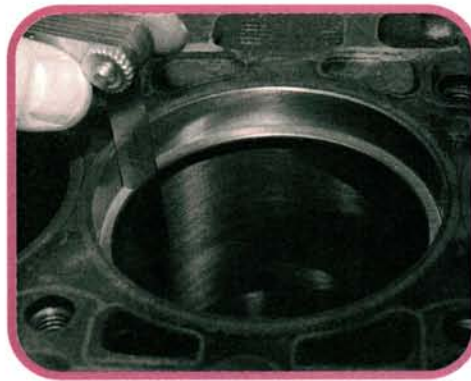
28

Check the ring end gap 15 mm from the top of the cylinder, using a feeler gauge. Use an inverted piston to square the ring in the cylinder bore. All three rings have different clearance requirements. They also vary according to engine size, so check a manual for the proper specs.
